Site: The Fields Neighborhood Park

Inspection Date: 10/22/2024

The Fields Park - 2024 Annual Cap Inspection Photo Log

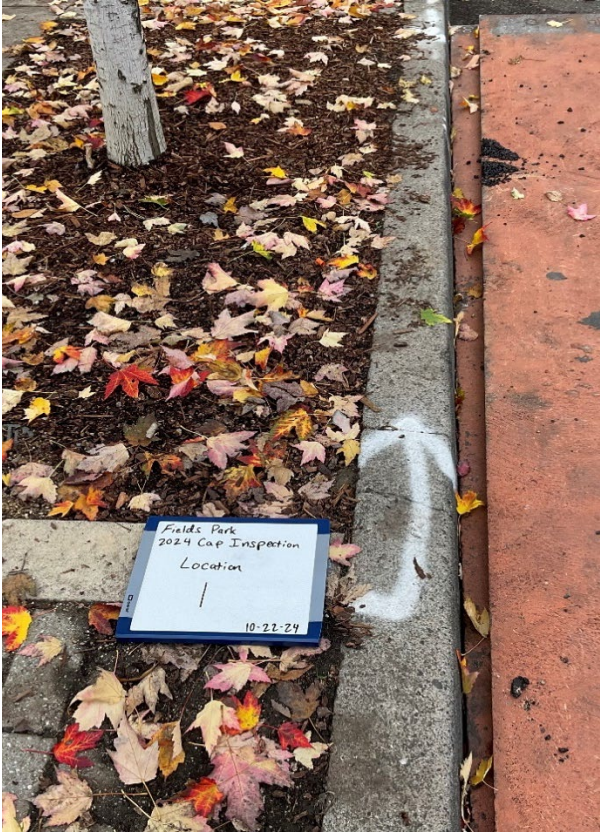
Photo Point #1

Minor surficial cracking and evidence of settling was observed in the concrete sidewalks on the perimeter of the park (photo points 1-3, 6-13, and 18). The minor cracks (generally <0.5 inches) were observed in previous inspections and do not penetrate the cap. Separation at the cracks was not observed. One (1) brick pathway is separating laterally, but the slight separation is limited to the uppermost brick layer and does not penetrate the sand pathway bedding. The separation does not penetrate the cap and the movement has not changed in several years (photo point #4).

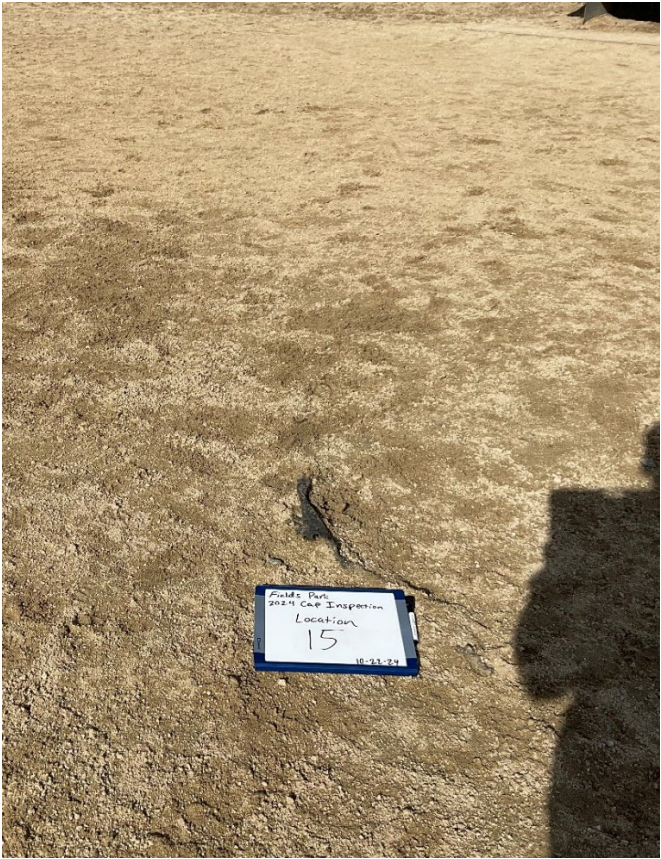
Landscaped areas, including the central grass area, other areas with plantings, as well as the dog off-leash area in the northern end of the park and the children’s playground in the southern end of the park, were inspected for holes, cracks, and visual evidence of exposed demarcation geotextile fabric. No damage was observed in the landscaped areas. A minor dug hole (< 4 inches deep) was observed in the off-leash dog area, but the hole was surficial in nature and did not penetrate the cap.

Photo Point #15 (off-leash dog park area)

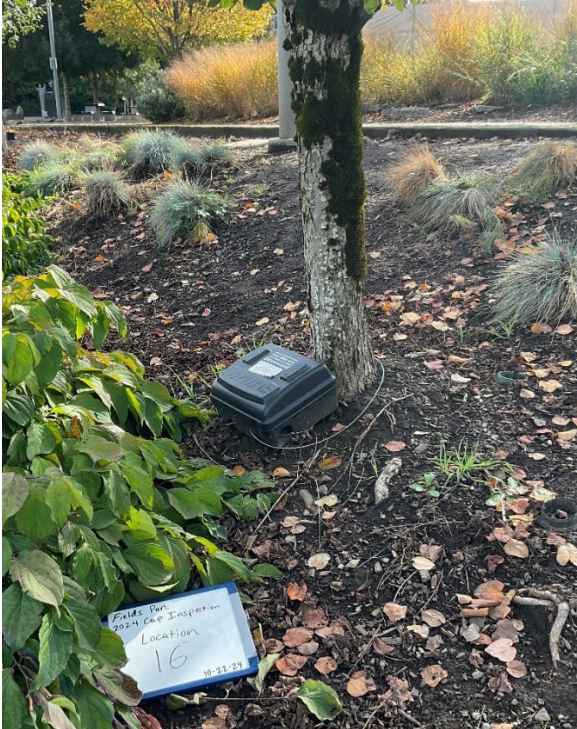
The children’s playground was in excellent condition and no damage was observed. Evidence of animal burrows were not observed this year and Parks staff continues to control for rodents in the park (photo point 16). See attached Photo Log for copies of the current year inspection photos.

Photo Point #16 (rodent hole monitoring/vector control, many located around park)

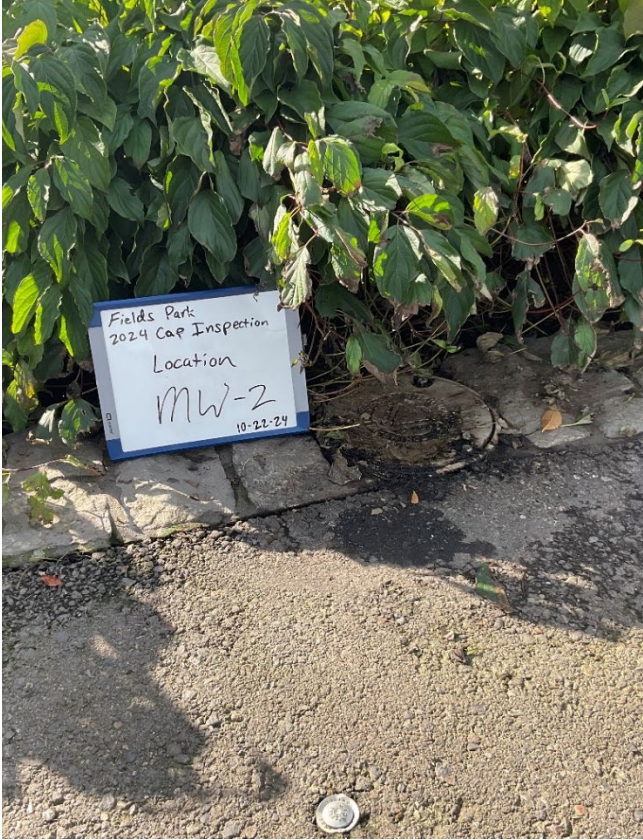
Monitoring Well #2

Monitoring wells 2, 3, and 4 were decommissioned in December 2023 by a Burlington Northern Santa Fe (BNSF) contractor. The monument for monitoring well 3 has been completely removed and replaced with a new concrete sidewalk panel. Monitoring wells 2 and 4 have been grouted in place and the monuments remain. The remaining monuments were in good condition. See attached Photo Log for current year inspection photos. Parks will continue to monitor these locations in the future.
