# ROAD REPAIR WORK PLAN

ALKALI LAKE SITE  
LAKE COUNTY, STATE OF OREGON  
PROJECT # 261M136620

ALKALI LAKE SITE  
LAKE COUNTY, STATE OF OREGON  
PROJECT # US261M136620.3223

September 17, 2024

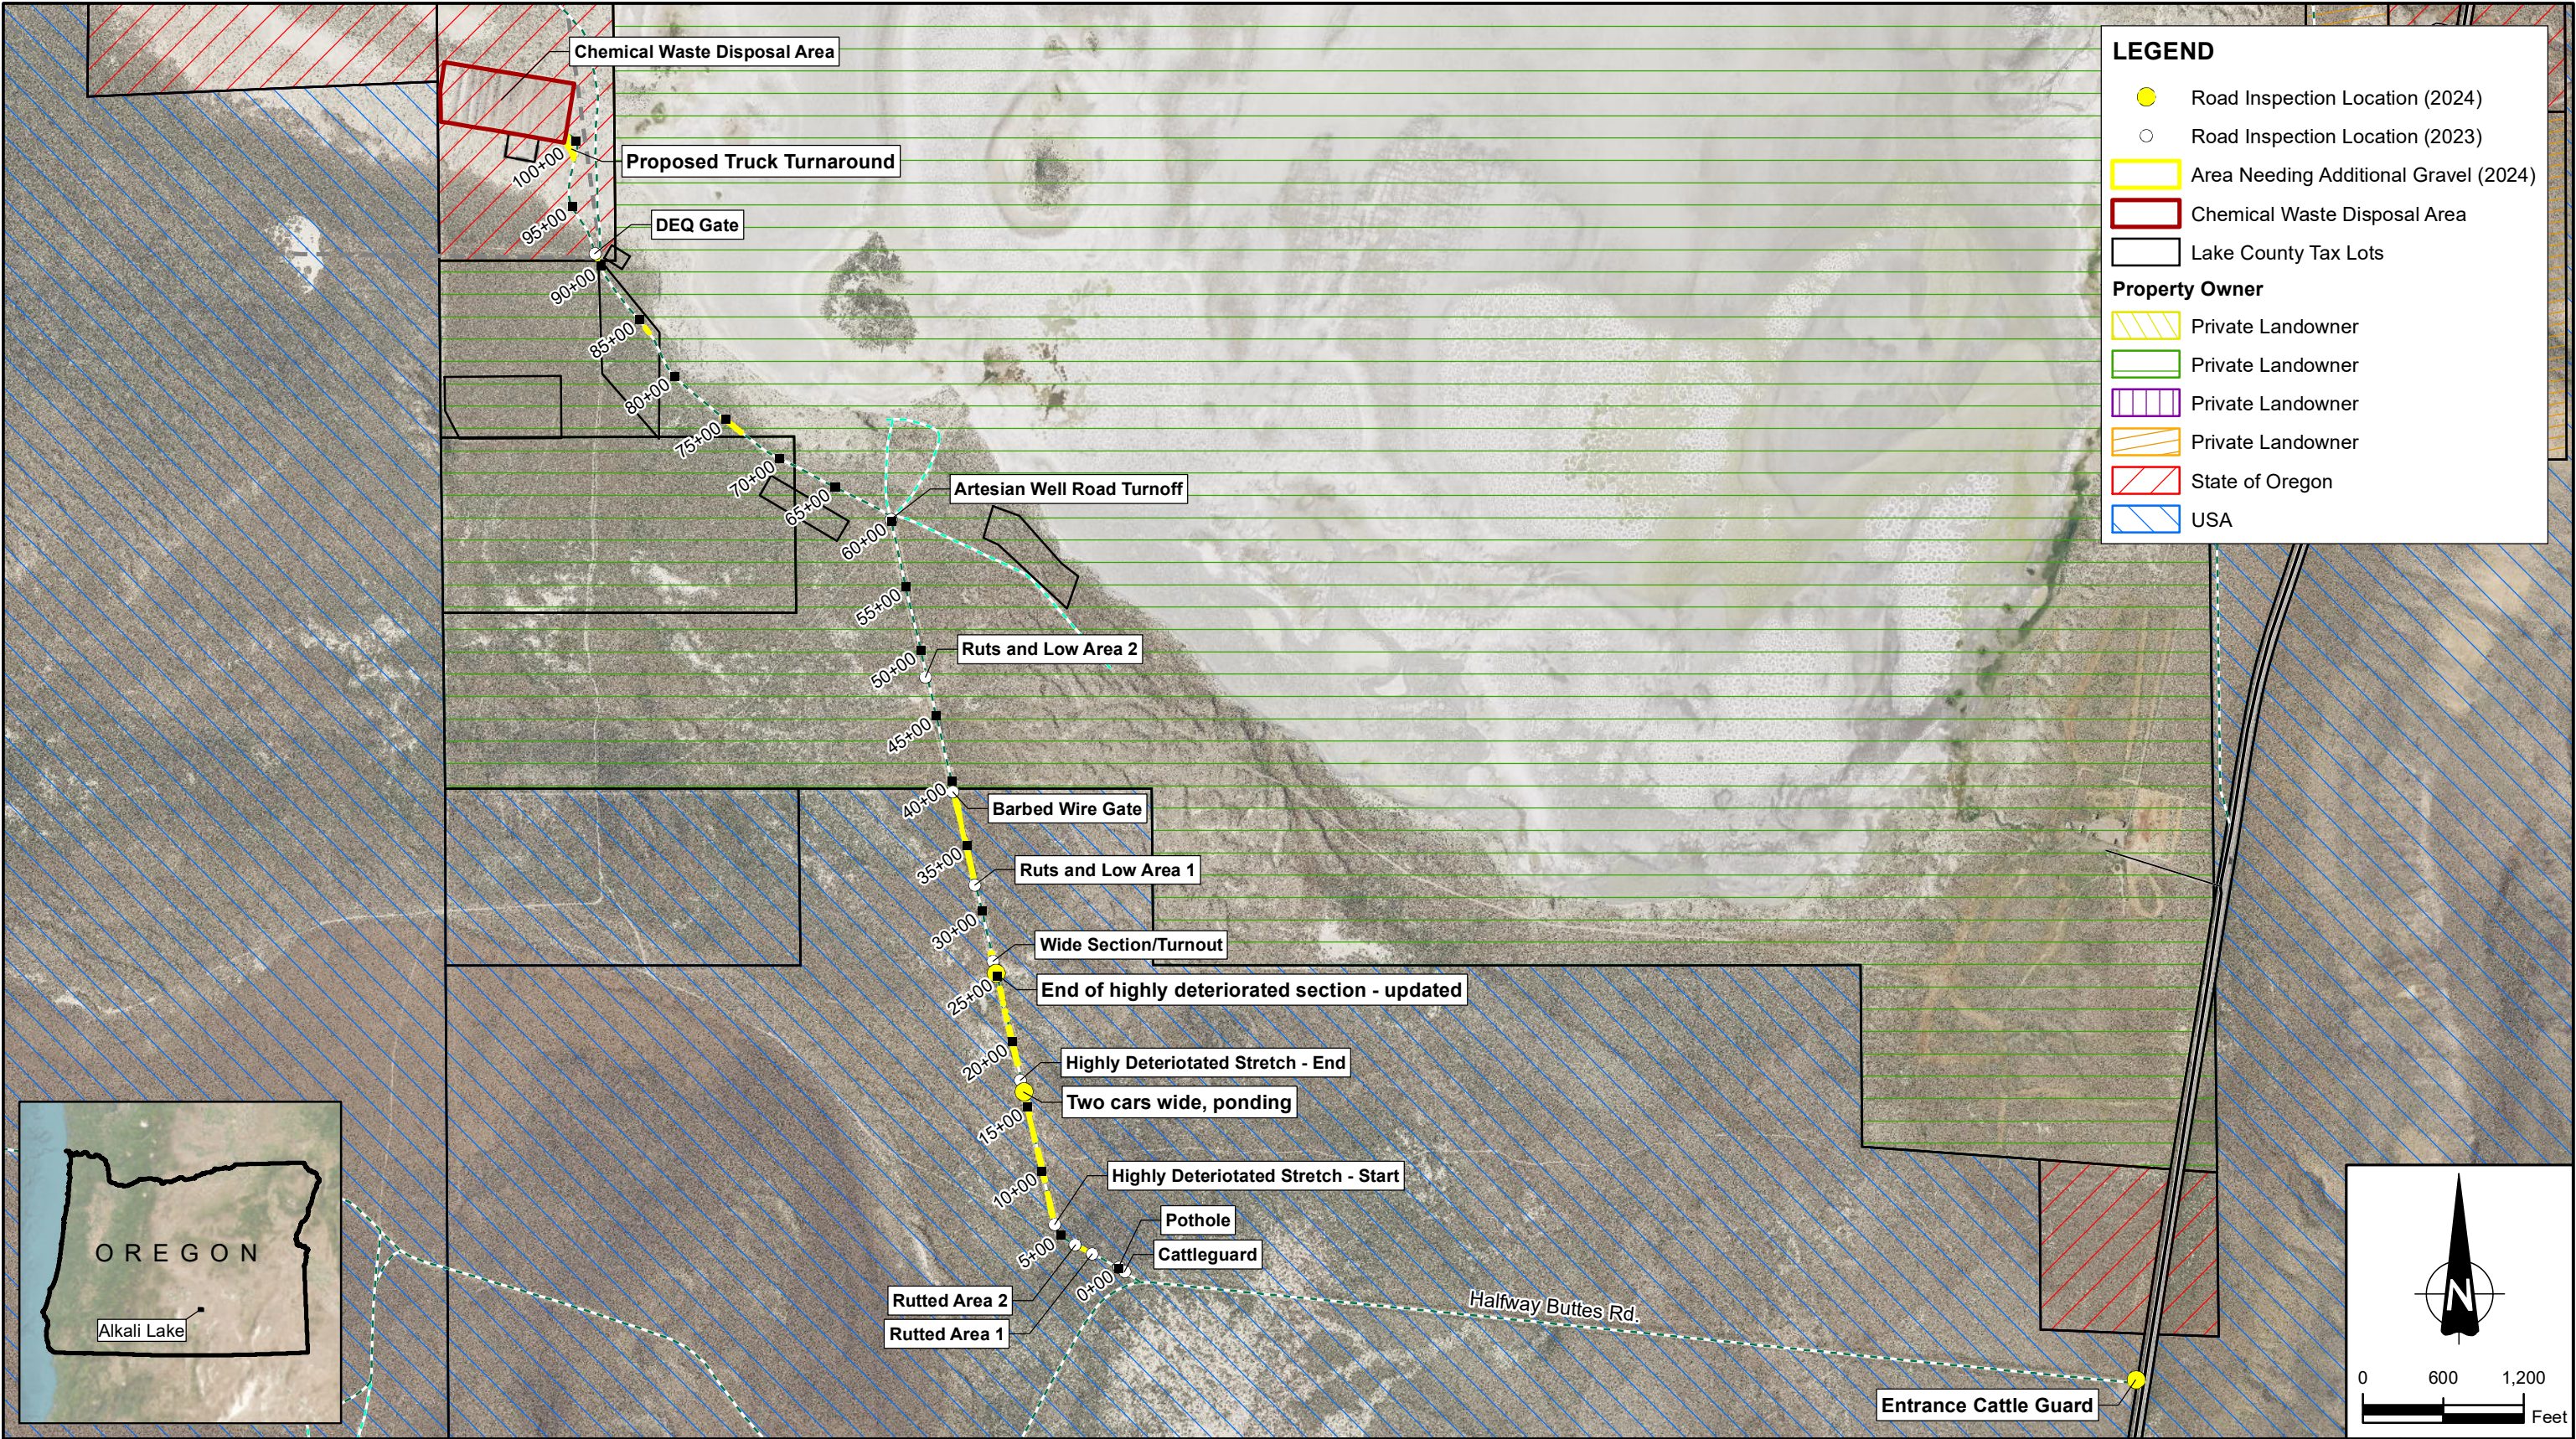
| FIGURE | 2 |

The road leading to the CWDA from Halfway Buttes Road is a one lane unimproved road with one wider section that could be used as a turn out to allow for passing vehicles. Portions of this road are potholed and have tire rutting that would limit Site access in its current condition to high-clearance and four-wheel drive vehicles during and following wet weather events. The road is narrow in places with only a foot or two on either side of a pickup truck between the sagebrush growing adjacent to the road. Additionally, there is sage brush growing in the middle of the road. The road consists primarily of the natural clayey silt and gravel from past road maintenance activities. Appendix A has a photograph log showing pictures of the current road conditions during the most recent site visit on August 27-28, 2024.

ACCESS ROAD INSPECTION  
AUGUST 27, 2024

In the locations along the access road identified to be degraded as shown in Figure 2 (i.e., potholes, tire ruts, and other deformations) the proposed repairs are to re-grade the surficial fine-grained soils, flatten the existing surface, and place up to 6 inches of 3/4-inch to 2-1/2-inch clean crushed gravel to fill in these areas as needed to raise the low spots to match the surrounding grade. The gravel repairs will be compacted and verified in the field by the WSP engineer of record or engineer's representative. Compaction verification will be limited to visual inspection via proof-rolling with a fully loaded truck.

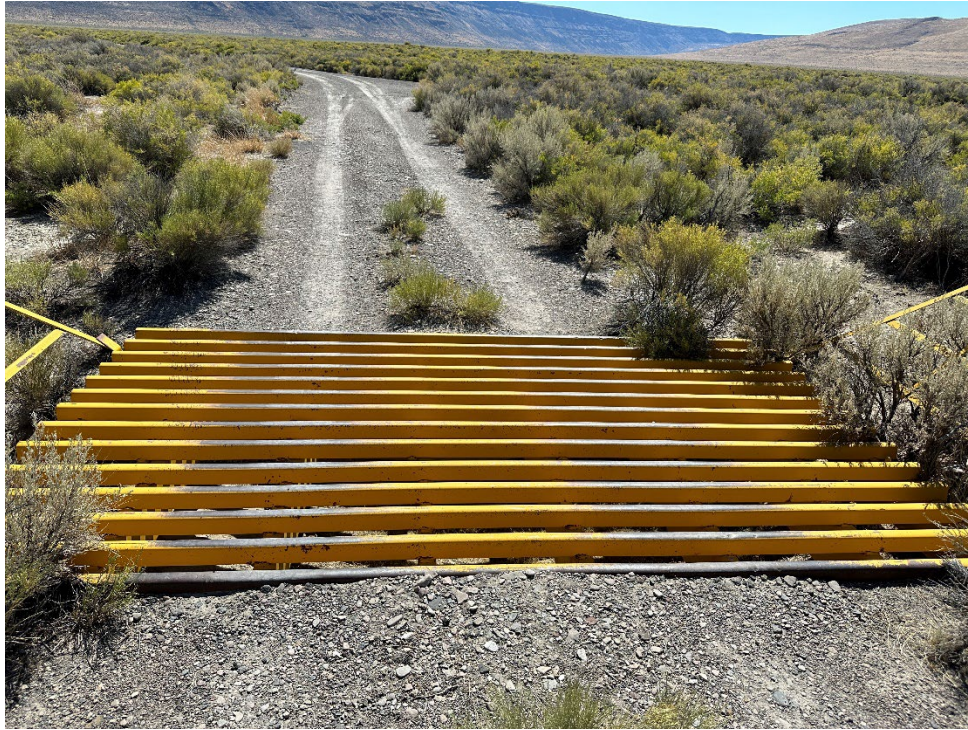
**Photograph No. 1:**

Cattleguard at start of single lane road after turning off two-lane Halfway Buttes BLM road. Station 0+00. Looking southeast.

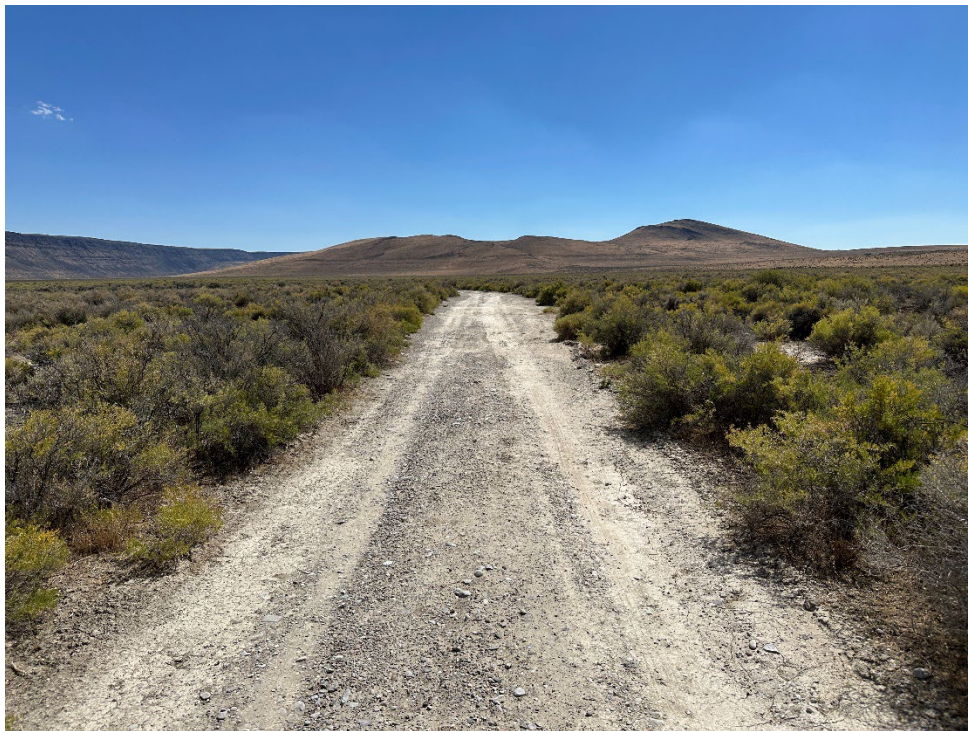
**Photograph No. 2:**

Typical road section with gravel from past roadwork that has been driven into to the native soils. Station 5+00 Looking south.

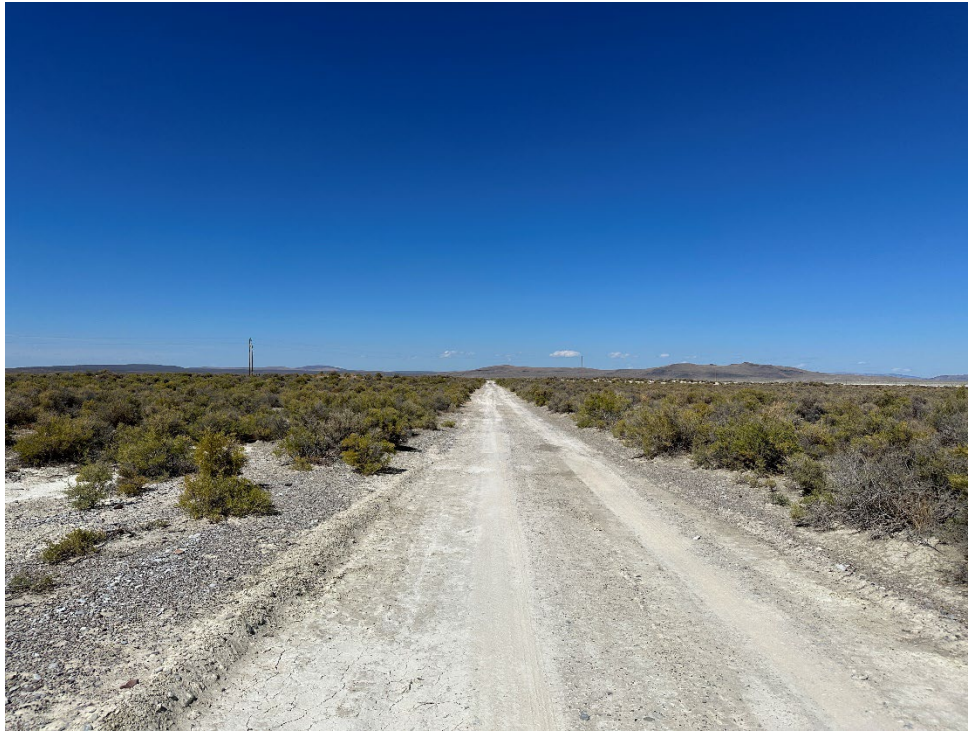
**Photograph No. 3:**

Low area of the road with cracked dry soil evident of ponding water during wet weather. Station 15+00  
Looking northwest.

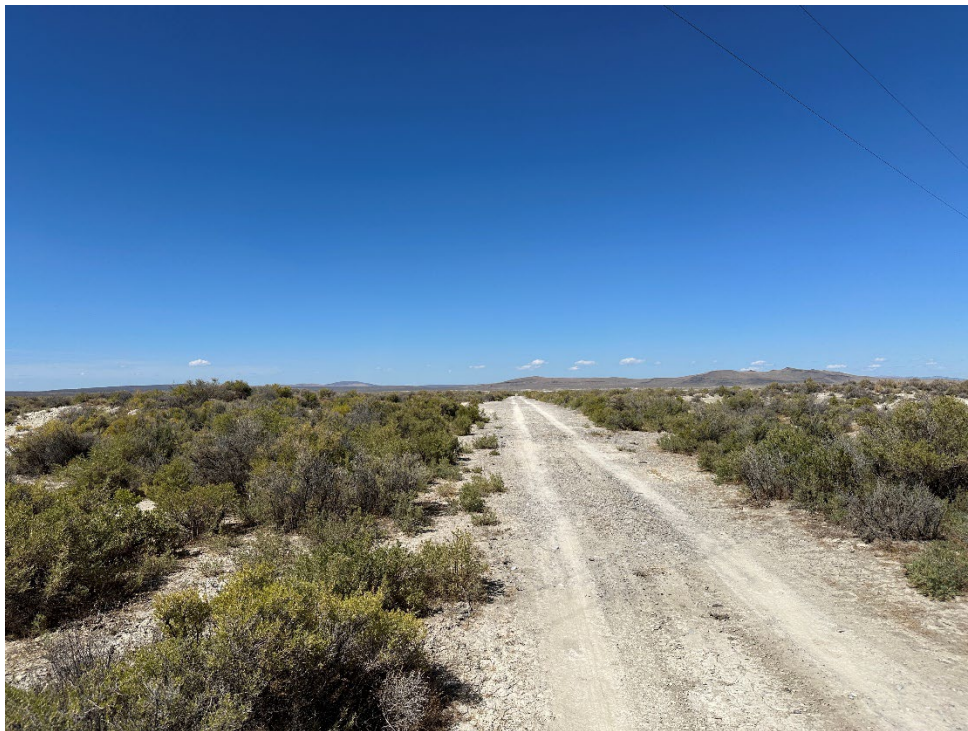
**Photograph No. 4:**

Slightly wider section of the road with minor tire rutting. Looking north towards Alkali Lake and the CWDA. Station 30+00

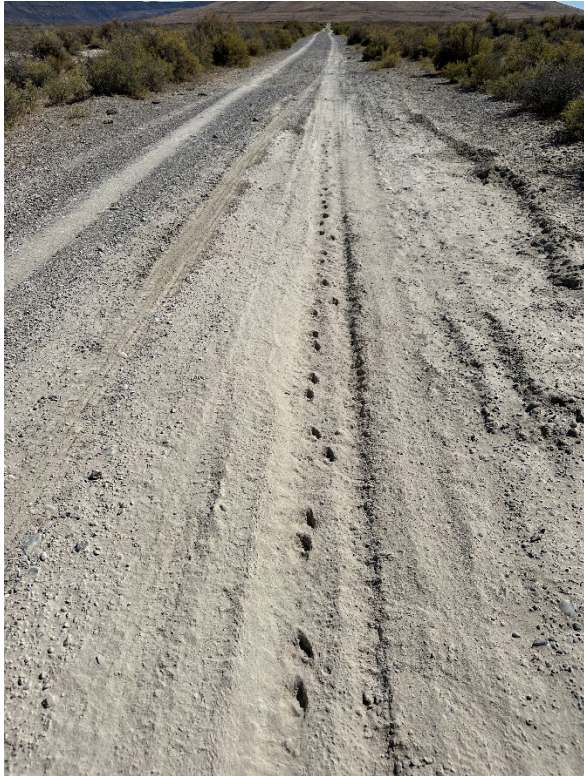
**Photograph No. 5:**

Low area with dry silty soils that were soft for 1-2" before hitting gravel. Station 35+00. Looking south.

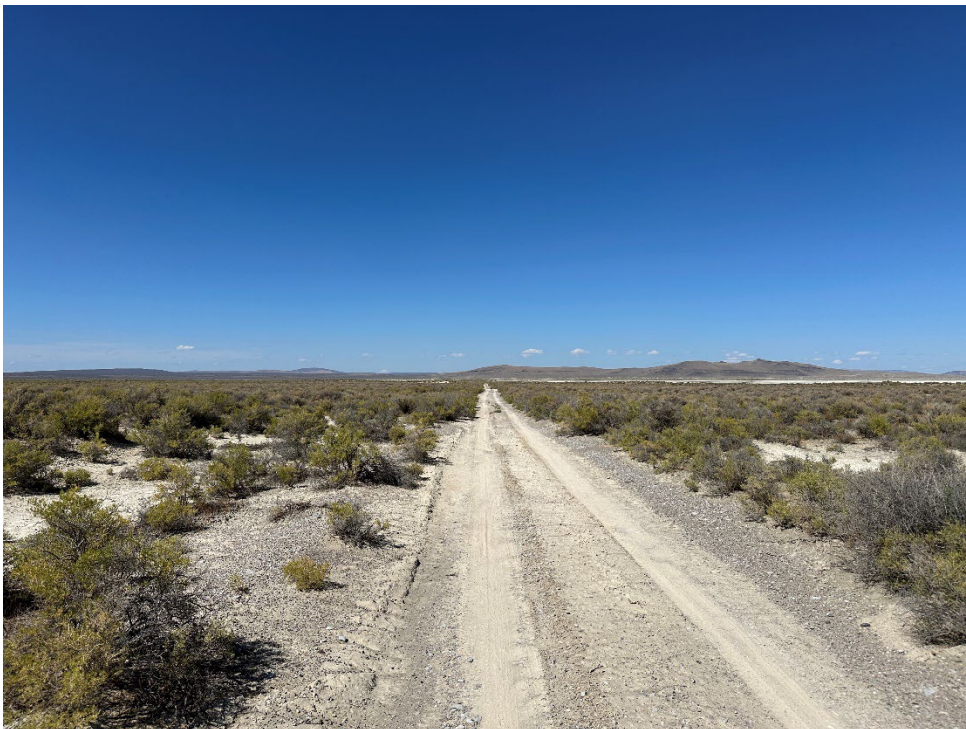
**Photograph No. 6:**

Typical shallow tire rutting of 1-2" in depth. Looking North. Station 70+00

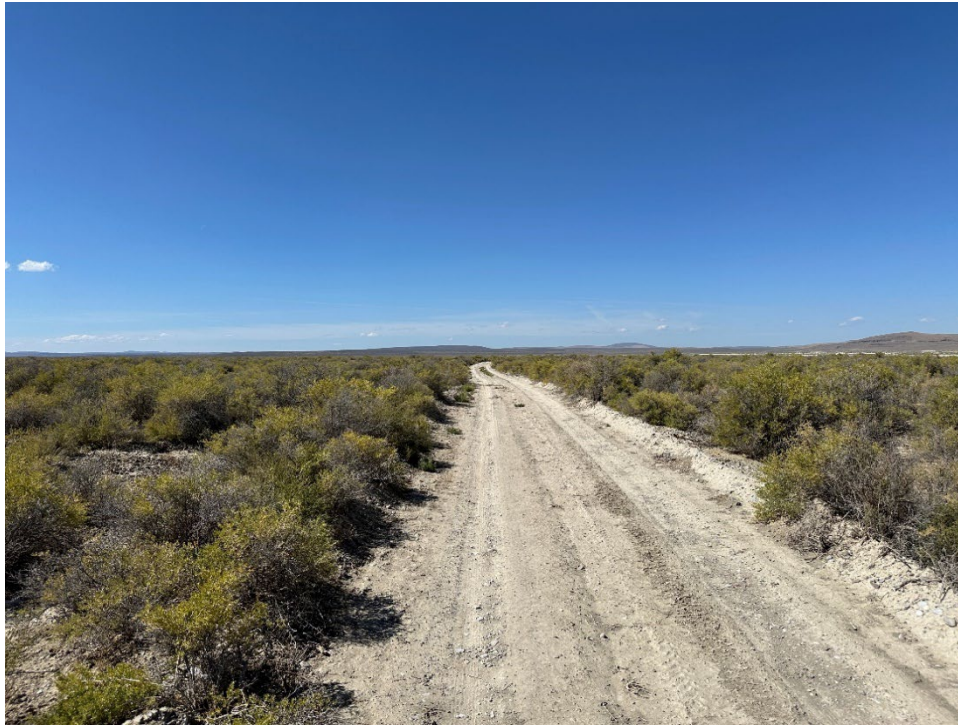
**Photograph No. 7:**

Road shown with surrounding grade 4-6" higher than the roadbed leading to drainage issues and ponding of water. Station 74+00 Looking north.

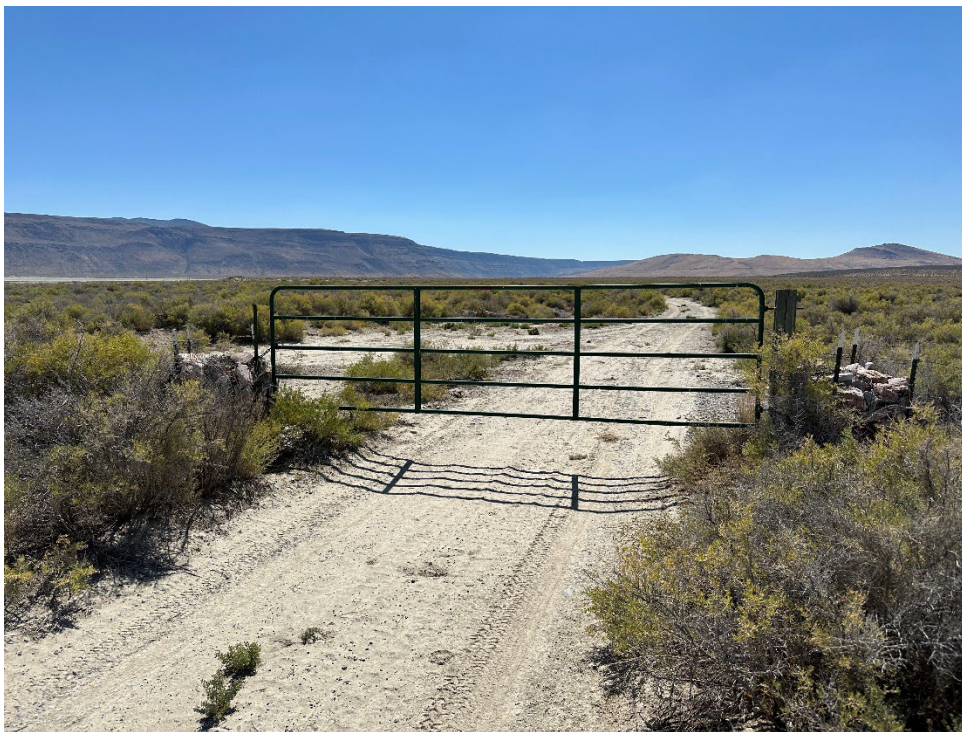
**Photograph No. 8:**

Fence separating private property from DEQ property. Station 90+00. Looking southeast.

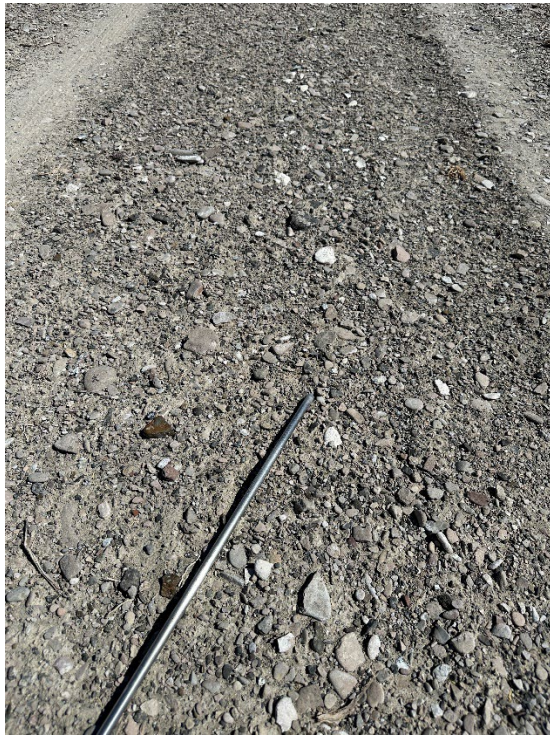
**Photograph No. 9:**

Existing gravel shown with a 1/2" diameter T-Probe shown for scale.

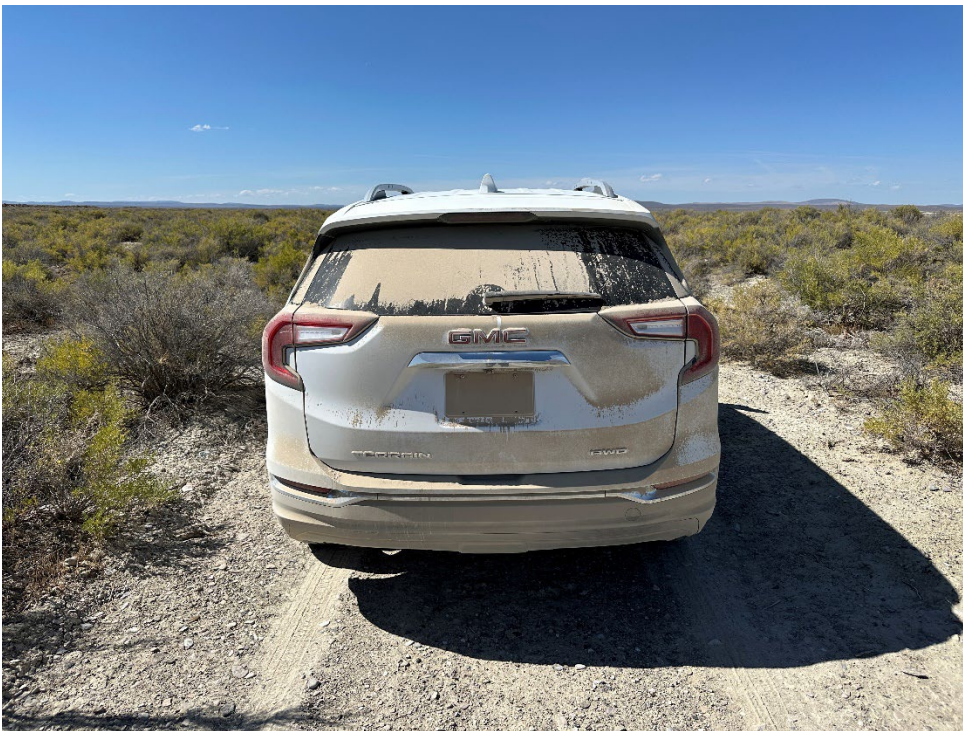
**Photograph No. 10:**

Typical roadway width in a narrow area with a vehicle shown for scale. Looking north.

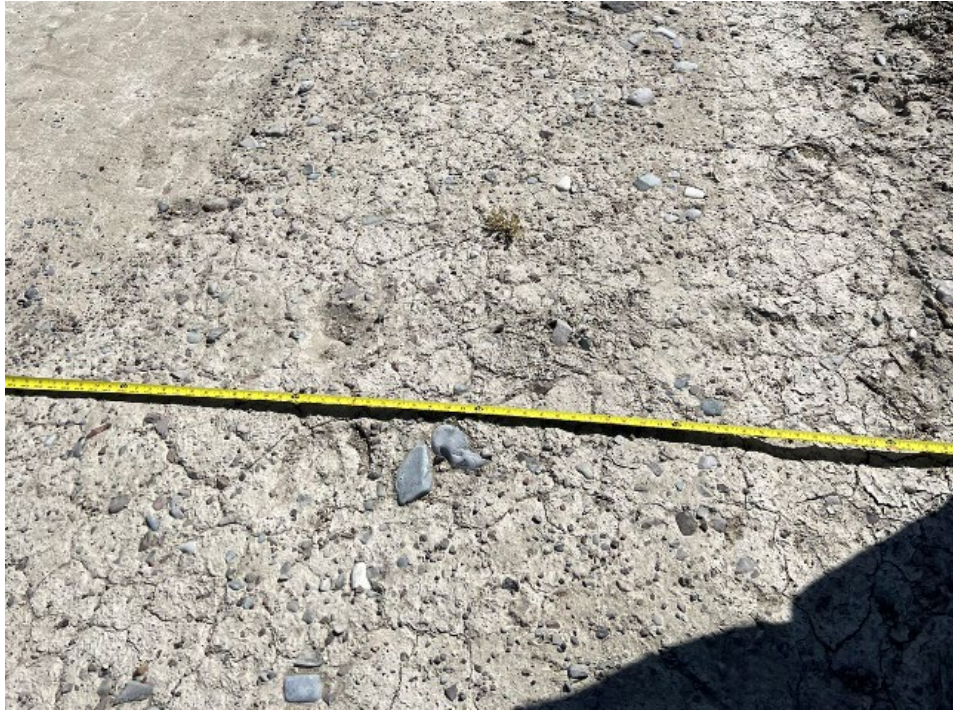
**Photograph No. 11:**

Road width of 20 feet in a wider area.
