April 2, 2025

Re: Riverbank Monitoring Report  
Swan Island Upland Facility - Operable Unit 5  
Portland, Oregon  
ECSI No. 271  
1115-25

### **2024 Photograph Log**

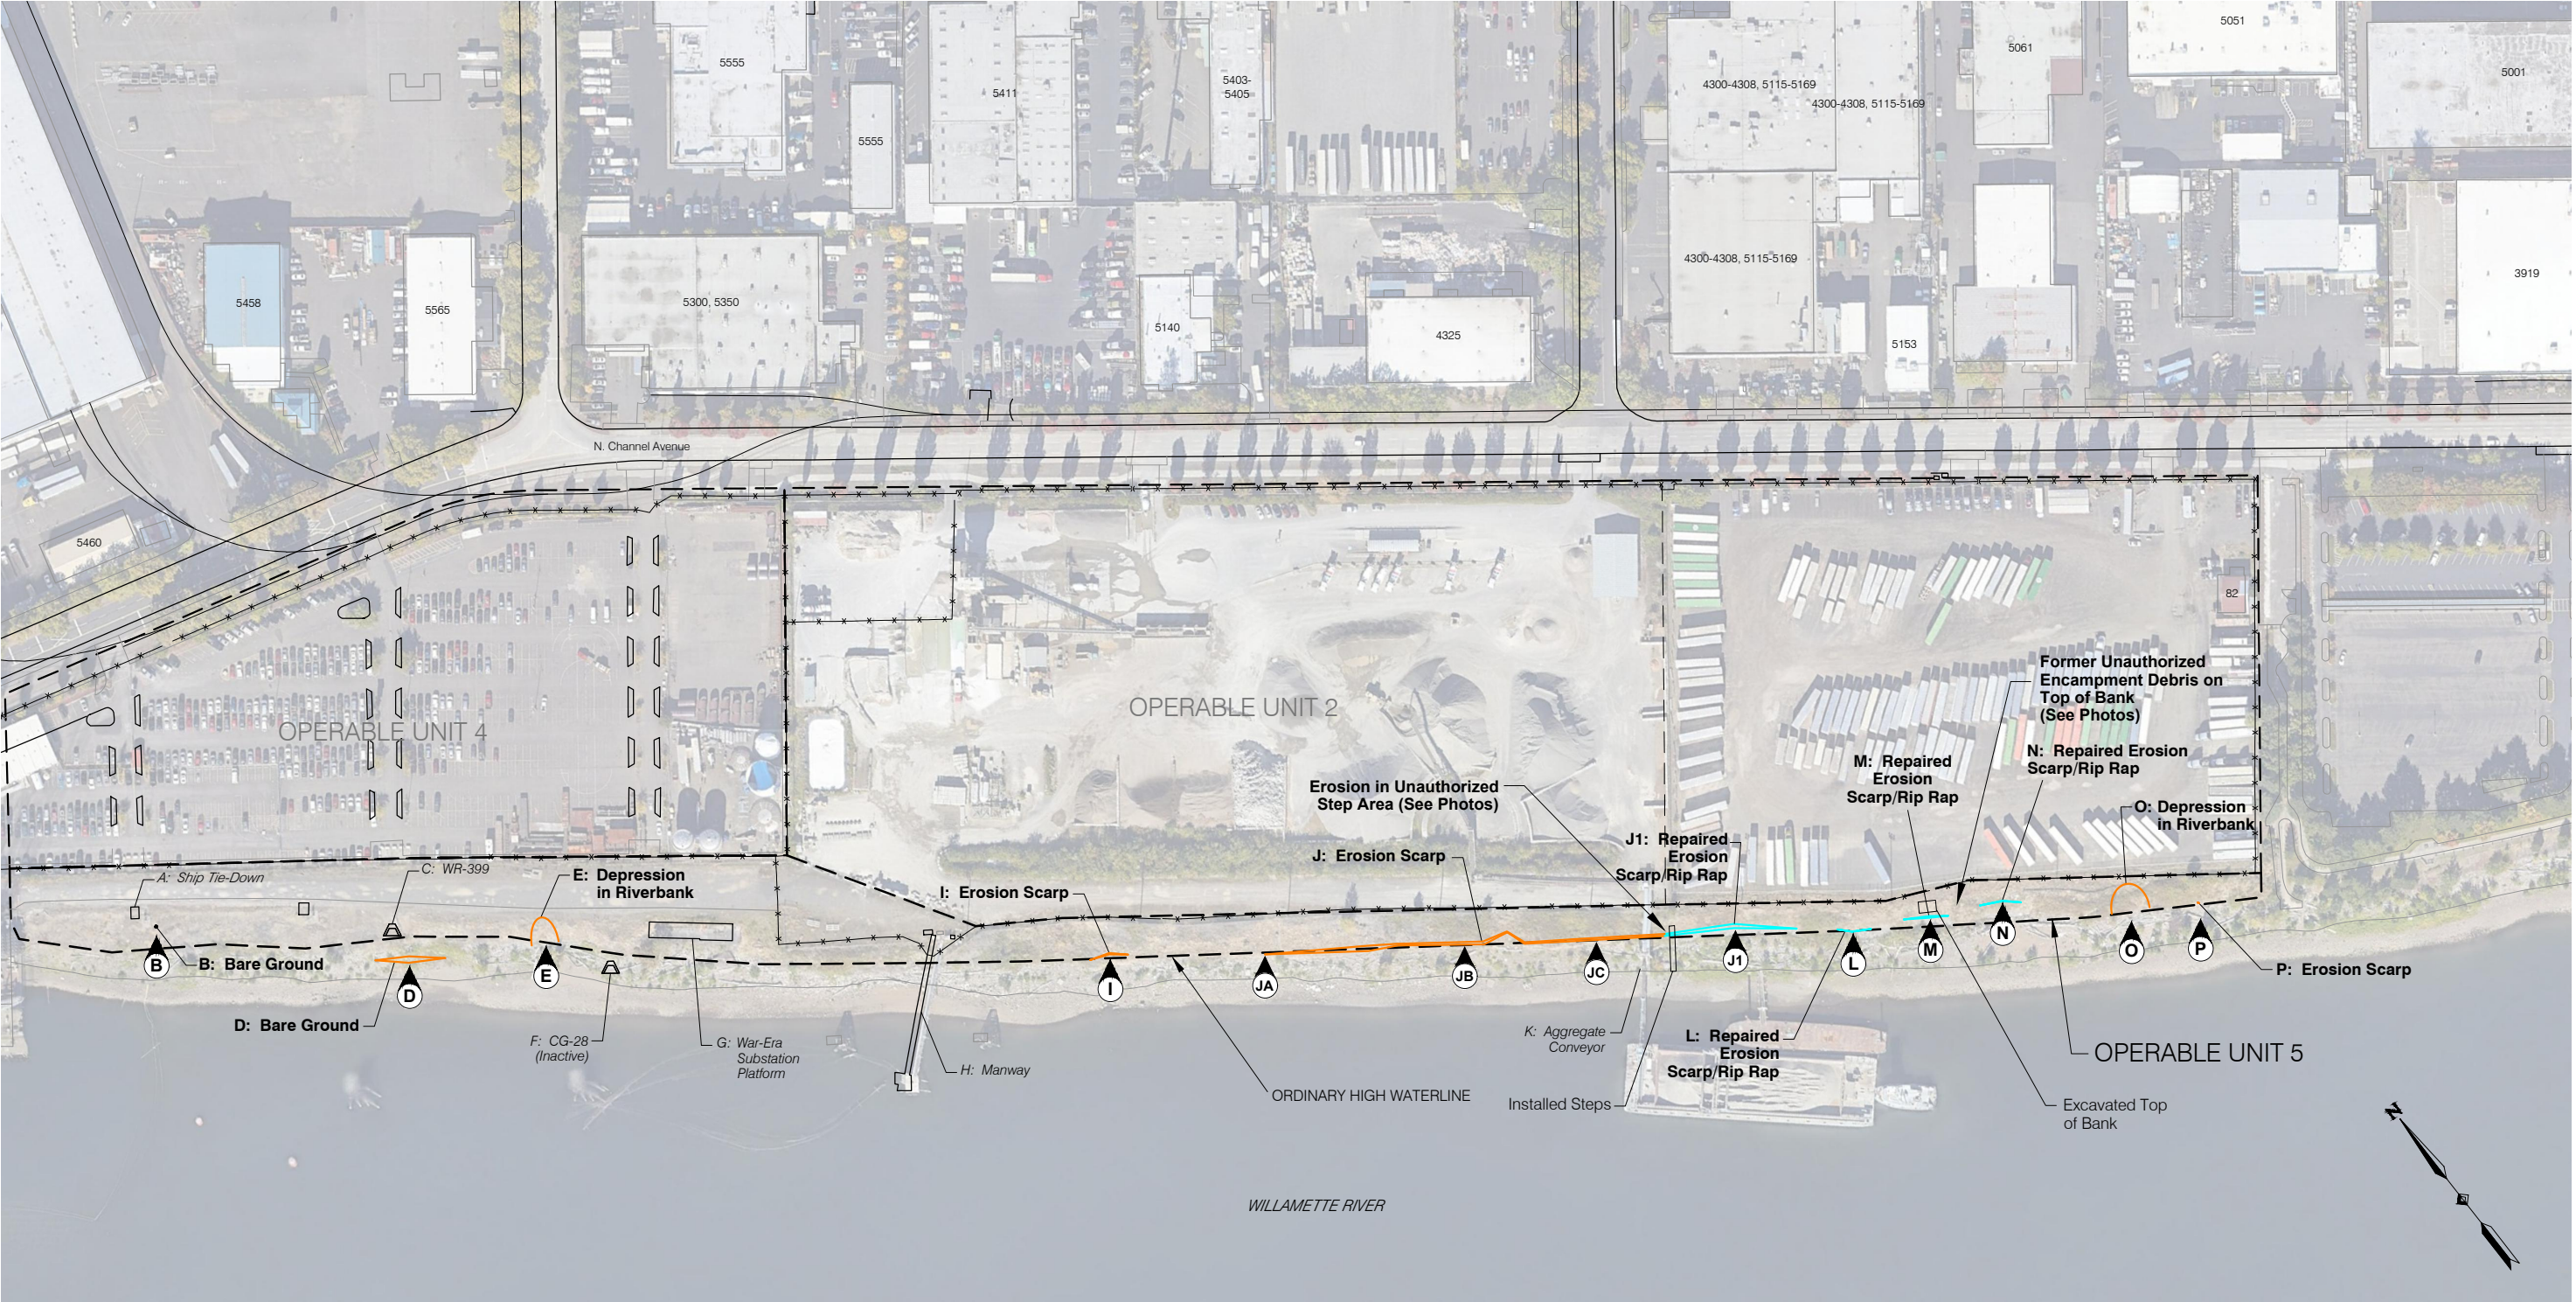
Figure  
**3**

**Rip Rap.** The rip rap coverage at repaired scarp locations J, L, M, and N as shown on Figure 3 was mostly consistent with the locations of the scarps as verified by utilizing previous inspection photos and landmarks along the riverbank. Minor exposure of filter fabric and depleted rip rap was observed at location L due to trespass. No other disturbances of the rip rap in areas outside the scarp repair were observed.

**Existing Erosional Features.** Existing erosional features B, D, E, I, J, O, and P were inspected for any change in size or location. Representative photographs in Attachment B show the existing conditions of these features. No significant changes in these features were observed during the 2024 inspection event.

### Erosional Features

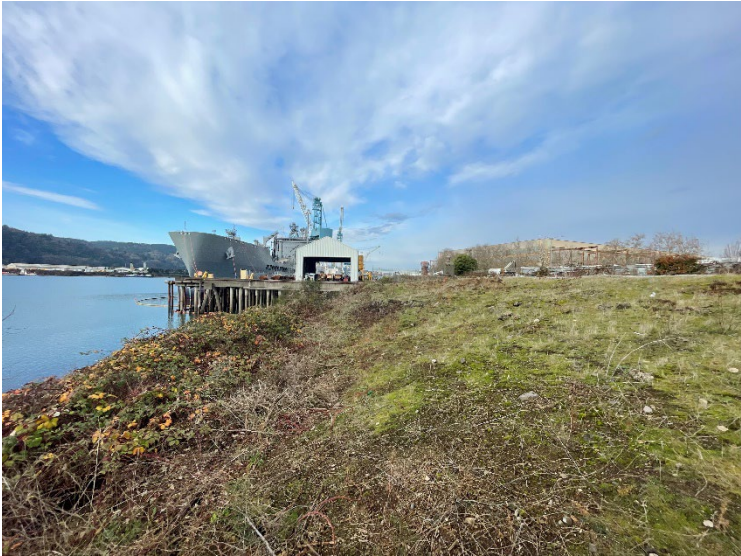
| <b>Photo Station:</b> B | A photograph showing a grassy, eroded bank in the foreground. In the background, a large ship is docked at a pier, and a body of water is visible under a blue sky with scattered clouds. |

| <b>Description:</b><br><br>Existing erosional feature B adjacent to Vigor Industries. | |

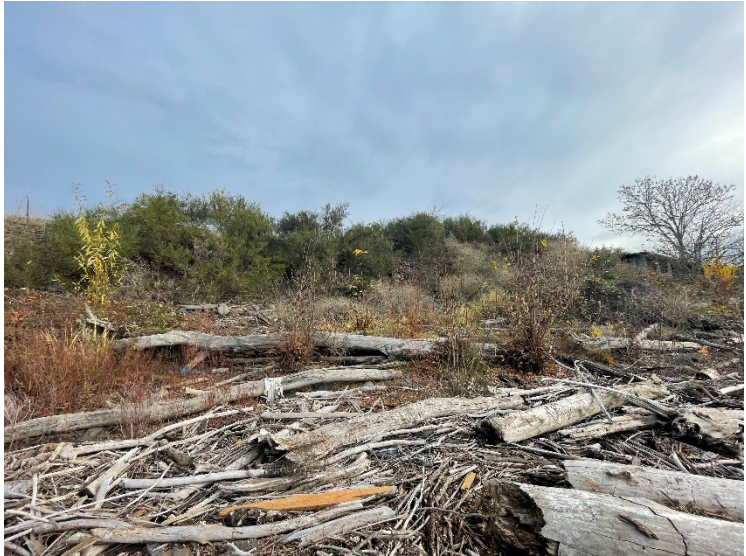
| <b>Photo Station:</b> E | |

| <b>Description:</b><br><br>Existing erosional feature E (depression in riverbank) adjacent to Vigor Industries. | |

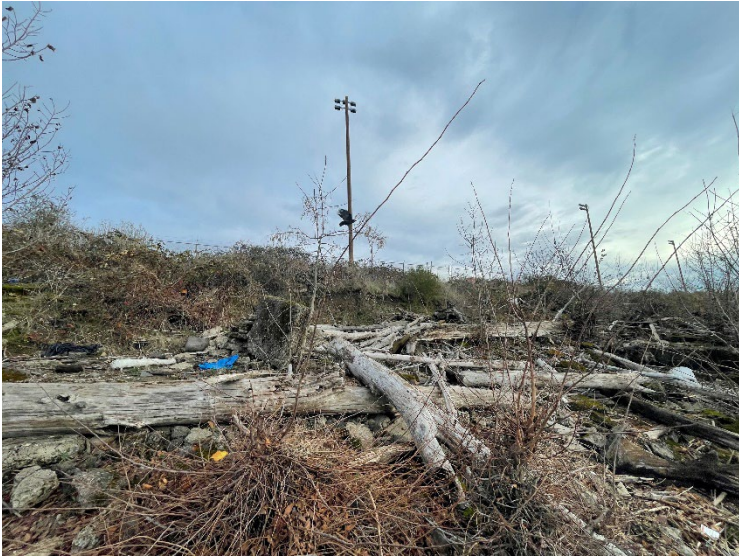
| <b>Photo Station:</b> I | A photograph showing a steep, eroded bank covered in dry, brown brush and scattered rocks. A utility pole is visible in the background against a cloudy sky. |

| <b>Description:</b><br><br>Erosional feature I (erosion scarp) adjacent to Cemex leasehold. | |

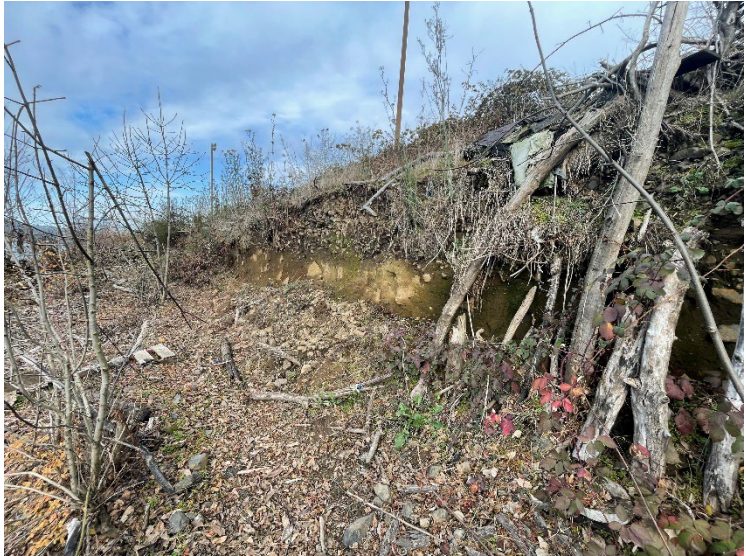
| <b>Description:</b><br><br>Existing erosional feature JB (center of erosion scarp) adjacent to Cemex leasehold. | |

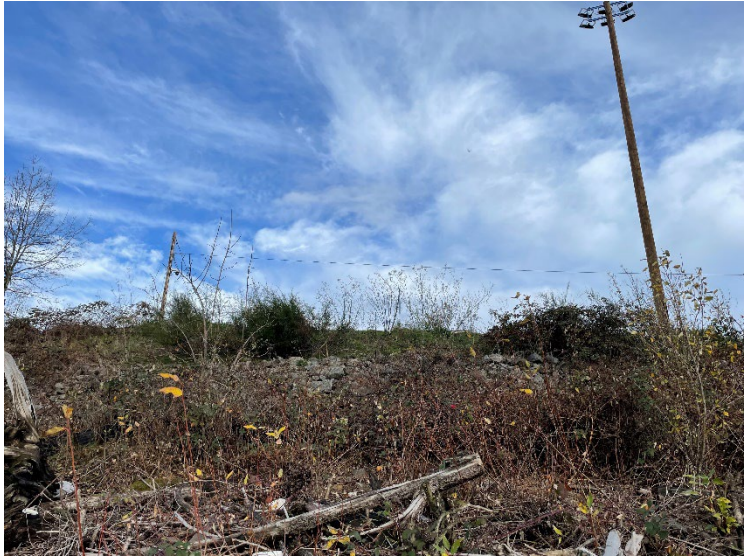
| <b>Description:</b><br><br>Erosional feature J1 (repaired former erosion scarp) rip rap at west end of Daimler leasehold.<br><br>Note: Rip rap in place and silt fence still visible. | |

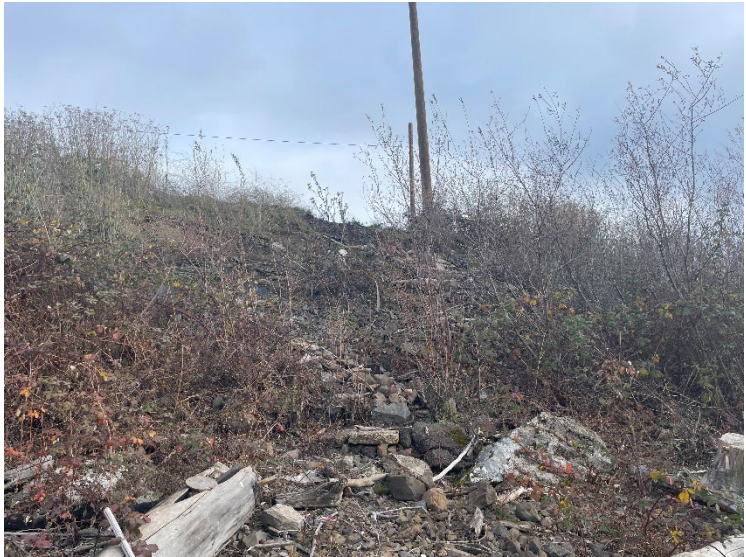
| SOURCE CONTROL INSPECTION CHECKLIST | | | | |
|---|---|---|---|---|
| | Is filter fabric visible?<br><i>Collect GPS coordinates and photos where visible.</i> | Yes <input checked="" type="checkbox"/> No <input type="checkbox"/> | Minor exposure of filter fabric and depleted rip rap was observed at location L. | Yes <input type="checkbox"/> No <input checked="" type="checkbox"/><br><br>Riverbank <input type="checkbox"/> |

| <b>Description:</b><br><br>Erosional feature L (repaired former erosion scarp) rip rap adjacent to Daimler leasehold.<br><br>Note: Exposed edge of filter fabric and depleted rip rap. | |

No corrective action is proposed at this time. No significant changes have been observed as a result of natural erosion since annual bank inspections were initiated in 2018 and the minor exposed bank repair demarcation and filter fabric layers will be addressed in coordination with in-water remedy activities. Based on the results of bank inspections conducted to date, the Port requests that the requirement for annual bank inspections be extended to once every three years (or following significant flood events).

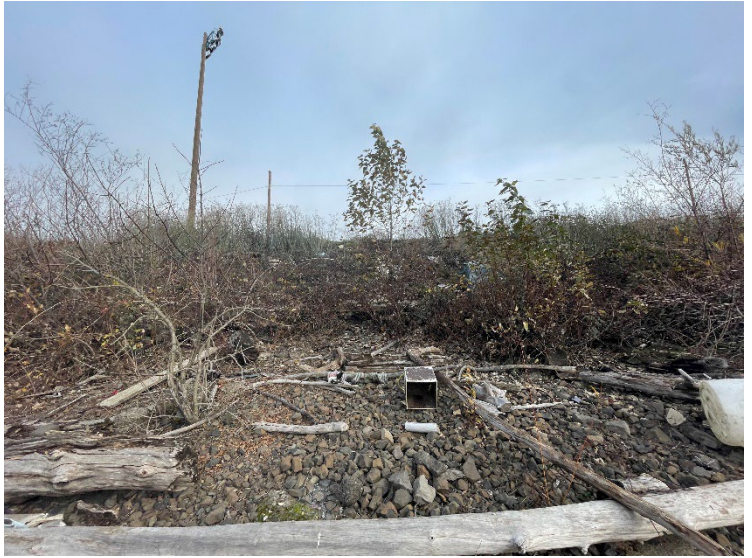
| <b>Photo Station:</b> M | |

| <b>Description:</b><br><br>Erosional feature M (repaired former erosion scarp) rip rap adjacent to Daimler leasehold.<br><br>Note: Area of former unauthorized encampment structures. | |

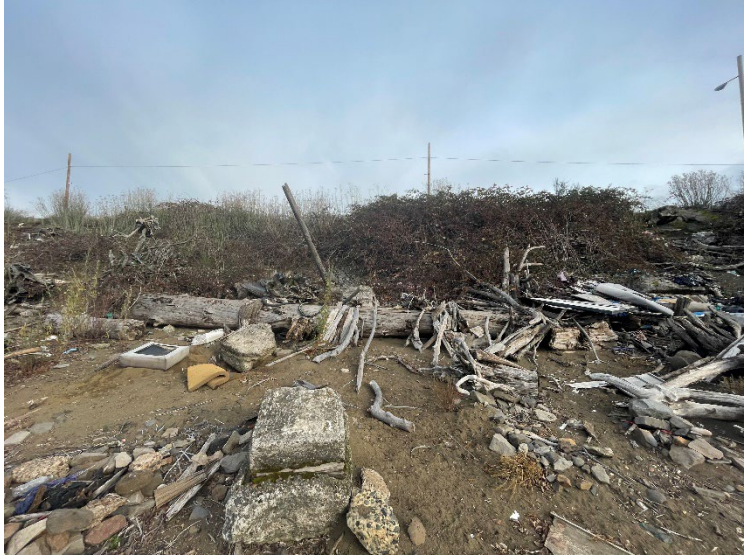
| <b>Photo Station:</b> N | |

| <b>Description:</b><br><br>Erosional feature N (repaired former erosion scarp) rip rap adjacent to Daimler leasehold. | |

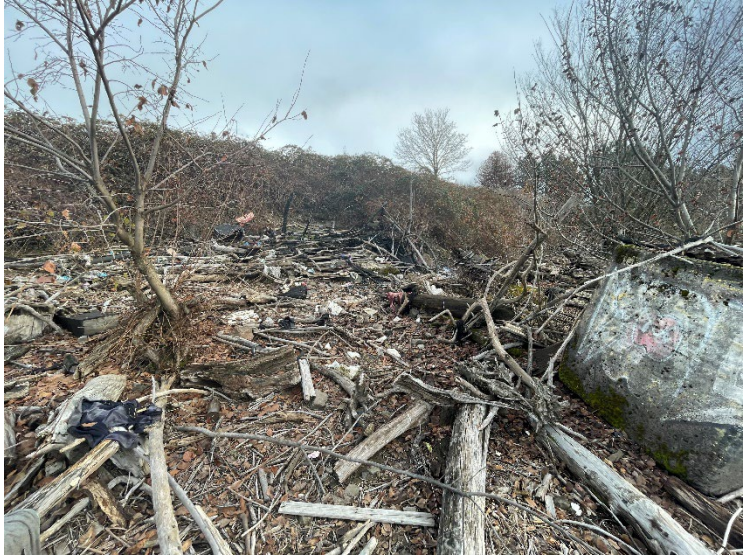
| <b>Photo Station:</b> O | |

| <b>Description:</b><br><br>Erosional feature O (depression in riverbank) adjacent to Daimler leasehold.<br><br>Note: Burned former unauthorized encampment structures. Large concrete blocks in the area. | |

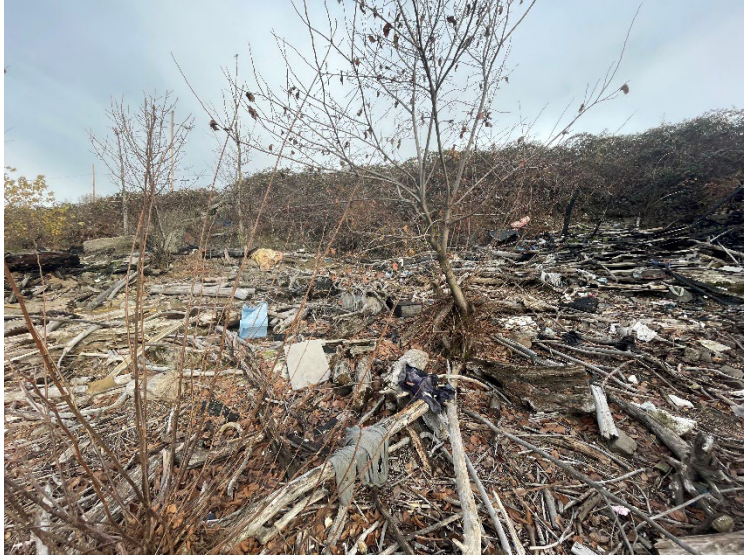
| <b>Photo Station:</b> O | |

| <b>Description:</b><br><br>Erosional feature O (depression in riverbank) adjacent to Daimler leasehold.<br><br>Note: Burned former unauthorized encampment structures. Large concrete blocks in the area. | |

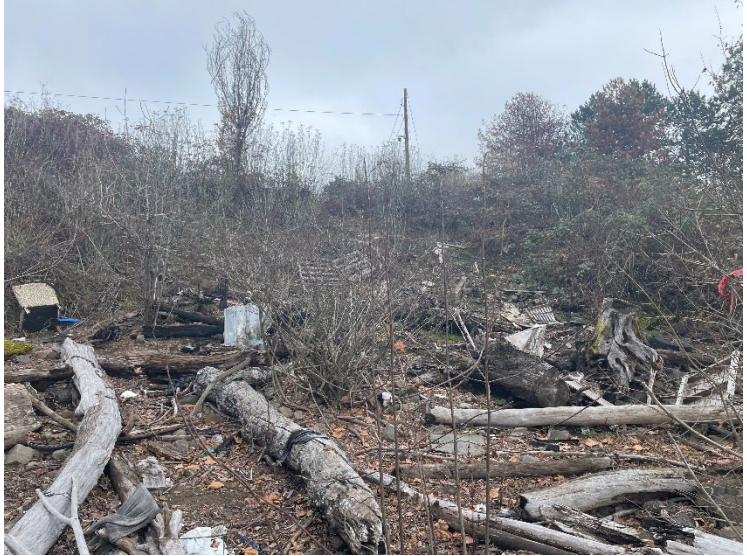
| <b>Photo Station:</b> P | |

| <b>Description:</b><br><br>Erosional feature P (erosion scarp) near east end of Daimler leasehold.<br><br>Note: Burned former unauthorized encampment structures. | |

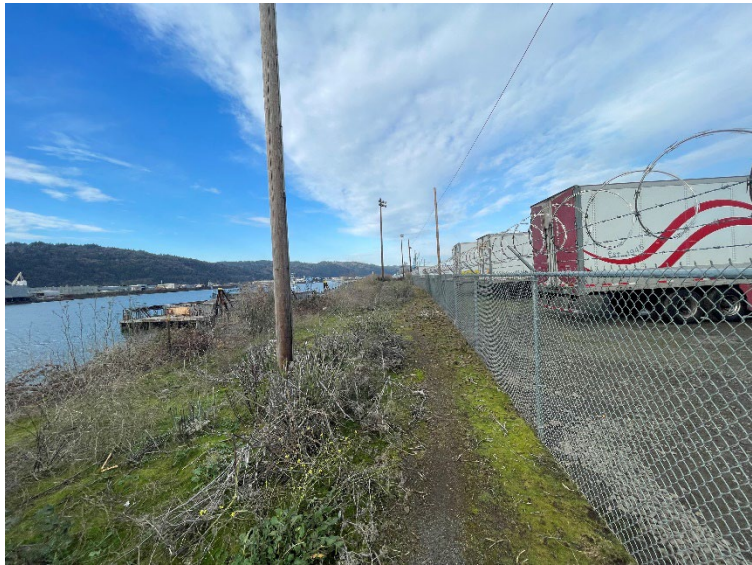
| <b>Description:</b><br><br>Top of bank near features M and N.<br><br>Note: Unauthorized encampment structures and litter observed in 2023 at top of bank have been cleared. | |

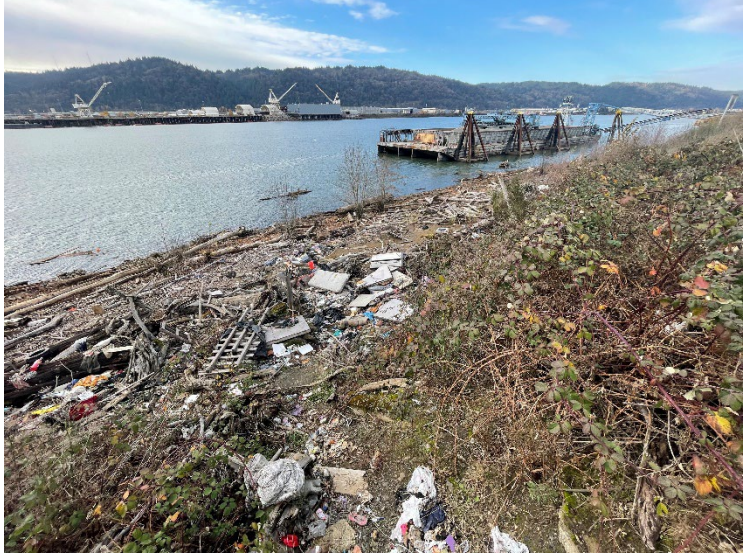
| <b>Description:</b><br><br>Top of bank near features M and N looking down.<br><br>Note: Observed unauthorized encampment litter. | |

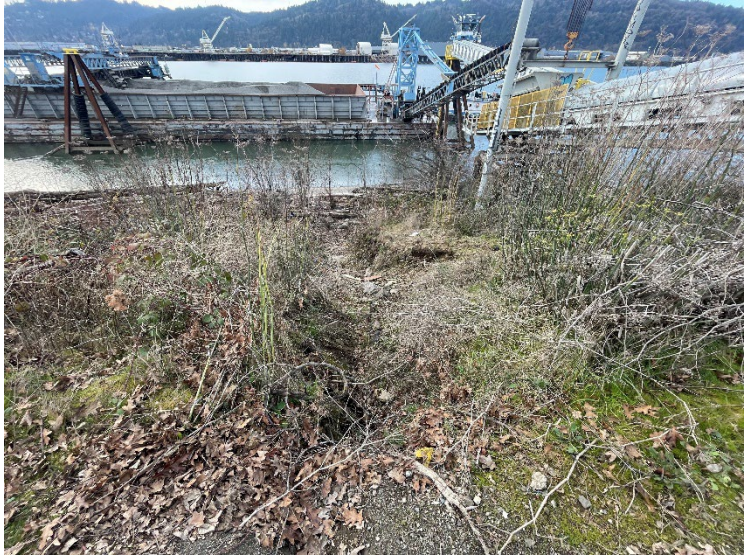
| <b>Description:</b><br><br>Previously noted location of the unauthorized installed steps at the north end of J1.<br><br>Note: Erosional features with exposure of filter fabric at the northern edge of the repaired scarp J1. The steps appear to have mostly disappeared. | |

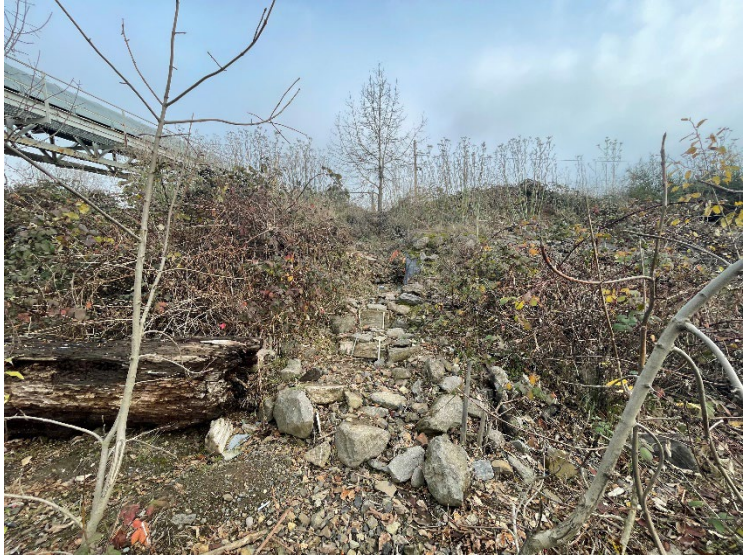
| <b>Description:</b><br><br>Previously noted location of the unauthorized installed steps at the north end of J1.<br><br>Note: Erosional features with exposure of filter fabric at the northern edge of the repaired scarp J1. The steps appear to have mostly disappeared. | |
