State of Oregon  
Department of Environmental Quality

Memorandum

**Subject:** Jerry's Clutch and Transmission Service, ECSI # 6573; Staff Memorandum in support of a Conditional No Further Action determination

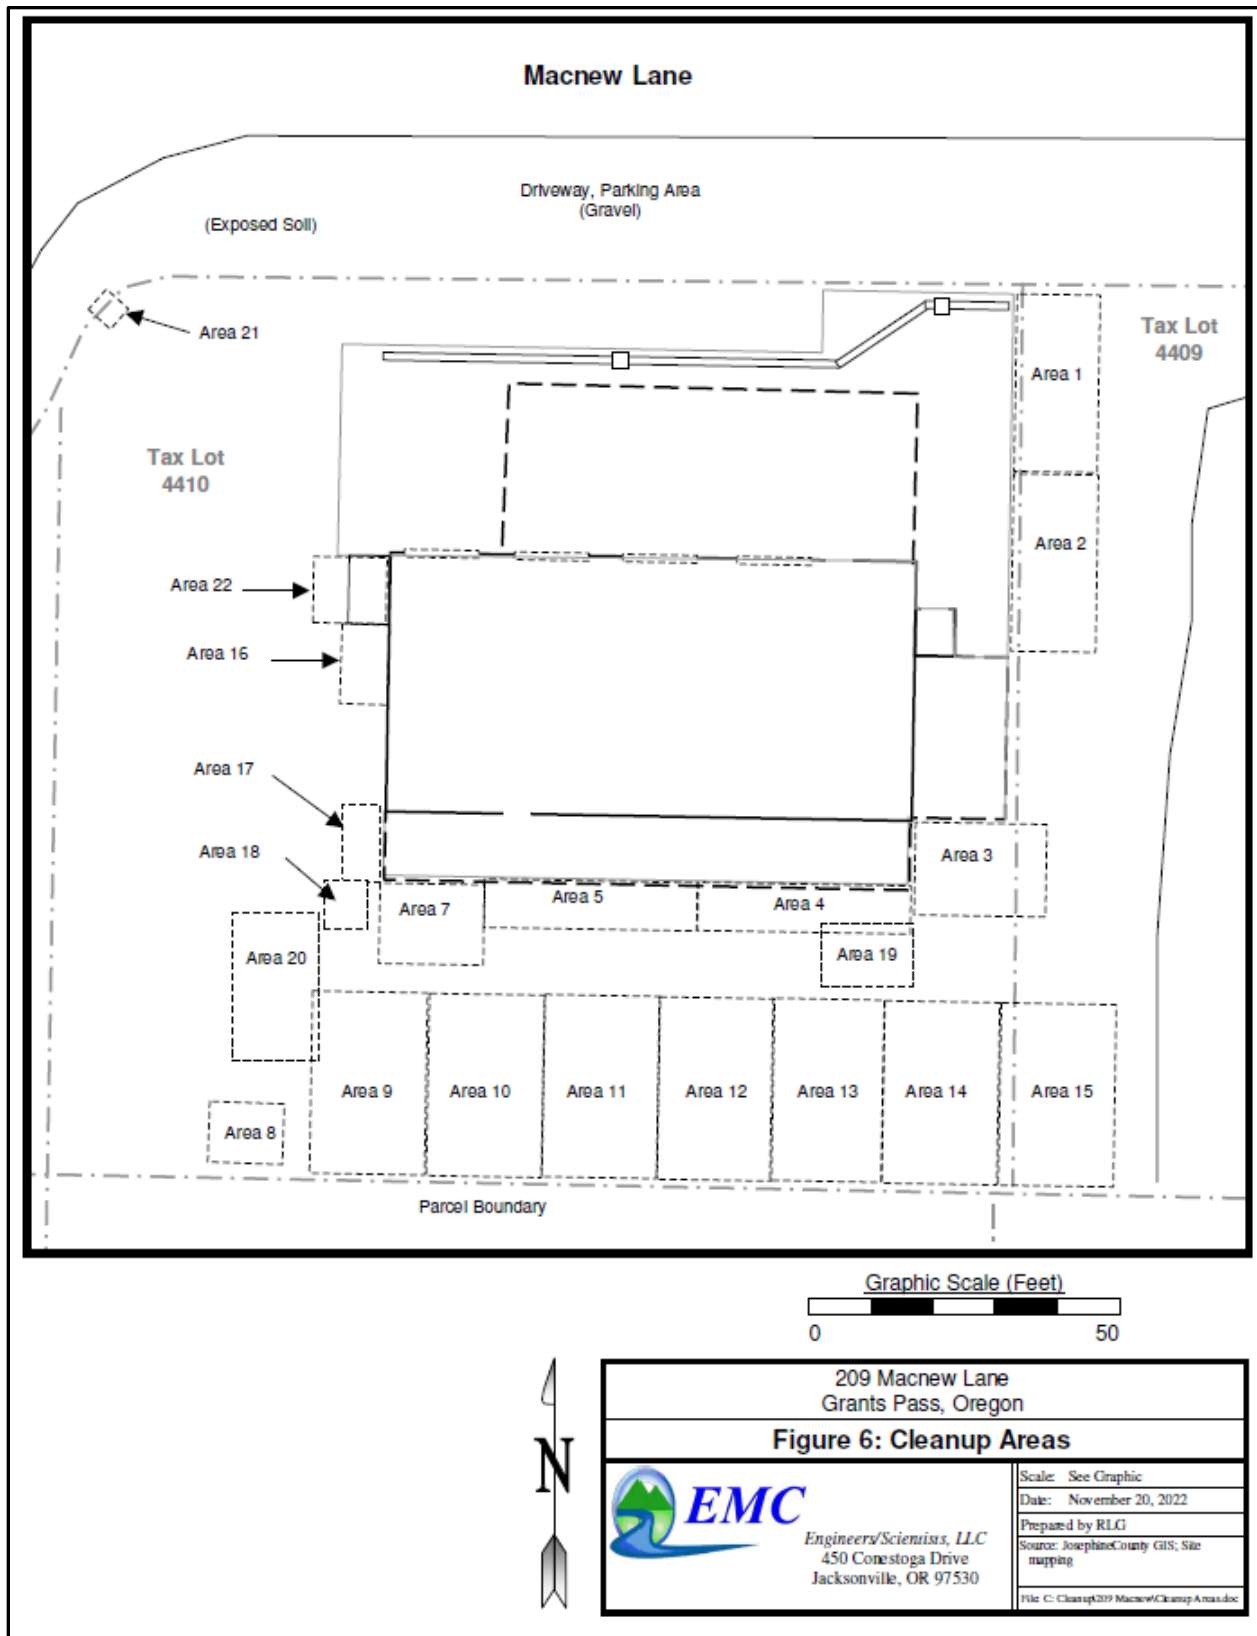
Site Map (Retrieved from EMC Cleanup Report January 16, 2024).

Several areas of concern (AOC) were identified by EMC, where fluids, oil, soil staining, and petroleum odors were present (Site map at end of staff memo). These areas were mainly concentrated on Tax Lot 4410, however several of these areas were located on Tax Lot 4409. There was significant staining visible in the drum storage areas south of the building, the covered areas between cargo containers where transmissions were stored, and around the cargo containers and outbuildings located south of the building. The wood and steel buildings on Tax Lot 4410 were demolished, and that exposed more stained soil in their proximity.

EMC identified 22 cleanup areas (Area 1 – Area 22) to simplify excavation and sampling activities. In September and October 2022 approximately 284 tons of petroleum contaminated soil (PCS) was excavated and transported to the Dry Creek Landfill in White City, Oregon for disposal under Special Waste Disposal Permits #2022-52 and #DC-23-85. The vertical extent of

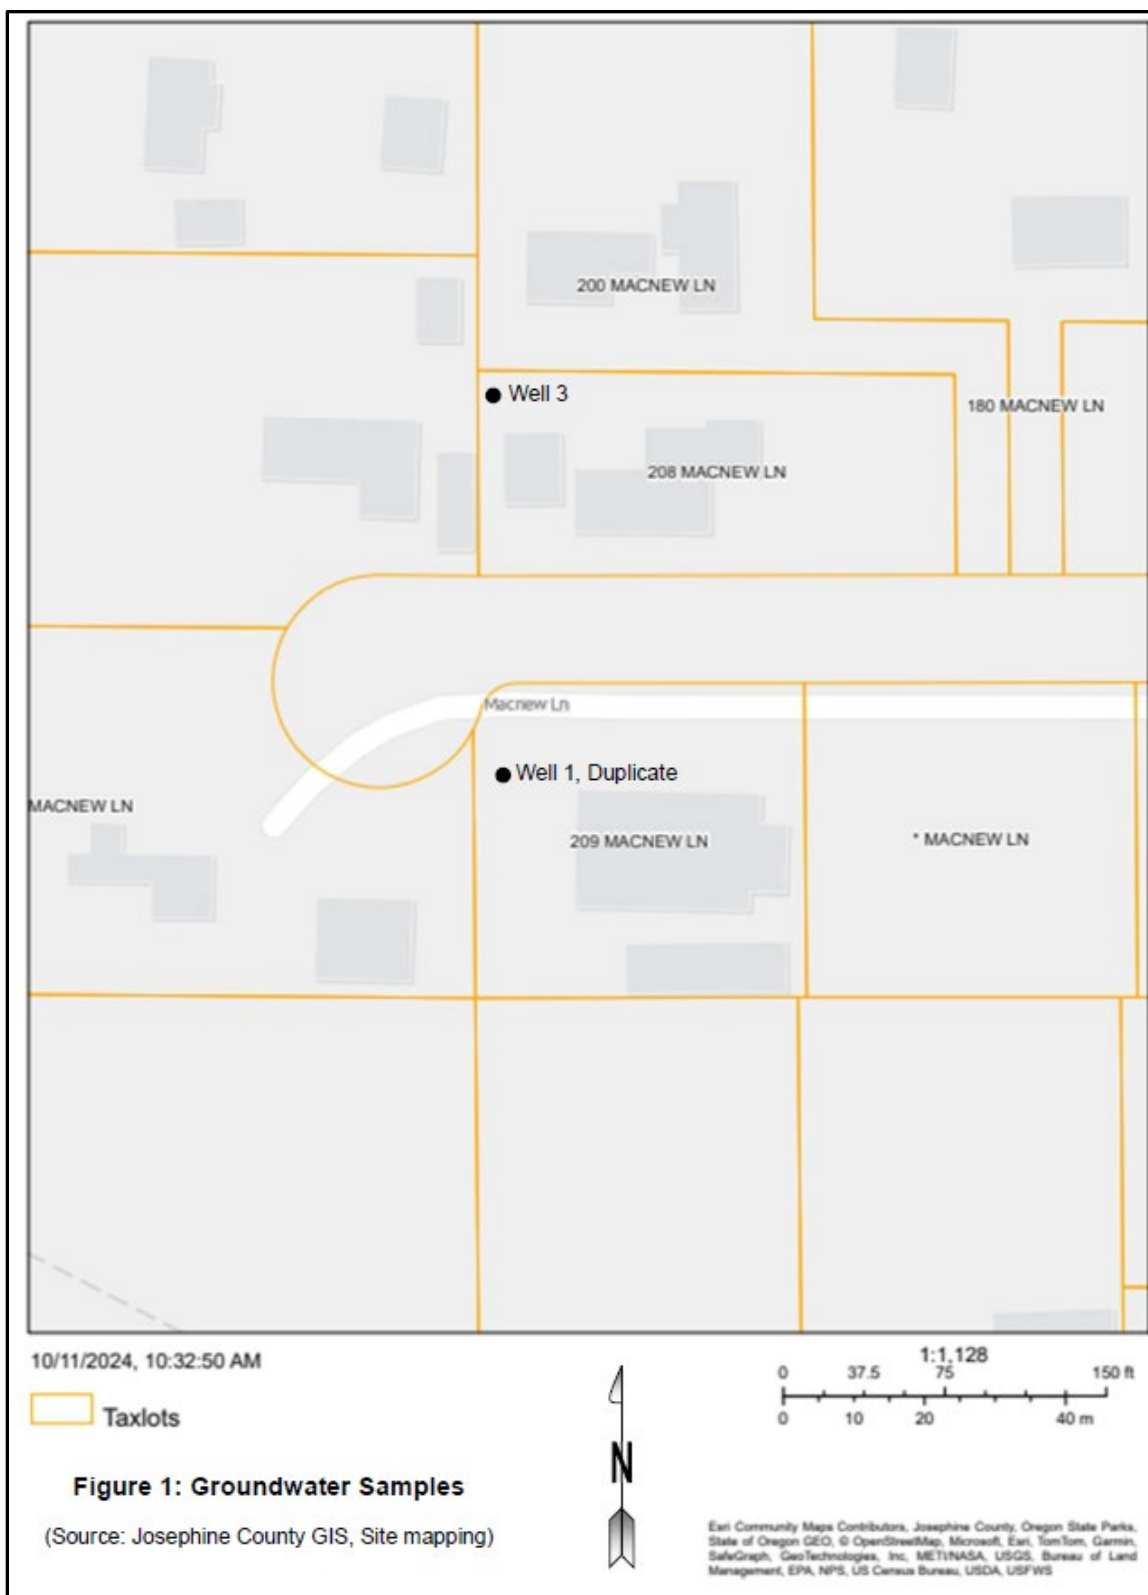
Groundwater sample locations map (Retrieved from EMC Supplemental Investigation Report November 22, 2024).

On July 9, 2024, groundwater samples were collected from the onsite well (JT-070924-Well 1) and the domestic well at 208 Macnew Lane (JT-070924-Well 3). Groundwater sample locations map is provided at end of staff memo. A field duplicate water sample (JT-070924-Well 2) was collected during the sampling of well JT-070924-Well 1. Groundwater samples were analyzed for volatile organic compounds (VOCs) by EPA Method 8260B and gasoline range hydrocarbons by Northwest Method TPH-Gx. The two wells were also analyzed for polynuclear aromatic hydrocarbons (PAHs) by EPA Method 8270 SIM and diesel and lube oil range hydrocarbons by Northwest Method TPH-Dx.

Groundwater samples were compared to risk-based concentrations (RBCs) for residential receptors. Heavy oil hydrocarbons, toluene, and bromoform were reported in the onsite well. The concentrations of toluene and bromoform were below the residential RBC for ingestion & inhalation from tapwater (RBC<sub>tw</sub>). However, the heavy oil hydrocarbons exceeded the RBC<sub>tw</sub>. The relevant RBC in this case is 100 µg/L (diesel). No contaminants were detected in the residential well at 208 Macnew Lane.

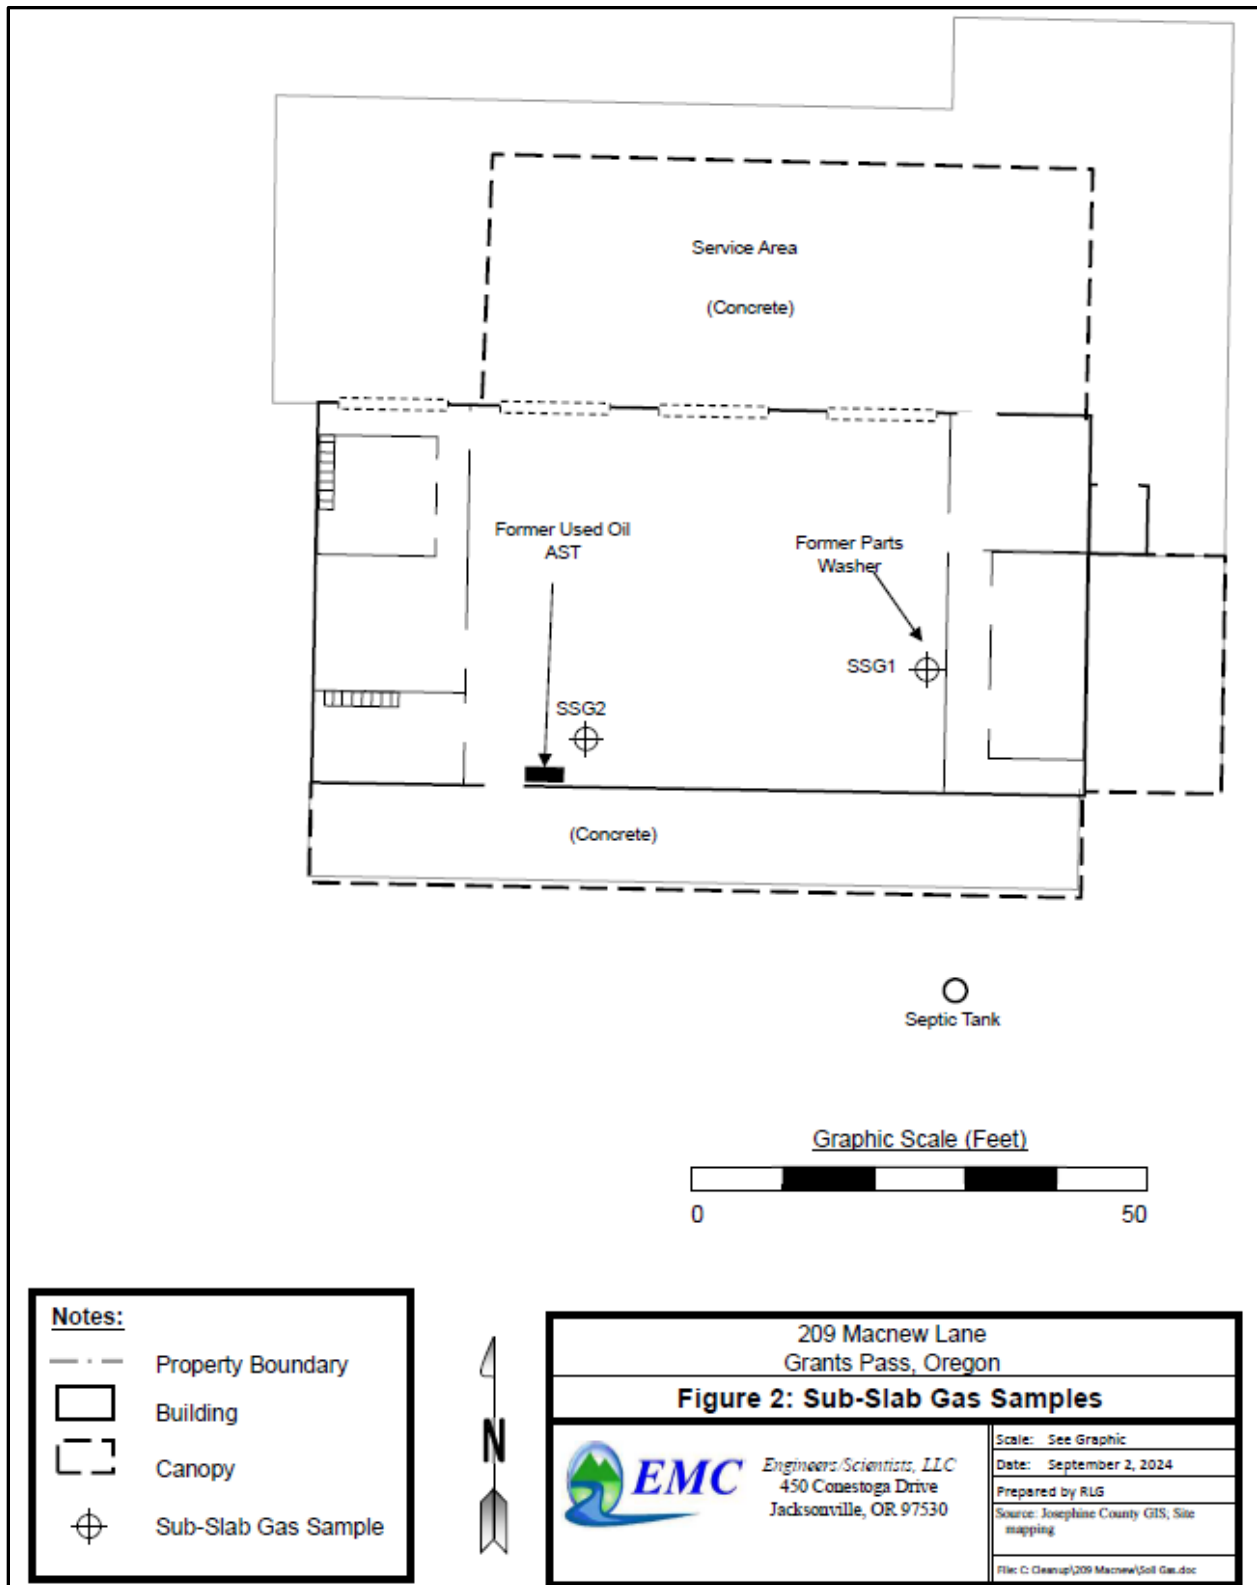
Sub-Slab sample locations map (Retrieved from EMC Supplemental Investigation Report November 22, 2024).

Sub-slab vapor sampling points were also installed during assessment with samples collected into a certified 1-liter stainless steel cannister (sub-slab sample locations map at end of staff memo). A sub-slab vapor sample designated JT-072224-SSG1 was collected near the former location of the parts washer. The location was moved to the west side of the temporary wall to avoid a crack in the concrete slab. A background sample designated JT-072224-Back was collected under the plastic sheet. A sub-slab vapor sample designated JT-072224-SSG2 was collected near the former location of the used oil storage tank.

Several volatile organic compounds were reported in one or more sub-slab vapor samples at concentrations below occupational worker and residential RBCs for inhalation (RBCsv). 1,3-Butadiene was reported in SSG1 slightly above the residential RBC for inhalation (RBCsv) and not detected in SSG2. The highest concentration is below occupational worker RBCsv. The average concentration is below the residential RBCsv. Method detection limits (MDLs) for 1,3-Butadiene, Hexachlorobutadiene, and 1,1,2,2- Tetrachloroethane were higher than RBCsv for residential receptors and may be present at the Site. The MDLs were below RBCsv for occupational workers.
