Subject: Response to DEQ Comments on *Initial Stormwater Conveyance Mapping Results* from November 16, 2021

Project: Blue Heron Mill PPA  
9-61M-135580.05

**Subject: Initial Stormwater Conveyance System Mapping Results – Revision 1  
Former Blue Heron Property  
419/427 Main Street  
Oregon City, Oregon**

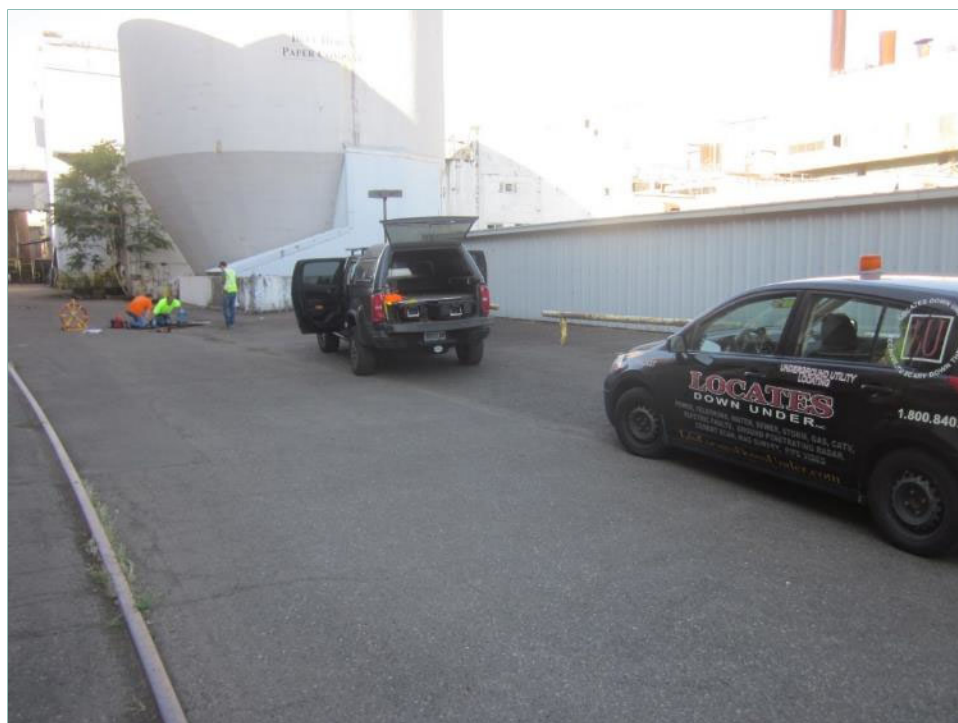
**Photo 1: View of  
Locates Down Under  
examining Catch Basin  
(CB)-43.**

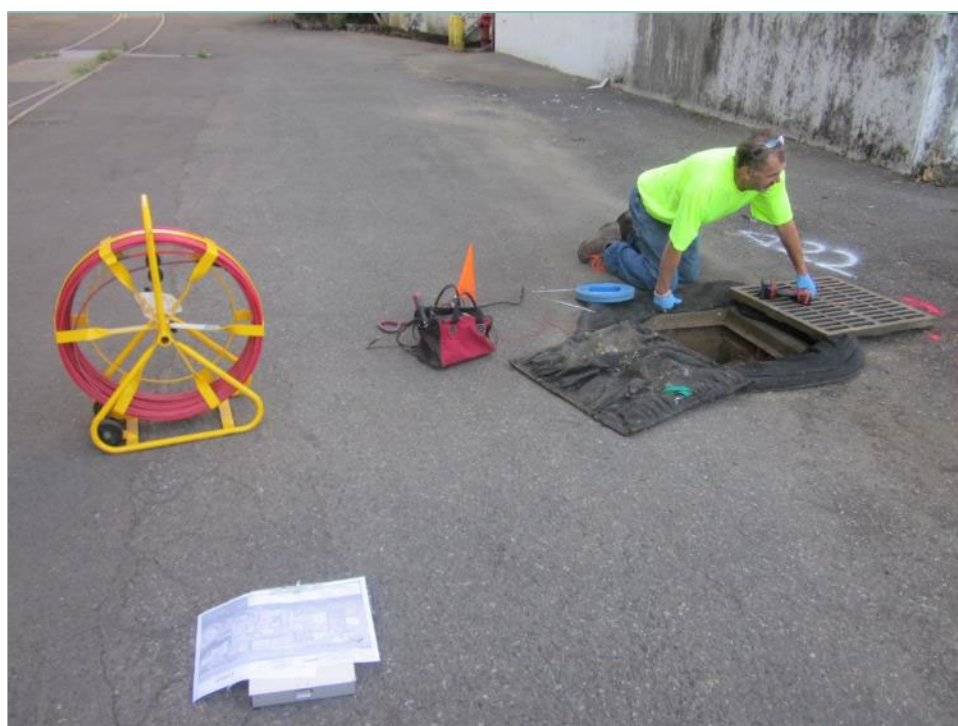
**Photo 2: View of  
CB-43.**

| General Info | | | | | | Source Investigation Notes | | | | | |
|---|---|---|---|---|---|---|---|---|---|---|---|
| CB-43 | Catch Basin | 24" x 24" | 32" | D | 15" | Outlet clogged | Fabric Insert | None | Unconfirmed | Cleaned Jan/Feb 2021 | Further investigation required |

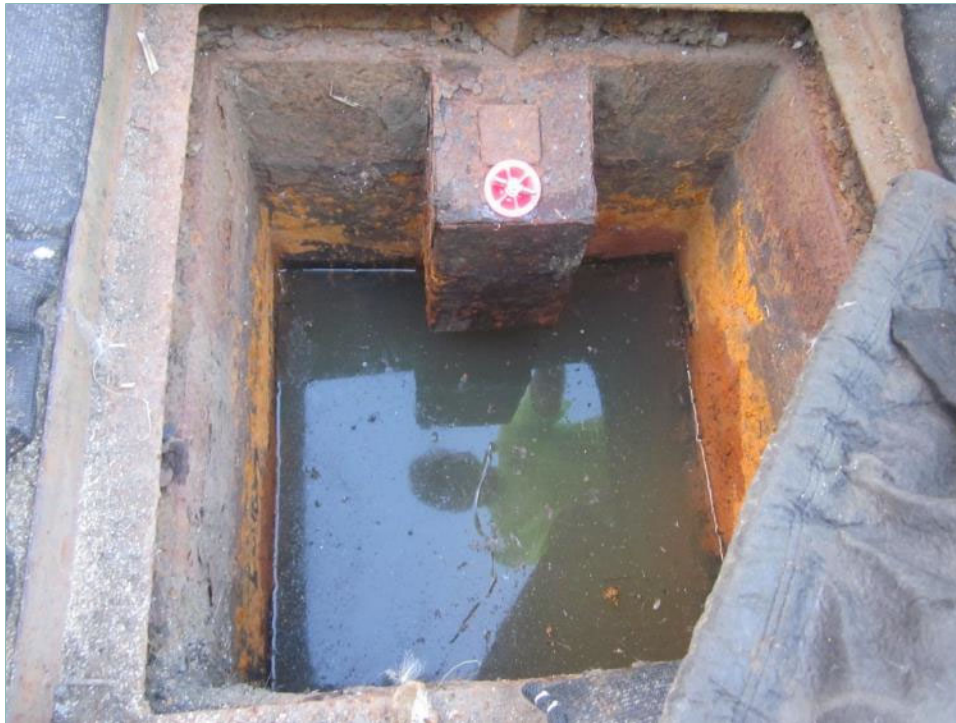
**Photo 3: Inside view of CB-43.**

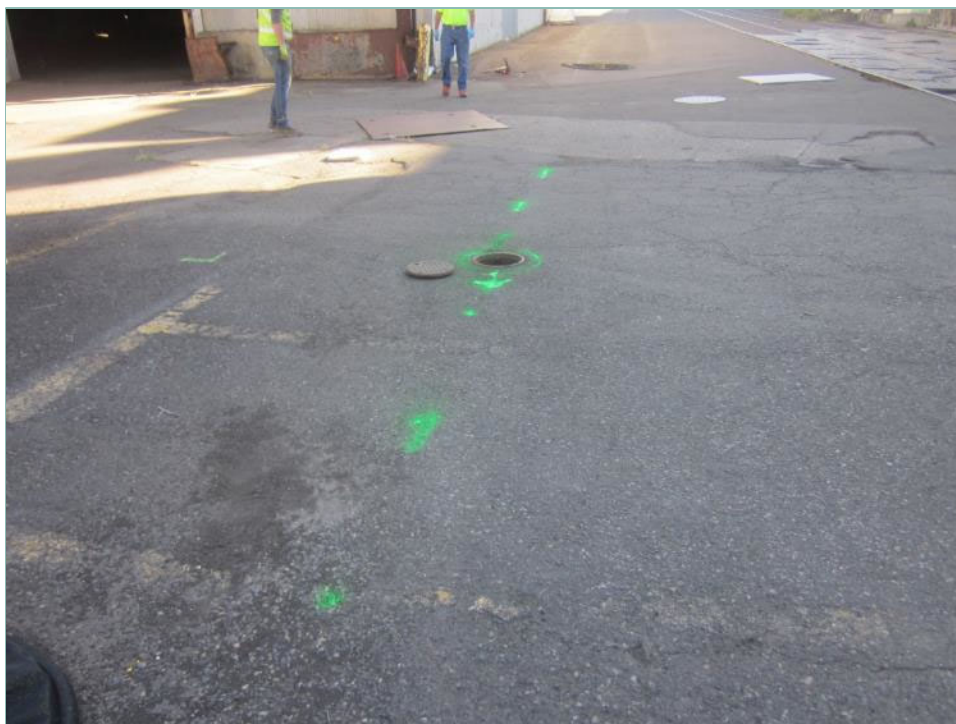
**Photo 4: View of stormwater line along vacated Main Street.**

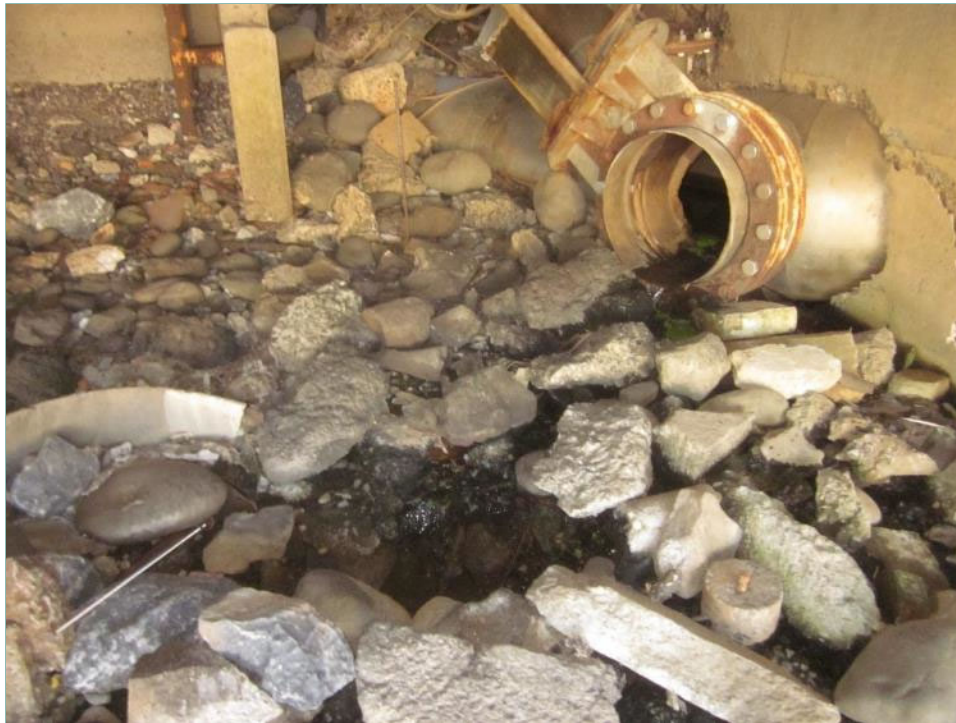
**Photo 5: View of knife gate at Tailrace 1 (Outfall 4) discharge area.**

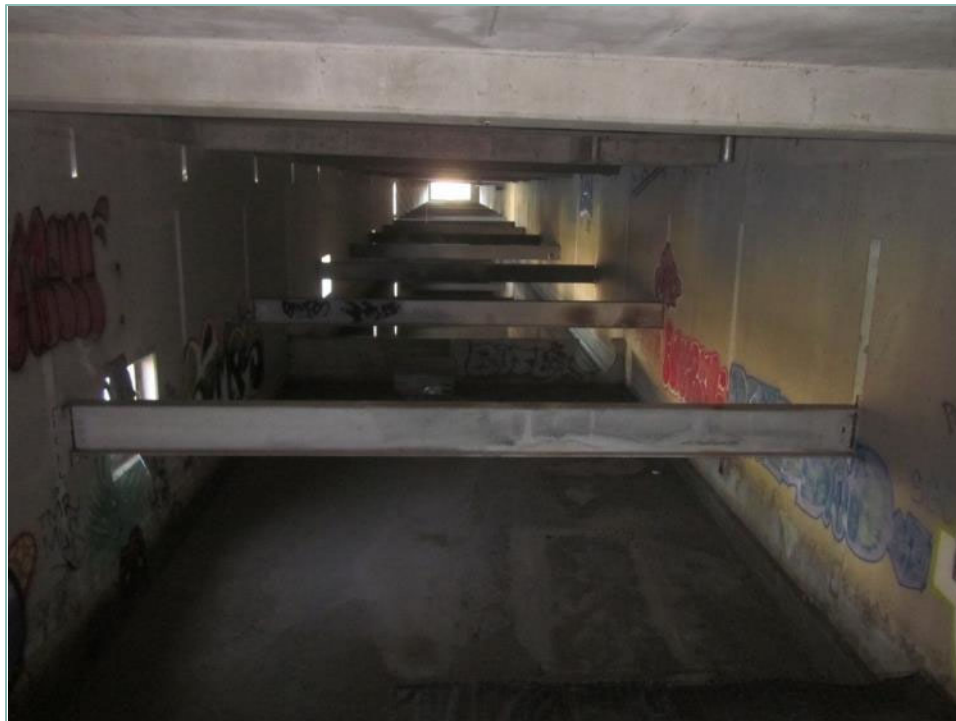
**Photo 6: View of inside Pipe Tunnel.**
