Subject: Strategy Recommendation

Gerber Legendary Blades 14200 SW 72nd Avenue

Portland, Oregon DEQ ECSI ID 118

GEI Project File No. 25941-001-04

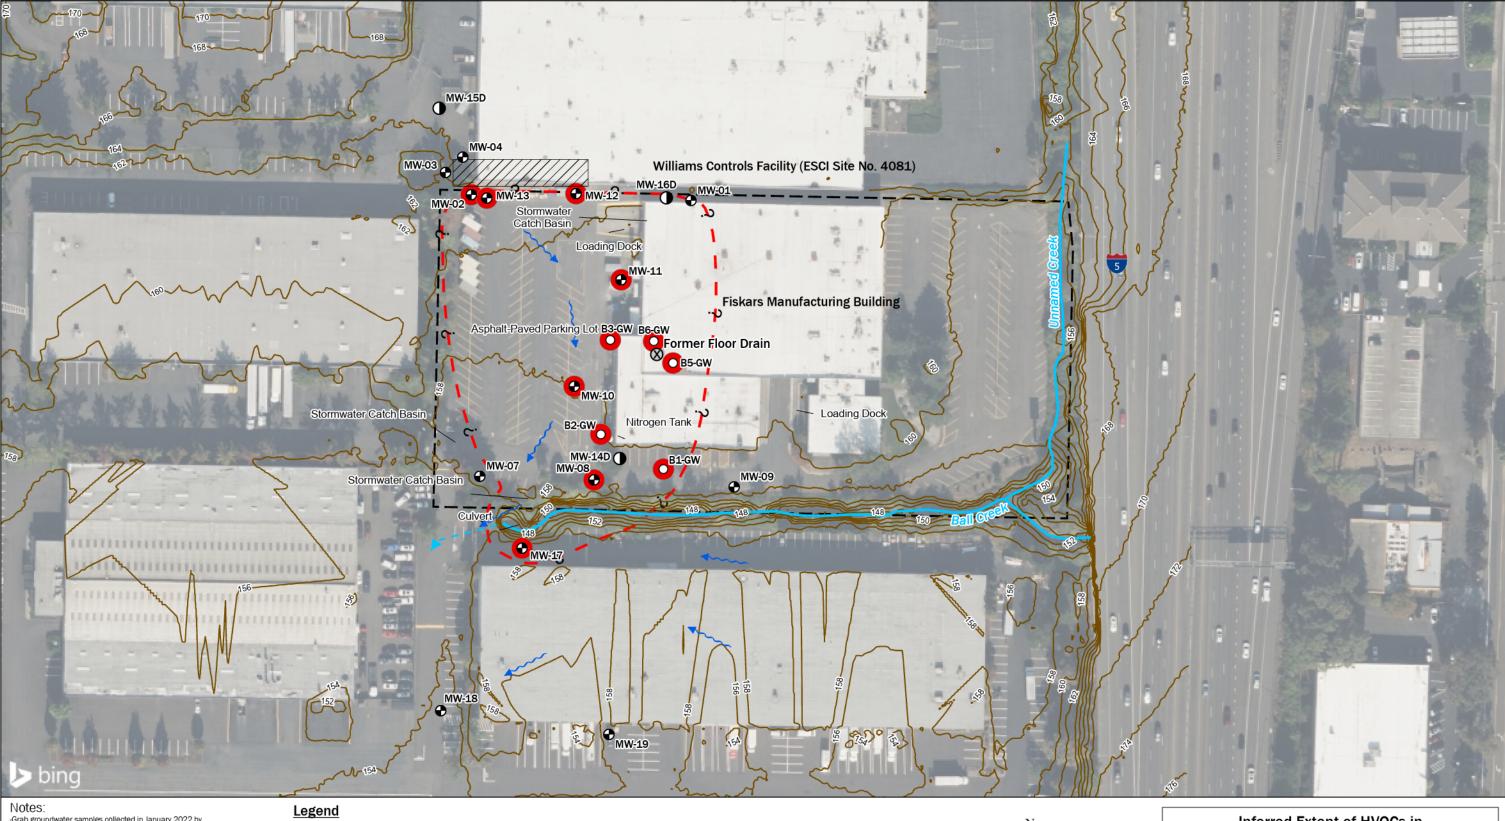
- HVOCs, also known as chlorinated solvents, have been detected at high concentrations in soil and shallow groundwater (contaminant plume) beneath the WC Site, as well as the GLB Site, resulting primarily from historical use of a vapor degreaser inside the southern portion of the WC Site building and former solvent storage area located on unpaved ground outside the southwest corner of the building (hatched area shown on Figure 2).

- Previous investigations of the WC Site plume have included the installation of groundwater monitoring wells on the GLB Site.
- The confirmed release of chlorinated solvents from the northern adjacent WC Site has impacted soil, soil vapor, and shallow groundwater beneath the GLB Site 's west parking lot and western portion of the GLB Site building. Detected concentrations of select HVOCs, including tetrachloroethene (PCE) and trichloroethene (TCE), and their degradation byproducts cis-1,2-dichloroethene (cis-1,2-DCE), trans-1,2-dichloroethene (trans-1,2-DCE) and vinyl chloride (VC) exceed DEQ RBCs in shallow groundwater beneath the GLB Site. The WC Site groundwater plume extends south of the GLB site as shown on Figure 2.

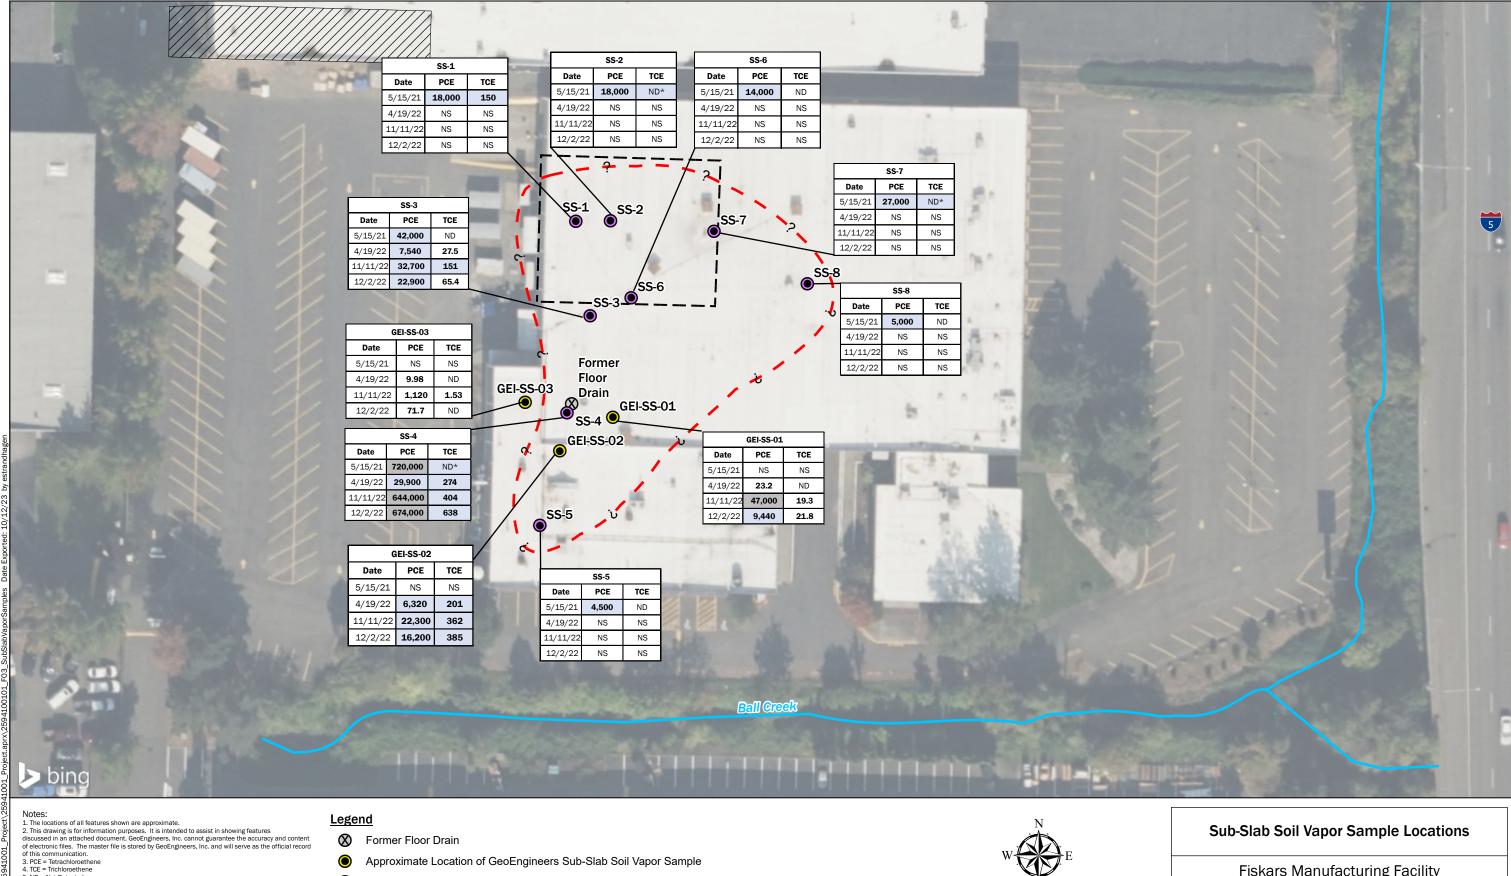
- Elevated concentrations of PCE were detected in soil vapor beneath the western portion of the GLB Site 's building, with the highest concentrations present near a former floor drain, ranging from 4,500 720,000 micrograms per cubic meter (μg/m³). At the time of this investigation, DEQ's RBC for soil VI into occupational buildings was 47,000 μg/m³ and only one of eight samples (SS-4) exceeded the RBC. Sub-slab soil vapor sampling locations and historic concentrations are presented in Table 2 and Figure 3.

- PCE was detected at concentrations at or exceeding the then-applicable DEQ occupational VI RBC<sub>sv</sub> of 47,000 μg/m³ in two of five soil vapor samples, GEI-SS-01 (47,000 μg/m³) and SS-4 (644,000 μg/m³), collected near the former floor drain. The remaining samples (GEI-SS-02, GEI-SS-03 and SS-3) contained PCE at concentrations greater than the laboratory reporting limit but less than the then-applicable DEQ RBC<sub>sv</sub>. Soil vapor samples GEI-SS-02 and SS-3 (22,300 and 32,700 μg/m³, respectively) were later found to exceed the updated 2023 RBC<sub>sv</sub> of 1,600 μg/m³.

- In December 2022, PCE was only detected at a concentration greater than the former DEQ occupational VI RBC<sub>sv</sub> of 47,000 μg/m³ in sample SS-4 (674,000 μg/m³) located adjacent to the former floor drain. Soil vapor samples GEI-SS-01, GEI-SS-02 and SS-3 (9,440, 16,200 and 22,900 μg/m³, respectively) were later found to exceed the updated 2023 chronic RBC<sub>sv</sub> of 1,600 μg/m³.
- Chloroform, TCE, 1,1-DCE, cis-1,2-DCE, or trans 1,2-DCE were either not detected or detected at concentrations less than the DEQ RBC<sub>sv</sub> screening values in place at the time of this investigation. Chloroform concentrations in one of five soil vapor samples (SS-4) exceed the updated 2023 chronic occupation RBC<sub>sv</sub>.
- VC was not detected in the sub-slab soil vapor samples.

As mentioned above, GeoEngineers recommends one additional round of HVOC sampling in all sub-slab monitoring points (i.e., installed vapor pins GEI-SS-01 through GEI-SS-03 and SS-1 through SS-8). Specifically, GeoEngineers recommends that concurrent sampling of sub-slab soil vapor and indoor air be conducted in the fall/early winter when groundwater levels are low and ambient temperature and pressure gradients between outdoor and indoor air are expected to be significant. In addition to HVOCs, we recommend measuring ambient pressures above and below the building's concrete floor at the time of sample collection. As mentioned above, additional sub-slab soil vapor monitoring pins may need to be installed east and southeast of the former floor drain and sample location GEI-SS-01. Further characterization of this secondary source of HVOCs around the former floor drain will assist in the evaluation and development of VI mitigation options (e.g., a sub-slab depressurization system, as described below).

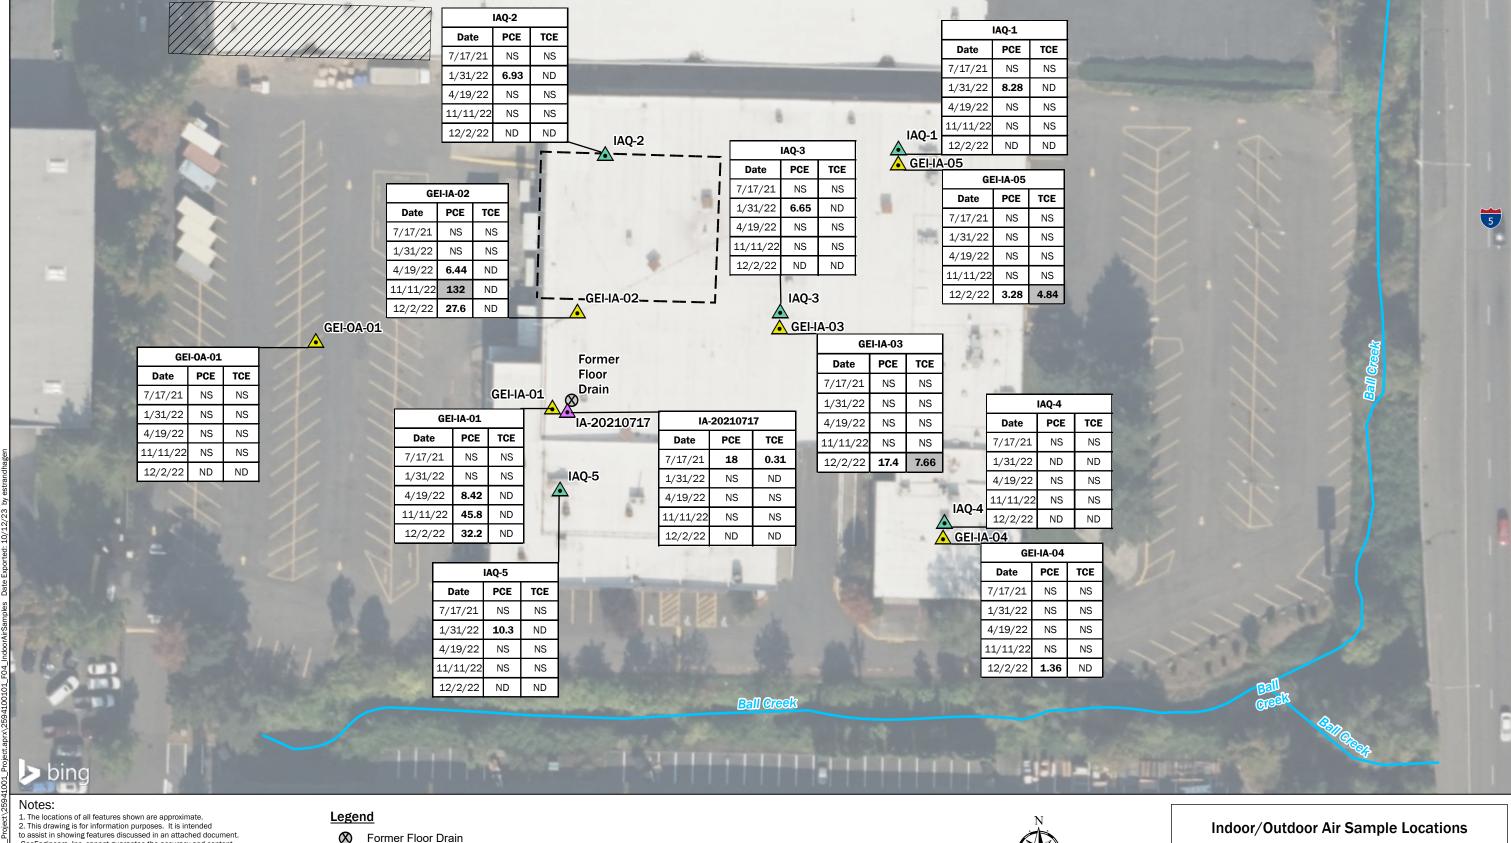
- Detected concentrations of HVOCs in indoor air were less than applicable DEQ RBC<sub>air</sub> screening values and Occupational Safety and Health Administration (OSHA) permissible exposure limits. Indoor air sampling locations and historic concentrations are presented in Table 3 and Figure 4.

In general, detected concentrations of HVOCs in indoor air samples collected over 6 to 8 hours intervals have been below occupational RBCs. Nonetheless, concurrent indoor air and sub-slab soil vapor monitoring is recommended, particularly in the vicinity of the building's former floor drain.

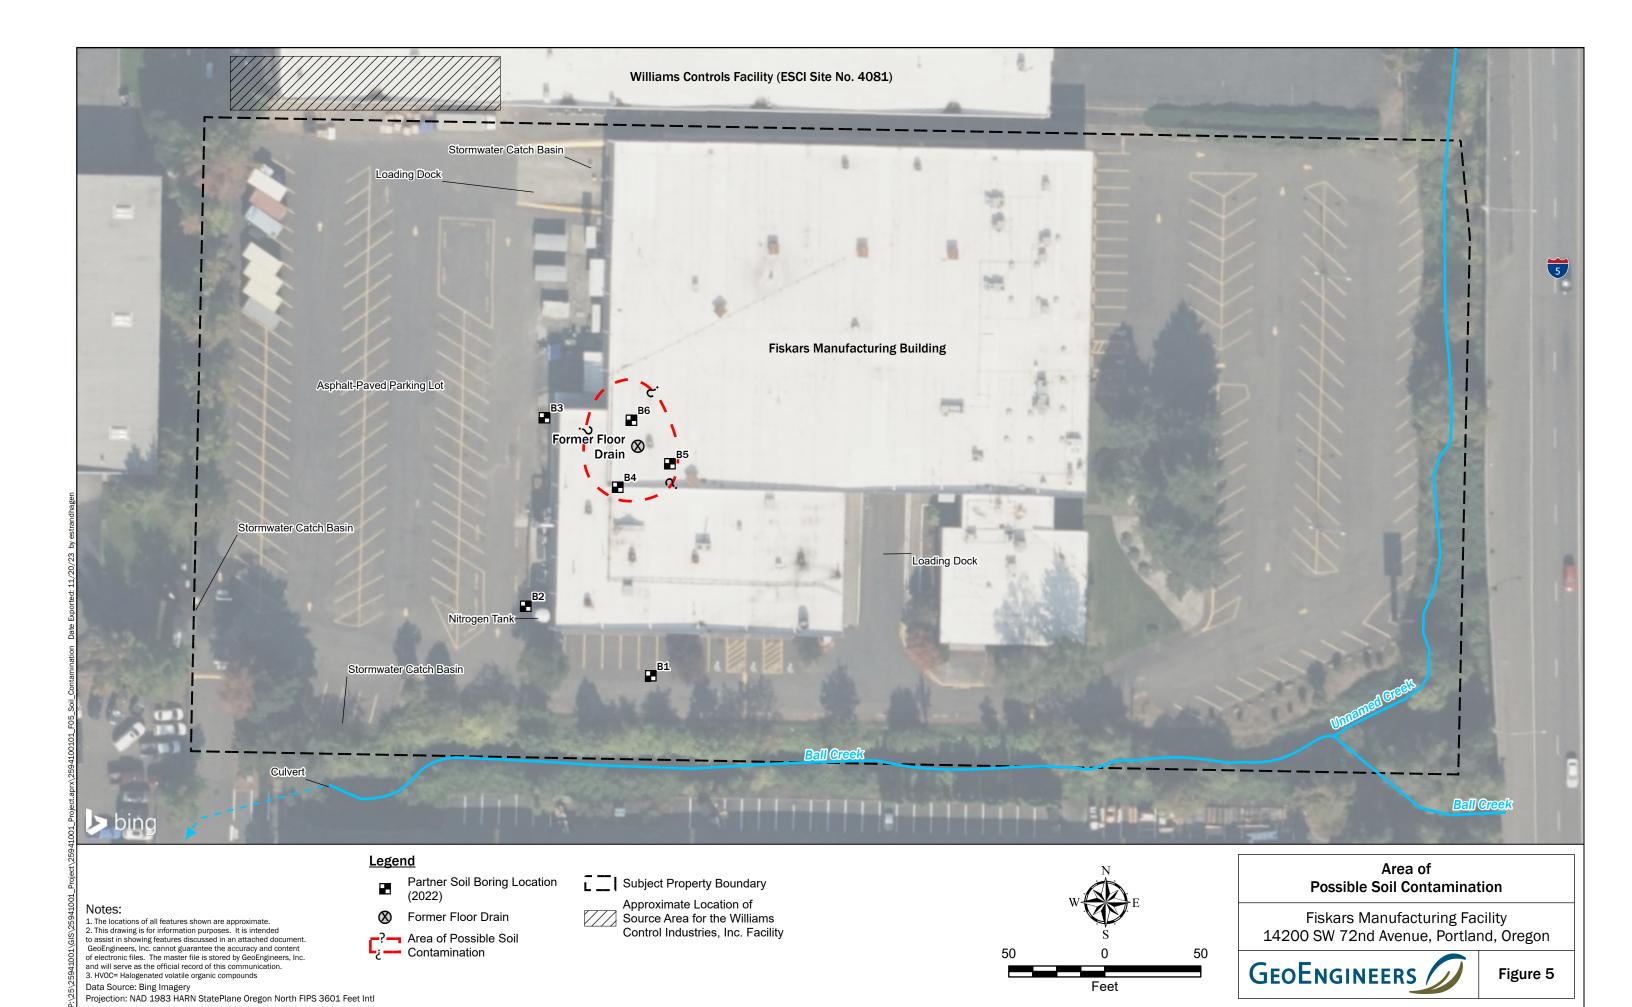
The limited extent of elevated PCE concentrations found near the sump suggests that the area of impacted soil associated with potential historical releases from the former floor drain is relatively small. The inferred extent of HVOC-impacted soil around the former floor drain is illustrated in Figure 5.
