**Operation and Maintenance Report
January 2021 to December 2021**

**McCormick & Baxter
Superfund Site
Portland, Oregon
ECSI Site No. 74**

Prepared for
**Oregon Department of
Environmental Quality**

May 6, 2022
0202315-000/003/01

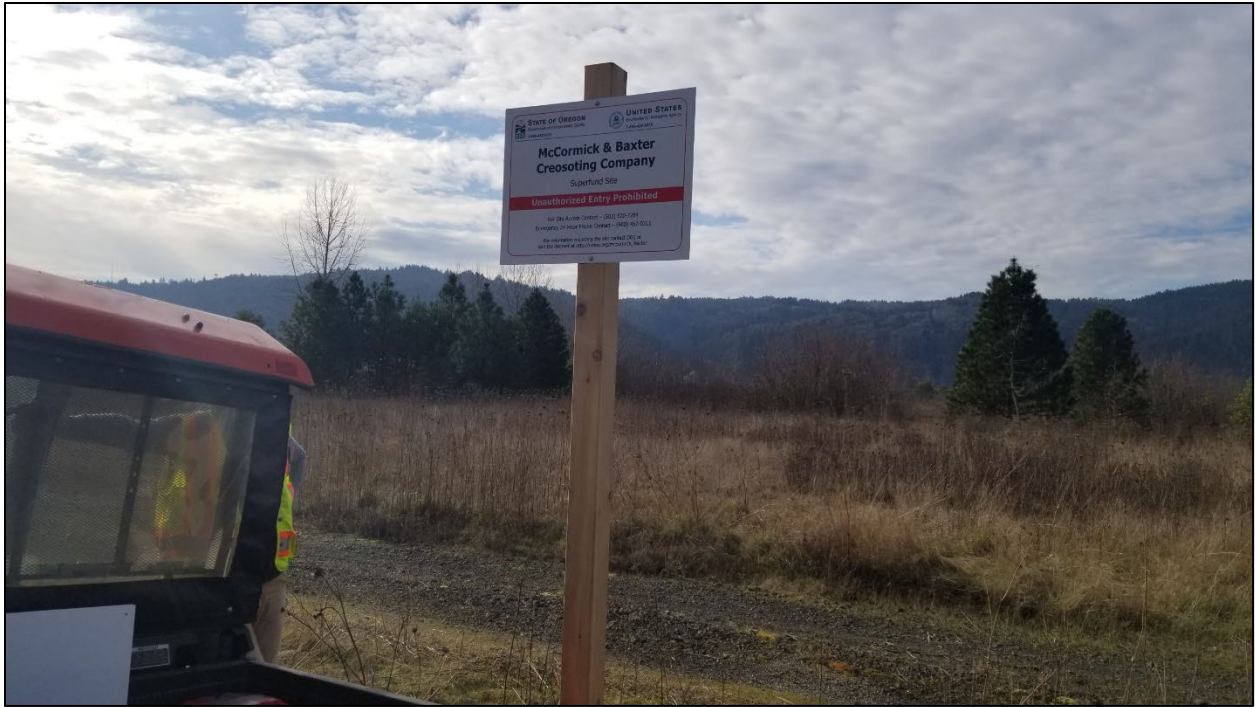
Photograph A1: Replaced signpost and sign along eastern perimeter fence. View facing southwest. (January 2021).

Perimeter signpost and sign replacement activities were initiated in December 2020, with the installation of replacement signposts along the eastern perimeter fence. This activity was completed on January 22, 2022, once replacement signs were received from the vendor and installed on Site gates and the newly installed signposts (Appendix A, Photographs A1 and A2).

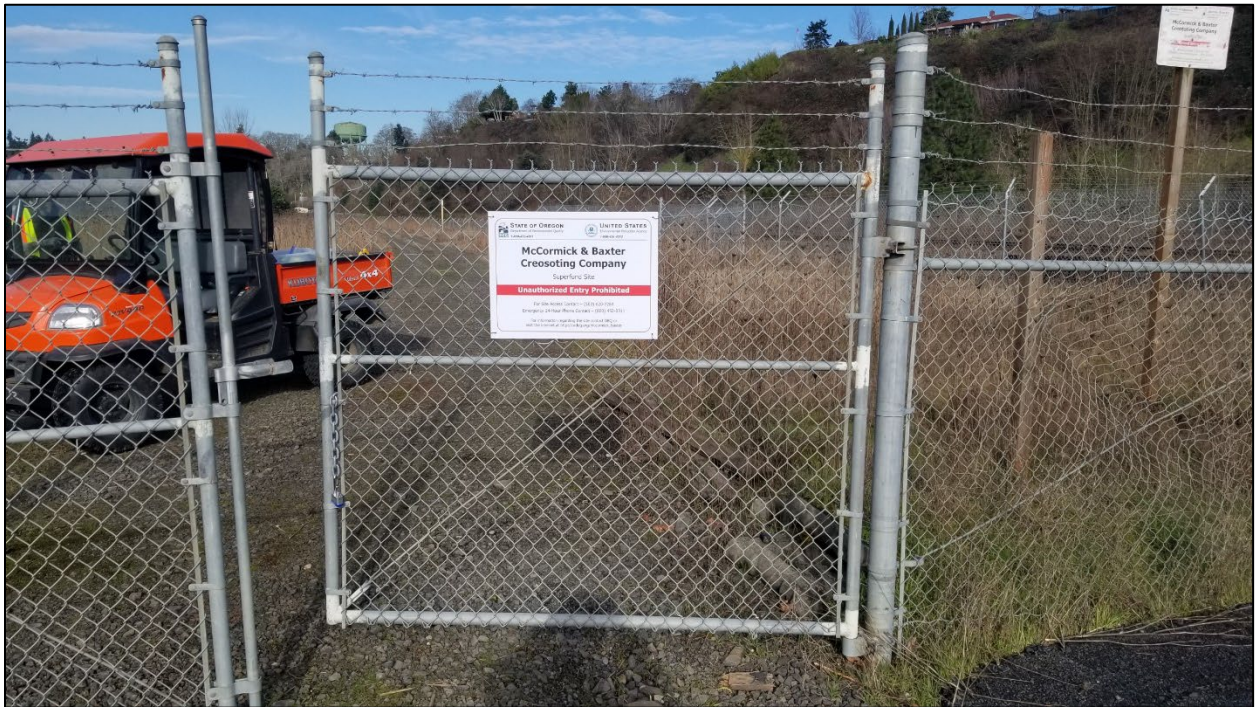
Photograph A2: Site informational sign added to entrance gate on Van Houten Street. View facing north. (January 2021).

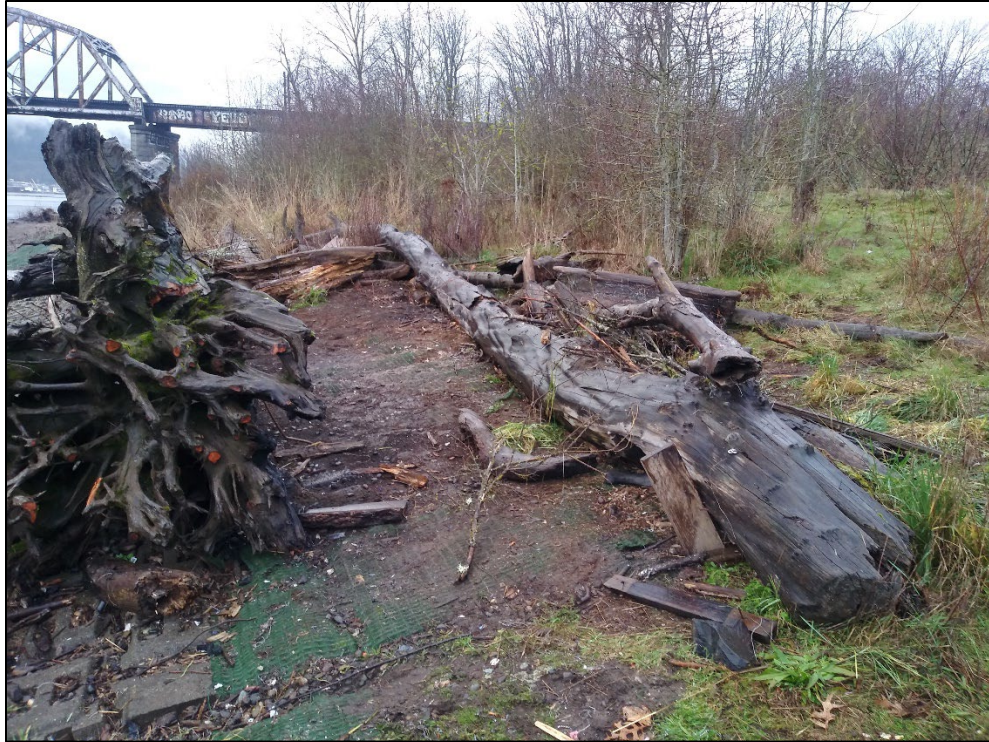
Photograph A3: Former homeless encampment area at the northern end of the Willamette River shoreline after removal of abandoned campsite and trash. View facing north (January 2021).

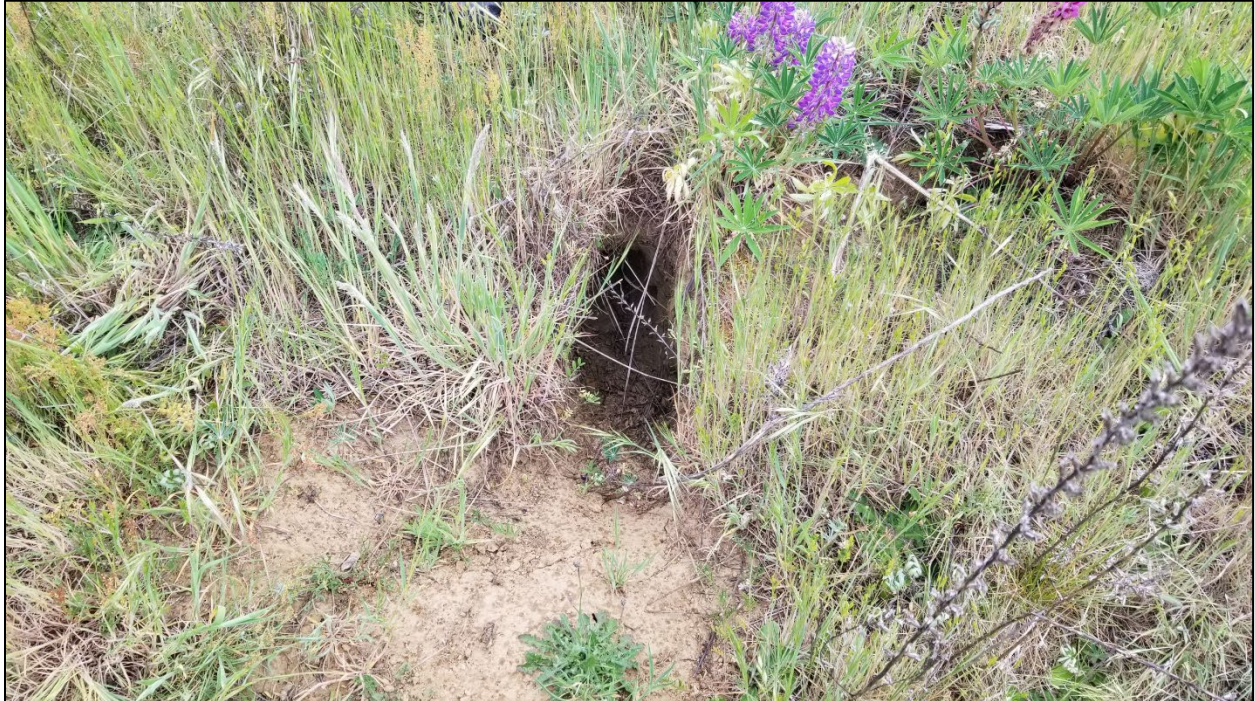
Photograph A8: Animal burrow in soil cap near MW-48s (May 2021).

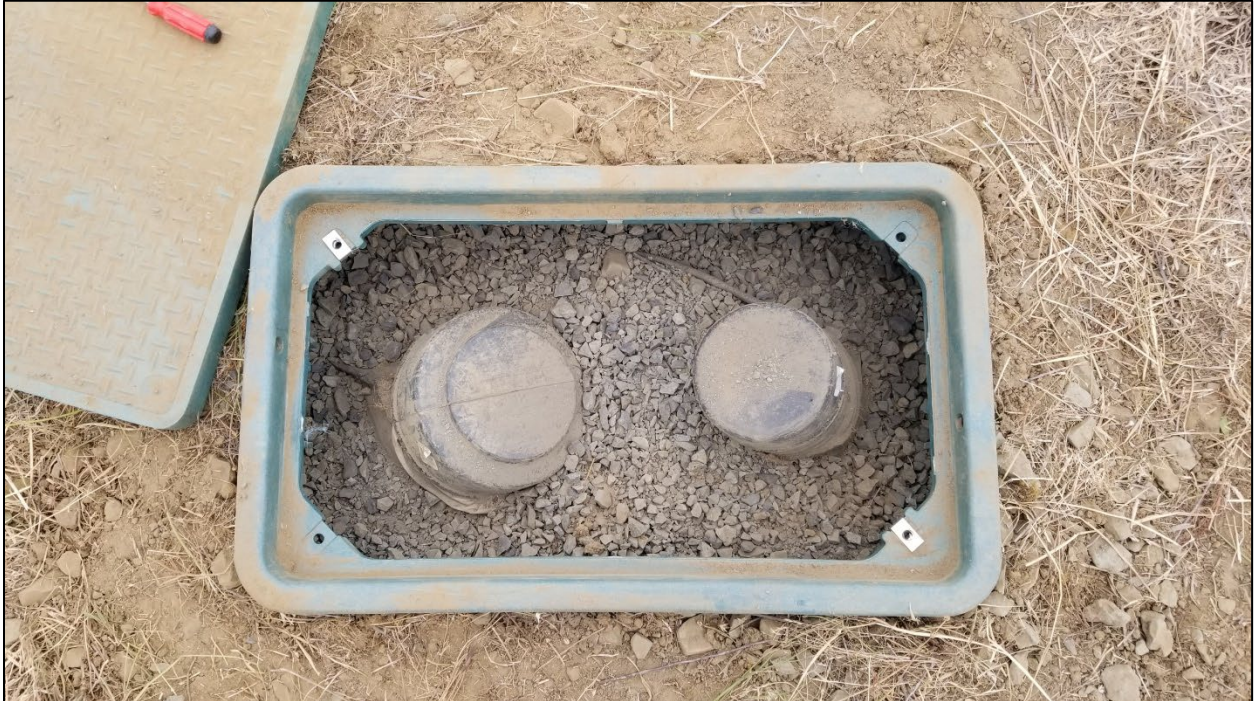
Photograph A10: Installation of vault box for stormwater conveyance piping cleanout CL-4 that was previously buried in the soil cap (August 2021).

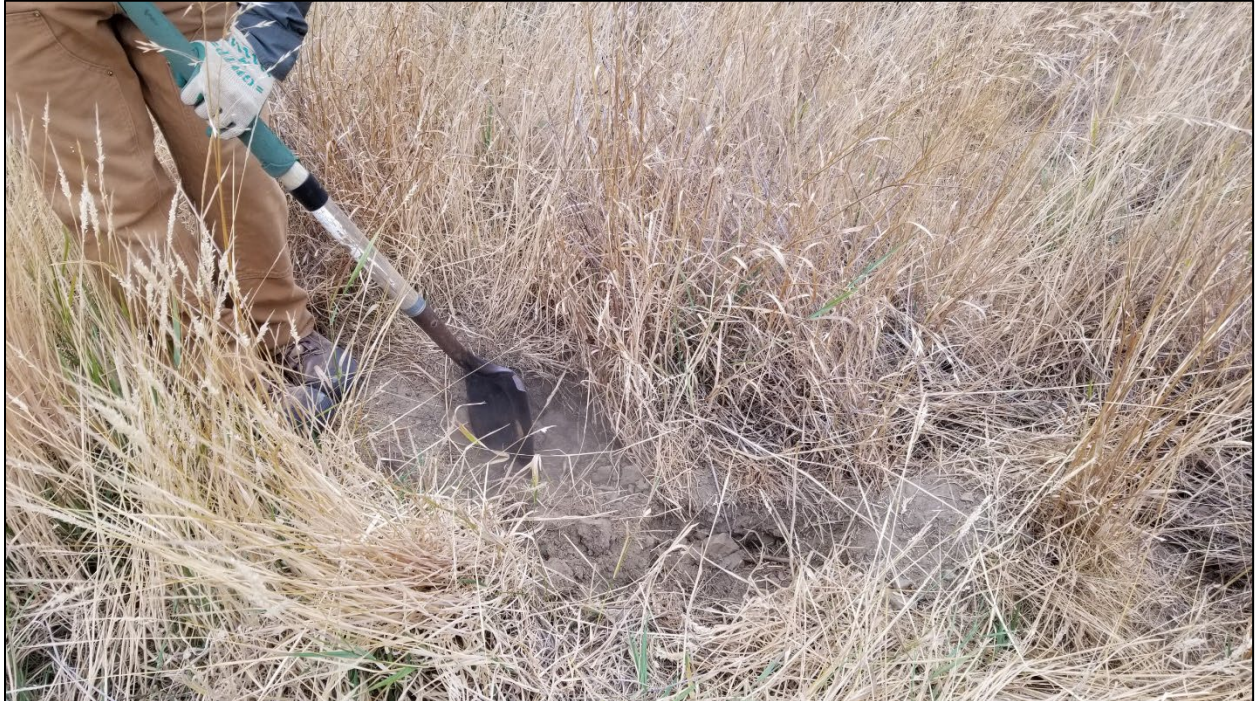
Photograph A12: Collapsing animal burrows in the soil cap and filling in with aggregate base rock material. Burrows were located in the vicinity of MW-48s (August 2021).

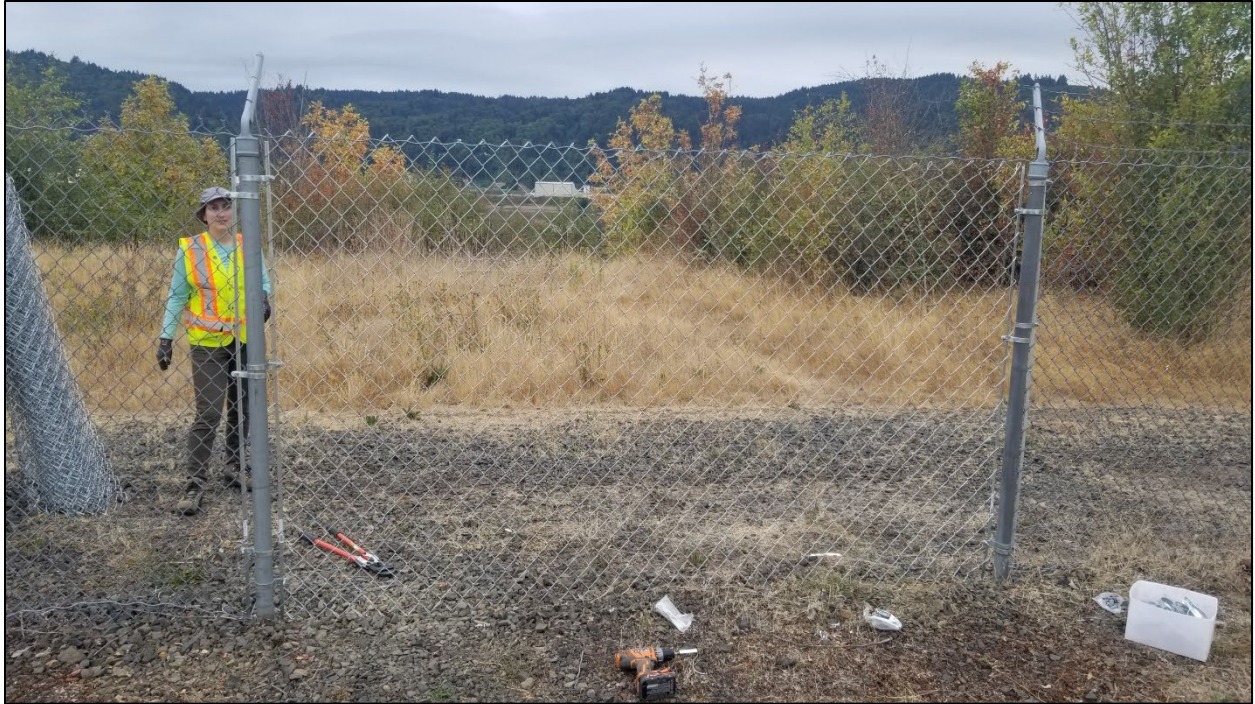
Photograph A13: Replacement of fence fabric section where hole was cut into western perimeter fence. View facing southwest (August 2021).

On August 26, 2021, five holes cut into the fabric of the perimeter fence were repaired, including replacement of fabric in some locations. Field staff installed tension bars into the existing fence fabric to secure it to the pole nearest the hole, cut the fence fabric with hole out, and installed new fence fabric between the adjacent poles (Appendix A, Photograph A13).

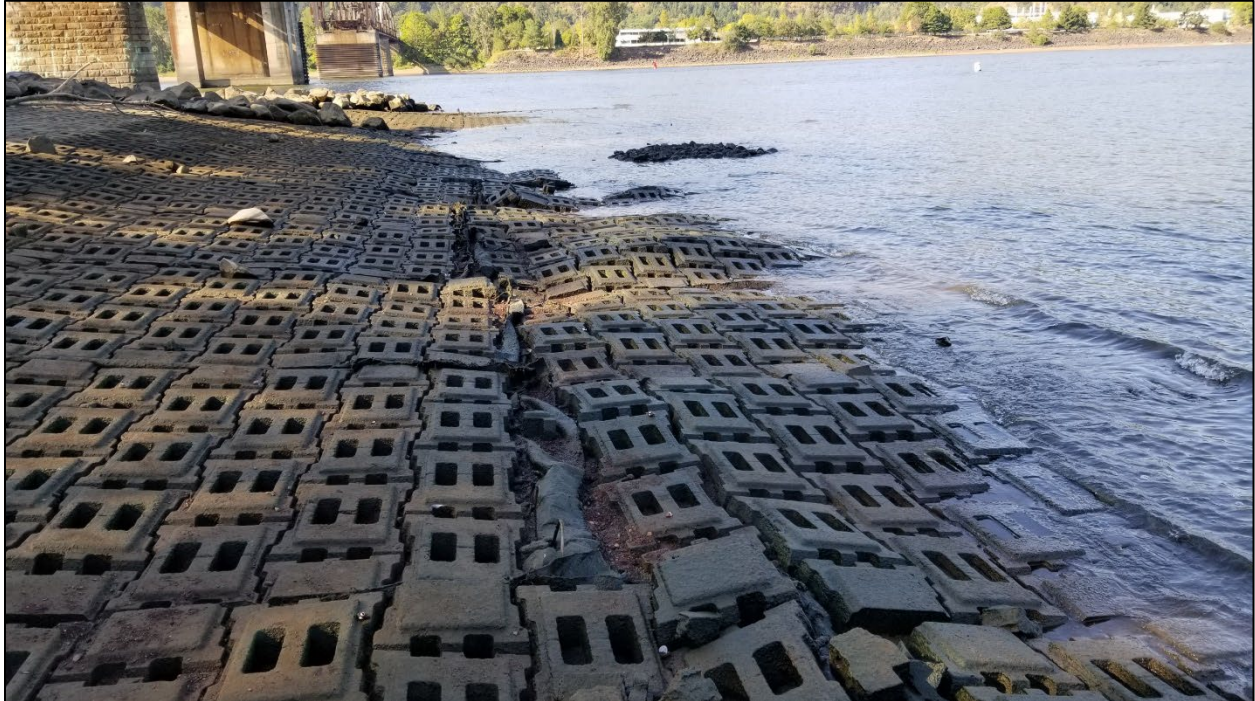
During the October 2018 site inspection, multiple 2- to 6-inch-wide voids were observed in the ACB along the shoreline in the Willamette Cove during seasonal and tidal low water levels. The gaps were visible for the first time since 2018 during the September 2021 Site inspection. Gaps up to approximately 6-inches wide were observed in areas and minor undulations of the ACB armoring were also observed (Appendix A, Photograph A14). These unconformities do not exhibit signs of erosion or impairment to the sediment cap; however, DEQ and Haley & Aldrich will continue to monitor the unconformities to evaluate the potential causes and to determine if maintenance of the ACB armoring is required.

Photograph A14: Low river level and low tide conditions showing unconformities of the ACB in Willamette Cove. View facing west (September 2021).

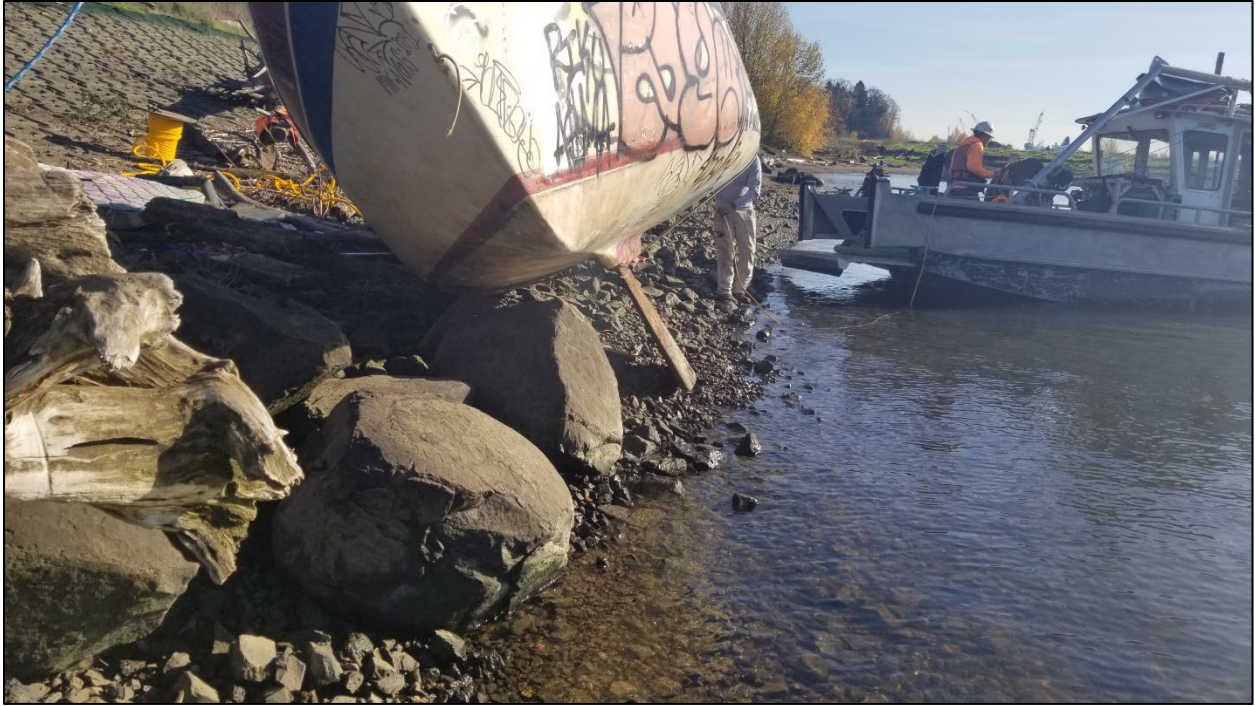
A derelict sailboat was first observed along the Willamette River Shoreline near the stormwater outfall in December 2020. The vessel remained beached along the shoreline through December 2021 at which point it was removed. Section 3.3 provides further details on vessel removal activities.

Photograph A17: Cutting of the fin keel on the derelict vessel to allow for removal of the vessel and trailering for transport to a disposal facility. View facing southeast (December 2021).

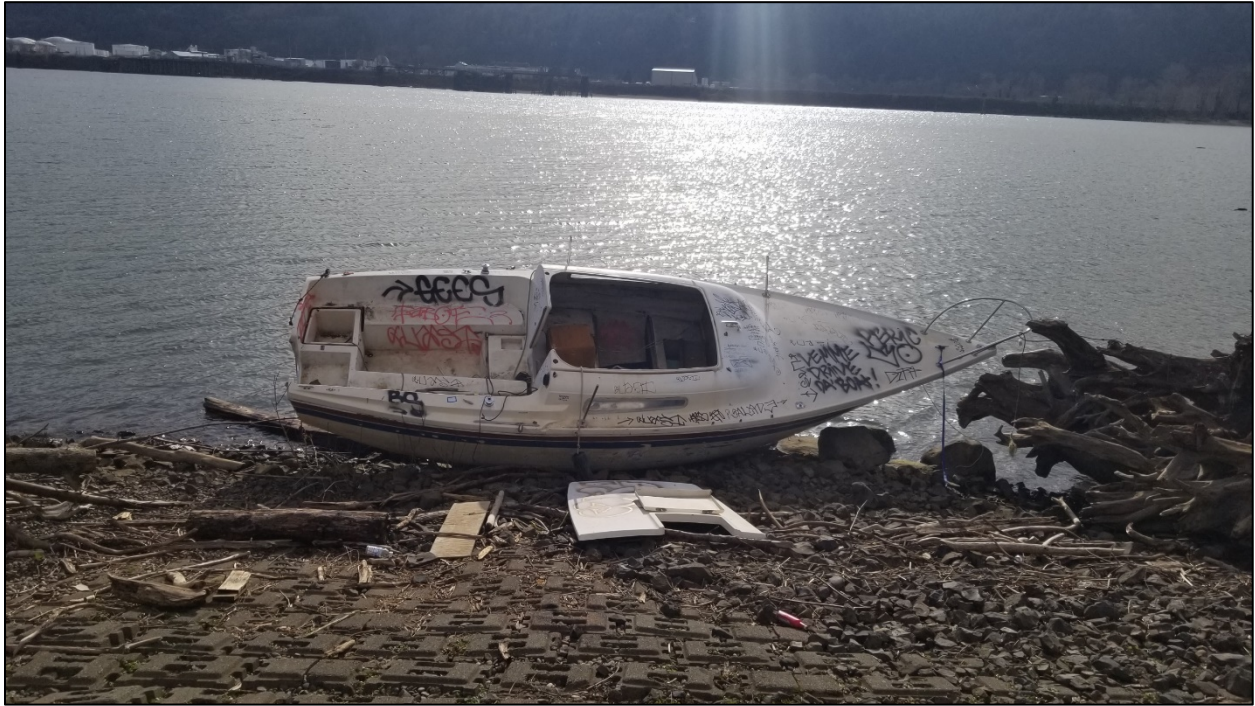
Photograph 4: Abandoned vessel on the shoreline of the Willamette River is still present. View facing west.

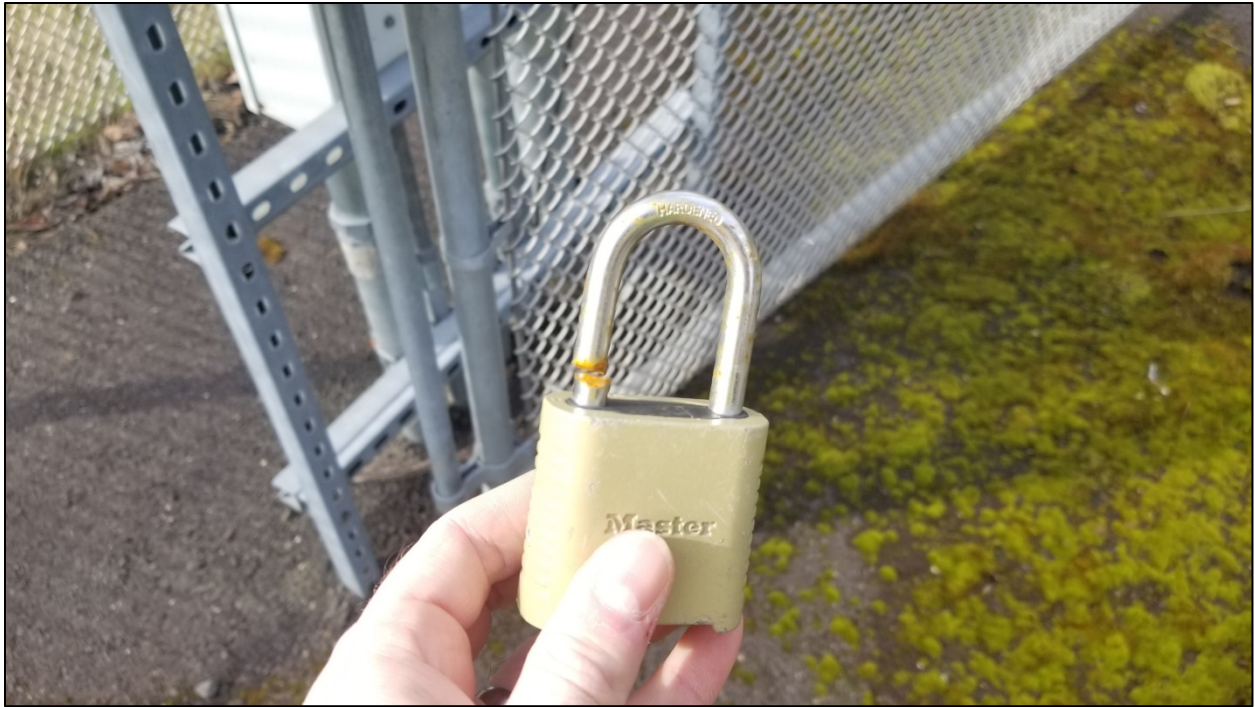
Locks on perimeter fence gates were found cut on March 8 and December 23, 2021. Field staff purchased replacement locks from a local hardware store and the gates were resecured prior to field staff leaving the Site on each occasion.

Photograph 5: Lock cut on the main gated entrance from N. Edgewater Avenue.

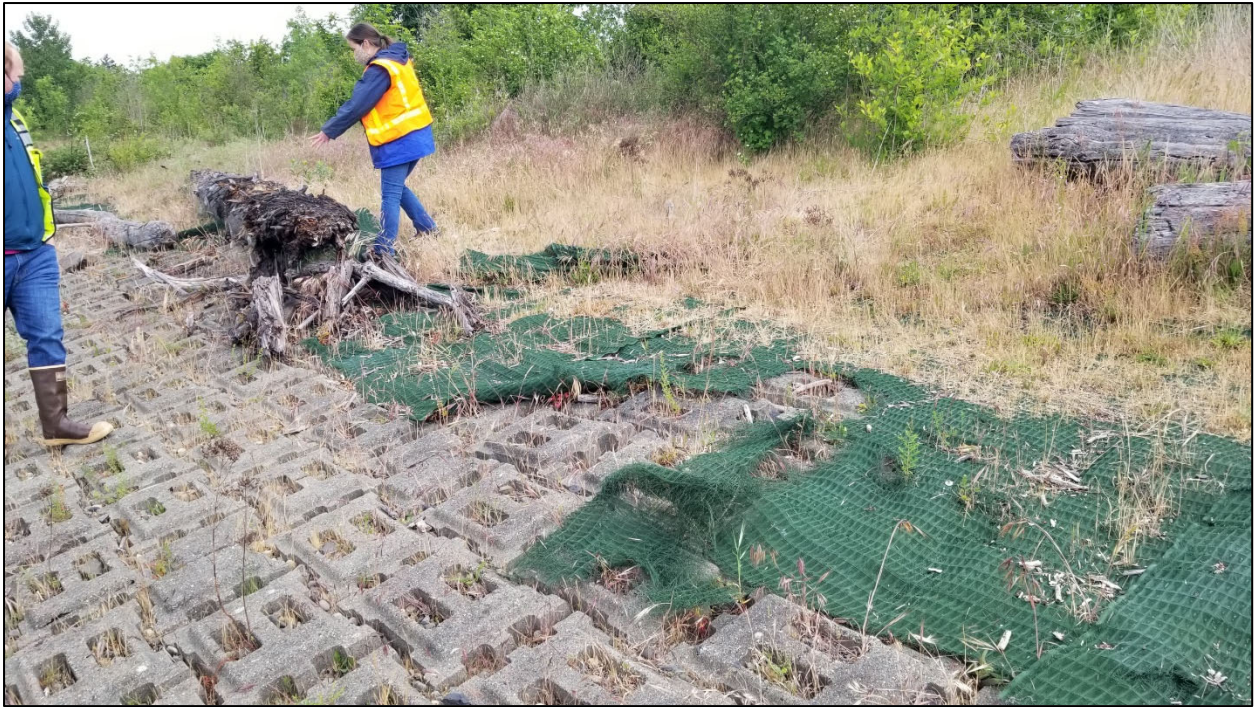
Photograph 3: Loose or torn section of TRM that requires repairs. View facing north.

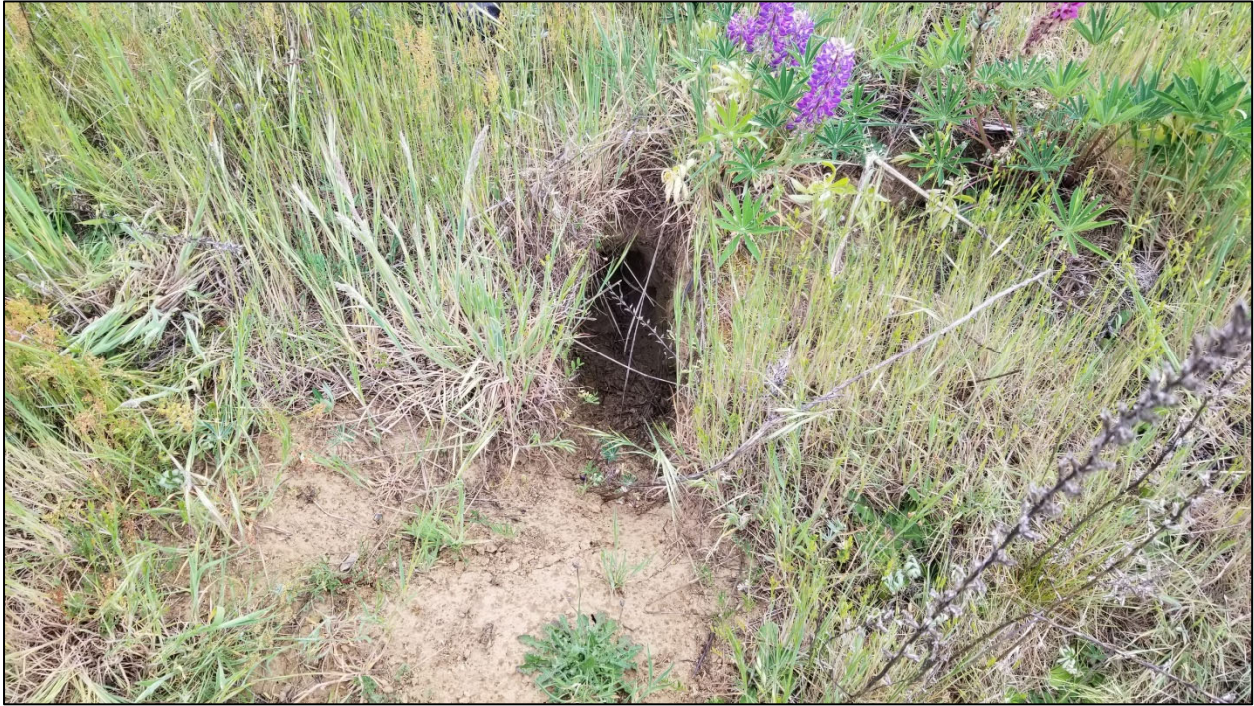
Photograph 4: Animal burrow in the vicinity of MW-48s.

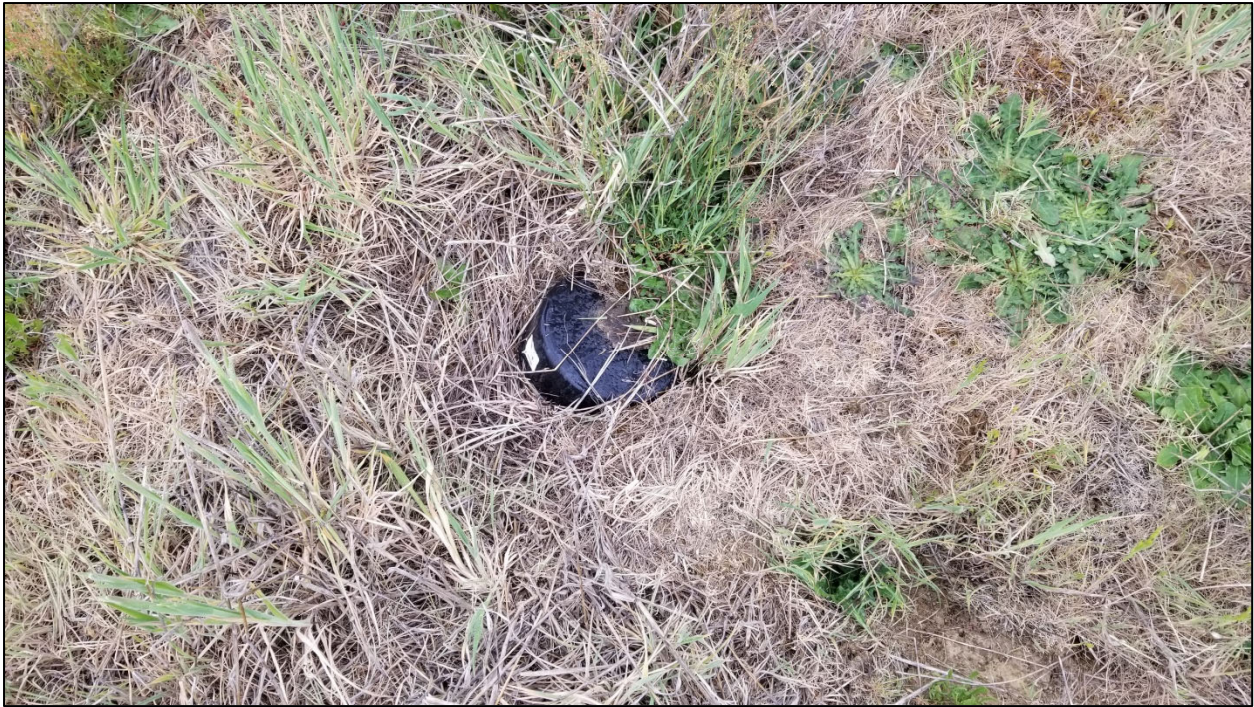
Photograph 5: PVC riser and cap protruding through the soil cap and presumed to be a storm sewer cleanout.

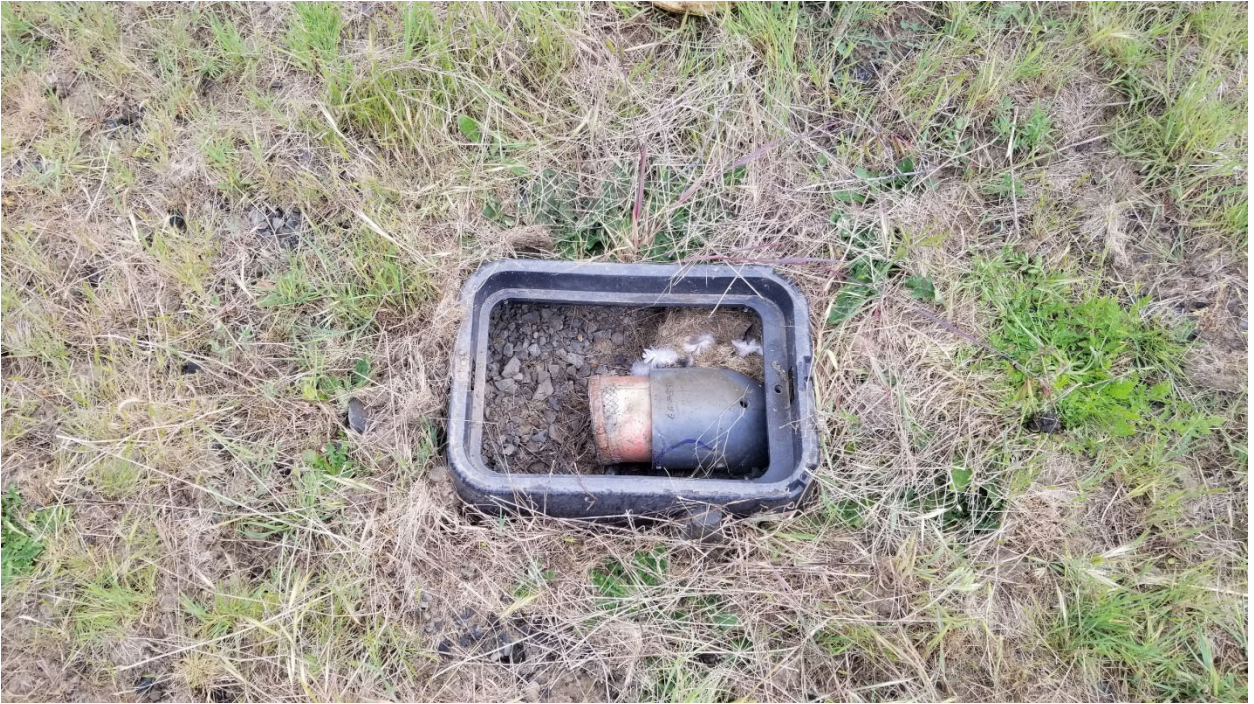
Photograph 6: Rodent nesting inside the gas vent vault box at GV-3.

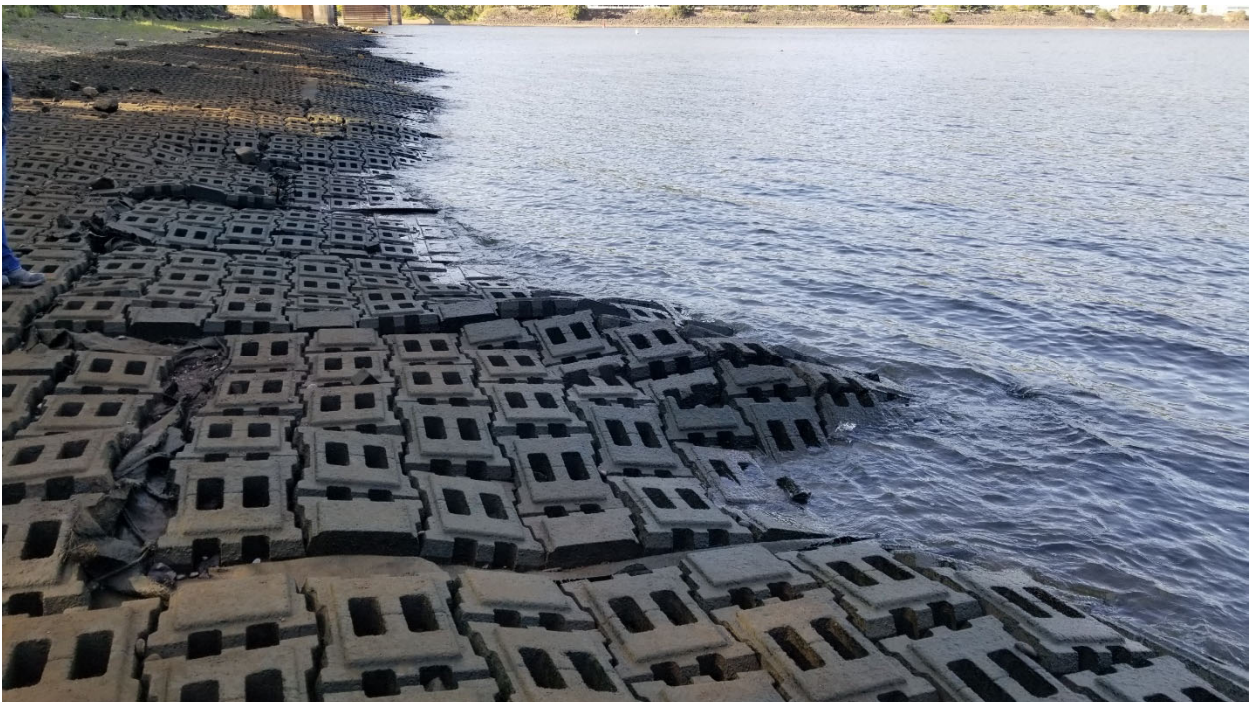
Photograph 2: Buckled ACB from the northeastern end of ACB along shoreline in Willamette Cove. View facing southwest.

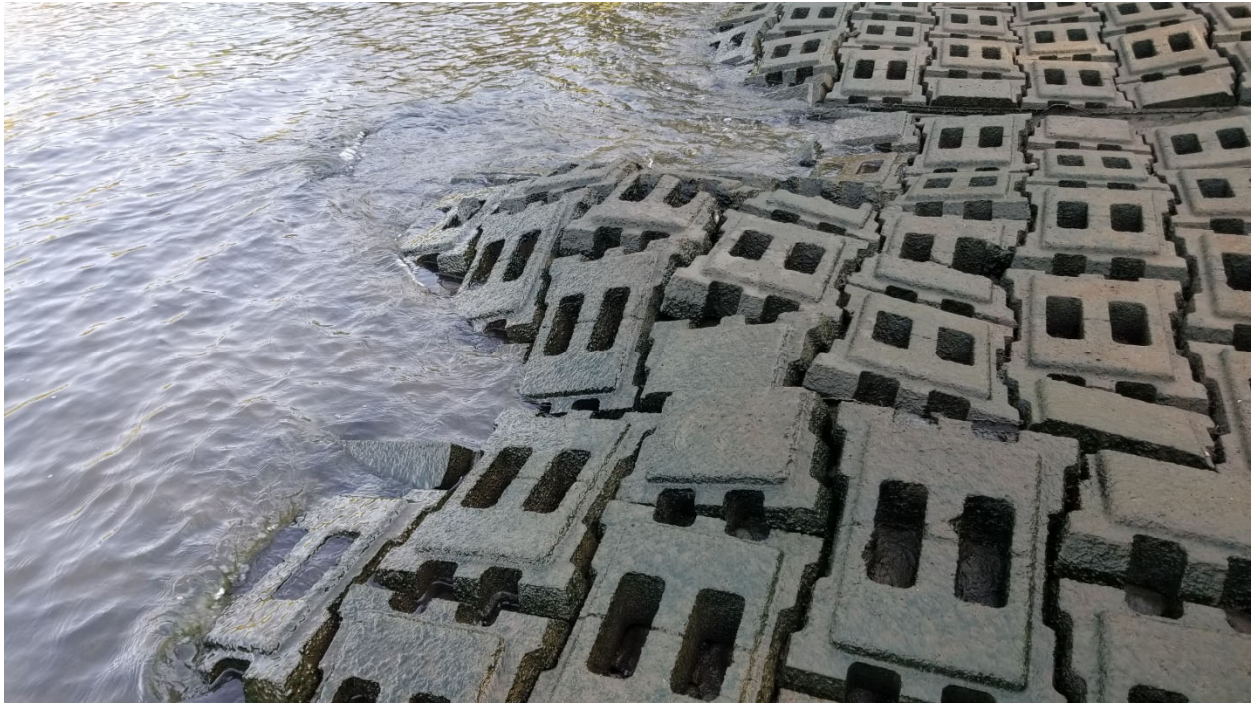
Photograph 3: A second section of buckled ACB from the northeastern end of ACB along shoreline in Willamette Cove. View facing northeast.

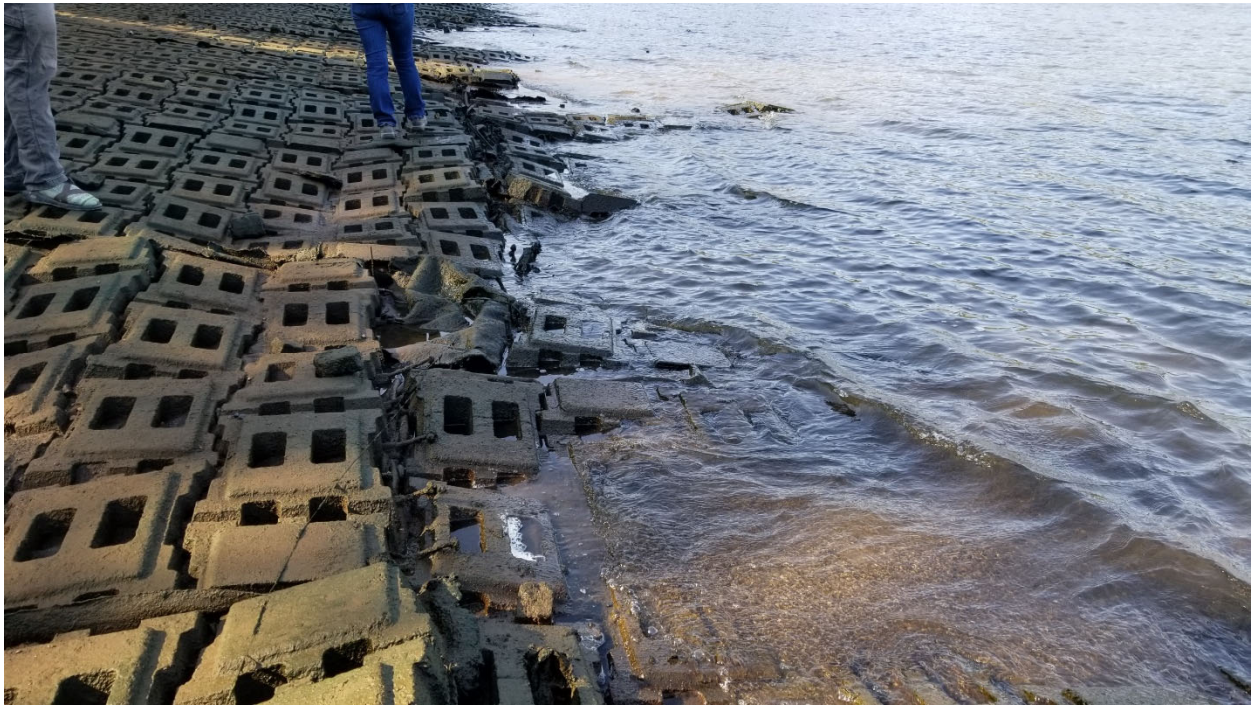
Photograph 4: Buckled ACB along center portion of ACB in Willamette Cove. View facing southwest.
