Operation and Maintenance Report January 2019 to December 2019

McCormick and Baxter Superfund Site Portland, Oregon ECSI Site No. 74

Prepared for Oregon Department of Environmental Quality

July 22, 2020 150-002-005/Task 3

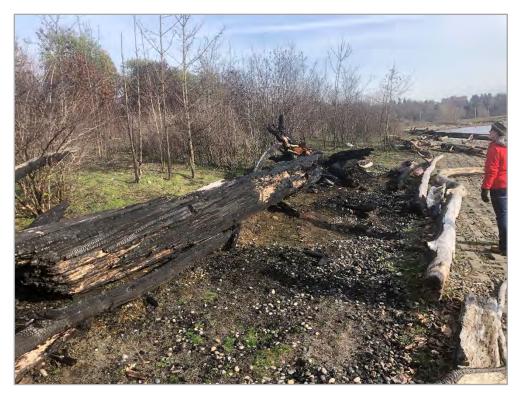
Photograph A3: Driftwood tree trunk burned in July 2018 riparian fire burn area (February 2019).

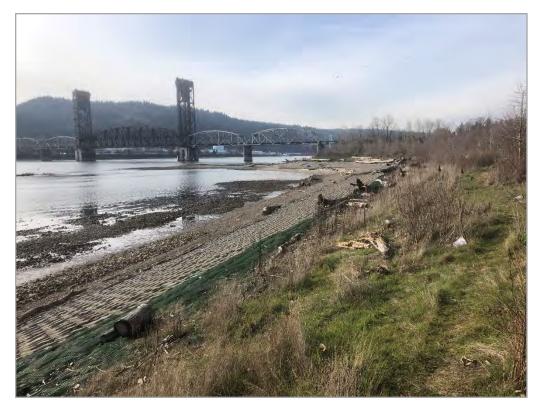
Photograph A4: Shoreline conditions along the Willamette River (February 2019).

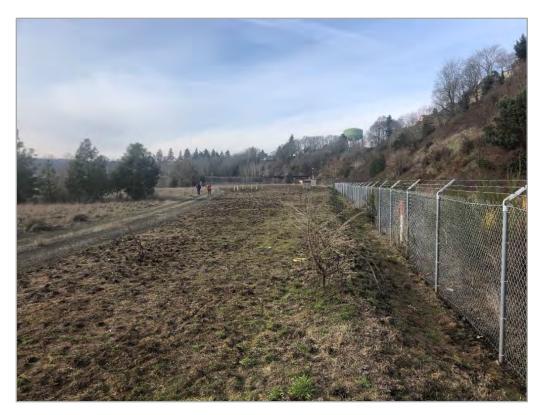
On September 24, 2018, a fire burned approximately 1 acre of grass at the northeast side of the site on the earthen soil cap. The fire burned an approximate 600-foot-long area between the gravel road and the northern perimeter fence. Evidence of the fire (e.g., charred or reduced grass coverage) was still observable during the February and April 2019 quarterly site inspections (Appendix A, Photograph A5). Following the spring rain season, grass coverage in the burned area had returned and no signs of fire were observable during the July 2019 quarterly site inspection.

Photograph A5: View facing north of September 2018 grass fire burn area (February 2019).

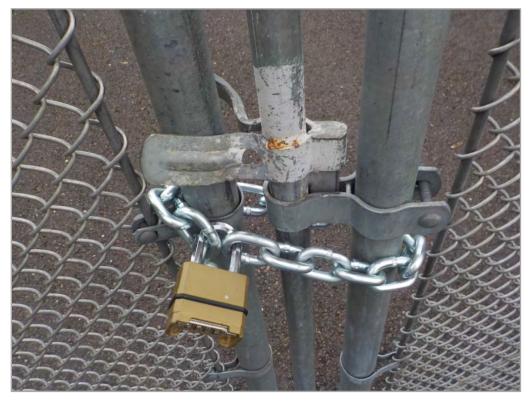
road outside the perimeter fence along the riparian area; and replacement of a cut lock (Appendix A, Photograph A6) and repairs to the main gate shackle which had been bent by unauthorized site entry. During the site visit, it was identified that two gas vents, GV-1 and GV-4, were missing vault boxes (Appendix A, Photograph A7) and required additional supplies to implement repairs.

Photograph A6: Replacement lock with hardened steel shackle on gate to paved storage area after prior lock was cut off (March 2019).

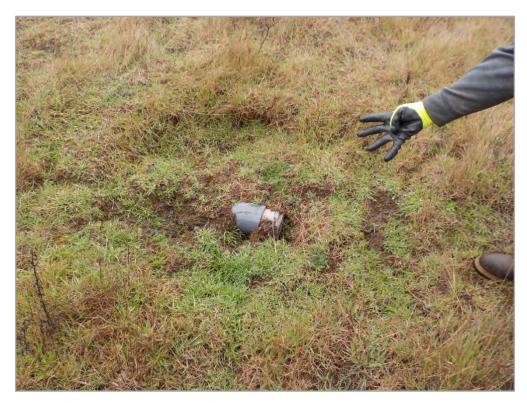
Photograph A7: Gas vent GV-4 with missing vault (March 2019).

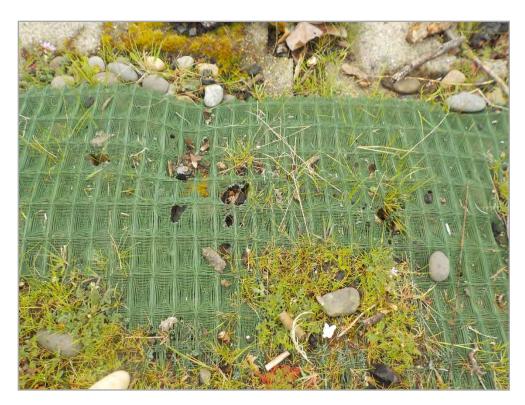
with trees developing new buds in the latter half of 2019. Burned holes in the TRM were monitored throughout the year and appeared stable without increases in size (Appendix A, Photograph A9).

Photograph A9: Burned holes in TRM following July 2018 riparian area fire. Holes appear stable and are not increasing in size (April 2019).

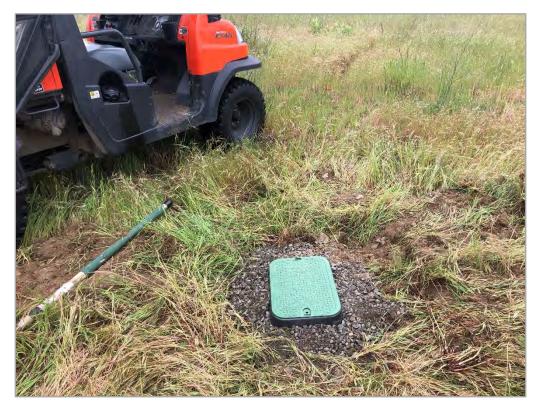
Photograph A12: Completed installation of replacement vault box for gas vent GV-4 (May 2019).

A vegetation inspection was performed on May 17, 2019, concurrently with O&M activities. The vegetation inspection results are described in detail in Section 5.3.2 and identified several noxious plant species in both the upland and riparian areas of the site. Replacement of the missing gas vent vaults for GV-1 and GV-4 was completed as part of the O&M activities (Appendix A, Photograph A12).

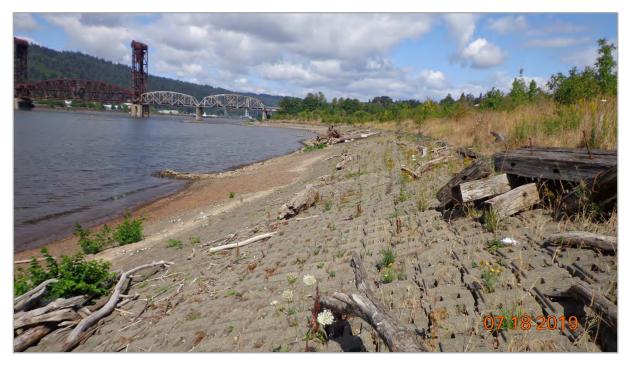
Habitat enhancement features, such as boulder clusters and sand cover as a biotic layer, are design elements of the sediment cap. Driftwood also provides habitat enhancement along the shoreline and in the riparian area above the shoreline. The distribution of sand cover over the ACB is similar to previous years. Originally, sand was placed over a large portion of the shoreline and Willamette Cove ACB armoring, but high river flow conditions and wakes from passing boats had washed sand from the ACB where the bank slopes are steeper. Rounded 1 ½-inch-minus gravel was placed within the ACB voids along a large portion of the shoreline and Willamette Cove in October 2012. The gravel has largely remained in place through 2019; however, some has washed down steeper shorelines and has settled onto lower ACB surfaces (Appendix A, Photographs A14 and A21).

Photograph A14: View facing northwest of the shoreline along the Willamette River (July 2019). Cover gravel washed from the upper slope of the ACB surface is visible along the waterline.

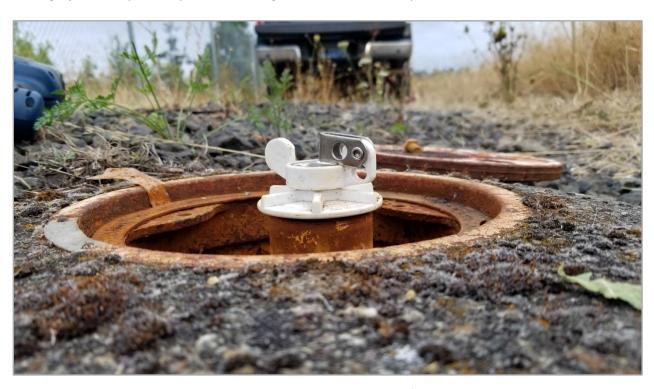
Photograph A16: MW-59s well casing and cap sticking above rim of well box prior to trimming (August 2019).

After obtaining additional materials and tools, Hart Crowser performed repairs to the items listed above during the next O&M visit on May 17, 2019, with the exception of the sunken well box for MW-59s. Hart Crowser and the DEQ discussed the sunken MW-59s well box during the April 2019 quarterly site inspection and agreed that the well casing could be trimmed down prior to the upcoming site surveying activities (Section 2.2.2) so that the well casing elevation could be resurveyed. On August 21, 2019, Hart Crowser trimmed the well casing for MW-59s down by 2.125 inches so that the well box lid could be properly bolted down (Appendix A, Photographs A16 and A17).

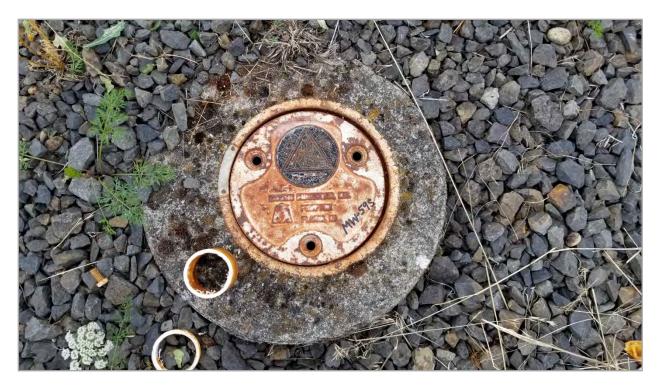
Photograph A17: Properly seated well box lid for MW-59s following trimming of the well casing by 2.125 inches (August 2019).

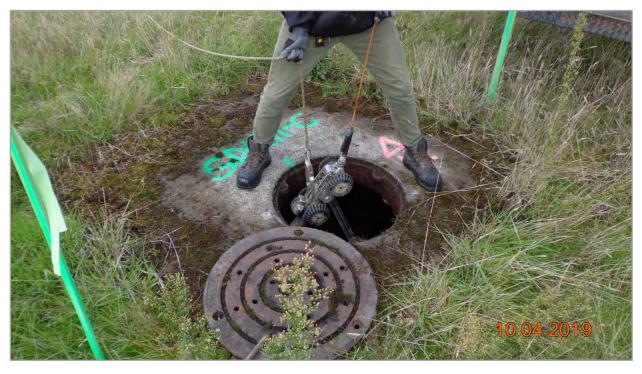
The storm sewer video inspection was performed to monitor for potential impacts to the storm drain line integrity from soil subsidence and to evaluate previously documented sags (Figure 1-4) in the pipe between manholes SDMH-B and SDMH-C. BEI performed the storm sewer video inspection on October 4, 2019, using a remote-operated crawler camera to inspect the line (Appendix A, Photograph A18). No new sags were identified during the video inspection, and no breaks, fractures, or cracks were identified.

Photograph A18: Video inspection of the storm sewer using a robotic crawler. Crawler is being lowered into manhole SDMH-C (October 2019).

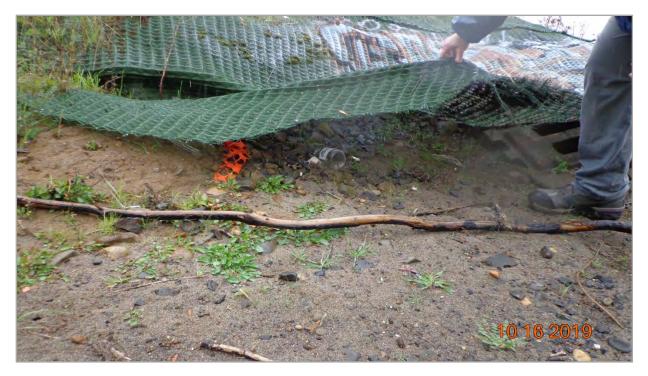
During the October 2019 quarterly site inspection, a minor amount of erosion was observed at the northwestern end of the turf-reinforced matting (TRM) at the upper edge of the ACB (Appendix A, Photograph A19), likely occurring only during very high water conditions of the Willamette River. The erosional area will be repaired during O&M activities for the site in summer 2020.

Photograph A19: Area of sand erosion under TRM along walking path near MW-37 well cluster (October 2019).

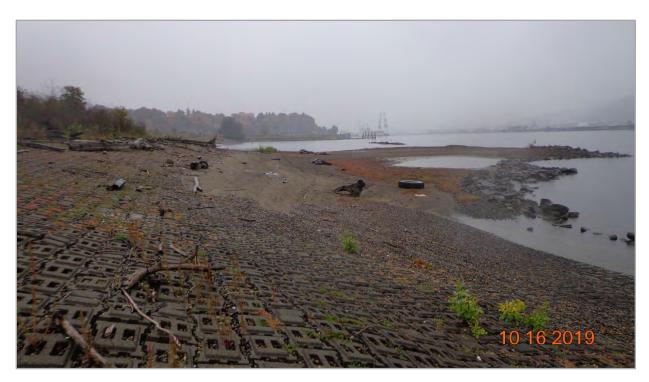
Photograph A21: Willamette River Shoreline during low tide in the vicinity of MW-39 well cluster facing southeast (October 2019). Driftwood and several items of trash visible, including a heavy equipment tire. Cover gravel washed down from the upper slope of the ACB is visible lower on the ACB slope.

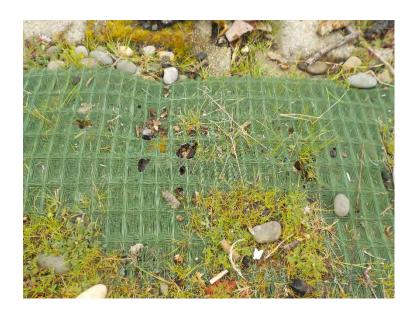
Photo 2 –View of one to three-inch diameter holes in the TRM caused by the 2018 fire in the riparian area.

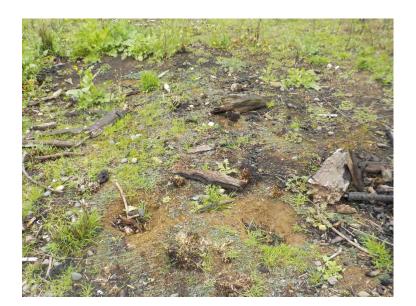
Photo 3 –View of six-inch diameter patches in the TRM as a result of the 2018 fire in the riparian area.

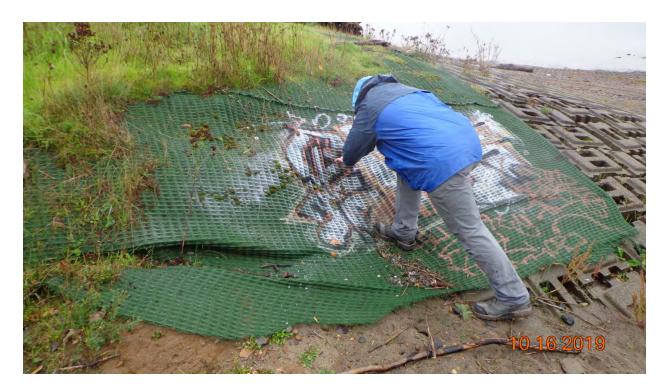
Photo 1: TRM at northern end of riparian area displaying signs of sagging.

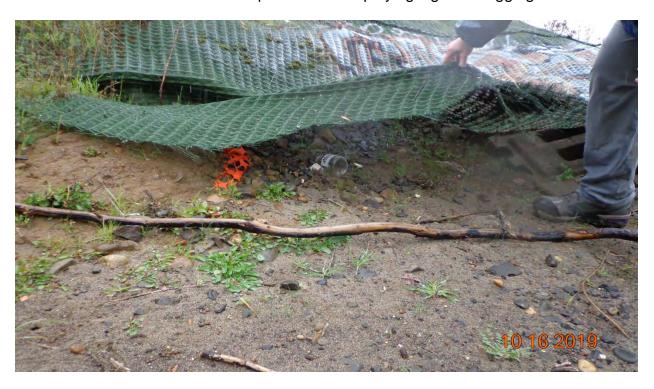
Photo 2: View of depression under TRM where sand appears to have washed out from under the corner of the mat.

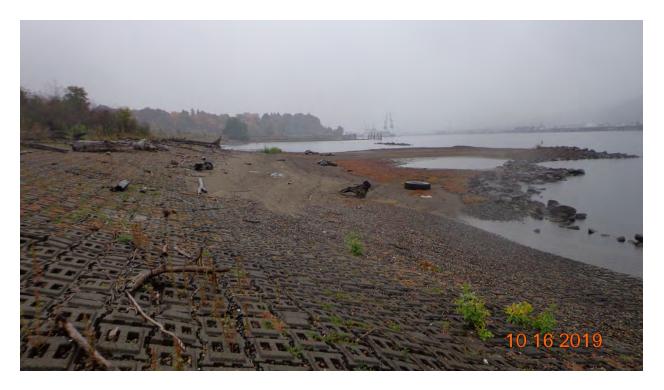
Photo 3: View of tidal mud flats at low tide during and the large, discarded tire that is present.

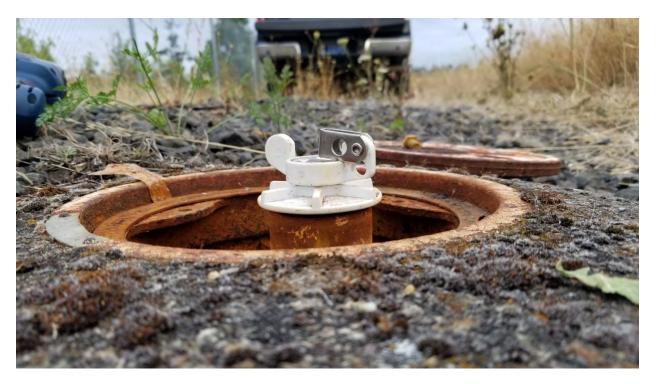
Photo 8: Well cap and casing for MW-59s protruding above the rim of the well box in the perimeter road.

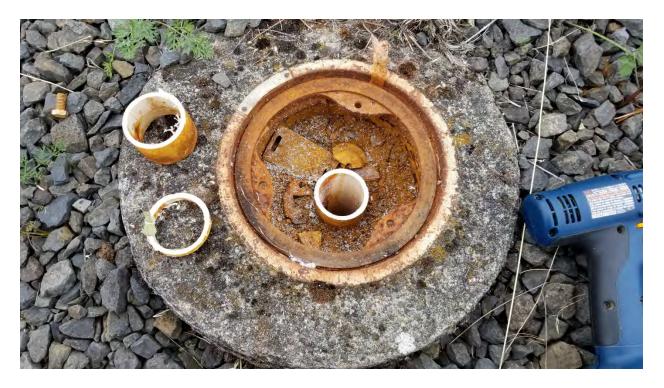
Photo 9: MW-59s well casing after removal of 3 inches using a power drill attached internal PVC pipe cutter.

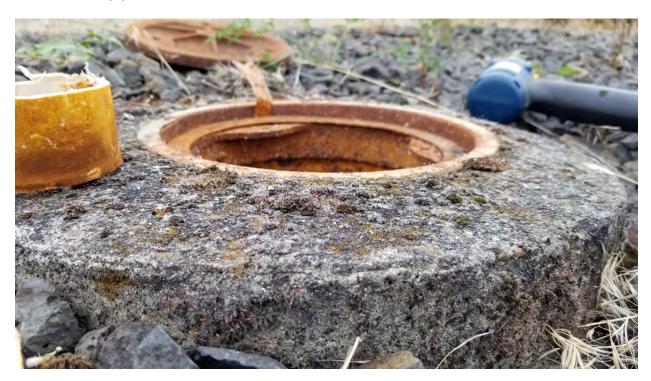
Photo 10: Well casing sitting below the rim of the well box after trimming.

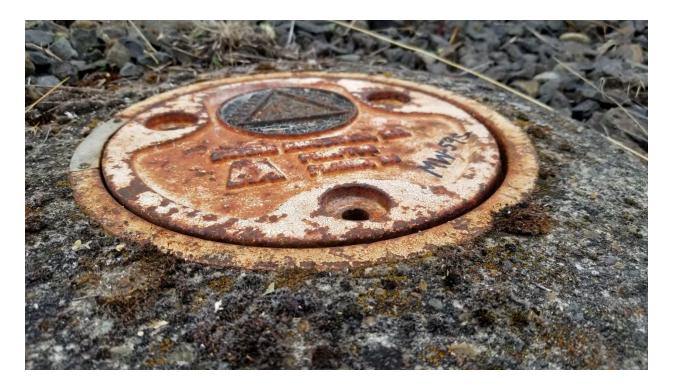
Photo 11: Well lid sitting correctly in well box after trimming of MW-59s casing.

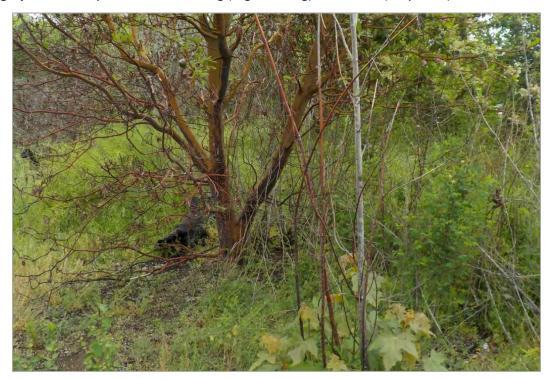
Photograph C20: Madrone that survived burned (only lower branches died) and big-leaf maple suckering in foreground (May 2019).

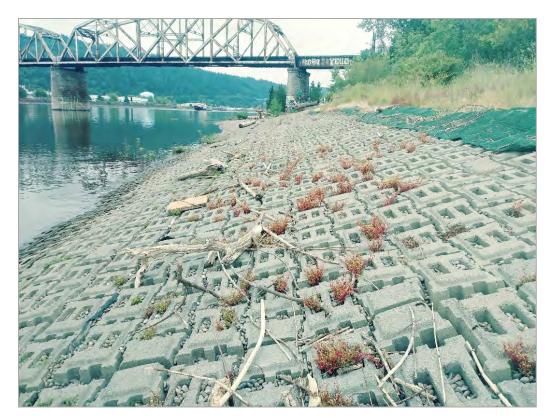
Photograph C23: Shiny-leaf geranium (Geranium lucidum) growing in lower riparian area (June 2019).
