Operation and Maintenance Report January 2018 to December 2018

McCormick and Baxter Superfund Site

Portland, Oregon ECSI Site No. 74

March 29, 2019 150-002-005/Task 3

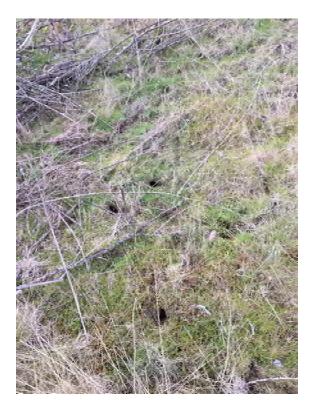
Evidence of ground squirrel activity was observed at several locations throughout the upland soil cap. Ground squirrels are common to the area, and their burrows typically extend to approximately 1 foot below the ground surface (bgs). The ground squirrels use the surplus articulated concrete block (ACB) stockpiled at the site, paved roadway, and concrete well monuments as habitat. A typical animal burrow was observed on the soil cap, likely from a small rodent (Photograph 1, Appendix A). None of the observed burrows extend more than 1 foot into the 2-foot soil cap and, therefore, the soil cap continues to isolate site contaminants from human and ecological receptors. Continued monitoring of the burrows is recommended; no action to remove burrowing animals or to fill in the burrows is planned or is necessary at this time.

Photograph 1 – Animal burrow observed during April 2018 site inspection.

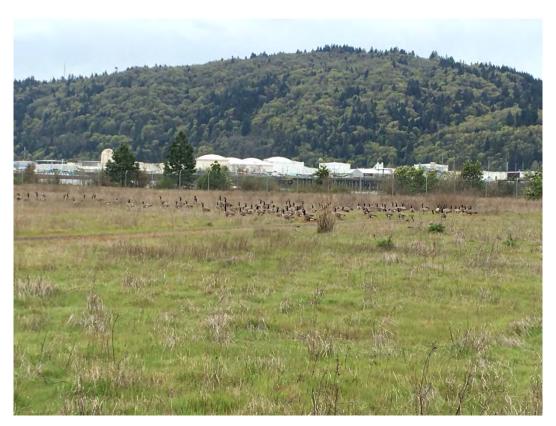
Canada geese were also observed on the upland soil cap during a maintenance site inspection on April 11, 2018 (Photograph 2, Appendix A). Approximately 100 Canada geese were foraging on the upland soil cap.

Photograph 2 – Geese observed in April 2018.

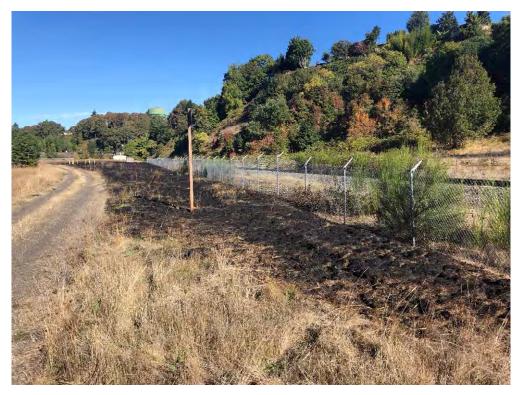
On September 24, 2018, a fire burned approximately one acre of grass at the northeast side of the site on the earthen soil cap. The northwest edge of the burned area was approximately 200 feet southeast of the site shop building and burned grass in between the fence and gravel road around monitoring wells PW-2d and MW-Os and the backflow assembly above ground vault (Photograph 3, Appendix A). The fire burned the grass groundcover leaving several bare areas of the soil exposed, but it did not

Photograph 3 – Looking northwest at the September 2018 fire damage at the northeast end of the site.

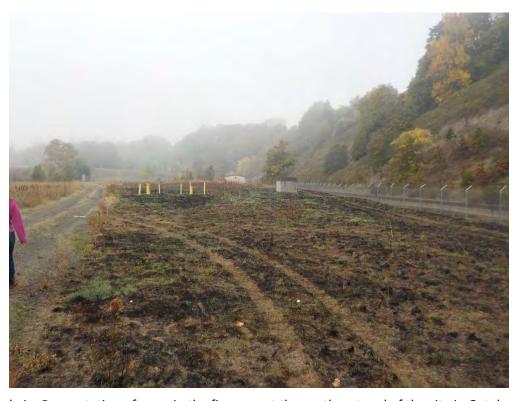
damage monitoring wells or "no trespassing" signs. During the October 2018 site inspection, there was evidence of grass sprouting and re-growing in the burned area (Photograph 4, Appendix A).

Photograph 4 – Revegetation of grass in the fire area at the northeast end of the site in October 2018.

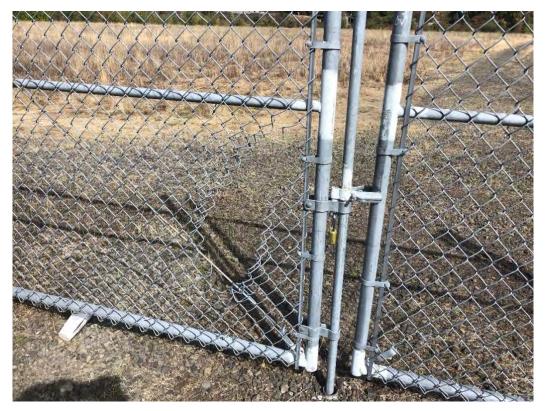
Photograph 5 – Cut hole in the second-most northwestern riverside gate fence in September 2018.

On October 23, 2018, McDonald Fence and Construction, Inc., patch-repaired the hole in the chain linked fence at the second-most northwestern riverside gate.

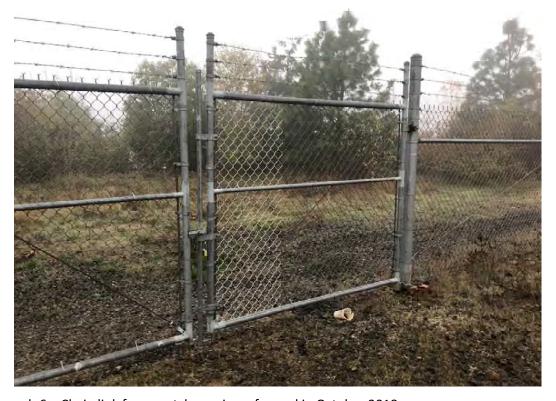
Photograph 6 – Chain link fence patch repair performed in October 2018.

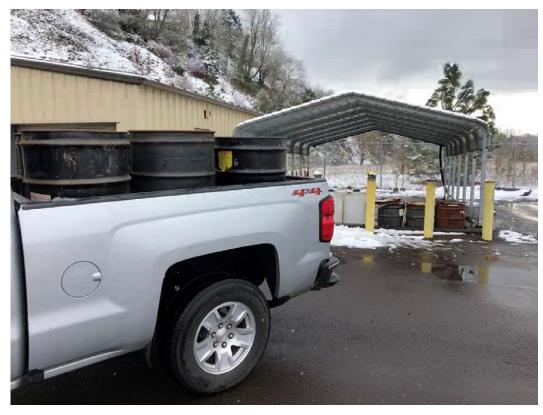
Photograph 7 – Removal of empty, rusting 55-gallon drums during February 2018 maintenance site visit.

On February 22, 2018, Hart Crowser removed approximately 12 empty, rusting 55-gallon steel drums stored under the outdoor canopy, adjacent to the site building, and recycled them at Rivergate Scrap Metals in Portland, Oregon (Photographs 7 and 8, Appendix A). A fallen over "no trespassing" sign along the southeastern side of the site was also repaired. On February 27, 2018, animal burrows along the fence were filled in with gravel (Photograph 9, Appendix A) and automotive maintenance (e.g., check oil and fuel filter) was performed on the Kubota site vehicle.

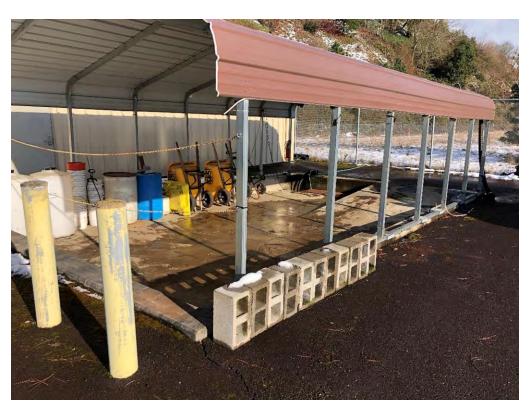
Photograph 8 – Site shop canopy after the removal of 55-gallon drums in February 2018.

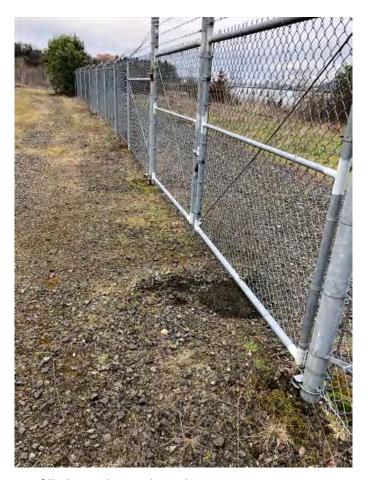
Photograph 9 – Animal burrow filled in with gravel in February 2018.

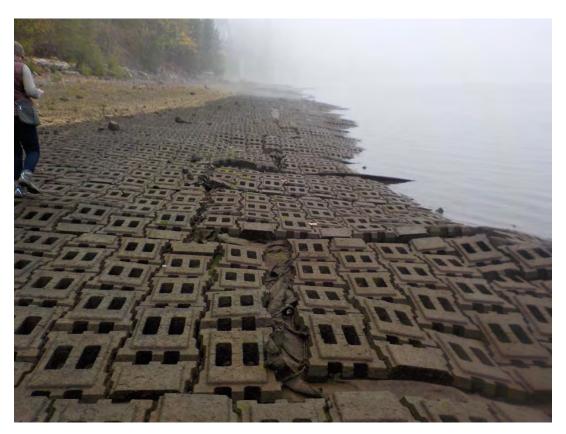
During the October 2018 site inspection, multiple 2- to 6-inch-wide voids were observed in the ACB along the shoreline in Willamette Cove (Photograph 12, Appendix A). The gaps were visible due to the low Willamette River water surface elevation conditions at the end of summer and during low tide.

Photograph 12 – Looking west at the ACB armoring in Willamette Cove in October 2018.

Overall, the sediment cap observations and inspections revealed no significant change in remedy performance or areas of concern. Future O&M activities primarily will consist of quarterly inspections and routine maintenance. Several voids in the ACB along the Willamette Cove were observed when the water level was at a seasonal and tidal low. Sediment cap porewater and surface water sampling was conducted in 2015 with results reported in the 2015 Annual Report and the Fourth Five-Year Review (DEQ/EPA 2016). Results indicated that the sediment cap is performing as designed. The next round of porewater and surface water sampling is scheduled to be conducted in 2020, before the Fifth Five-Year Review Report in 2021.

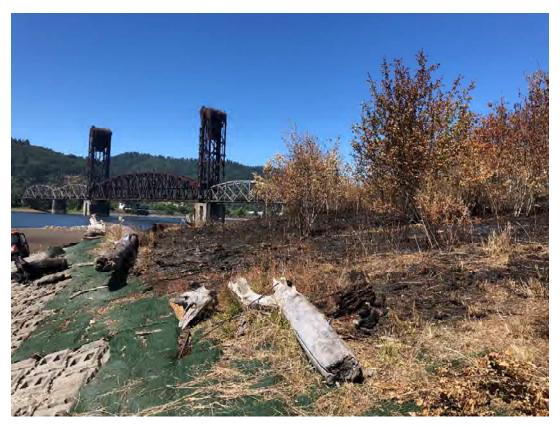
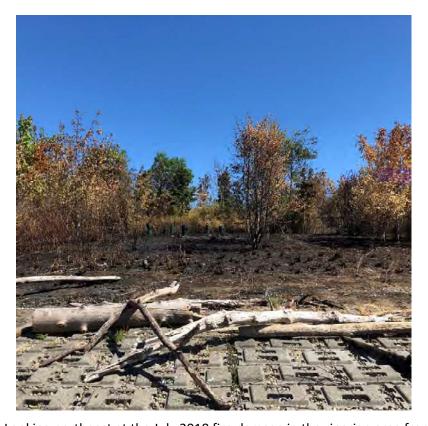
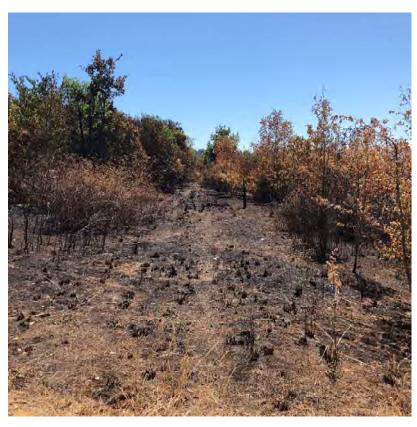
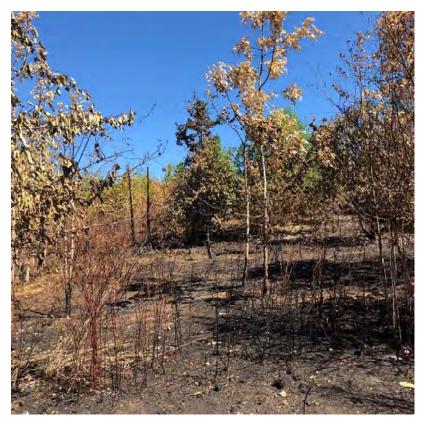
On July 18, 2018, a fire burned approximately 1 acre at the northwestern end of the riparian area between monitoring wells MW-39s and MW-43s (Photographs 13 through 16, Appendix A). The fire primarily burned undergrowth brush and grass vegetation impacting the riparian area closer to the river. It appears many of the trees survived the fire. Hart Crowser inspected PVC well casings and did not see any signs of damage to the monitoring wells. The fire burned several holes approximately 3 inches in diameter in the turf-reinforced matting (TRM) in the riparian area. During the October 2018 site inspection, we observed grass sprouting in the burned areas.

Photograph 13 – Looking northwest at the July 2018 fire damage in the riparian area.

Photograph 14 – Looking northeast at the July 2018 fire damage in the riparian area from the shoreline.

Photograph 15 – Looking southeast at the July 2018 fire damage in the riparian area.

Photograph 16 – Looking at the July 2018 fire damage in the lower portion of the riparian area.

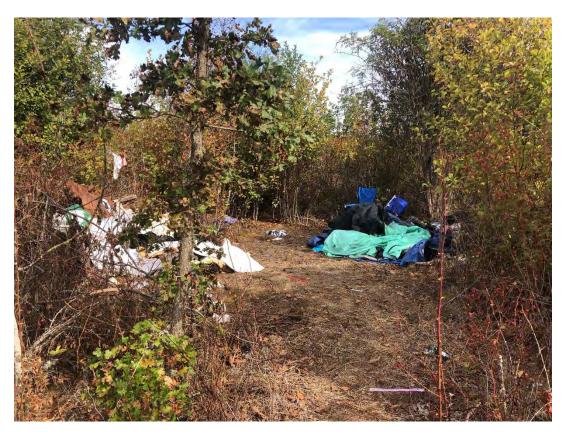
The shoreline along the site and in the Willamette Cove is accessible and is used by the public for various forms of recreation. Throughout 2018, shoreline trash and graffiti were observed, including scattered car parts, garbage cans, bicycle parts, clothes, and numerous dumpsites (Photograph 19, Appendix A). One active camp was observed at the northwestern end of the riparian area in September 2018. Follow up quarterly inspections found the camp abandoned. In October 2018, a representative from Metro Regional Government's RID Program accompanied the quarterly site inspection to assist in evaluating options to remove trash from dumpsites.

Photograph 19 – Temporary dumpsite in the riparian area in September 2018.

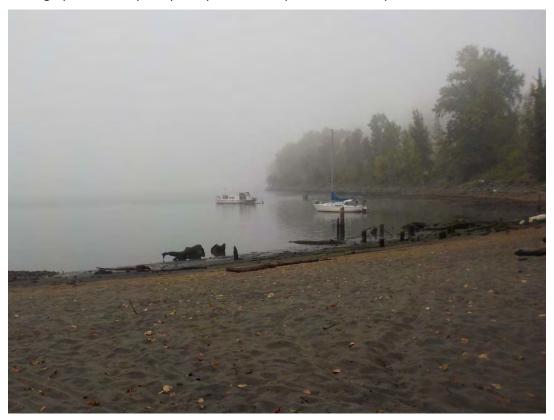
Numerous dilapidated boats (used as dwellings) were also seen anchored in the Willamette Cove during every site visit (Photograph 20, Appendix A). We did not observe any damage to the sediment cap from moorage or physical contact by boats in the Willamette Cove. The U.S. Coast Guard and Oregon State Marine Board rules prohibit anchoring on the sediment cap.

Photograph 20 – Derelict boats in the Willamette Cove in October 2018.

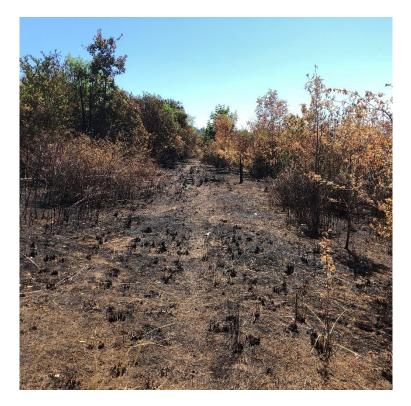
Photo 1 –View of fire damage along the service road in the riparian area.

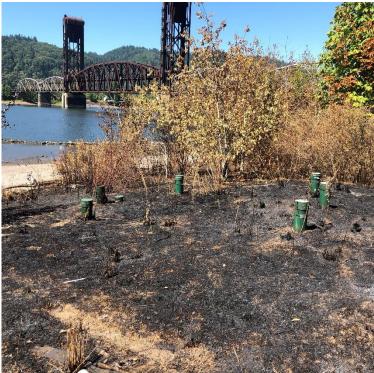
Photo 2 – Northwest view of fire damage surrounding monitoring wells (MW-40i, MW-40s, MW-40d, MW-41i, MW-41s, and MW-41d).

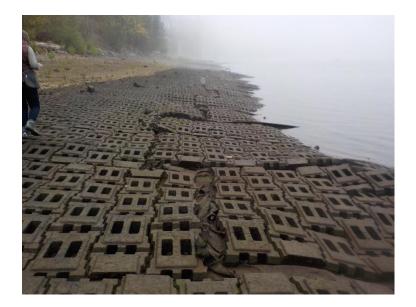
Photo 1 –View of separation gaps in the ACB along the Willamette Cove Shoreline.

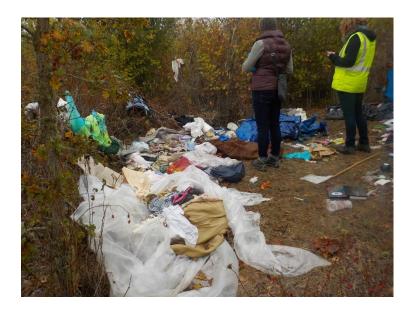
Photo 2 –View of debris left from dump site in the riparian area.

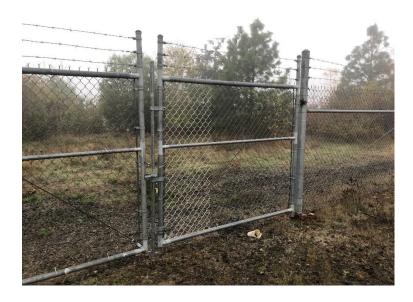
Photo 3 – View of repaired gate fence that was damaged from a 2-foot by 2-foot cut in the chain link fence.

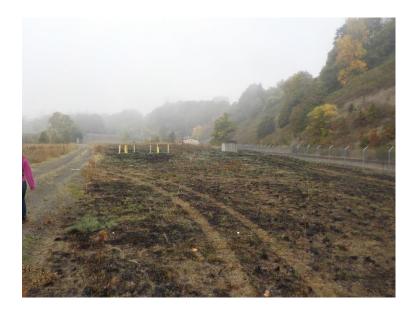
Photo 4 – View of the fire damage at the northeastern end of the site along the railroad.

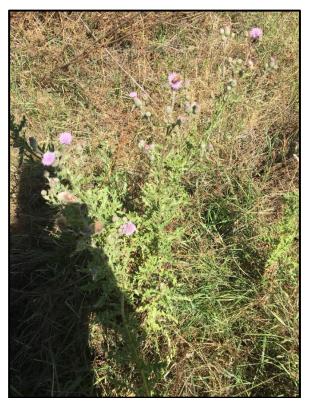
Photograph 10 - Canada thistle, a B-listed noxious weed in Oregon, was found scattered (June 2018)

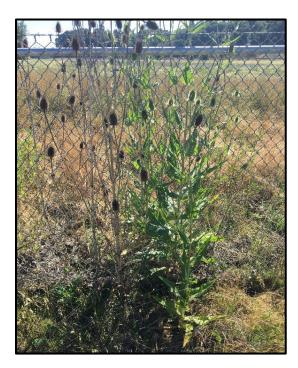
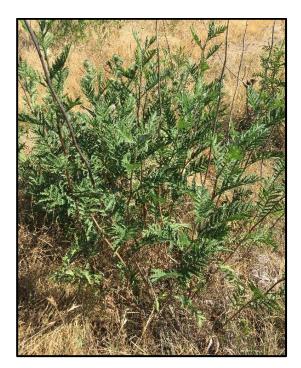
Photograph 11 – Two species that are not on the noxious plant list but have been known to become invasive in other parts of the country are common teasel (*Dipsacus sylvestris*) and tansy (*Tanacetum vulgare*) (June 2018)
