Operation and Maintenance Report January 2017 to December 2017

McCormick and Baxter Superfund Site Portland, Oregon ECSI Site No. 74

Prepared forOregon Department of
Environmental Quality

March 29, 2018 15670-10/Task 4

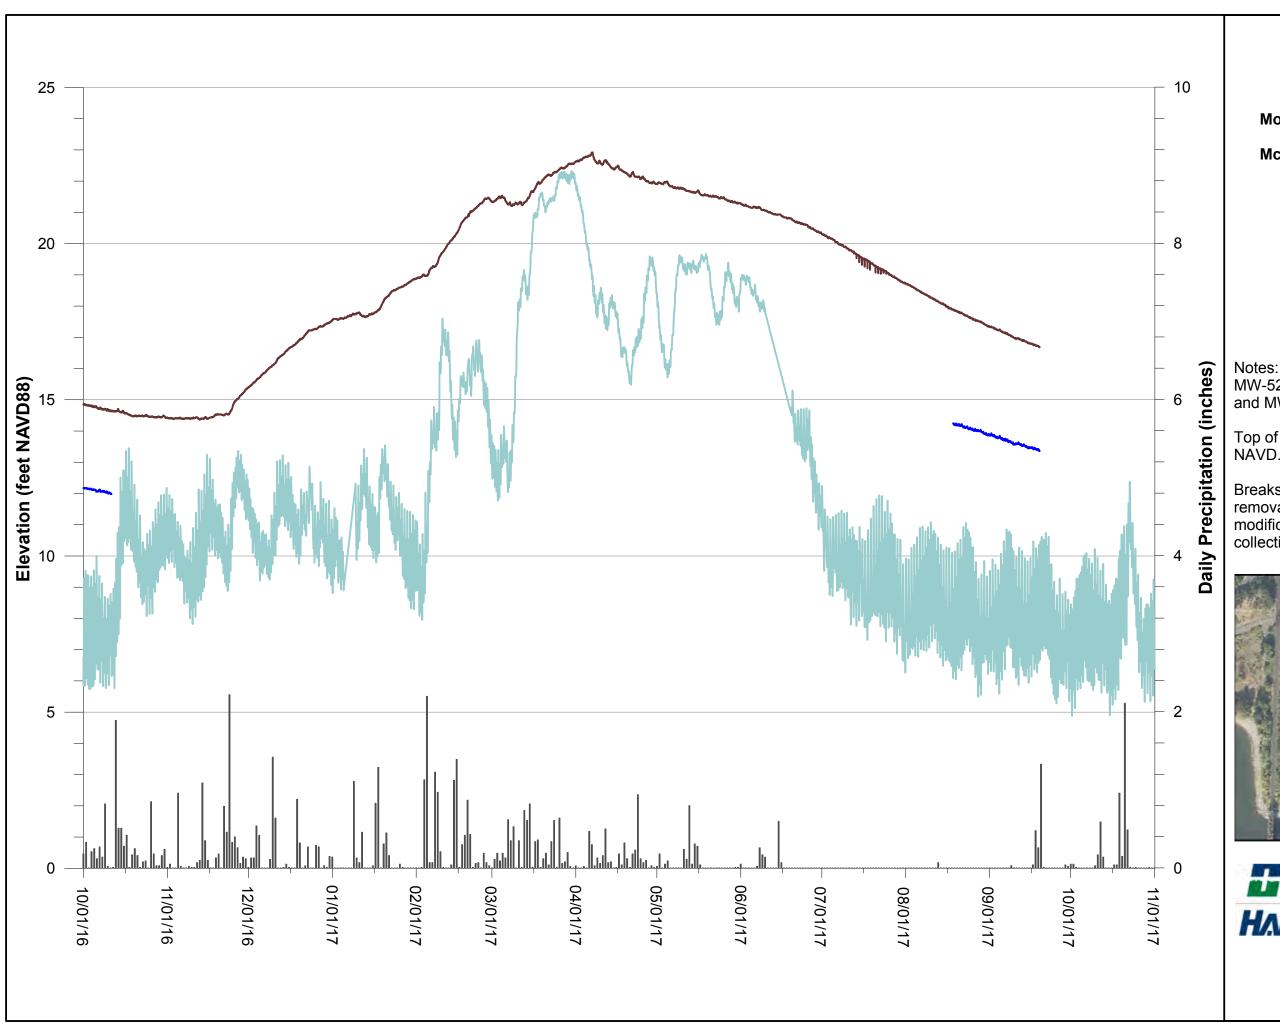
Figure 4-5: 2017 Groundwater Elevations Monitoring Wells MW-52s and MW-53s

The break in MW-52s data (Figure 4-5) occurred as a result of water damage in the probe, which was identified in the June semiannual event. The transducer was sent in for repairs and re-installed in August. Currently, all transducers at the site are functional and installed in the wells shown on Figure 4-1.

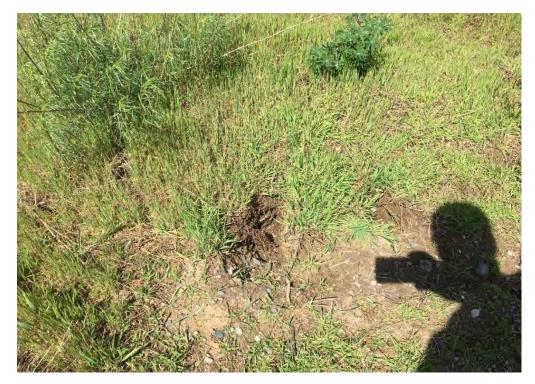
Evidence of ground squirrel activity was observed at several locations throughout the upland soil cap. Ground squirrels are common to the area, and their burrows typically extend to approximately 1 foot below ground surface (bgs). The ground squirrels use the surplus articulated concrete block (ACB) stockpiled at the site, paved roadway, and concrete well monuments as habitat. A typical animal burrow was observed on the soil cap, likely from a small rodent (Photograph 1, Appendix A). None of the observed burrows extend more than 1 foot into the 2-foot soil cap and, therefore, the soil cap continues to isolate site contaminants from human and ecological receptors. Continued monitoring of the burrows is recommended; no action to remove burrowing animals or to fill in the burrows is planned or is necessary at this time.

Photograph 1 – Animal burrow observed during April 2017 site inspection.

Following the July 20, 2017, site inspection, burrows were filled around the perimeter fence. Additional site infrastructure activities were conducted. The power to the trailers was disconnected and the alarm system removed on January 26, 2017. Oregon Demolition removed and took title to the two job trailers, which were deteriorating and obsolete, on February 9, 2017 (Photograph 2; Appendix A). The backflow preventer on the waterline was tested on September 15, 2017.

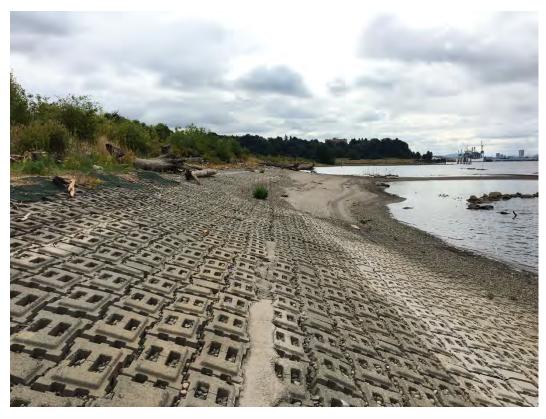
Habitat enhancement features such as boulder clusters and sand cover as a biotic layer are design elements of the sediment cap. Large woody debris also provides habitat enhancement along the shoreline and in the Riparian Area above the shoreline. The distribution of sand cover over the ACB is similar to previous years. Originally, sand was placed over a large portion of the shoreline and Willamette Cove ACB armoring, but high river flow conditions and wake from passing boats have washed sand from the ACB where the bank slopes are steeper. Rounded gravel (1-1/2-inch-minus) was placed within the ACB voids along a large portion of the shoreline and Willamette Cove in October 2012. The gravel has largely remained in place through 2017; however, some has washed down steeper shorelines and has settled onto lower ACB surfaces. Shoreline conditions and the distribution of the ACB gravel are shown in the Photograph Log (Photograph 3, Appendix A).

Photograph 3 – ACB observed during the July 2017 site inspection.

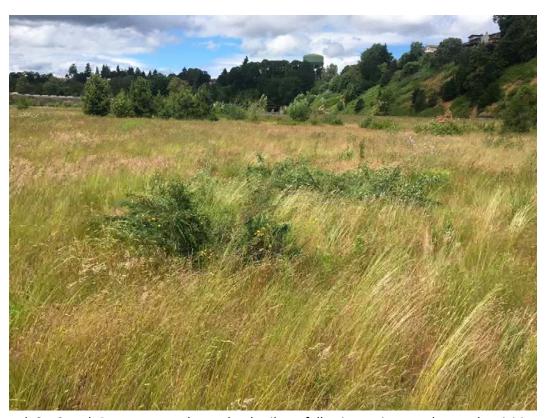
Photograph 8 – Scotch Broom removal on upland soil cap following spring weed control activities.

A preventive control approach continues to be implemented as part of an ongoing effort to control the spread of noxious weed species. Spot spraying was last completed over the entire site in May 2017. This follows weed suppression efforts in spring and fall 2016. Vegetation inspections in June and October found that noxious weed populations had been reduced. Various noxious weeds continue to be observed throughout the site, but at numbers that aren't significantly inhibiting growth of native plants. Future weed control efforts will be evaluated following the June 2018 vegetation inspection.

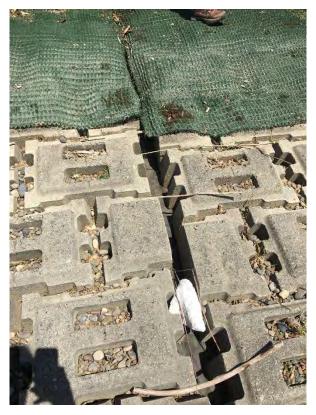
Photograph 9 – Gap observed in ACB during April 2017 site inspection.

The sediment cap was designed to be generally maintenance free. ACB repairs were completed in September 2017 that consisted of placing concrete in 11 areas where 2- to 4-inch voids developed between ACB mats (Photograph 9, Appendix A). The repairs were completed by placing concrete in the voids to reduce the trip hazard and protect the cap. Repairs were completed when river levels were low, allowing the concrete ample time to cure and eliminating the chance for runoff to the river. Additionally, riparian vegetation at the upper portions of the sediment cap required watering in August 2017 (see Section 5.3 for further discussion).

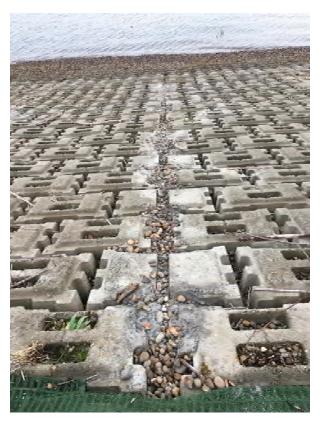
Photograph 11 – ACB repairs observed during October 2017 site inspection.

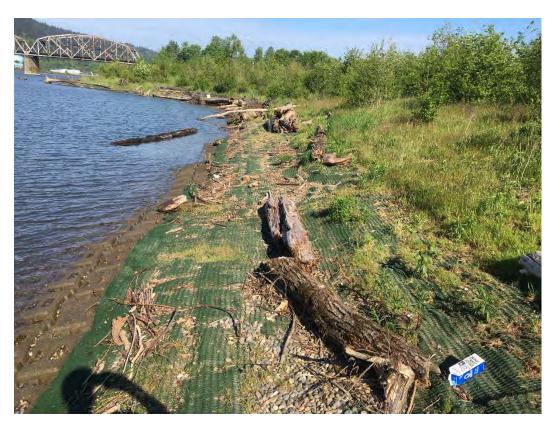
Sand covers the shoreline at lower, less steep elevations, and significant amounts of large driftwood have accumulated to help create wildlife habitat. Numerous wildlife species continue to be observed; various birds including Canada geese, gulls, cormorants, pigeons, blue herons, ospreys, and hawks were observed in 2017. The public frequents the shoreline for recreation, most commonly for walking dogs. Infrequent and minor instances of vandalism and littering have been noted, including car parts that were abandoned along the west fence line. Rounded gravel used to fill voids within the ACB has created a more stable substrate for wildlife and a consistent, safer walking surface for public use, although much of the gravel has been eroded from the upper potions of the ACB.

Photograph 13 – Lower portion of the ACB armoring – May 2017.

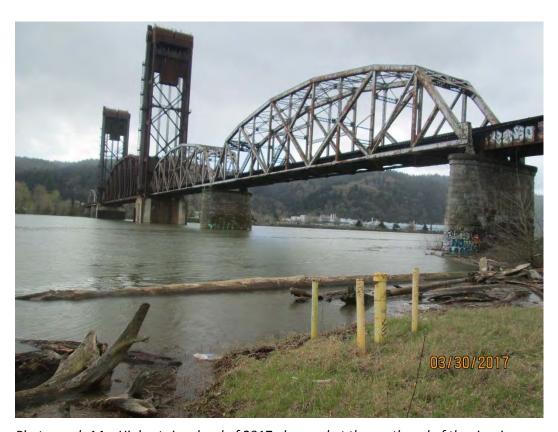
Photograph 14 – Highest river level of 2017 observed at the south end of the riparian area on March 30, 2017.

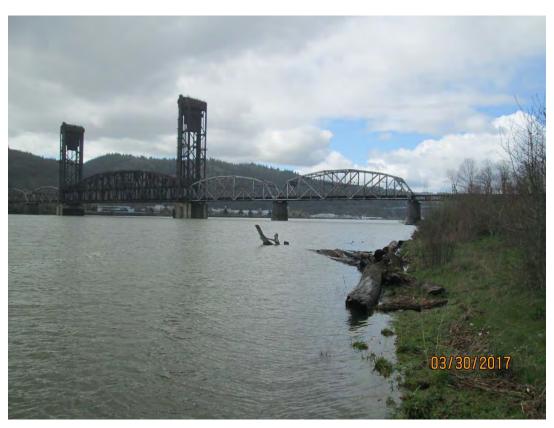
Photograph 15 – Highest river level of 2017 observed at the south end of the riparian area.

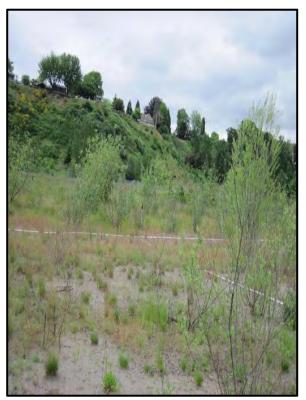
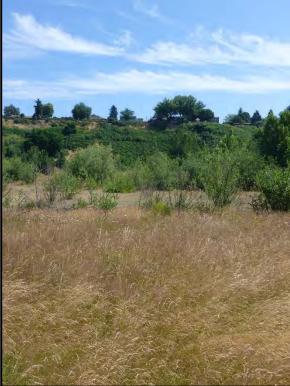
Stormwater Retention Pond/Drainage Swale Component. Vegetation in the drainage swale area was well established and appeared healthy, but most shrubs were either highly stressed or dead within the stormwater retention pond and riprap-lined outlet (Photograph 4, Appendix C). Red-osier dogwood volunteers were observed within the northwest portion of the swale. Sitka willow had grown to 10 to 15 feet tall, and the Piper's willow were 6 to 8 feet tall. Volunteer cottonwoods were observed to range from 20 to 25 feet tall. Alder and willow were present and expanding around the periphery of the stormwater retention pond, but some dead and stressed shrubs were observed in the pond and its outlet (Photograph 4, Appendix C). Most of the herbaceous and emergent plantings in this component did not survive because of the sandy nature of the soil, which does not provide adequate moisture retention and inundation to support all of the originally installed plant species during the dry months of the year. Various grasses make up nearly all of the groundcover in the retention pond; however, a few bare areas were observed.

Photograph 4 – View of stormwater pond. Willow and alder have increased in size, although most of the pond remains barren or vegetated with grasses. The irrigation system was removed in 2016. Taken looking northeast from Photograph Location 4 comparing baseline and current conditions. (Left - June 2011, Right - June 2017)

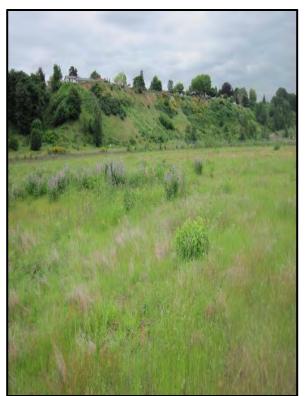
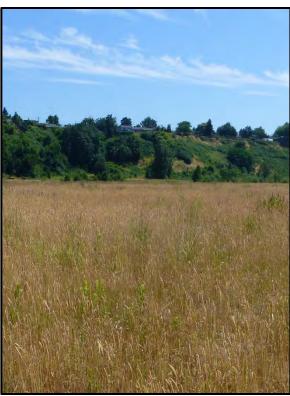
Impermeable Cap Component. The grassland species on the impermeable cap provided excellent coverage of the ground (Photograph 6, Appendix C). Gumweed was observed along the southwestern edge of the impermeable cap and provides increased diversity in this area. The remaining grasses and herbs were thriving. The spring 2017 herbicide treatment continued to shrink populations of scotch broom, knapweed, thistle, and skeleton weed that were observed on the cap. During the late spring, lupine appeared to be thriving, as an impressive spring bloom was observed.

Photograph 6 – Impermeable cap dominated by grasses and herbaceous vegetation. Baseline photograph on the left taken looking east from Photograph Location 6 (June – 2011). Current conditions from June 2017 shown on the right.

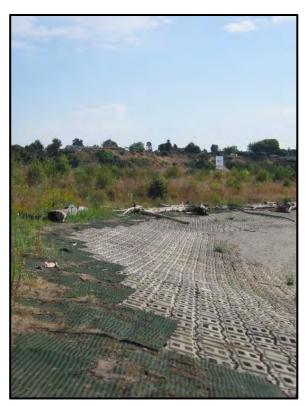
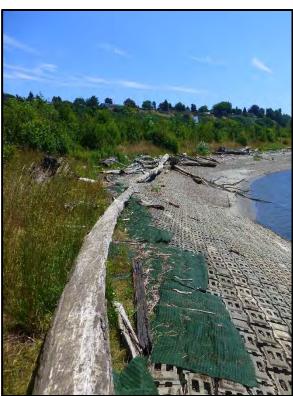
Photograph 7 – Vegetation growth and wood debris within the lower riparian component and along the shoreline. Taken looking southeast from Photograph Location 7 comparing baseline and current conditions. (Left - September 2011, Right – June 2017)

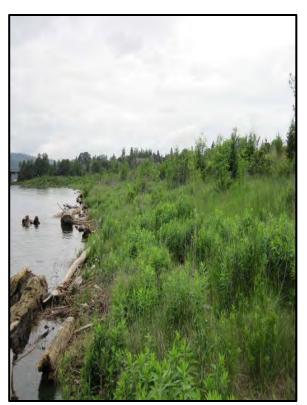
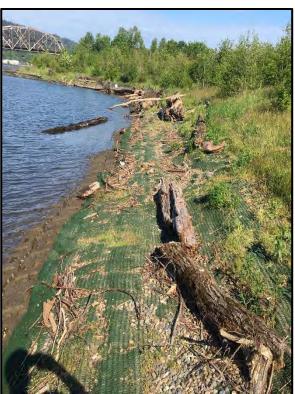
Photograph 9 – Lower riparian component with large wood debris along the edge. Taken looking northwest from Photograph Location 9 comparing baseline and current conditions. (Left - June 2011, Right – May 2017)

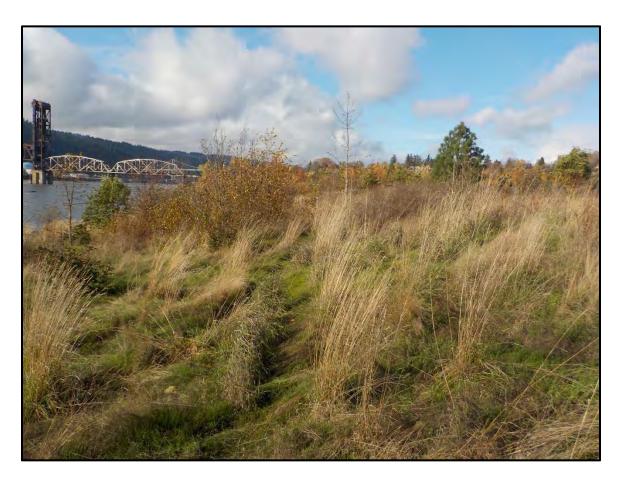
Photograph 10 – South end of the lower riparian area, looking northeast. Oregon ash, red osierdogwood, and oak trees are faring relatively well within this area. (October 2017)

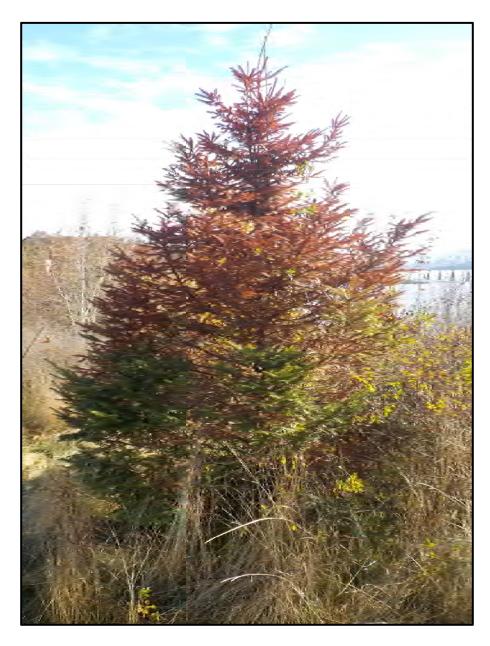
Summary. In general, the upper and lower components appeared to be performing well with the trees and shrubs generally recovering from somewhat drier than normal summers. Only the Grand Fir seem to have been significantly impacted by the recent dry weather. Groundcover species are providing good coverage of the site soils; no areas of bare ground were observed. In general, the canopy in the north portion of the Riparian Area is much denser when compared to the south.

Photograph 11 – Middle portion of upper riparian area, looking south. A Grand Fir exhibiting drought and/or disease stress. (October 2017)

It is anticipated that additional irrigation water may be needed in 2018, particularly if the site is again subject to drought conditions. It will be particularly important to provide water remaining conifers, as they appear to be the most stressed. The water tank trailer and firehose worked well to apply water throughout the site and this same technique could be used again, if needed. Conditions will be monitored during the summer months and, if dry conditions are prevalent, another drought assessment survey will be conducted to determine if additional watering is needed.
