# Oregon Department of Environmental Quality SSO Reporting Form

# Public Works Department INCIDENT REPORT

DATE OF INCIDENT	7/23/2025	TIME OF INCIDENT	9:30-10:00 pm	SUPERVISOR	
REPORTING PARTY	Jeff Dwire		PHONE NUMBER OF		
LOCATION OF INCIDENT	3069 and 3074 Crater Lake Ave				
CITY DEPARTMENT(S) and/or EMPLOYEES INVOLVED	Public Works Operations and Engineering Inspection staff				
CITY OWNED EQUIPMENT INVOLVED					
CITY OWNED INFRASTRUCTURE	Sewer Collections system				
DESCRIPTION OF INCIDENT					
<p>I was notified at 10pm on July 23 by Jeff Dwire that there was an overflow that occurred due to the by-pass operation performed by Pilot Rock excavation while working on P-25 (Capital improvement project upside). He said he arrived on site while they were setting up an additional pump, they said there appeared to be an issue with the pump keeping up and the line on Delta Waters was surcharged. They showed Jeff an area in the parking lot of 3074 CLA where sewage had backed up from a cleanout. He said they had fixed the issue and the sewage went away back down the cleanout, I told him I would follow up in the morning. On 7/24 I notified local DEQ of a small spill from a cleanout but aft

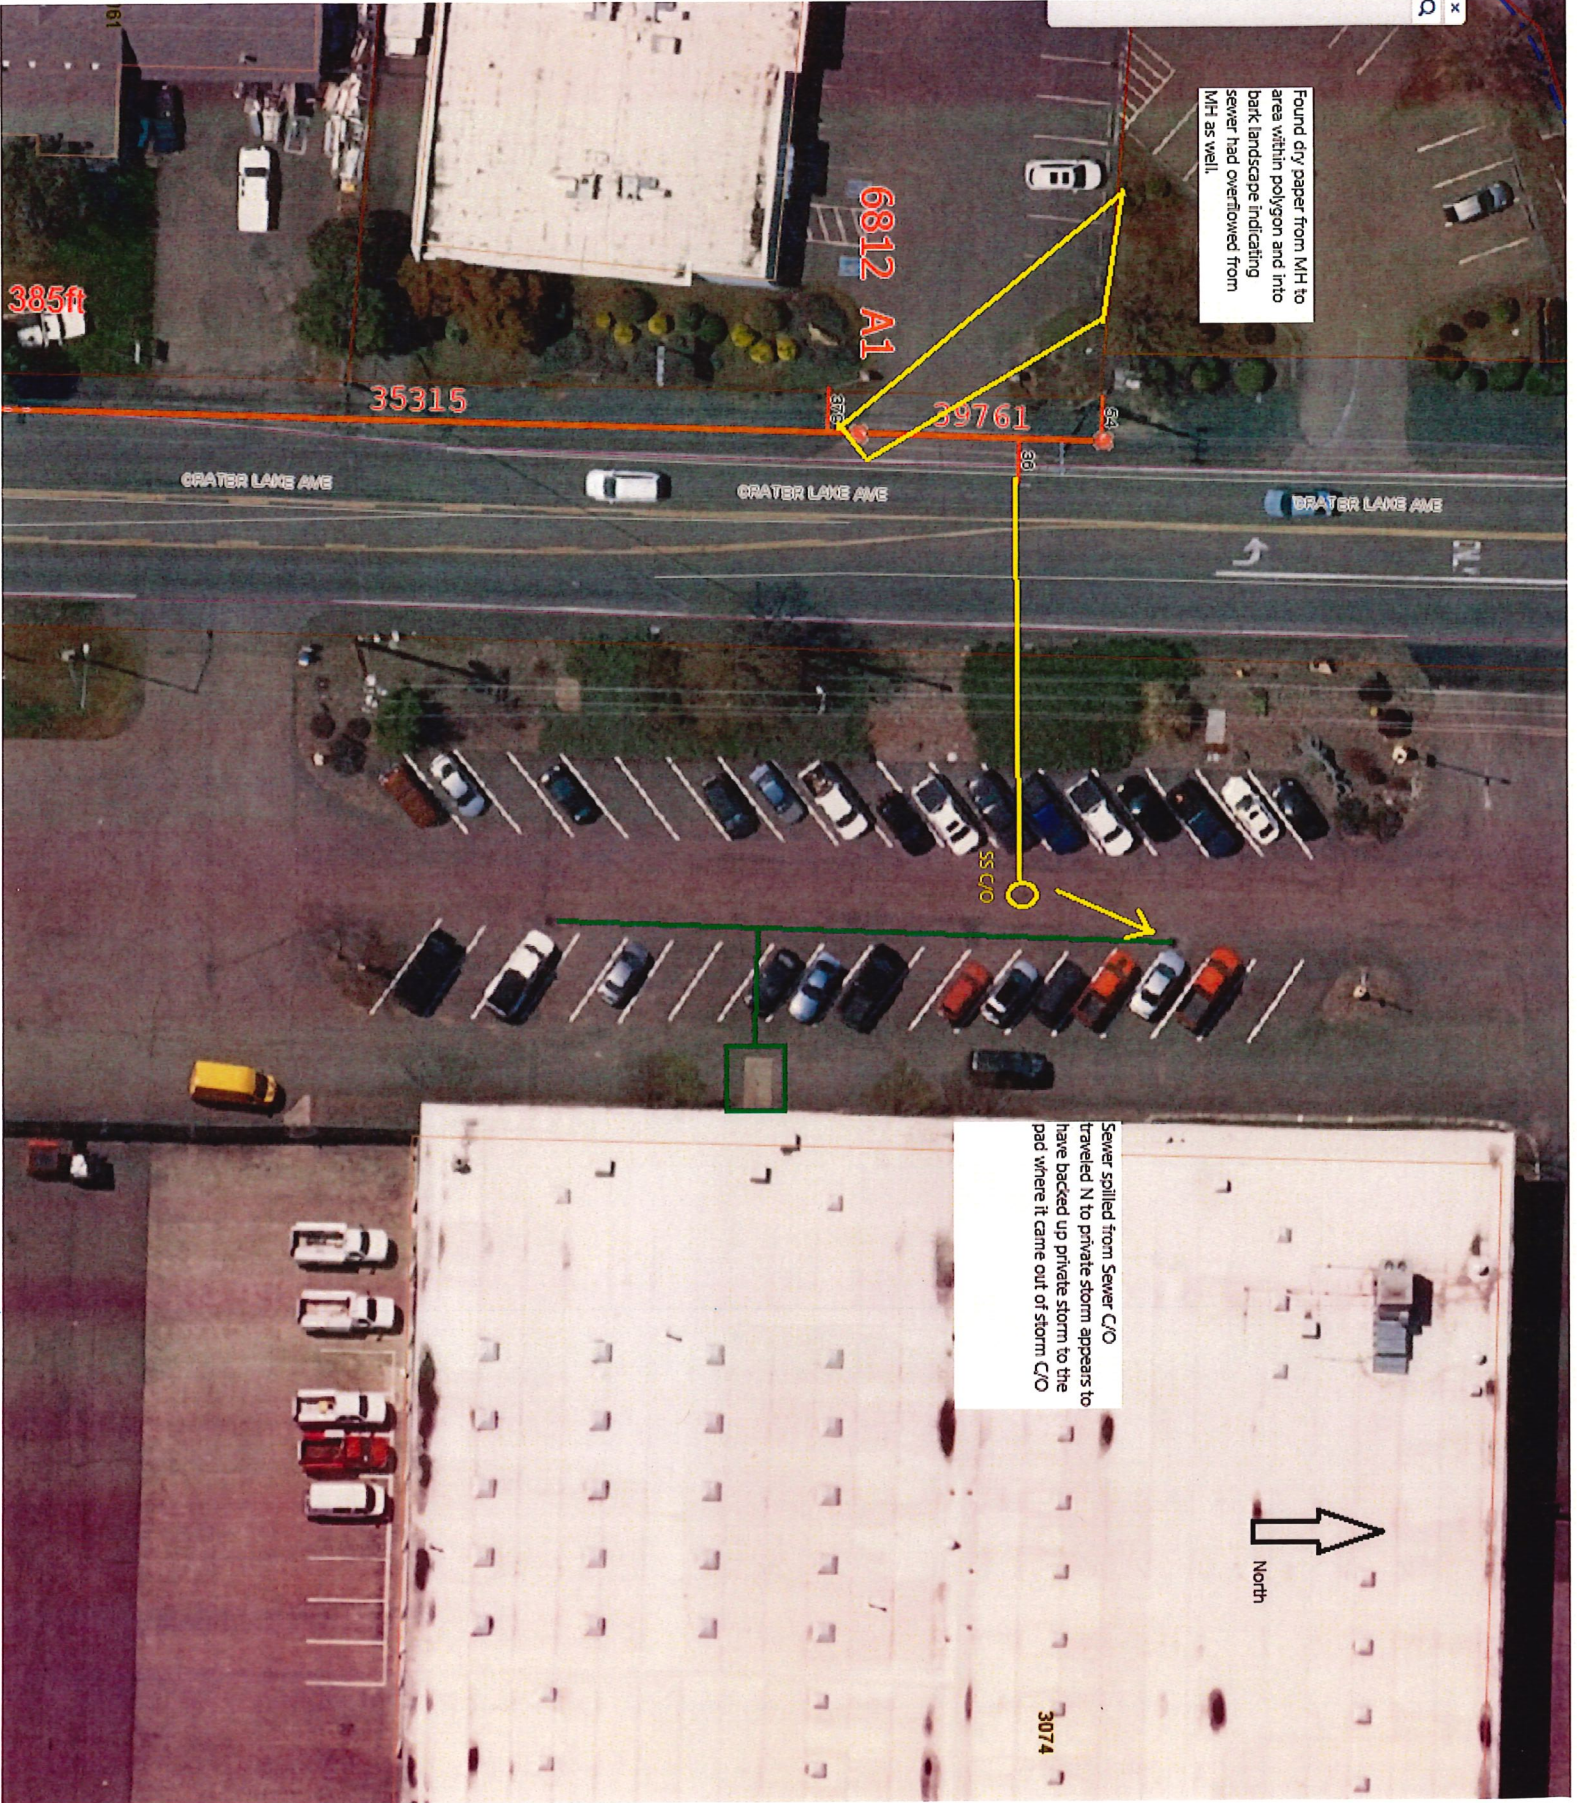
Found dry paper from MH to area within polygon and into bark landscape indicating sewer had overflowed from MH as well.

Sewer spilled from Sewer C/O traveled N to private storm appears to have backed up private storm to the pad where it came out of storm C/O

Other measures taken (describe):  
 Contractor ordered to clean areas of spill including private storm drains. Both locations were in private property paved parking lots. At time of day spill was investigated temperatures were in high 90 degrees in direct sunlight indicating surface UV disinfection likely occurring.

Steps taken or planned to reduce, eliminate, and prevent the reoccurrence of the overflow and schedule for those steps:  
 City of Medford Utilities Engineer indicated contractor would be issued an illicit discharge violation.
