**Subject: Progress Report for Groundwater and Stormwater Source Control  
Activities – May/June 2025  
Former Gunderson LLC Portland Facility  
Portland, Oregon**

DOCUMENT: Health, Safety and Environment  
TITLE: Gunderson River Bank Erosion Inspection Form

### Visual Wattle Inspection Form

DOCUMENT: Health, Safety and Environment  
TITLE: Corrective Actions Record  
SITE: Gunderson Portland, OR

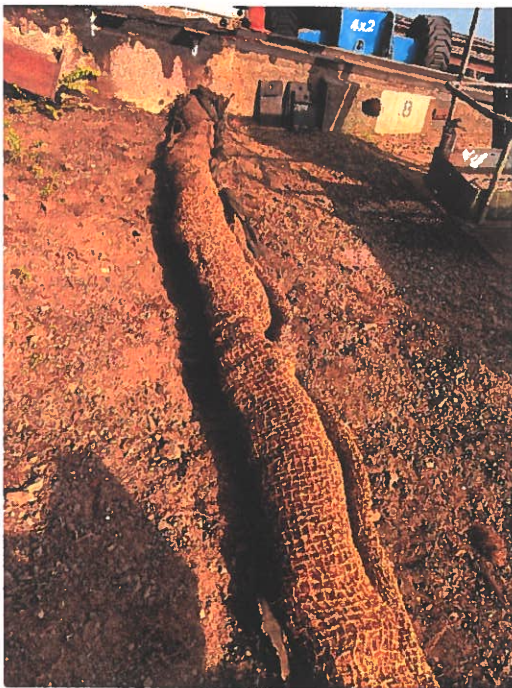
| Wattles | Upper | Middle | Lower | Minimum of 1 functional? | Comments |
|---|---|---|---|---|---|
| Ways 8 | | ✓ | 0 | ✓ | |

Replace lower waddle on Ways 8

| Wattles | Upper | Middle | Lower | Minimum of 1 functional? | Comments |
|---|---|---|---|---|---|
| Ways 9 | | ✓ | 0 | ✓ | ↑ REPAIR LOWER ON 8 |
