LEVEL 1 ENVIRONMENTAL
SITE ASSESSMENT REPORT

PYROMID, INC.
3292 SOUTH HIGHWAY 97
REDMOND, OREGON

JUNE 27, 1989

SRH Environmental Management
12245 N.E. Whitaker Way
Portland, Oregon 97230
(503) 252-8316

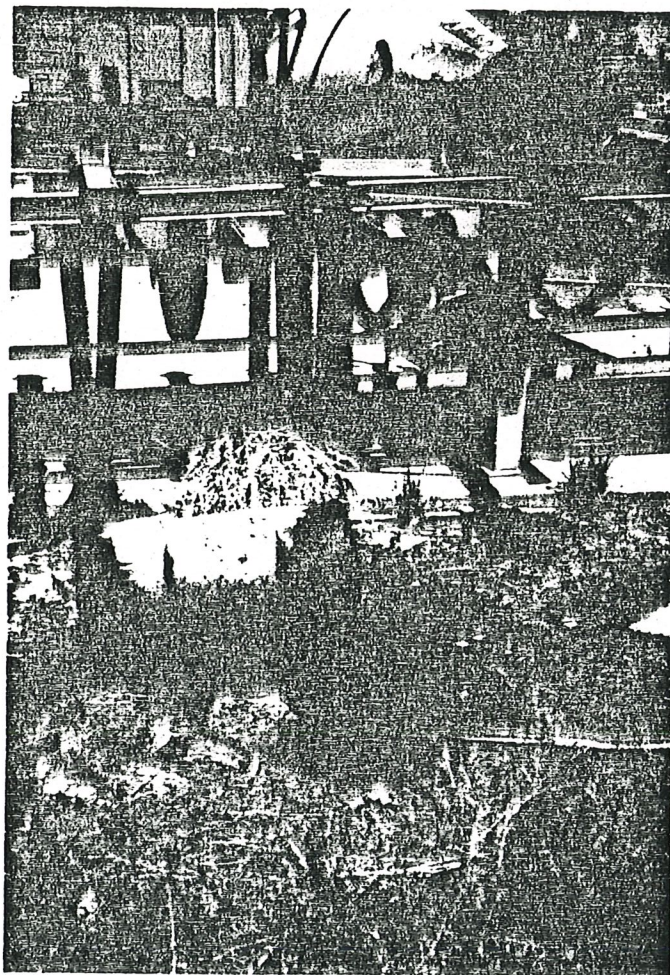
Observations. Four areas of potential surface contamination were observed on the subject site. Stained soil was observed adjacent to the north side of building B. The source of the staining was not apparent. The second and third areas of staining were located north and east of building B, in the vicinity of overturned containers that appeared to contain waste oil. The fourth area of staining was located west of building B in an area where fill pipes of suspected underground storage tanks were observed. Recommendations for further investigation are made in the recommendation section.

AREA OF STAINING

Although isolated areas of oil stained soils do not necessarily present a significant source of contamination, such stains could be indicative of ongoing practices that contribute to further contamination. It is recommended that the nature of the contaminant be investigated and, if appropriate, based on that investigation, remedial action be taken.

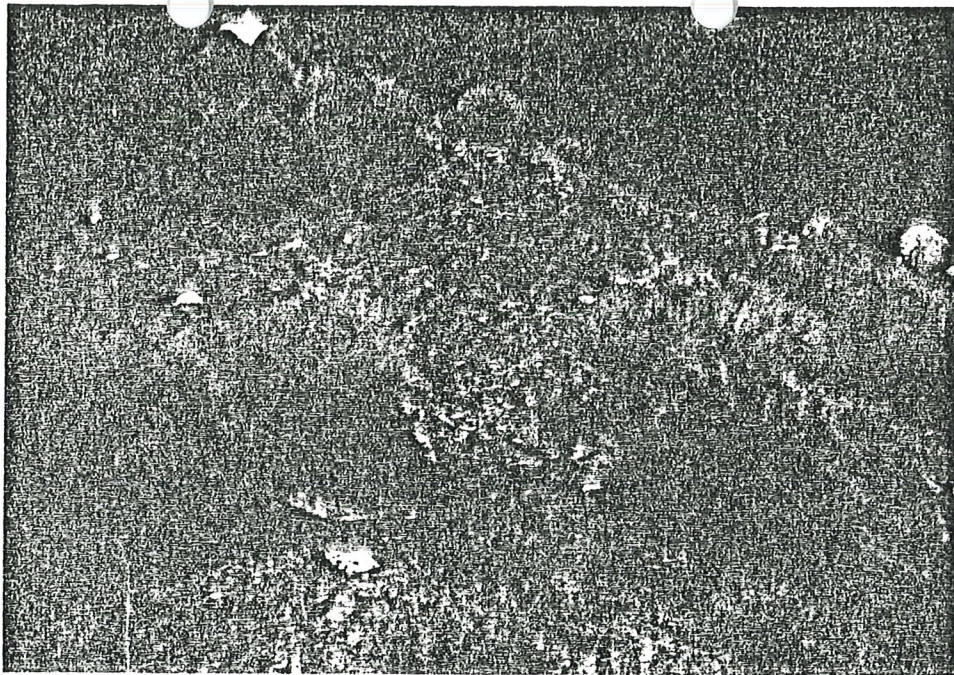
A fill area containing asphalt, dirt, and metal debris was located east of building B. No staining or odor was observed around the fill area. According to Mr. Rohrer, over several years, asphalt and dirt have been used to fill in a pit located in this area. The purpose of this pit is unknown. Due to past manufacturing processes and unknown disposal practices on the site, this fill area should be further evaluated to determine if its presence creates a potential for environmental contamination. Recommendations for further investigation are made in the recommendation section.

**ASPHALT PILING
FILL AREA**

Previous manufacturing processes and unknown disposal methods indicate that this area could be a potential source of improper disposal. SRH recommends designing and implementing a sampling plan at this location to evaluate the presence of environmental contamination to the subject property exists.

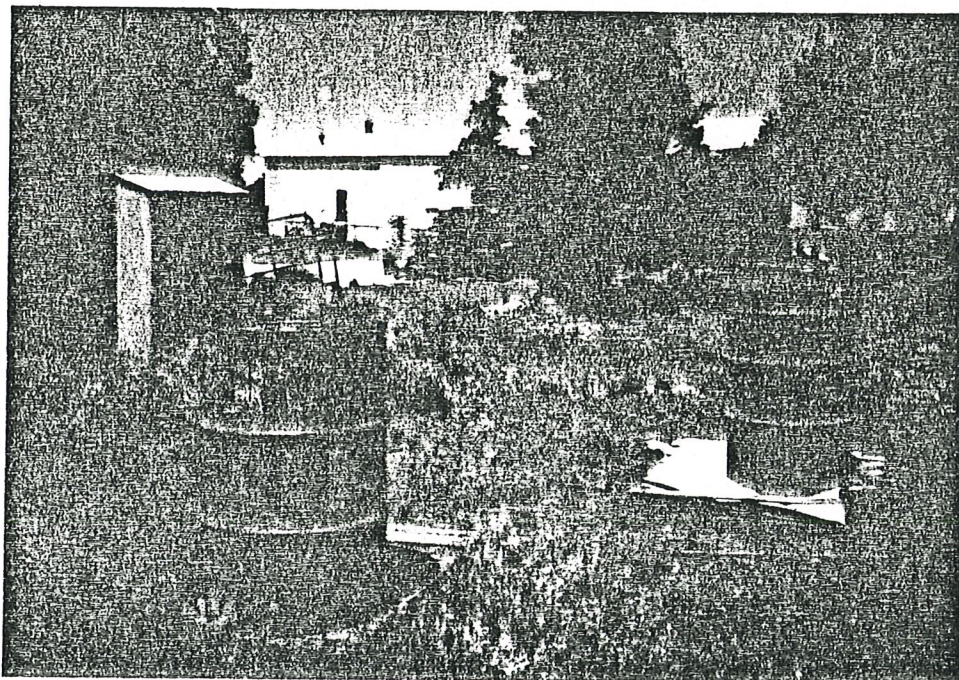
Three 55 gallon metal drums were located east of building B. The drums were not labelled, and two were empty. The third drum, according to Mr. Rohrer, Manager of Pyromid, belonged to Redmond Lumber Products. The unlabelled drum was filled with an unknown liquid. He stated that Redmond Lumber Products often stores items on Pyromid property. No staining was observed around the drum. Recommendations for characterizing the drum's contents are made in the recommendation section. GONE

55 GALLON DRUMS

The unidentified liquids in the drums should be sampled and characterized prior to disposal. If these liquids are determined to be hazardous materials, they should be properly disposed of in accordance with all state and federal regulations. If these liquids are to be used for their intended purpose, they should be labelled and stored according to state and federal regulations.

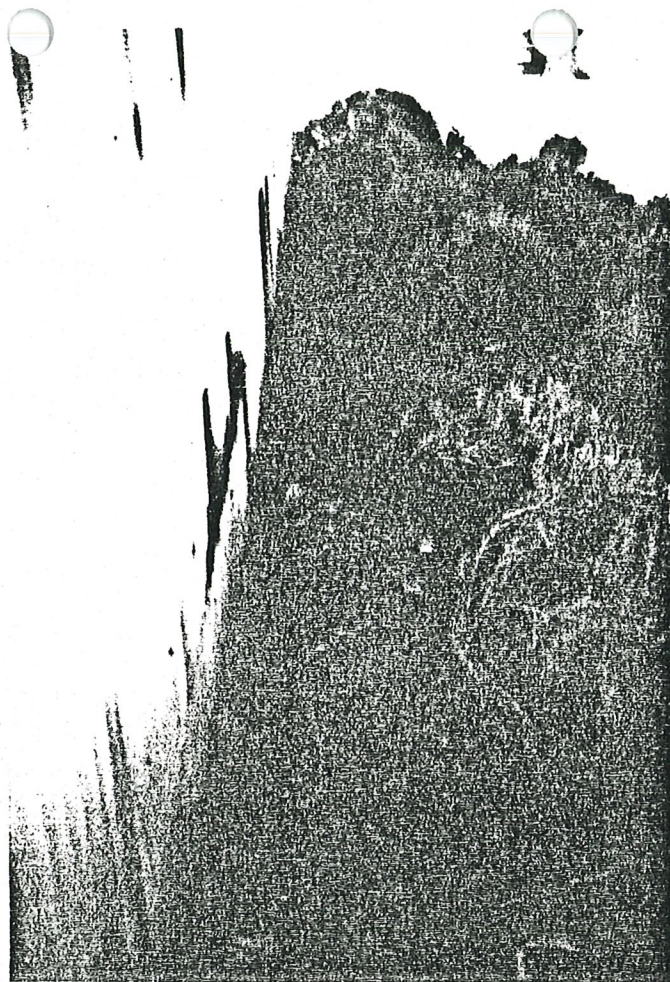
AREA OF STAINING

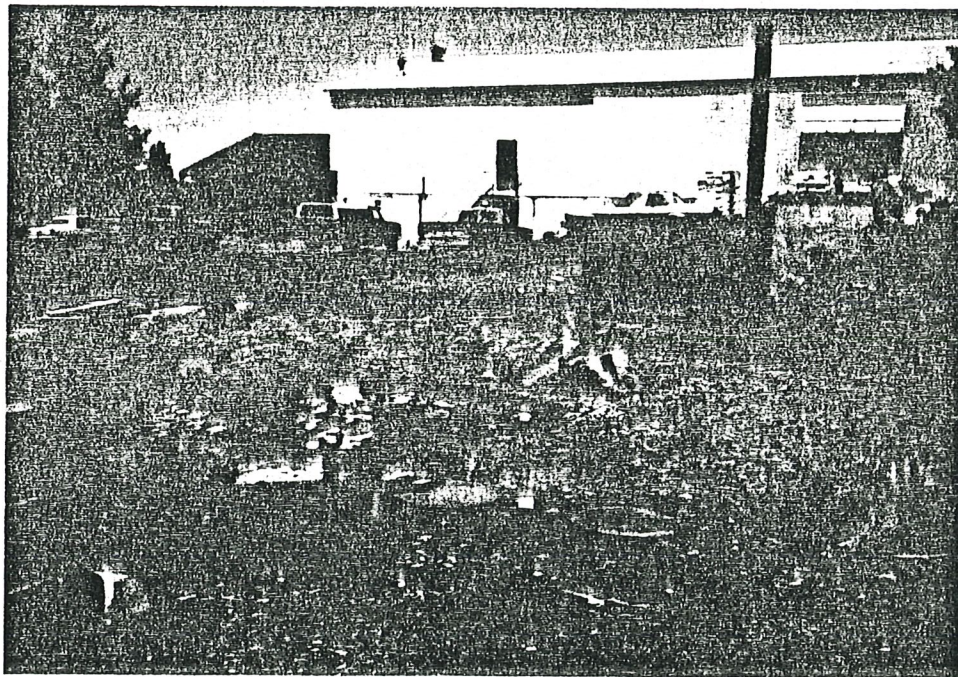
Observations. Two locked fill pipes labelled "fuel oil" and two vent pipes were observed west of building B. Significant staining was visible in the vicinity of the fill pipes, as discussed above. Recommendations for further investigation are made in the recommendation section.

Observations. Exterior areas of the property were traversed on a grid of approximately 10 feet. Access to approximately 5 percent of the area was limited because of parked automobiles. Two areas of magnetometric activity, each approximately 3 feet by 6 feet, were detected in the vicinity of observed fill and vent pipes.

Observations. Two vent pipes and two fill pipes indicative of UST's were located west of building B. Significant staining was visible in the vicinity. According to Mr. Rohrer, these UST's are presently not in use.

AREA OF STAINING AND UST'S

SRH recommends that an evaluation be completed to ascertain whether subsurface contamination exists as a result of releases, spills or over filling of the UST's.

- o Exploratory test pits or borings adjacent to the tanks.
- o Decommissioning the tanks by removal.
- o Decommissioning the tanks in place in accordance with local, state, and federal regulations in conjunction with soil borings and/or soil gas analysis.

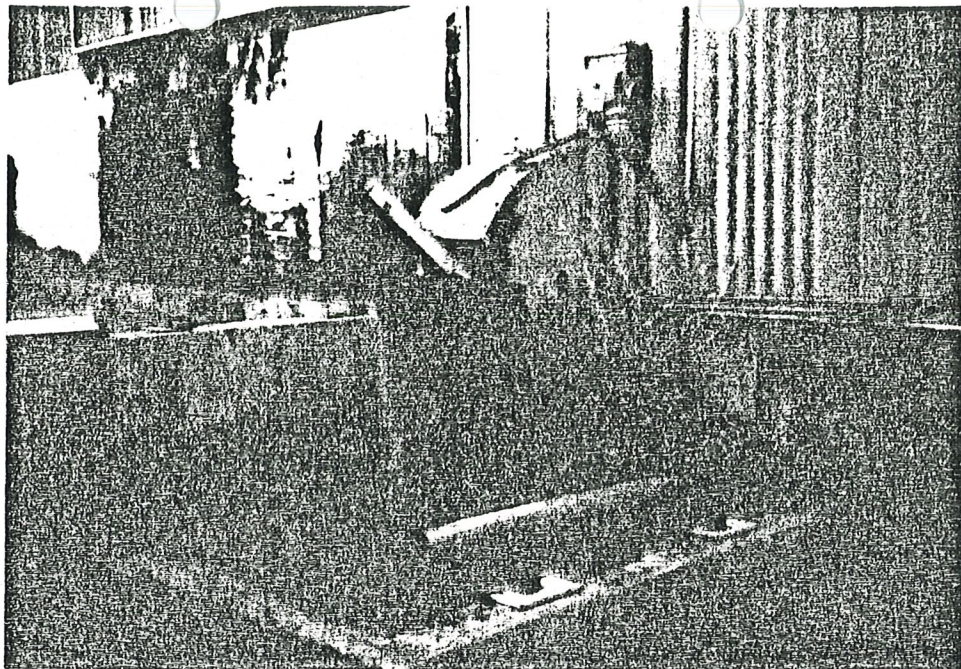
A concrete-lined sump, approximately 4 feet in width and of unknown depth, was located north of building B. The structure was filled with an unknown, odorless liquid and was covered with a metal top. The specific function of the sump is unknown. According to Mr. Rohrer, the structure is presently not in use. This sump appears to be a component of the former vinyl manufacturing process. Recommendations for characterization of the liquid are made in the recommendation section.

This sump and concrete pad appear to have been components utilized by the former site tenant in the manufacturing of vinyl plastics. Their specific function in this process is currently unknown. However, because of the chemicals commonly used in the manufacturing of vinyl, the area around the pad and sump represent a potential source of subsurface contamination. SRH recommends designing and implementing a sampling plan for each of these locations to evaluate the presence of environmental contamination.

CONCRETE LINED SUMP WITH METAL TOP

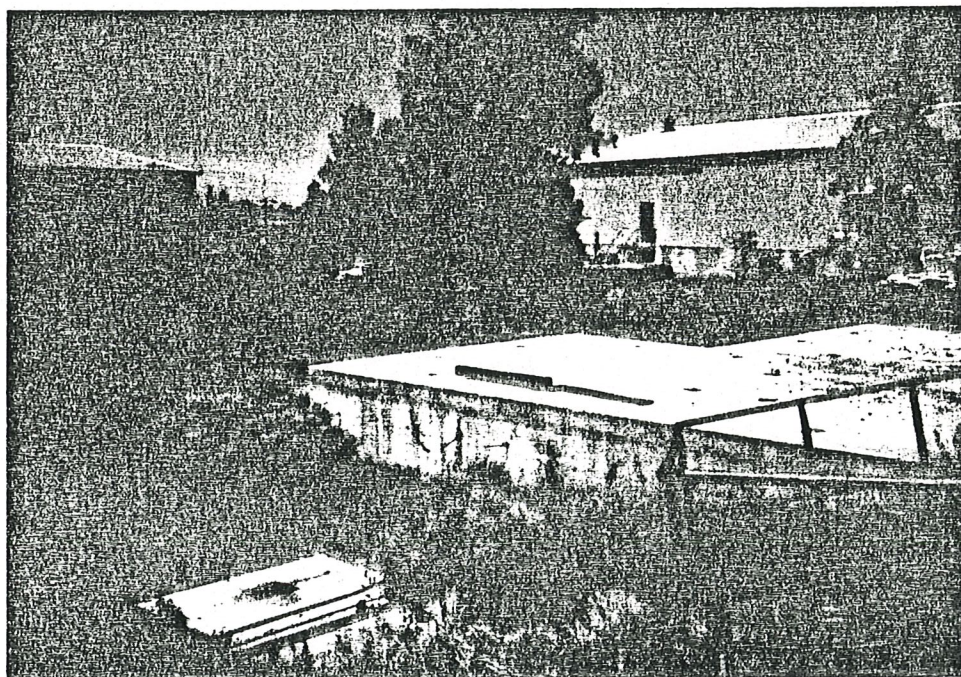
A large concrete pad located to the north of building B was observed. According to Mr. Rohrer, a large mixing apparatus formerly rested on the pad and was utilized by the prior occupants in the manufacture of vinyl plastics. It is possible that, through normal operation of the mixing apparatus, leakage and/or spillage of chemicals associated with the manufacture of vinyl plastics may have occurred. No staining was observed around the concrete pad. Recommendations for sampling of soil in this area are made in the recommendation section.

CONCRETE PAD

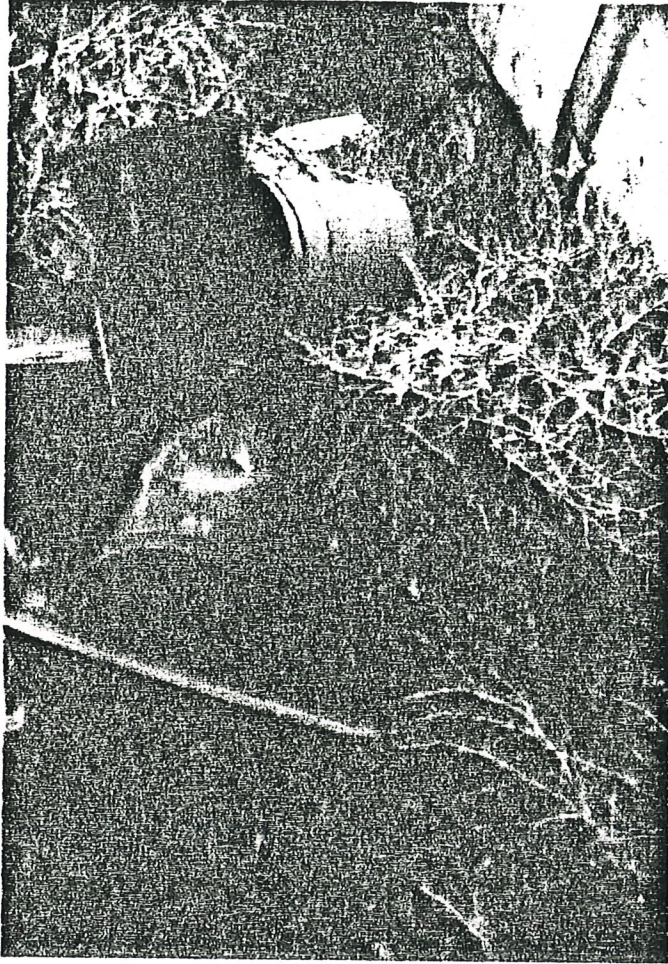
AREA OF STAINING
