# Department of Environmental Quality

# Memorandum

Subject: Witham's Truck Stop Oil Spill, LUST # 15-20-0238 (DEQ UST Facility ID #

1571); Staff Memorandum in support of a No Further Action determination

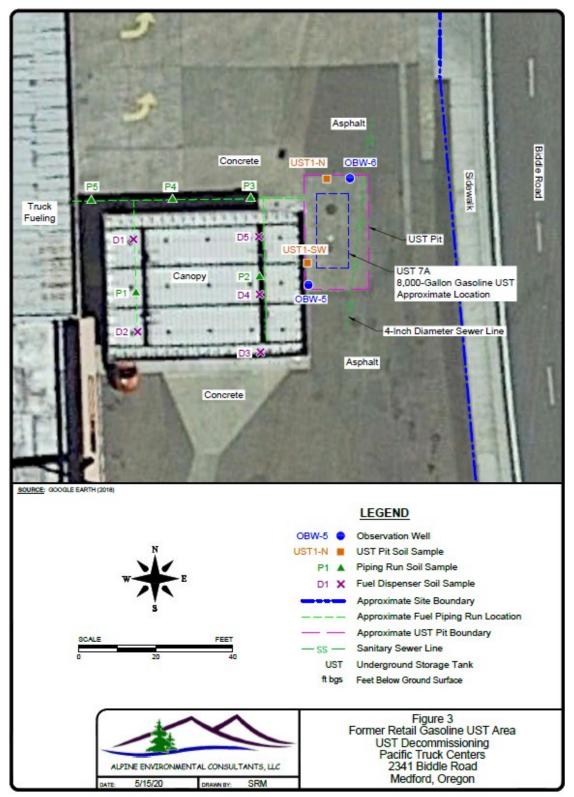
Figure 3. AOC 1 – Former Retail Gasoline UST Area (Provided by Alpine Environmental Consultants, LLC, 5/15/2020).

Soil samples. AOC 1 had one UST (UST 7A- 8,000-gallon gasoline UST). Two soil samples (UST1-N and UST1-SW) were collected from the UST pit (Figure 3). There were no detections of gasoline or diesel exceeding risk-based concentrations (RBCs) at the UST pit. However, there were relatively mild vapors and relatively low level shallow soil contamination (< 3 feet bgs) identified in some areas beneath the dispensers and fuel lines, and there is a 4" diameter sewer line running from north to south along the UST pit, therefore approximately 30 cubic yards of petroleum contaminated soil was excavated from the UST pit and stockpiled over and under Visqueen plastic sheeting prior to being hauled to and disposed of at the Dry Creek Landfill in Eagle Point, Oregon.

OBW-6 were located at UST 7A (AOC 1, Figure 3). Groundwater samples were collected from the observation wells on February 19, 2020. Groundwater samples were submitted for the following analysis: TPH-d, TPH-o, TPH-g, PAHs, and VOCs. In addition, OBW-6 was tested for total lead.

There were detections of TPH-d, TPH-o and TPH-g in OBW-5 and OBW-6 in the groundwater samples, but none of the results exceeded any RBCs. No PAHs were detected, and trace amounts of lead were detected.

AOC 1. There were detections of gasoline and diesel in the shallow soil samples. There were also detections of gasoline, diesel, and oil in the groundwater samples.

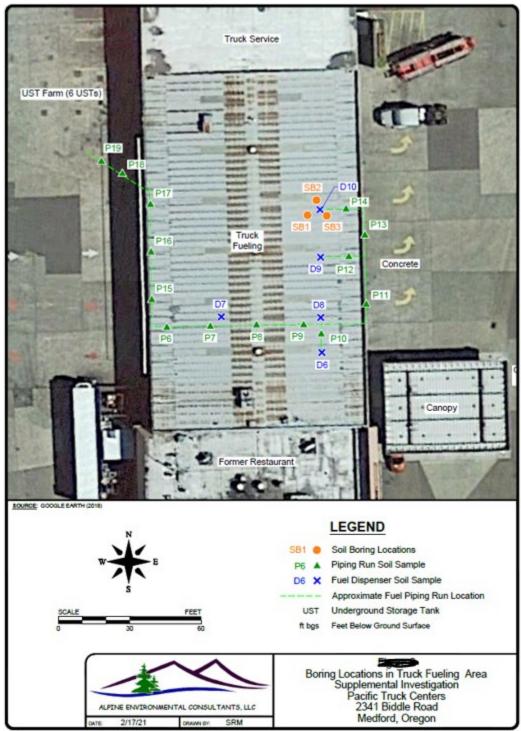
Figure 4. AOC 2 – Truck fueling area (Provided by Alpine Environmental Consultants, LLC, 2/17/2021).

AOC 2 – Truck Fueling Area (Figure 4). Associated Dispensers and Piping Runs
Soil samples. A total of ten (10) soil samples were collected beneath the ten (10) fuel dispensers present at the Site (D6 through D10, Figure 4). D6, D8, and D-10 had detections oil-range hydrocarbons when screened by DEQ Method NWTPH-HCID. DEQ Method NWTPH Gx and Dx were then tested. Diesel range constituents were found in D6, D8, D10 but did not exceed RBCs.

A total of nineteen (19) fuel piping run soil samples were collected beneath the piping runs in shallow soil (via hand sampling) from the USTs to the dispensers (P1 through P19, Figure 4). P14 had detections of diesel range total petroleum hydrocarbons (8,120 mg/kg) exceeding RBCs for ingestion, dermal contact, and inhalation for construction worker receptors (4,600 mg/kg). P15 had detections of gasoline (255 mg/kg) exceeding the RBC for leaching to groundwater.

P14 and P15 also had detections of naphthalene (1.30 mg/kg, 0.51 mg/kg) exceeding the RBC for leaching to groundwater pathway (0.34 mg/kg). In the P15 soil sample benzene and ethylbenzene (0.145 mg/kg, 1.53 mg/kg) were also detected exceeding the RBC for leaching to groundwater pathway (0.10 mg/kg).

TPH-d was detected in several soil samples, including SB2-3' (124 mg/kg) SB3-1' (1,120 mg/kg), and SB3-8' (650 mg/kg). None of the analytes sampled in soil borings SB1-SB3 exceeded any applicable RBCs.

AOC 2. There was relatively low-level shallow soil contamination (< 3 feet bgs) identified in some areas beneath the fuel piping runs from the USTs to the dispensers exceeding RBCs for ingestion, dermal contact, and inhalation for construction worker receptors. There were also detections of gasoline and naphthalene in soil samples exceeding the leaching to groundwater pathway. Supplemental investigation was conducted and found diesel detections in several soil samples at approximately ten (10) feet bgs.

The leaching to groundwater pathway was exceeded for naphthalene, benzene, and ethylbenzene in P14 and P15 soil samples. However, there were no exceedances of these contaminants of concern in the groundwater samples and groundwater is not used at the Site for beneficial uses, therefore the leaching to groundwater RBCs do not apply.

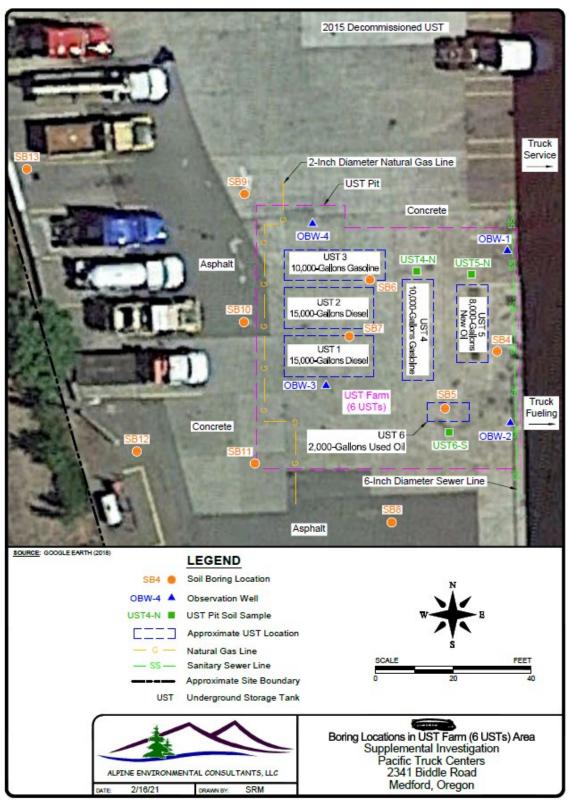
Figure 5. AOC 3 - UST Farm (6 USTs) Area (Provided by Alpine Environmental Consultants, LLC, 2/16/2021).

Soil samples collected from the tank pit had diesel detections ranging from 151 mg/kg (UST6-S) to 1,590 mg/kg (UST4-N). These detections did not exceed RBCs for any occupational or construction worker receptors.

Groundwater samples. Observation wells OBW-1 through OBW-4 were in the UST pit (AOC 3, Figure 5). Groundwater samples collected from the observation wells on February 19, 2020, were submitted for the following analysis: TPH-d, TPH-o, TPH-g, PAHs, and VOCs. In addition, OBW-4 was tested for total lead.

Groundwater samples from OBW-2 through OBW-4 had detections of diesel using DEQ Method NWTPH-Dx, ranging from 1,120  $\mu g/L$  to 2,320  $\mu g/L$  . There were no exceedances for PAHs in wells OBW-1 through OBW-4. Total lead was detected in OBW-4 at a very low level, below the method reporting limit.

Furthermore, the highest reported concentration of TPH-d in groundwater was  $10,500~\mu g/L$  in the groundwater sample collected from boring SB9, which is located on the northwest corner of the tank pit. The reported concentration of TPH-d in the groundwater sample collected from boring SB13 was  $560~\mu g/L$ . The relatively large decrease in TPH-d concentrations (i.e. from  $10,500~\mu g/L$ ) over approximately 50 feet demonstrates a significant amount of natural attenuation to the west of the tank pit.

TPH-d in groundwater is the main contaminant of concern at this Site. Boring SB13 is located approximately 50 feet to the north-northwest of boring SB9 with groundwater flowing to the west (Figure 5). The extent of diesel-impacted groundwater north and west of SB9 has not been determined. Based on the nature of diesel contamination in groundwater, it is unlikely that the diesel contamination plume would flow toward and/or beneath the administrative office and warehouse building. The diesel contamination in groundwater at AOC 3 appears to also be migrating off-site, beneath the I-5 right-of-way (ROW) in the vicinity of soil boring SB13 on the west side of the Site. Based on the nature of diesel contamination in groundwater, DEQ feels that it is unlikely that this contamination would extend very far beneath the ROW, or beyond it.

AOC 3. The highest reported concentration of diesel in groundwater is located at the northwest corner of the tank pit. The diesel contamination in one groundwater sample from AOC 3 (GW-SB9) exceeded DEQ's RBCs for occupational vapor intrusion (VI). Samples from observation wells at AOC 3 also exceeded the VI RBC.

Soil samples had detections of diesel above 500 mg/kg, the level II soil matrix level, indicating that vapor intrusion (VI) could be a concern from contaminated soil. Diesel concentrations in shallow groundwater samples from one observation well (OBW-4) and boring SB9 in AOC 3 exceeded the occupational RBC for vapor intrusion (1,700 µg/L).

Following removal of the most contaminated soil, and based on sample results for soil and groundwater, acceptable risk levels are generally not exceeded, however there may be a potential for vapor intrusion at and north of AOC 3 from diesel contamination remaining in that area. The risk from these areas is currently low, but a contaminated media management plan (CMMP) should be prepared before DEQ will recommend a No Further Action (NFA) determination for this Site. Buildings for human use should not be constructed over the AOC 3 area without further investigation or vapor resistant construction. DEQ will solicit public comments on this recommendation, including from the Oregon Department of Transportation, because of the off-site impacts to their ROW.
