Draft Final Remedial Action Report

Former Astoria Marine Construction Company
DEQ Task Order 067-23-13
ECSI No. 1898
92134 Front Road
Astoria, Oregon

October 23, 2025

Maul Foster & Alongi, Inc.

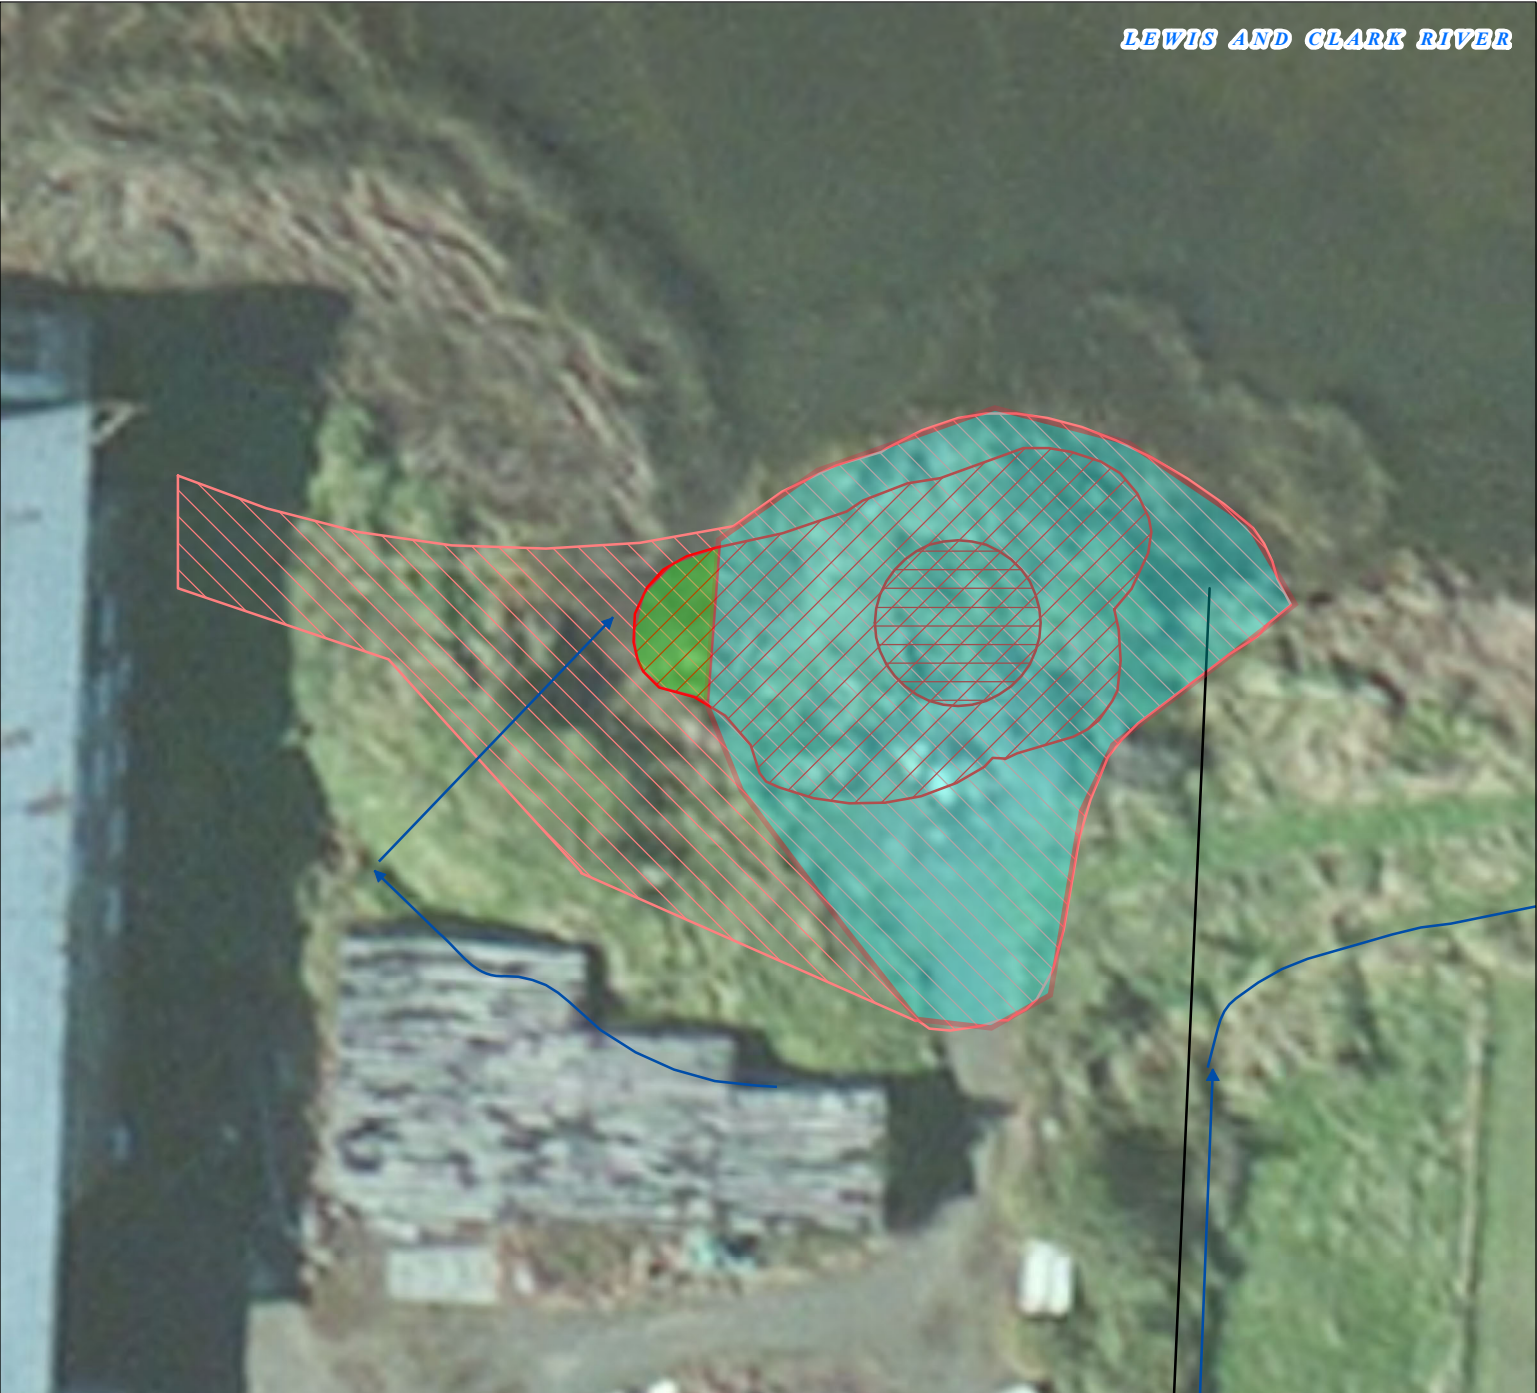
Figure 4-3
Burn Pit

To address the discrepancy between planned and actual excavation volumes, MFA reexamined remedial investigation data and figures from the 2016 Supplemental Remedial Investigation Results (GSI 2016). Figures depicting hot spot and source control exceedances were compiled and incorporated into ROD figures (see Figure 4-2). MFA prepared an analysis recommending that excavation focus on highly contaminated hot spot soils rather than broader areas with residual concentrations above source screening values (MFA 2024). This proposal optimized limited project funding while maximizing environmental benefit.

Copper impacted soil above source control screening level, to remain in place with a stabilized surface of dense ground cover vegetation (at riverward dike face) or two feet of dike fill soil (at dike crest)
