# **BASIN M VEGETATED INFILTRATION BASIN OPERATIONAL YEAR 4 ANNUAL SUMMARY REPORT**

## **Terminal 4 Slip 1**

**Port of Portland**

October 2025

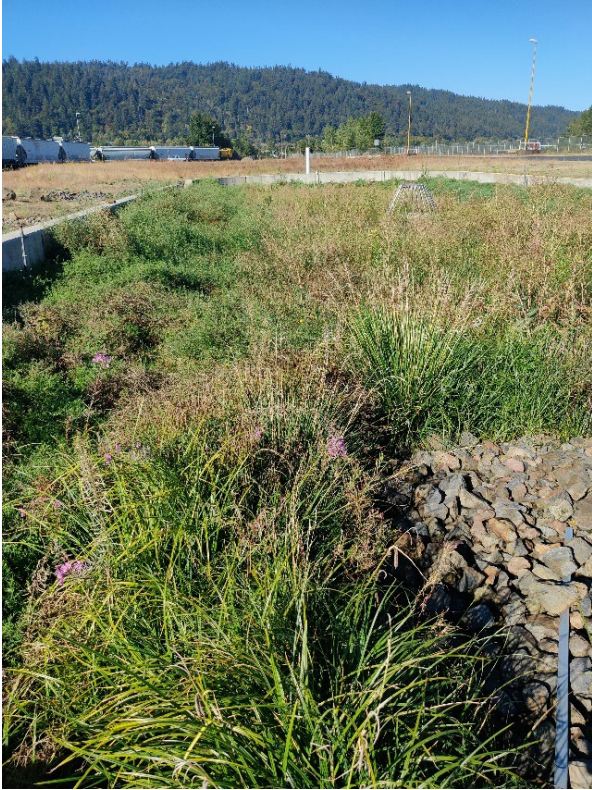
| <p><b>Photo B-1</b></p> <p><b>Date:</b><br/>9/24/2024</p> <p><b>Direction:</b> W</p> <p><b>Description:</b><br/>Healthy vegetation and weeds present at the start of the wet season.</p> | |

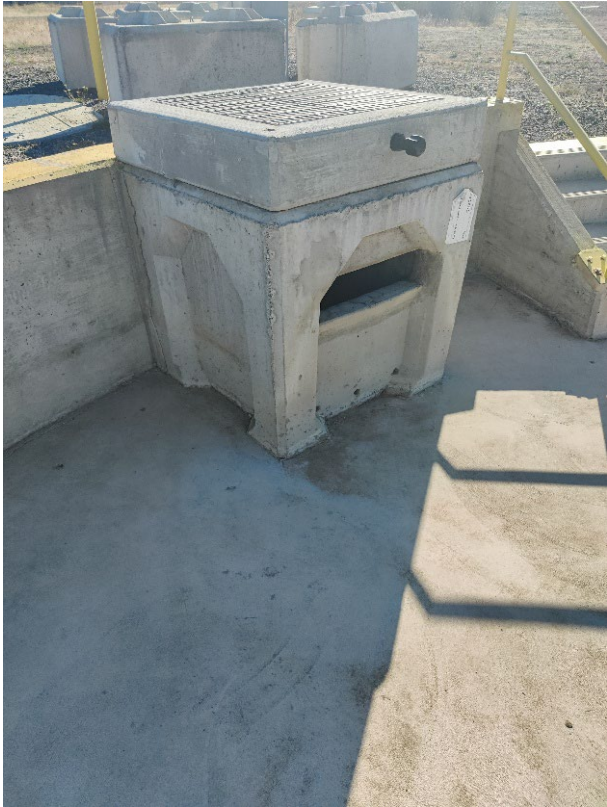
| <p><b>Photo B-2</b></p> <p><b>Date:</b><br/>9/24/2024</p> <p><b>Direction:</b> SE</p> <p><b>Description:</b><br/>Pump inlet and forebay condition at the start of the wet season.</p> | |

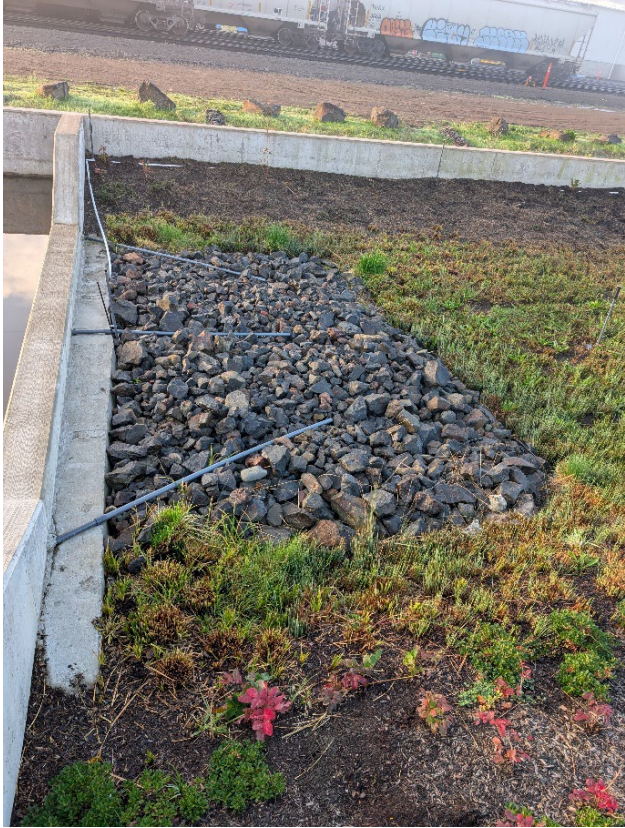
| <p><b>Photo B-3</b></p> <p><b>Date:</b><br/>10/29/2024</p> <p><b>Direction:</b> S</p> <p><b>Description:</b><br/>Condition of the upstream side of the basin adjacent to the forebay post-vegetation maintenance.</p> | A photograph showing the upstream side of a bio-infiltration basin. A concrete curb runs along the left side. The area is covered with dark mulch and patches of green and brown vegetation. A large pile of dark, irregularly shaped rocks is visible in the center. In the background, a paved area with some graffiti and a white structure is visible. |

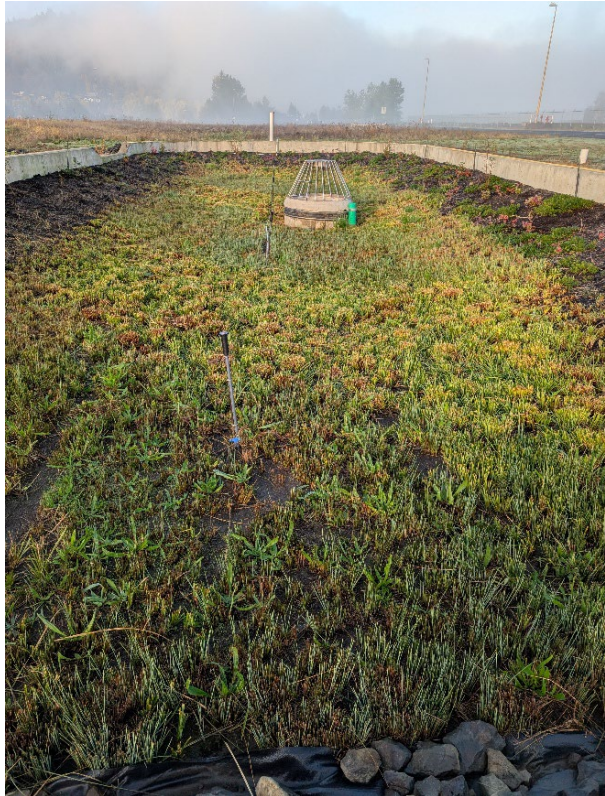
| <p><b>Photo B-4</b></p> <p><b>Date:</b><br/>10/29/2024</p> <p><b>Direction:</b> W</p> <p><b>Description:</b><br/>Basin and vegetation condition after weeding and vegetation thinning.</p> | A photograph showing the basin and vegetation condition after weeding and vegetation thinning. The basin is filled with dense, green and brown vegetation. A concrete curb runs along the top edge. In the background, a paved area with some graffiti and a white structure is visible. A small, rectangular, metal mesh structure is placed in the center of the basin. |

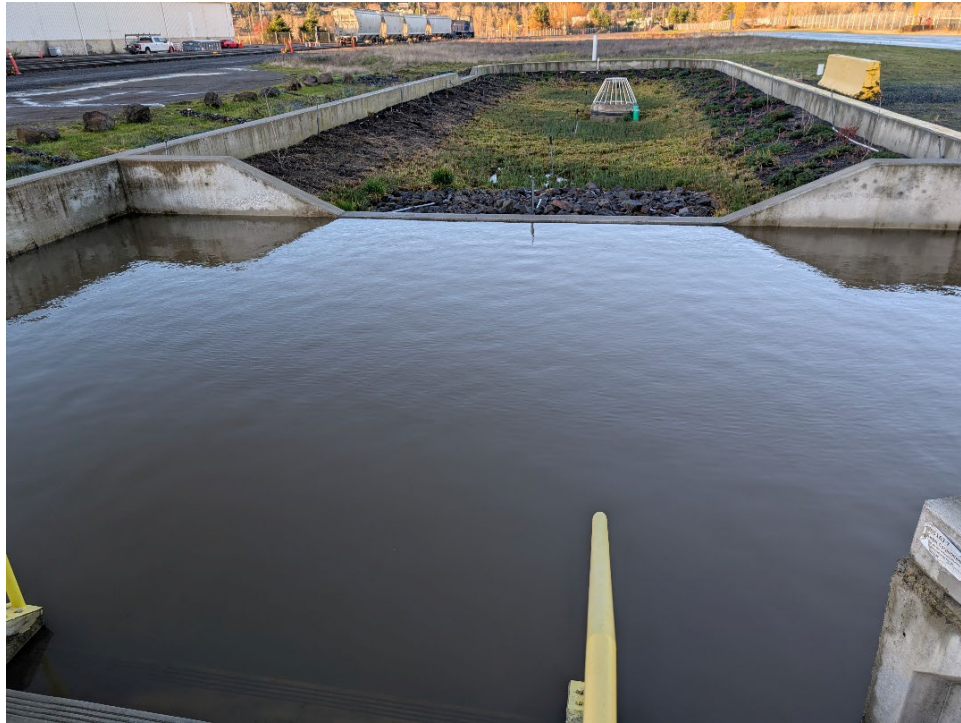
**Photo B-5**

Infiltration basin shortly after a storm, showing a full forebay.

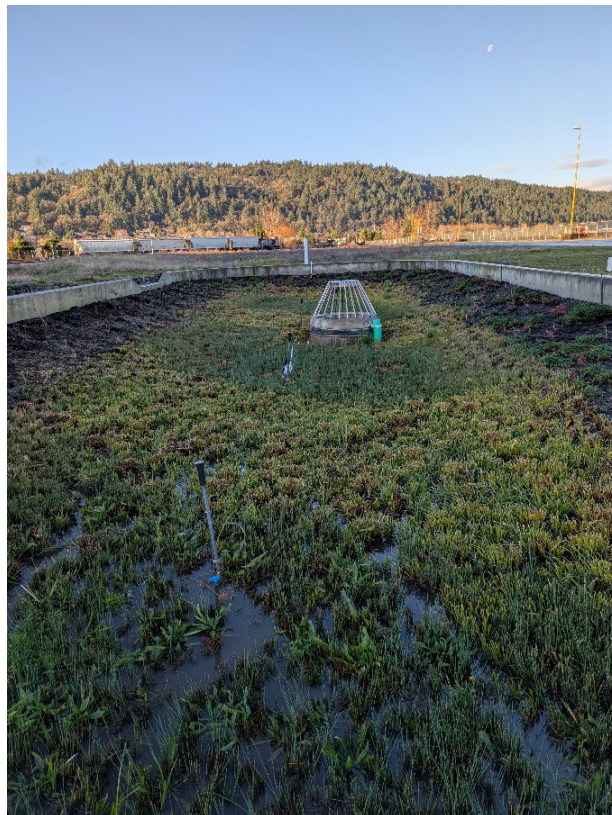
**Photo B-6**

Basin condition in early winter.

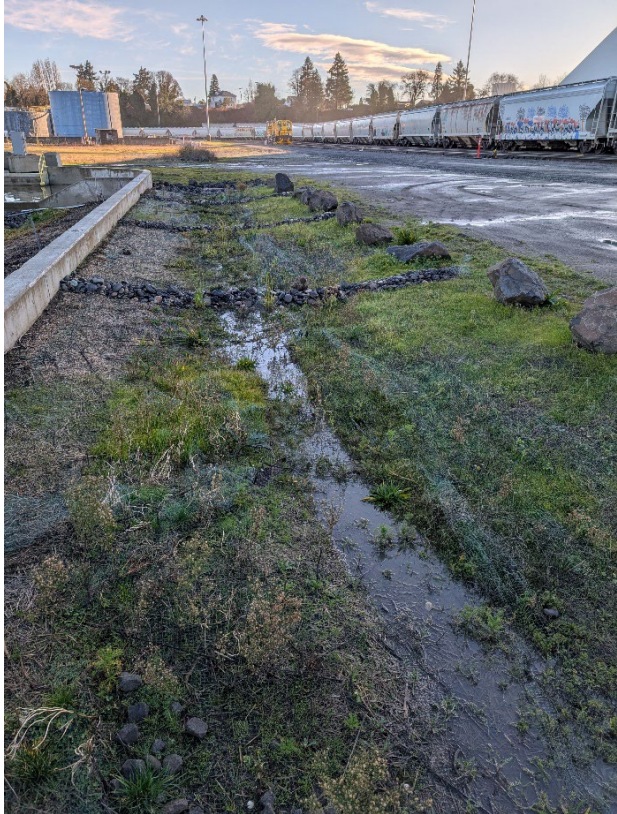
| <p><b>Photo B-7</b><br/><b>Date:</b><br/>12/18/2024<br/><b>Direction: E</b><br/><b>Description:</b><br/>Condition of side swale in early winter, showing vegetation growth after addition of previous year's erosion control measures.</p> | A photograph showing a side swale in early winter. The swale is a narrow, shallow channel filled with water, bordered by a concrete curb on the left. The surrounding area is covered with green vegetation and rocks. In the background, there are industrial buildings and a large white container. |

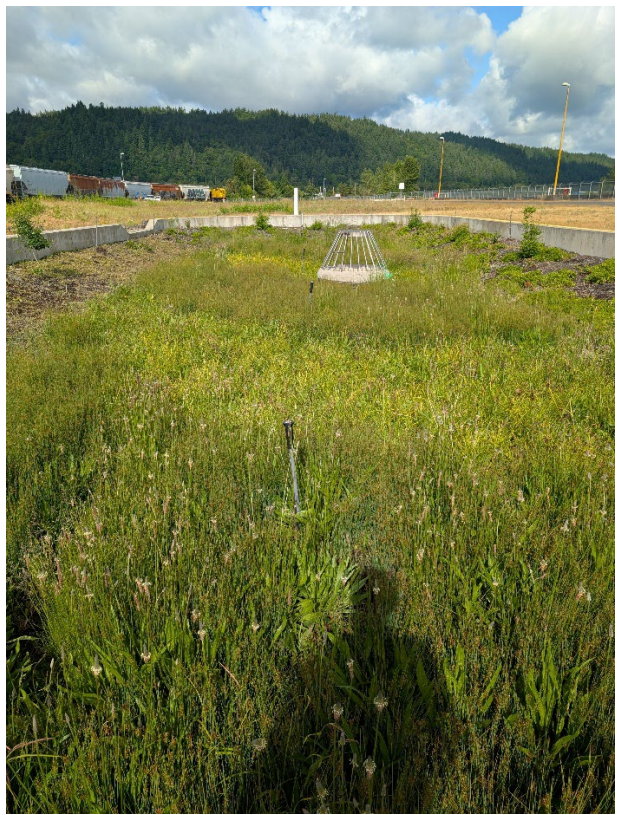
| <p><b>Photo B-8</b><br/><b>Date:</b><br/>5/20/2025<br/><b>Direction: W</b><br/><b>Description:</b><br/>Condition of basin near the end of the wet season.</p> | A photograph showing a basin near the end of the wet season. The basin is filled with tall, green grass and other vegetation. In the background, there are industrial buildings and a large white container. The sky is blue with some clouds. |

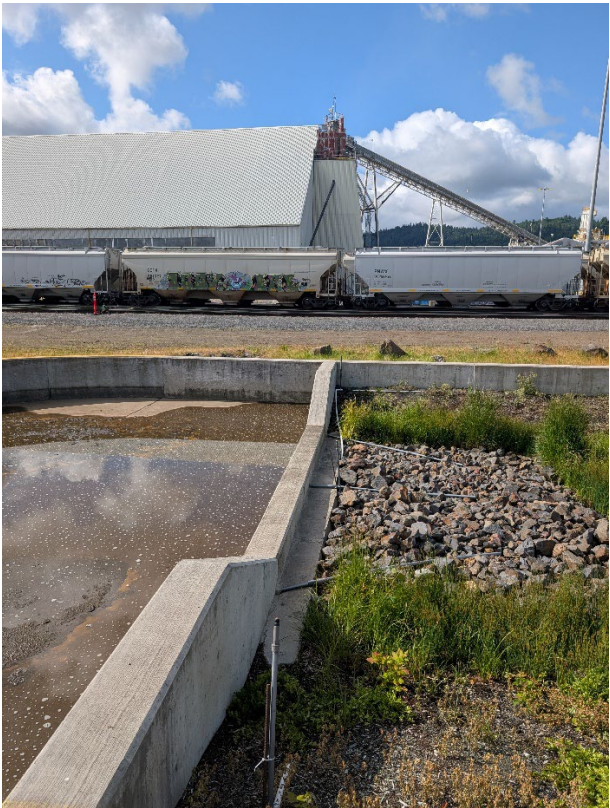
| <p><b>Photo B-9</b></p> <p><b>Date:</b><br/>5/20/2025</p> <p><b>Direction:</b> S</p> <p><b>Description:</b><br/>Forebay showing some accumulated sediment and upstream end of basin near the end of the wet season.</p> | |

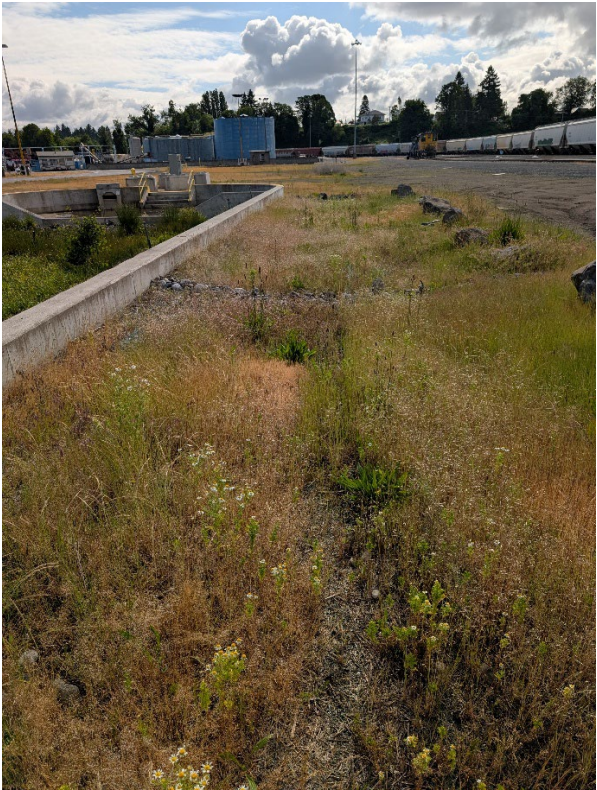
| <p><b>Photo B-9</b></p> <p><b>Date:</b><br/>5/20/2025</p> <p><b>Direction:</b> E</p> <p><b>Description:</b><br/>Side swale showing healthy vegetation with increased density near the end of the wet season.</p> | |
