APPENDIX B

Daily Field Reports Continued

Phase II RA

OFFSITE REMOVAL ACTION - DAILY FIELD REPORT
JH BAXTER OFFSITE REMEDIAL ACTION
EUGENE, OREGON

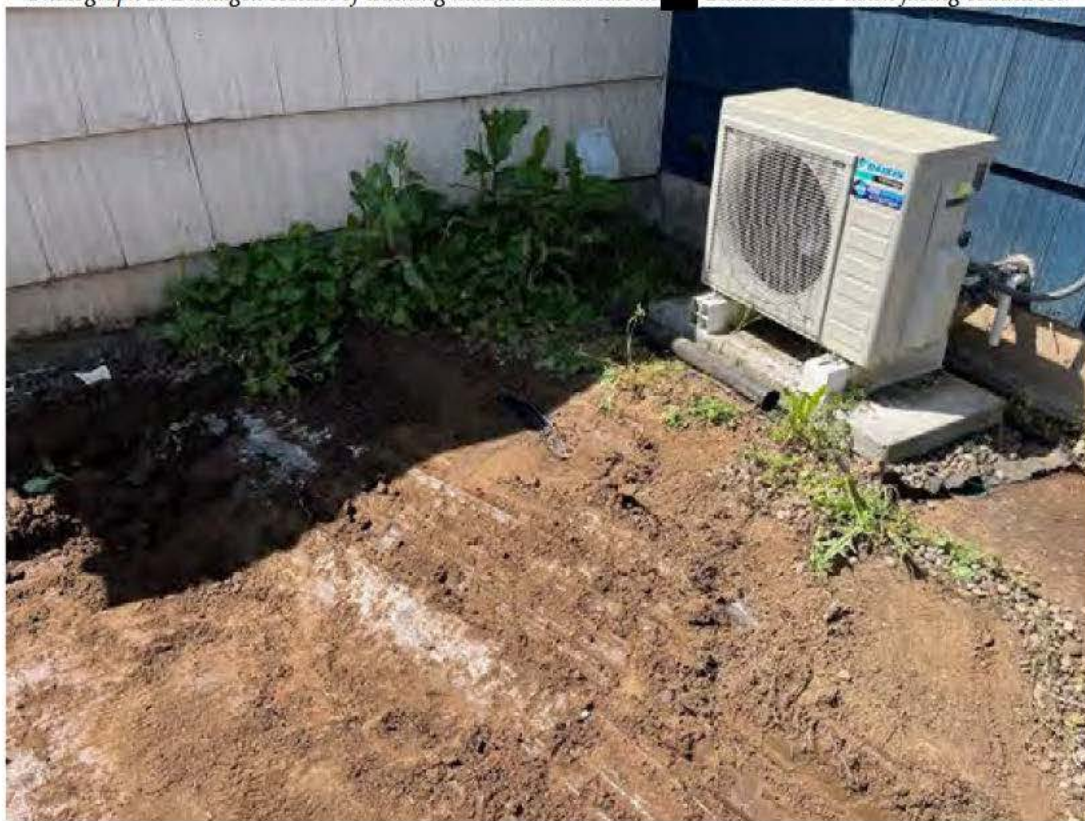
1125 – GSI observed that 3 Kings had impacted a drainage line on the backside of the residence at [REDACTED] Baxter. 3 Kings indicated the drain line was connected to properties washer unit and the residents were made aware of the impact. 3 Kings planning on replacing damaged section of line. 3 Kings operator indicated he had felt what may be part of a septic system while excavating 12 inch excavation cuts in the area to the east of the residence.

Photograph 5. Damaged section of washing machine drain line at [REDACTED] Baxter. Photo taken facing southwest.

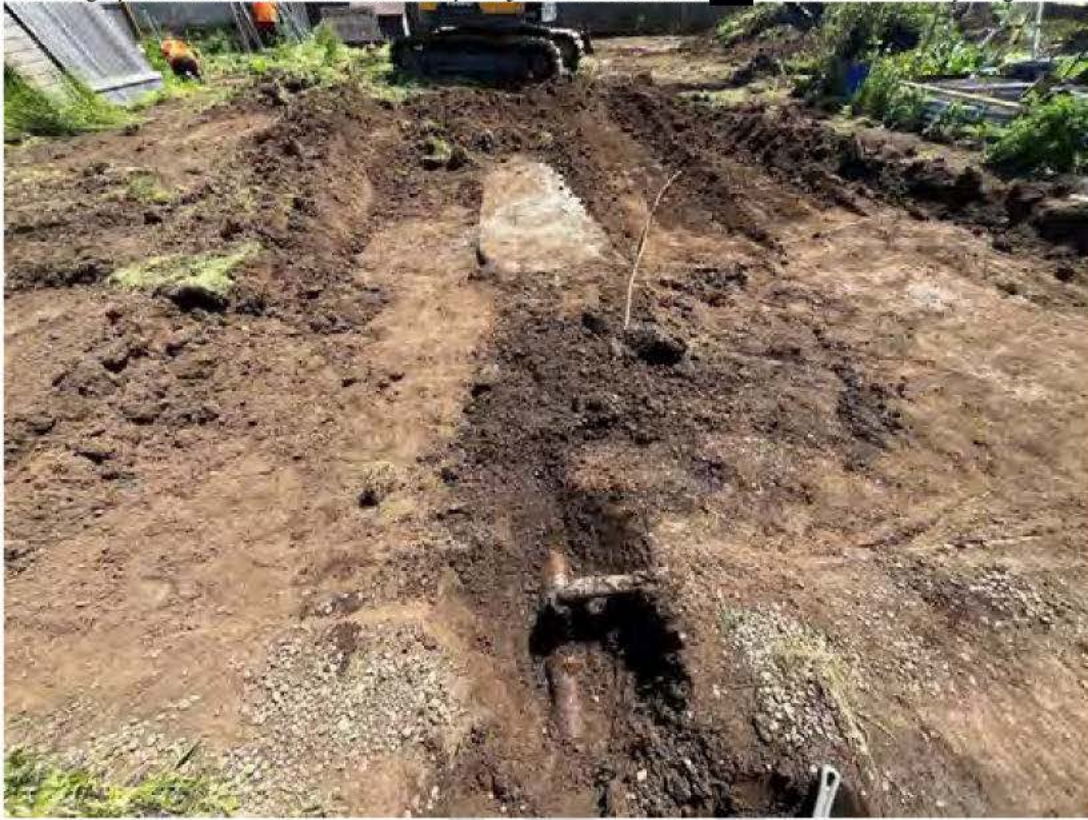
1155 - 3 Kings encountered a septic system in the backyard of [REDACTED] Baxter. GSI observed that the concrete lid for the system was still intact with no obvious damage and/or voids observed. At the time it was unclear if the system had been decommissioned. GSI observed that the damaged drain line from the washer system ran to a T in the line that disappeared below the surface in the direction of the septic tank. 3 Kings indicated that it was possible that the line appearing to run to the septic system had been capped with concrete at a partially buried coupler. GSI asked 3 Kings to uncover potential section of line running to septic tank to investigate further. GSI to notify DEQ that septic system was encountered at this property.

Photograph 9. Drain line, sewer line, and septic system encountered at [REDACTED] Baxter. Photo taken facing east.

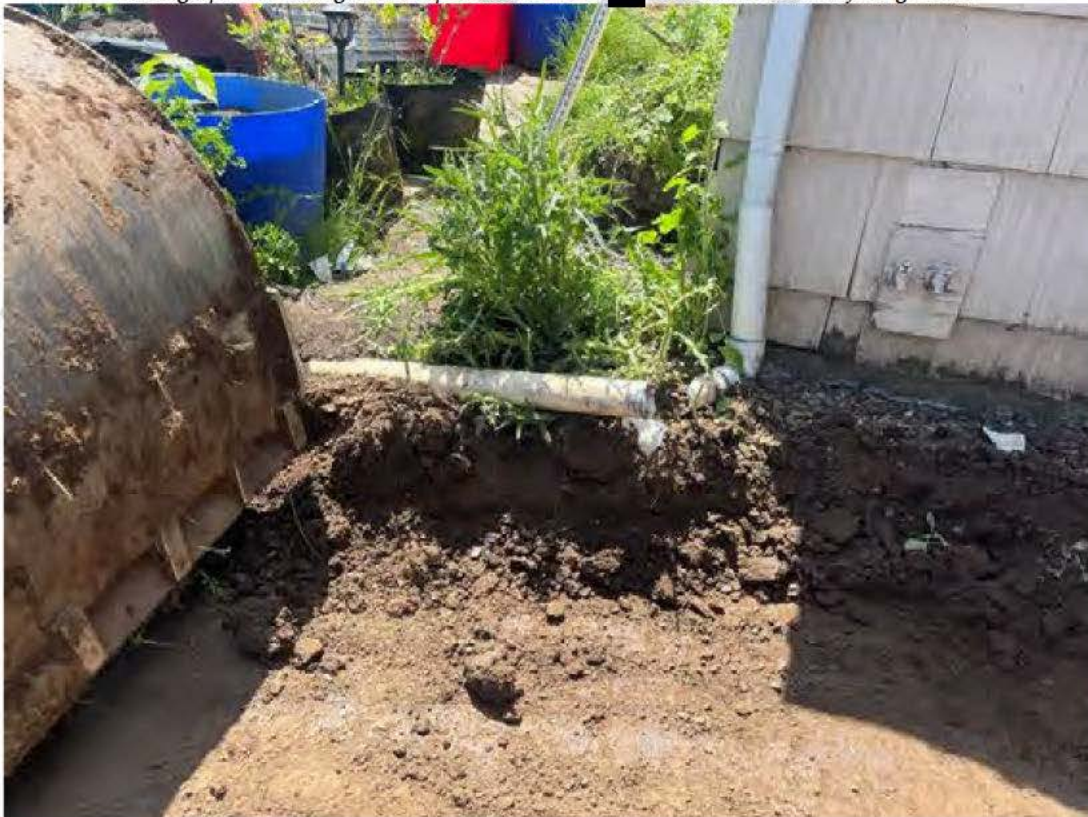
1200 - GSI observed that 3 Kings operators were damaging downspout drain lines running to the east in the backyard of [REDACTED] Baxter. GSI reminded operators that the configuration of these would need to be tracked so that they can be replaced in like kind after removal activities. GSI/DEQ discussed septic system and DEQ concurred that status of line running to tank should be determined. DEQ indicated that if line appeared to be capped or no longer connected to tank, the system could be left without further investigation unless evidence of voids or damage to the lid are observed. 3 Kings continuing to troubleshoot plumbing within [REDACTED] residence - indicated that everything except the toilet appeared to be functioning correctly.

Photograph 10. Damaged downspout drain line at [REDACTED] Baxter. Photo taken facing south.

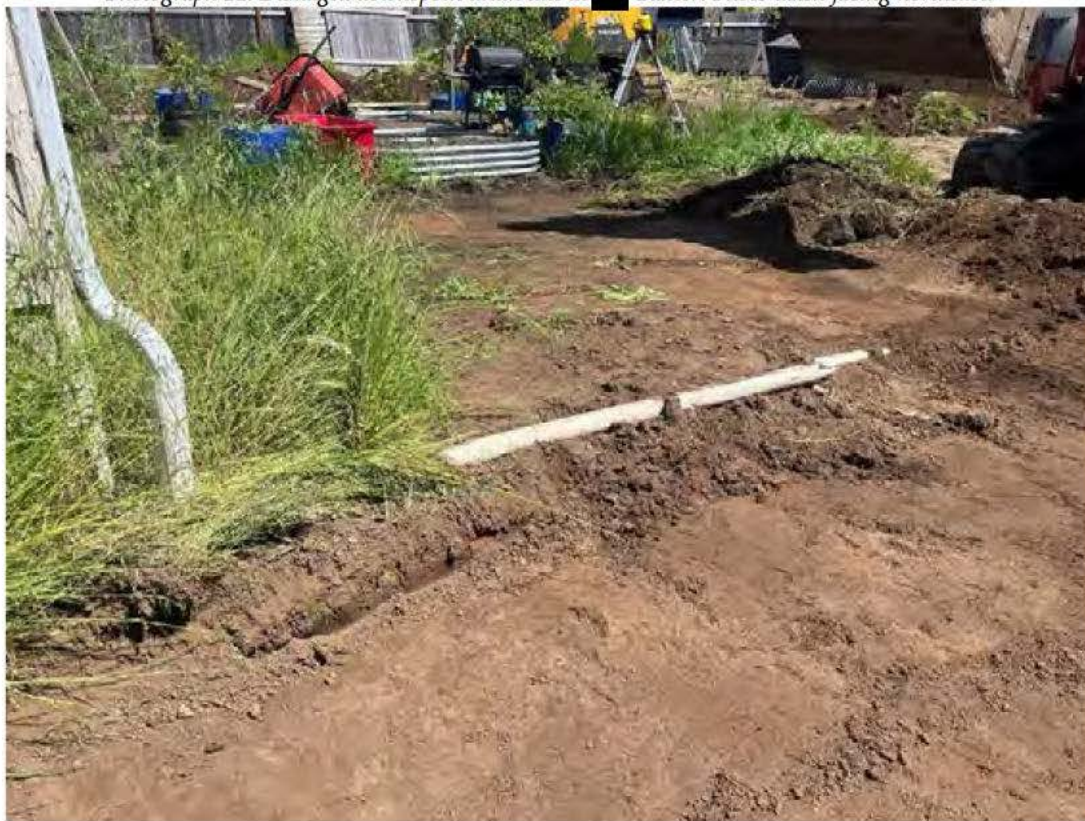
Photograph 11. Damaged downspout drain line at Baxter. Photo taken facing northeast.

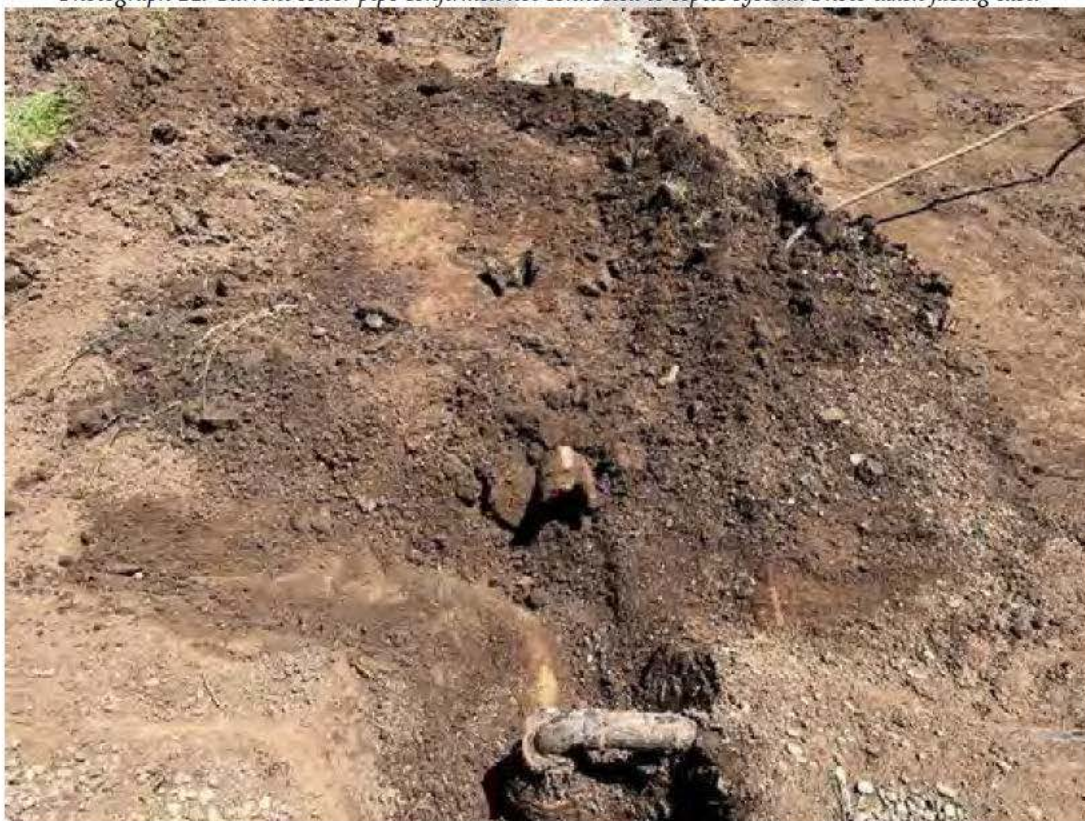
1315 - 3 Kings began excavating to uncover sewer line potentially still connected to septic system at [REDACTED] Baxter. GSI observed that the uncovered line ran to the north shortly after the T in the line where the lateral presumably ran east-west and connected to the main line in the ROW. 3 Kings also uncovered disconnected portions of the old septic line that were left after abandoning the system. Based on this, and no obvious voids or damage observed around the septic tank, GSI/DEQ concluded that the system will be assumed to have been decommissioned and no further investigation would be taken. No potential ACM material was encountered when excavating around the sewer line/septic in this area.

Photograph 14. Current sewer pipe confirmed not connected to septic system. Photo taken facing east.

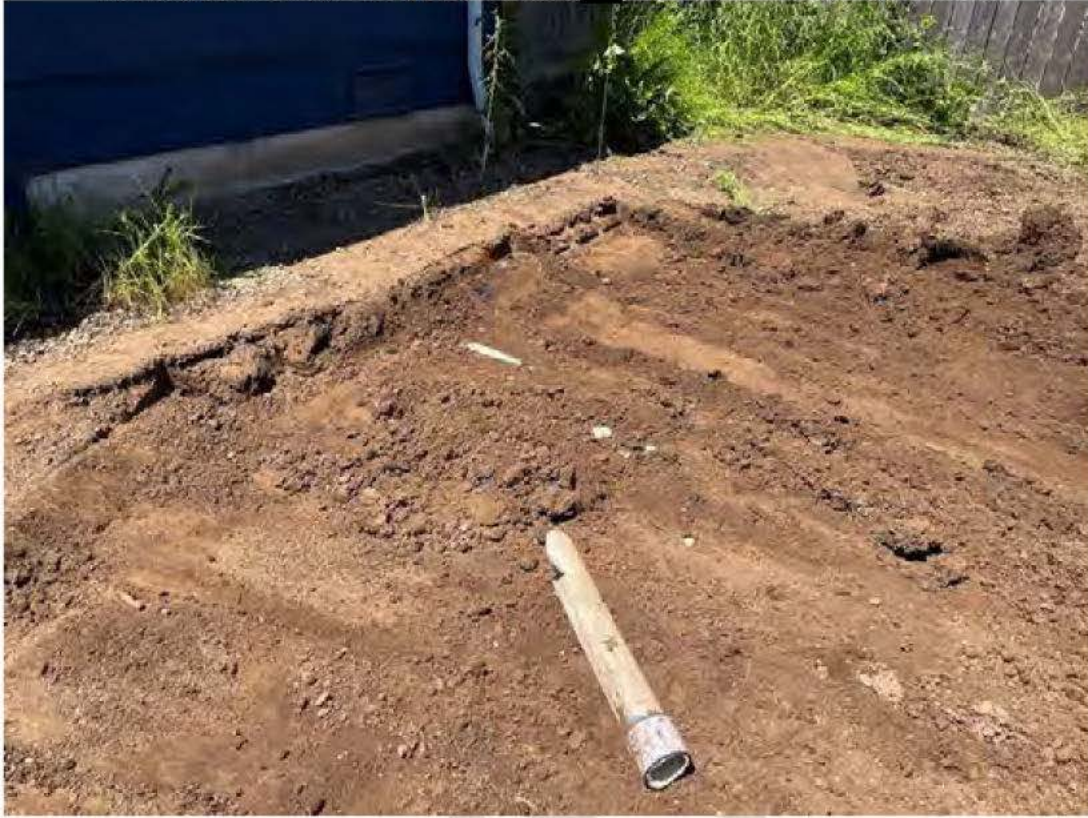
Photograph 15. Damaged downspout drain line at [REDACTED] Baxter. Photo taken facing northwest.

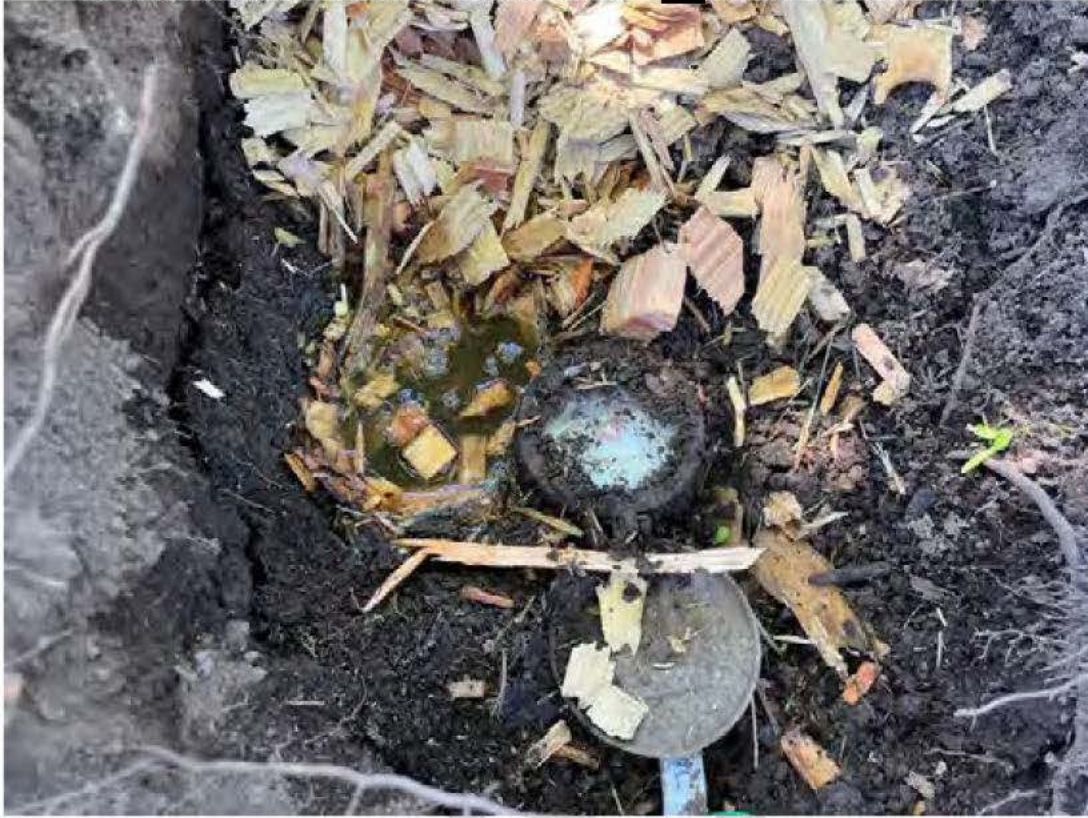
1405 - DEQ/GSI observed some leaking on the public side of the water meter at [REDACTED] Baxter. GSI brought this up to 3 Kings who indicated they would inform EWEB to visit and inspect any potential damage. GSI/3 Kings discussed anticipated cost for additional HVAC contractor visit to diagnose system at [REDACTED] Baxter. 3 Kings to provide cost for DEQ approval of additional visit.

Photograph 17. Apparent leaking observed at water meter at [REDACTED] Baxter. Photo taken facing west.

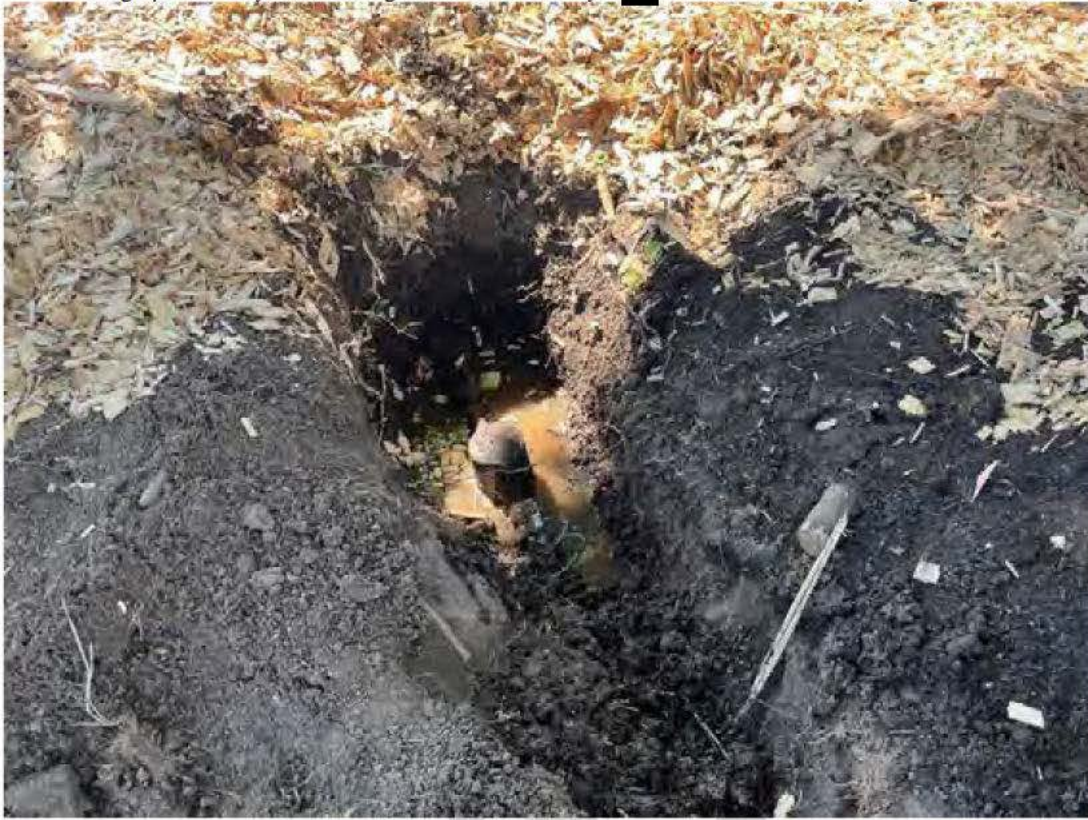
1600 – GSI observed 3 Kings had removed some additional soil around water meter at [REDACTED] Baxter to better expose leaking section of line. 3 Kings indicated EWEB had been notified and would be onsite to inspect/repair any damaged line as needed.

Photograph 23. Confirmed leaking water line at meter for Baxter. Photo taken facing northwest.

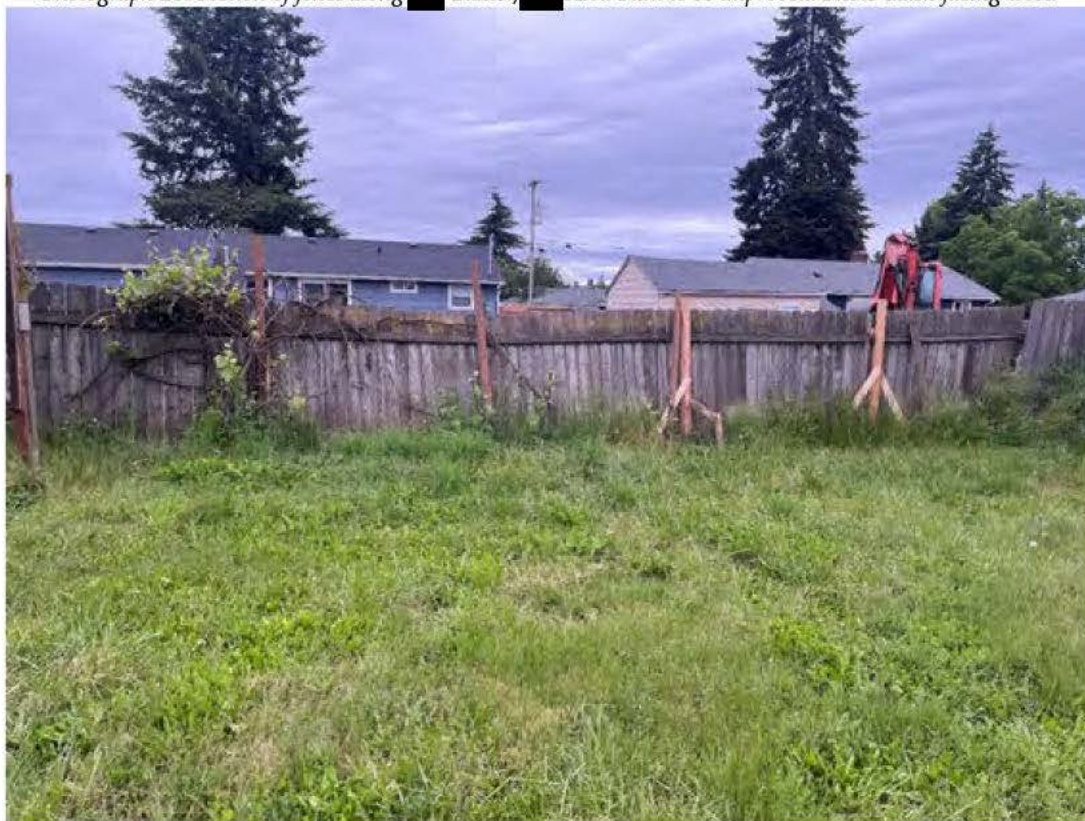
1420 – 3 Kings asked about restoration requirements along eastern fence line of [REDACTED] Baxter. This portion of fence had been over buried and the bottom of the fence boards were approximately at the current excavation grade (6 inches removed). Backfilling per project specs would cause the fence to again be over buried by roughly 6 inches. GSI indicated that restoration would likely still occur as planned here with placement of 6 inches of topsoil, but that GSI/DEQ would discuss and possibly bring up to resident.

Photograph 20. Section of fence along [REDACTED] Baxter, [REDACTED] Alva Park to be improved. Photo taken facing west.

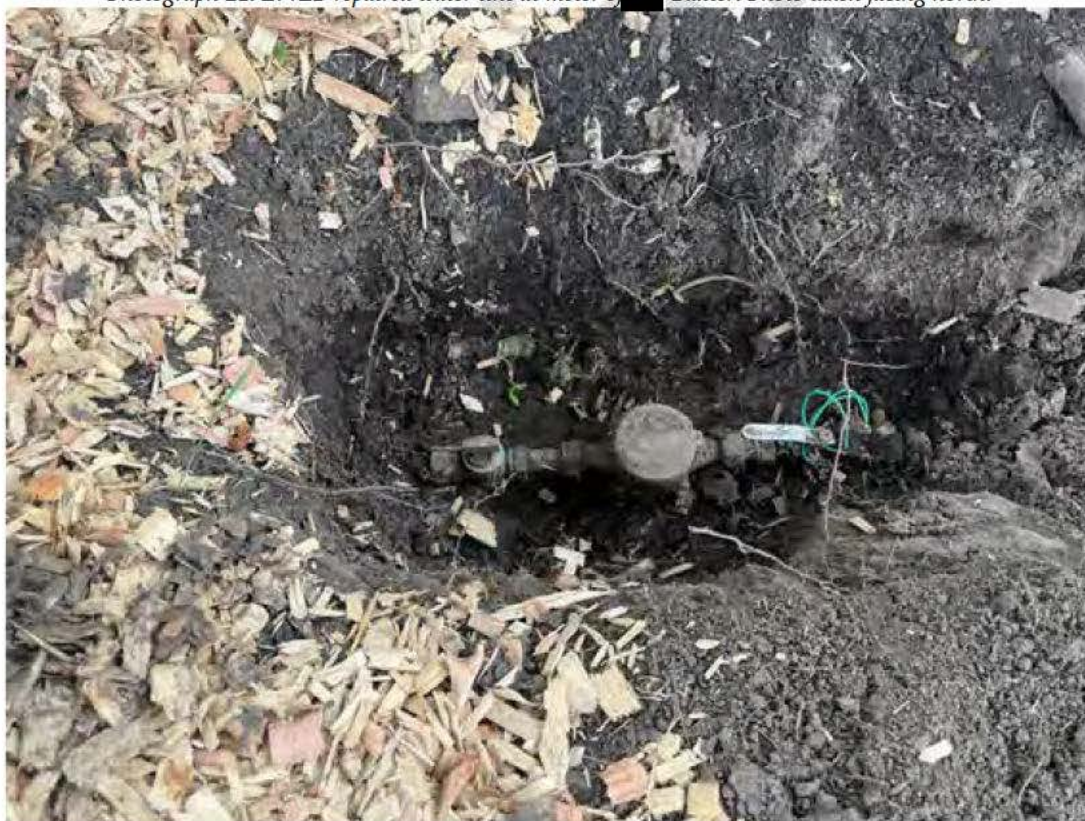
Photograph 21. EWEB repaired water line at meter of [REDACTED] Baxter. Photo taken facing north.

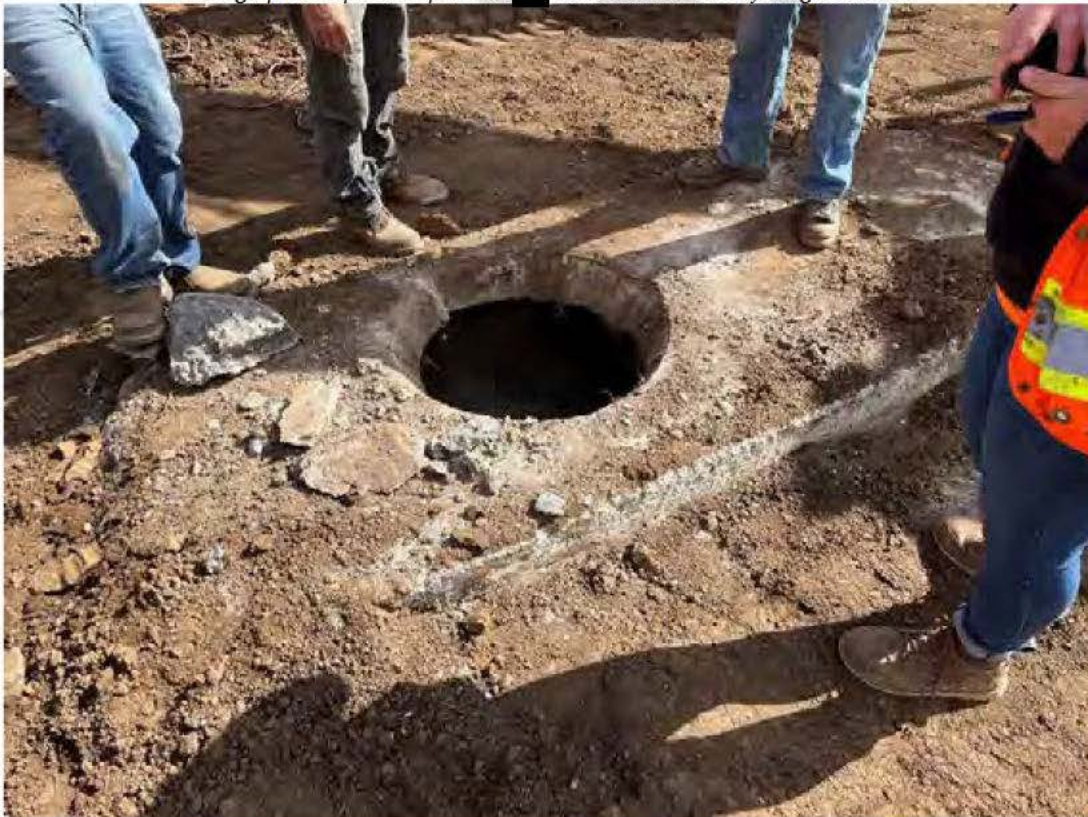
Photograph 7. Septic lid opened at [REDACTED] Baxter. Photo taken facing northeast.

Don confirmed DEQ approval and preference for 3 Kings to investigate septic system at [REDACTED] Baxter and decommission appropriately if found to be empty.

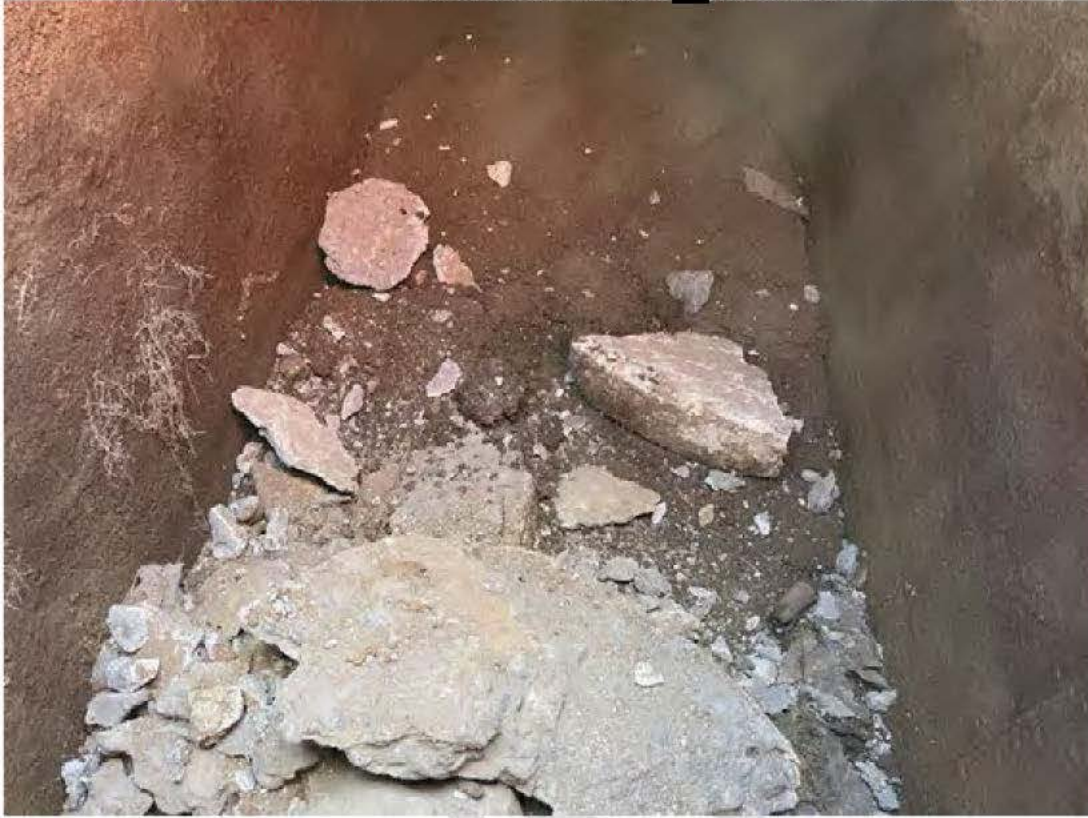
Photograph 8. No liquid contents observed in septic system at [REDACTED] Baxter. Photo taken facing east.

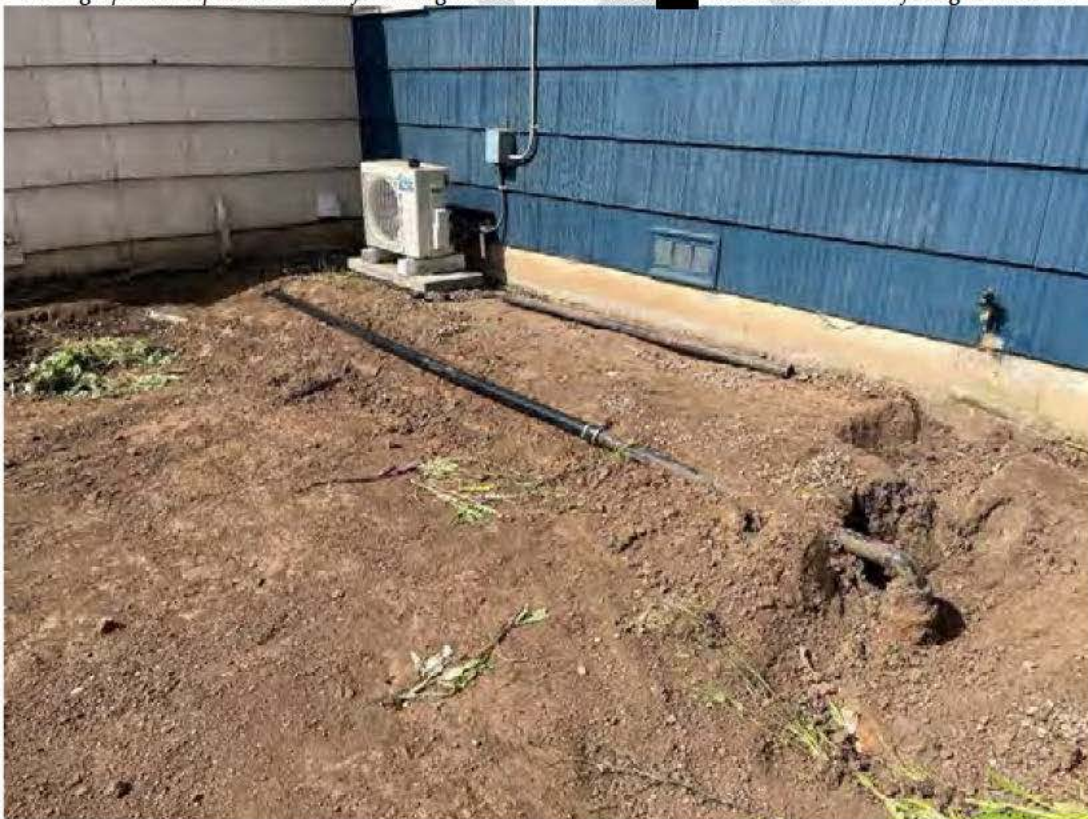
Photograph 12. Replaced section of washing machine drain line at [REDACTED] Baxter. Photo taken facing southwest.

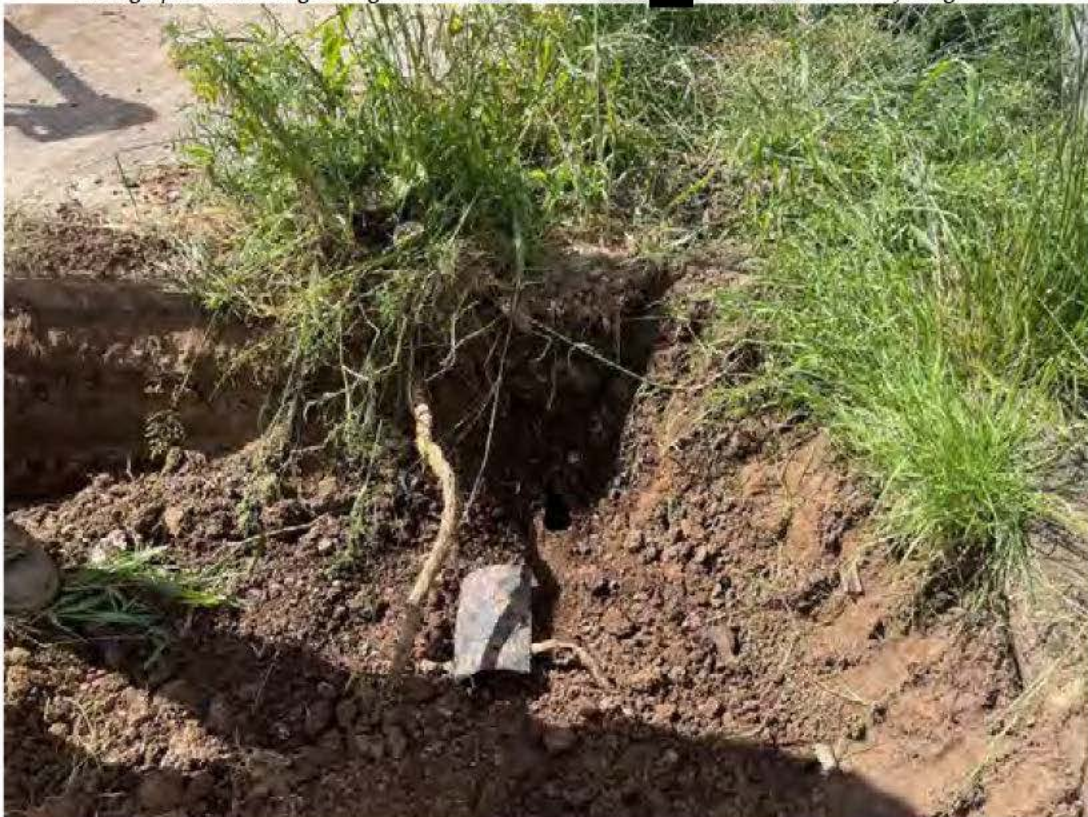
Photograph 14. Existing damaged sewer line encountered at [REDACTED] Baxter. Photo taken facing south.

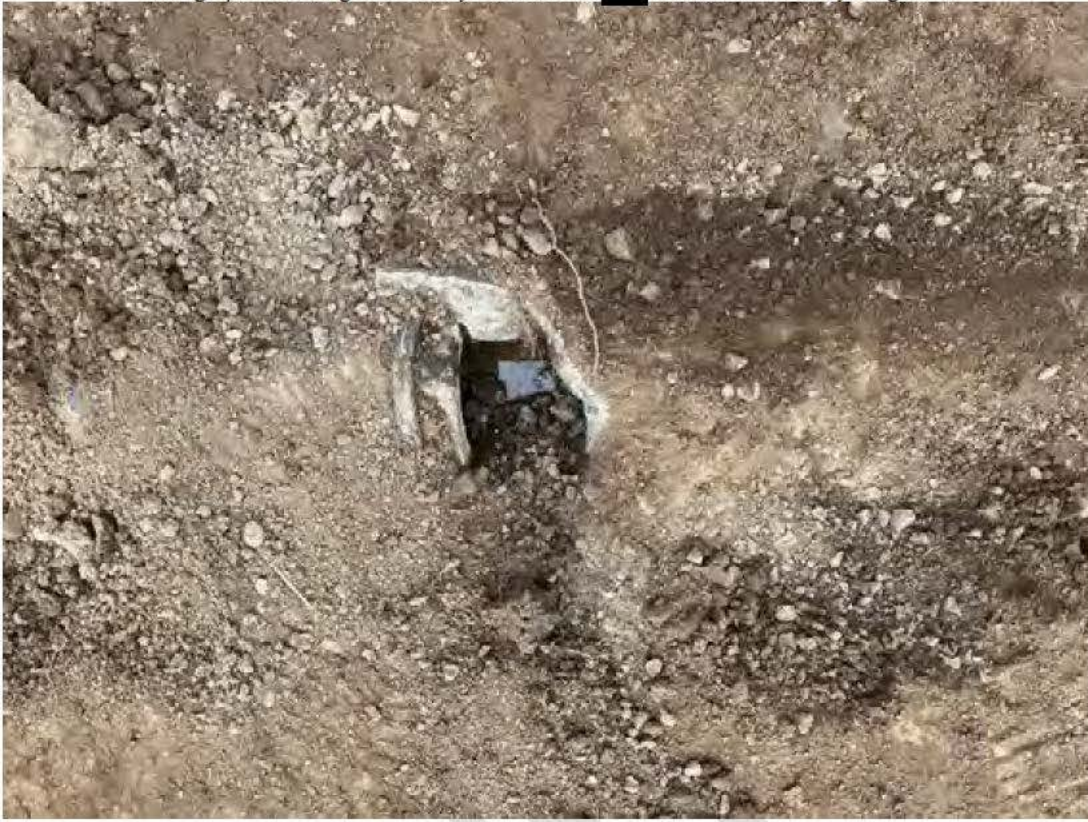
Photograph 5. Damaged section of sewer line at [REDACTED] Baxter. Photo taken facing west.

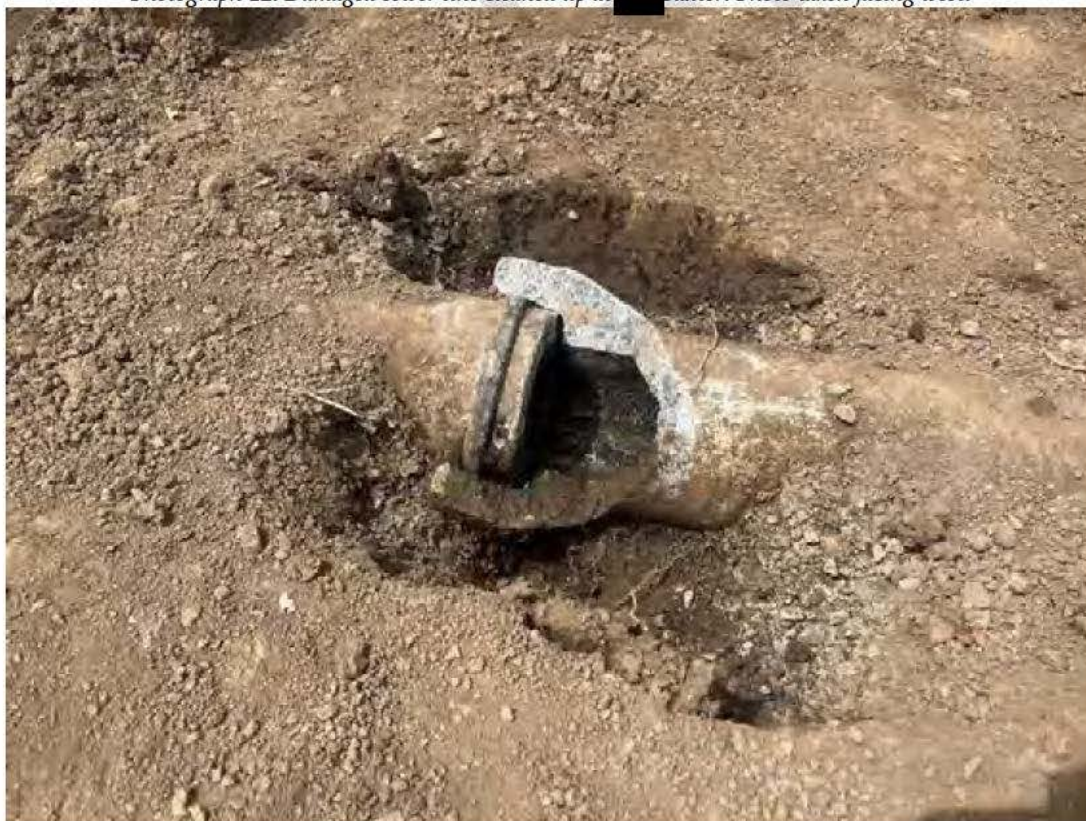
Photograph 12. Damaged sewer line cleaned up at [REDACTED] Baxter. Photo taken facing west.

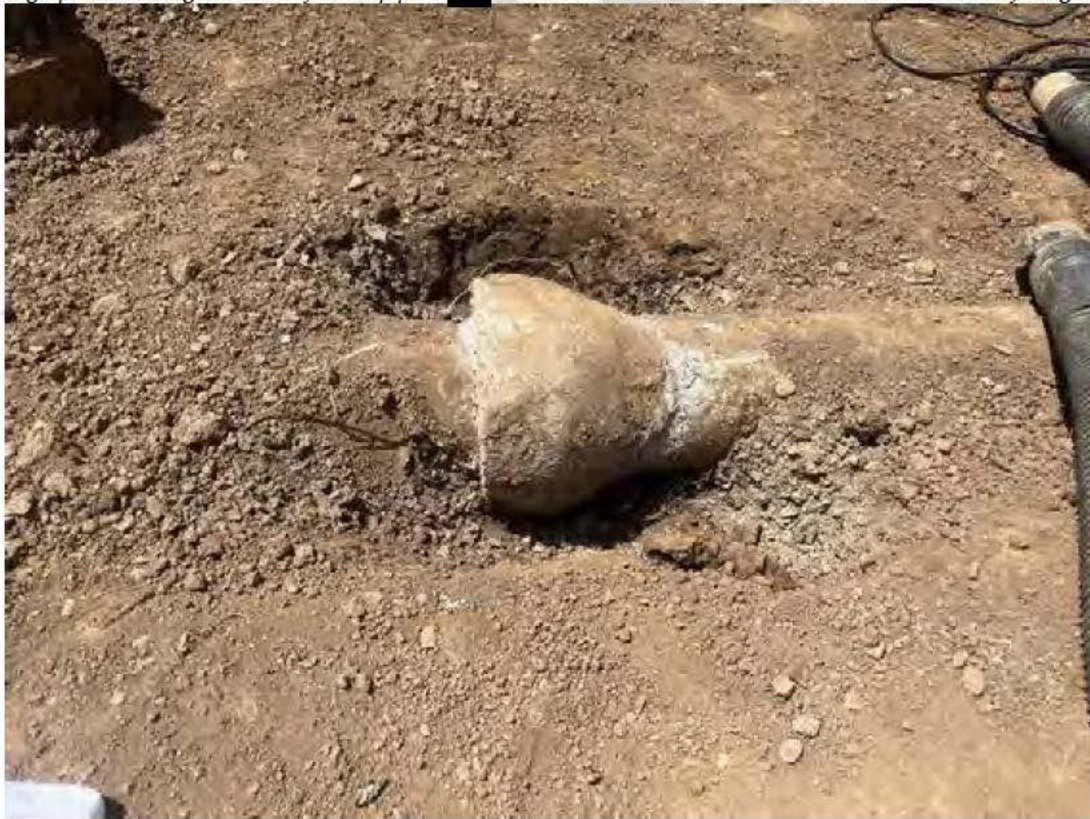
Photograph 18. Damaged section of sewer pipe at [REDACTED] Baxter connected with concrete adhesive. Photo taken facing west.

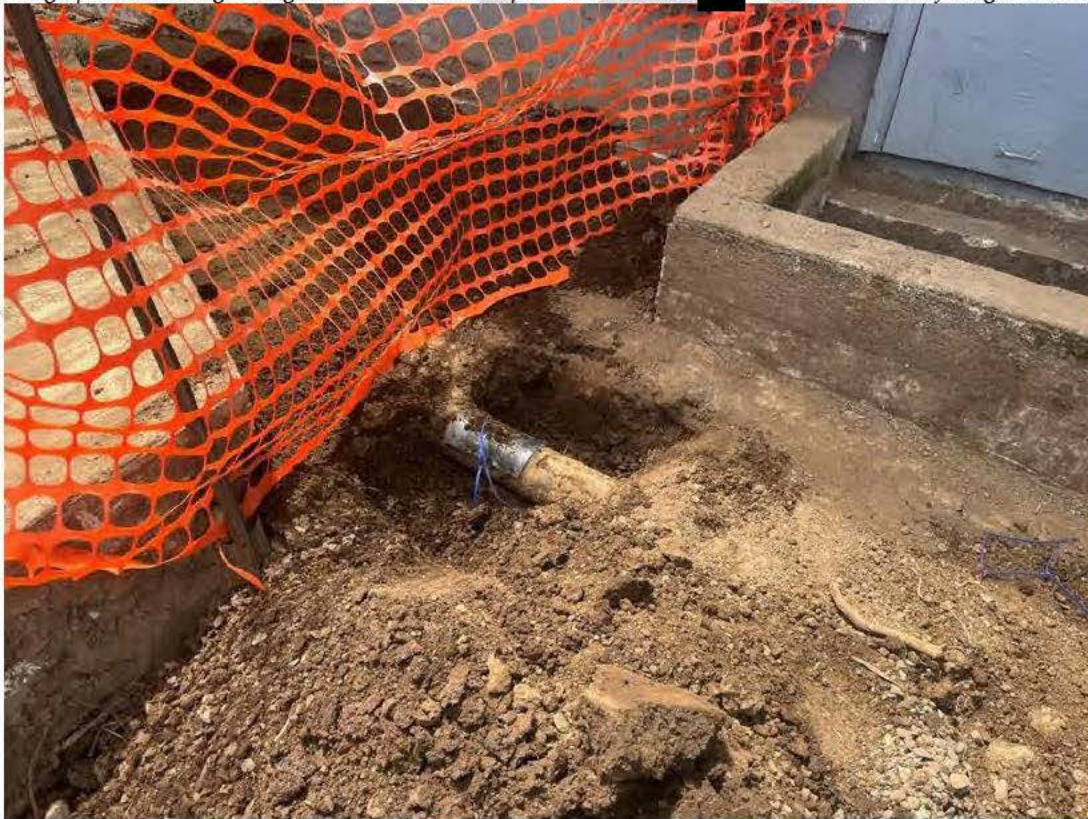
Photograph 22. Existing damaged sewer line with temp cover installed at [REDACTED] Baxter. Photo taken facing southwest.

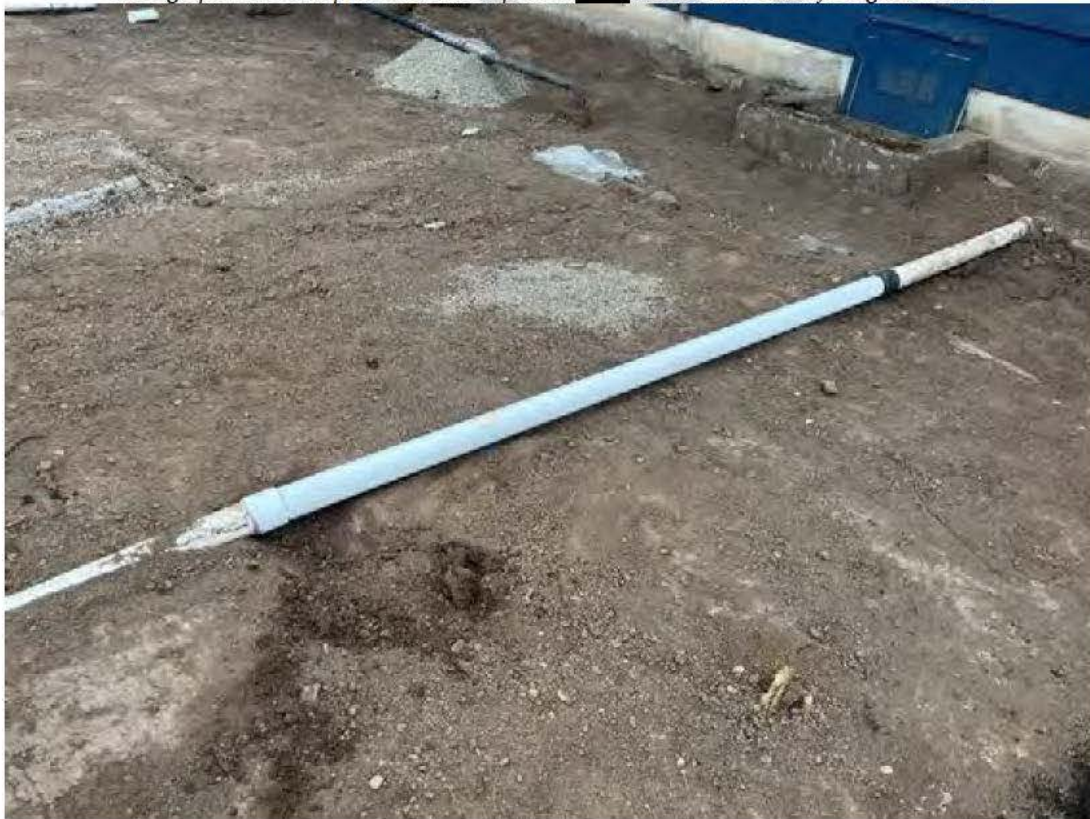
Photograph 16. Downspout drain line repairs at [REDACTED] Baxter. Photo taken facing southwest.

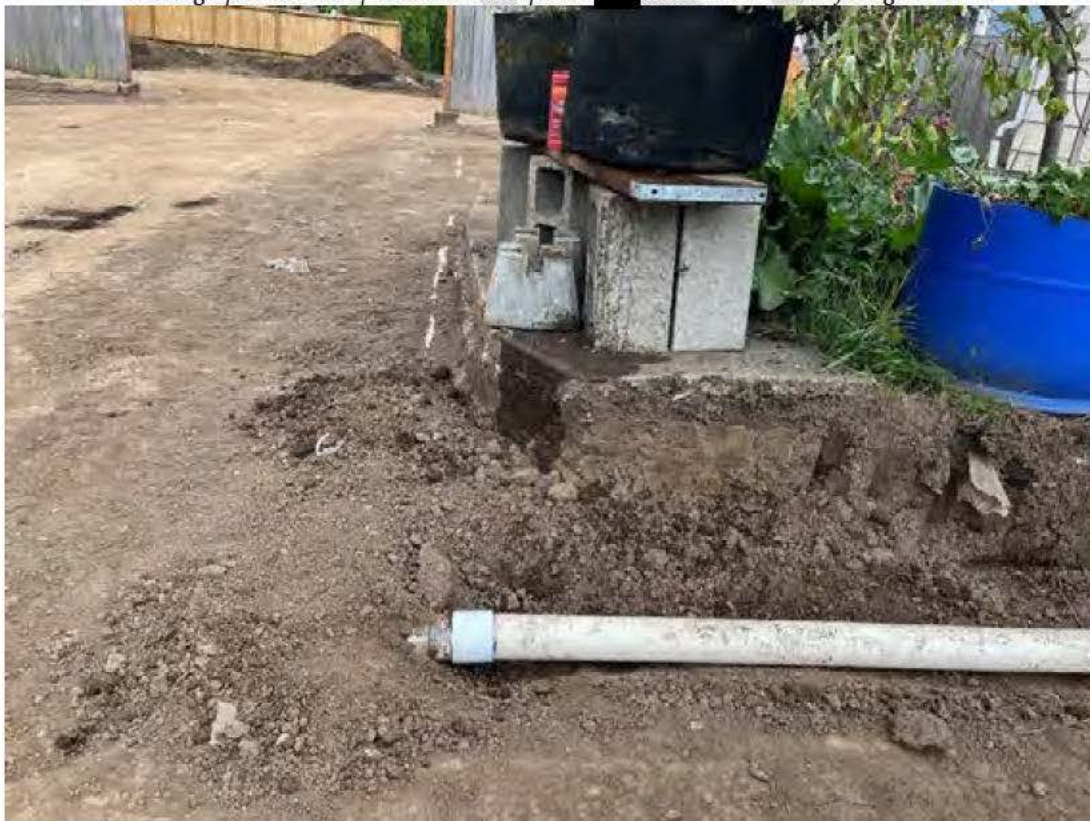
Photograph 18. Downspout drain line repair at [REDACTED] Baxter. Photo taken facing south.

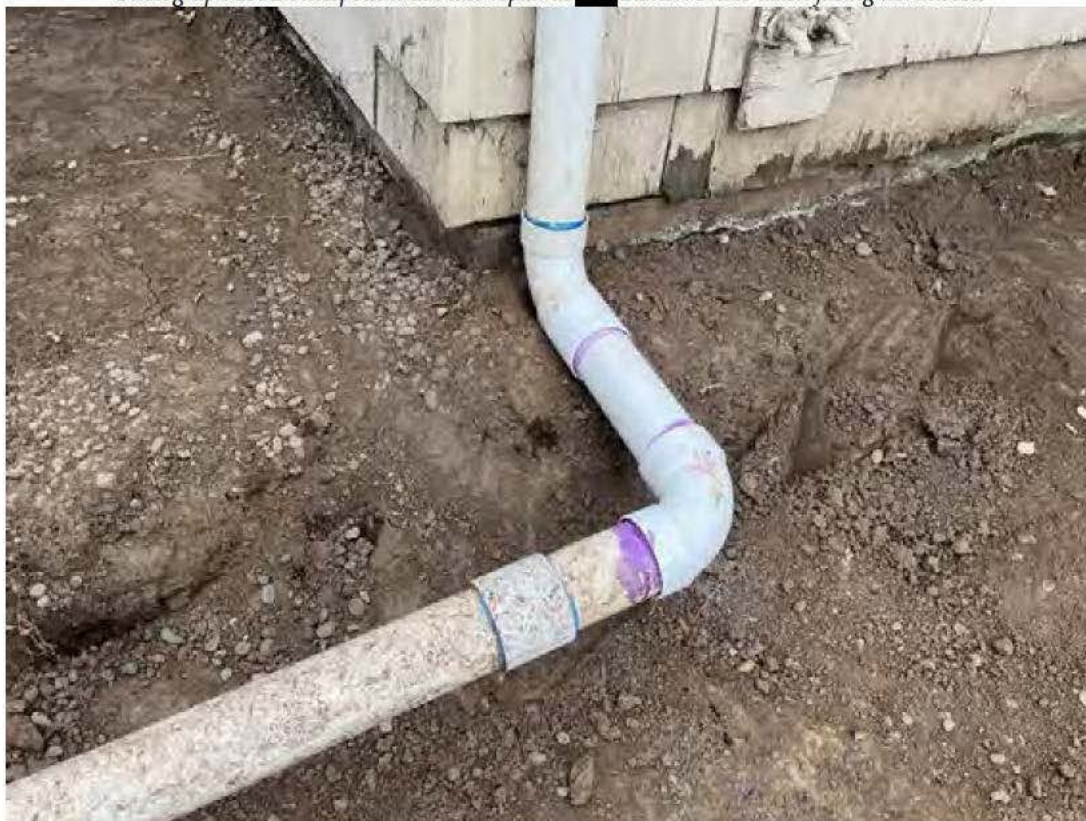
Photograph 19. Downspout drain line repair at [REDACTED] Baxter. Photo taken facing northwest.

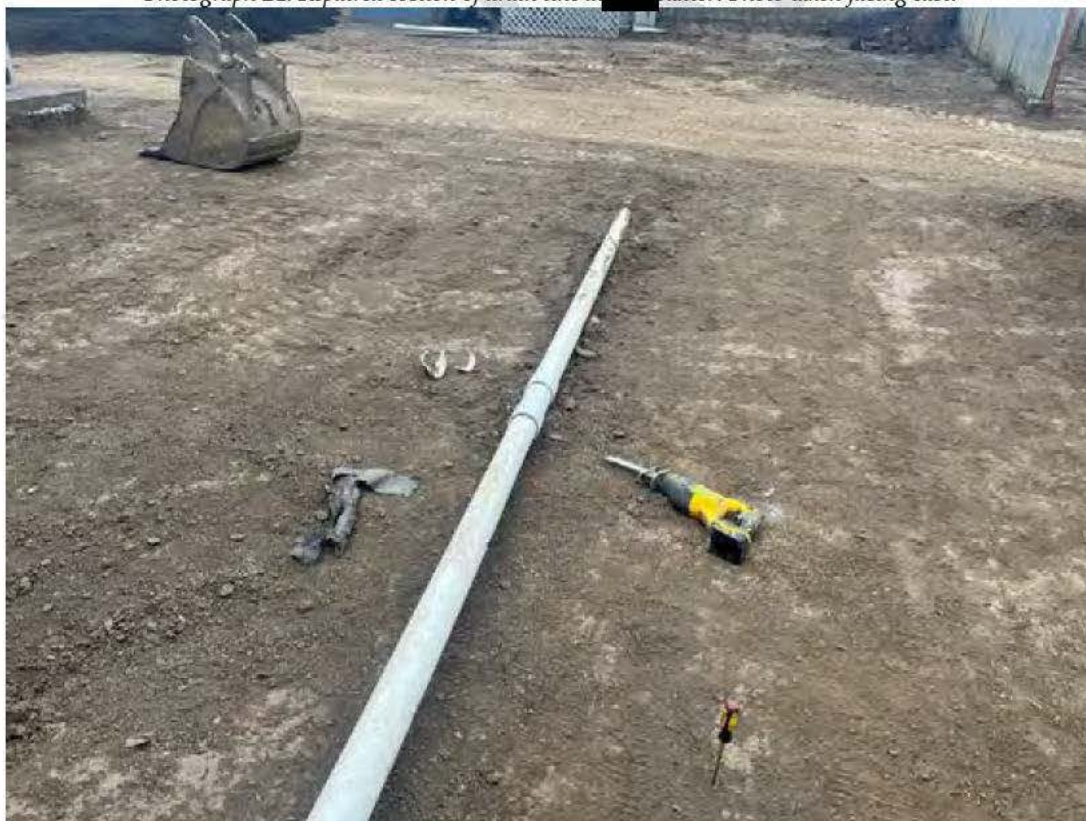
Photograph 24. Repaired section of drain line at [REDACTED] Baxter. Photo taken facing east.

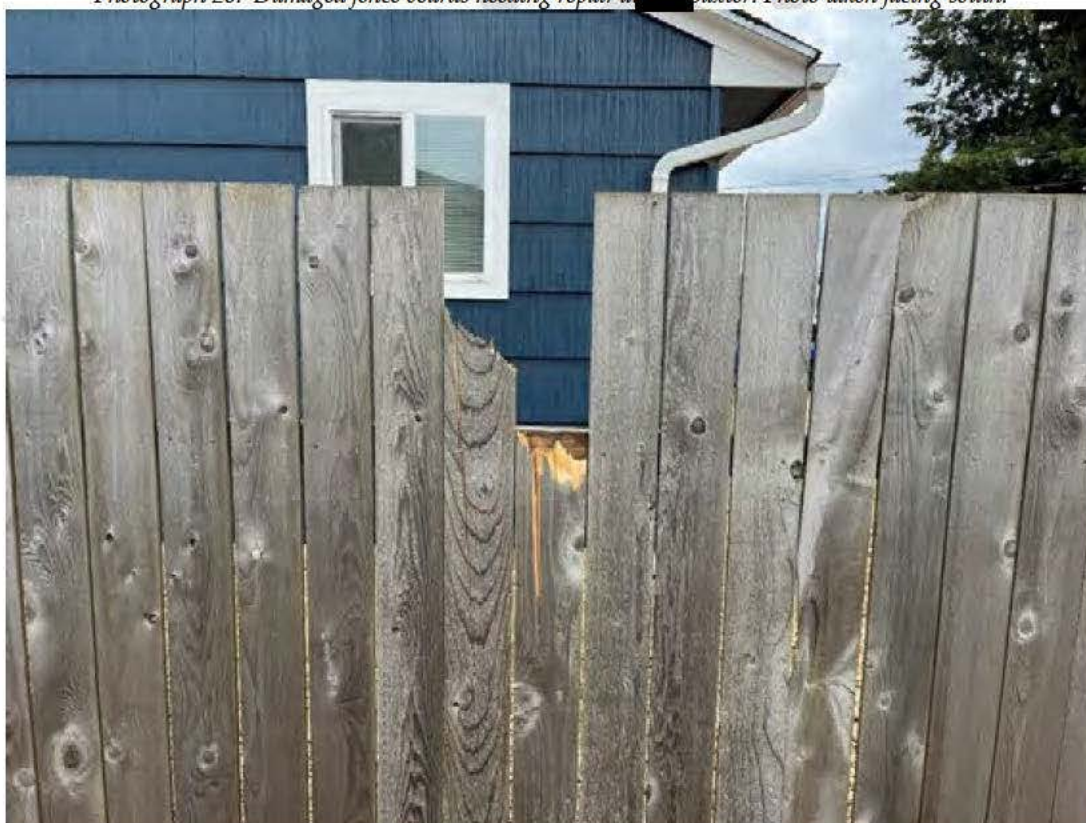
Photograph 26. Damaged fence boards needing repair at [REDACTED] Baxter. Photo taken facing south.

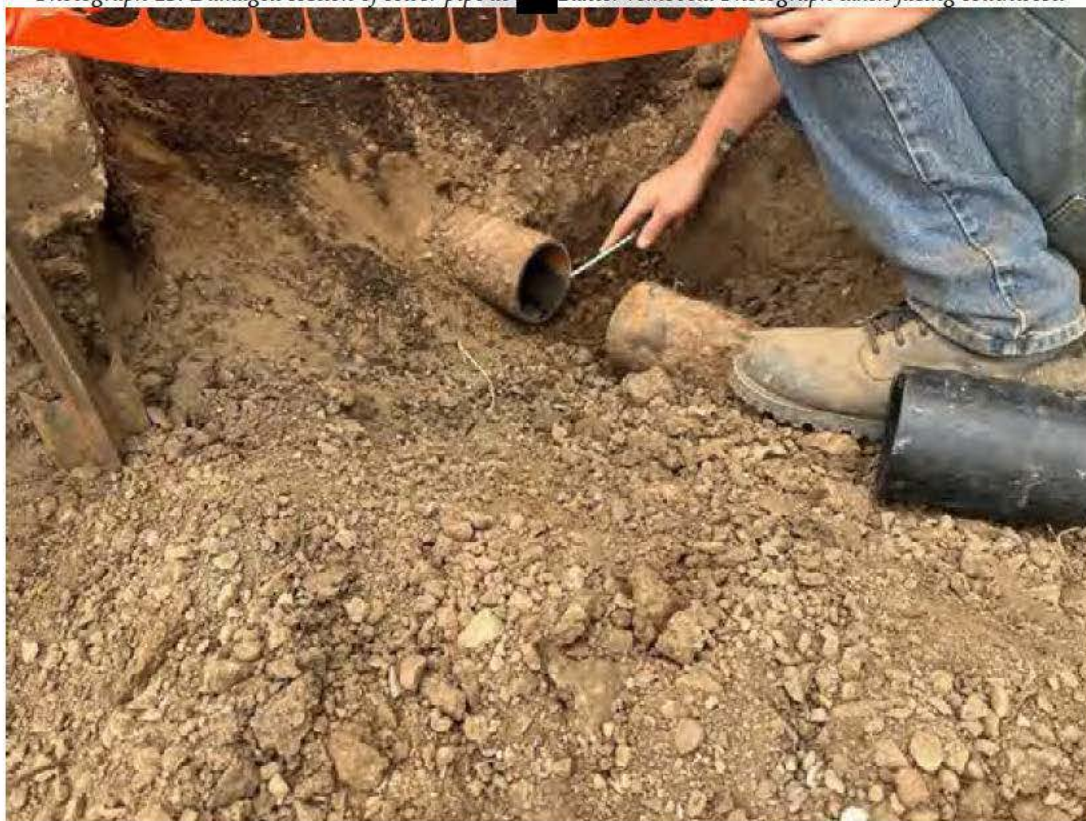
Photograph 13. Damaged section of sewer pipe at [REDACTED] Baxter removed. Photograph taken facing southwest.
