APPENDIX B

Daily Field Reports Continued

Phase II RA

OFFSITE REMOVAL ACTION - DAILY FIELD REPORT
JH BAXTER OFFSITE REMEDIAL ACTION
EUGENE, OREGON

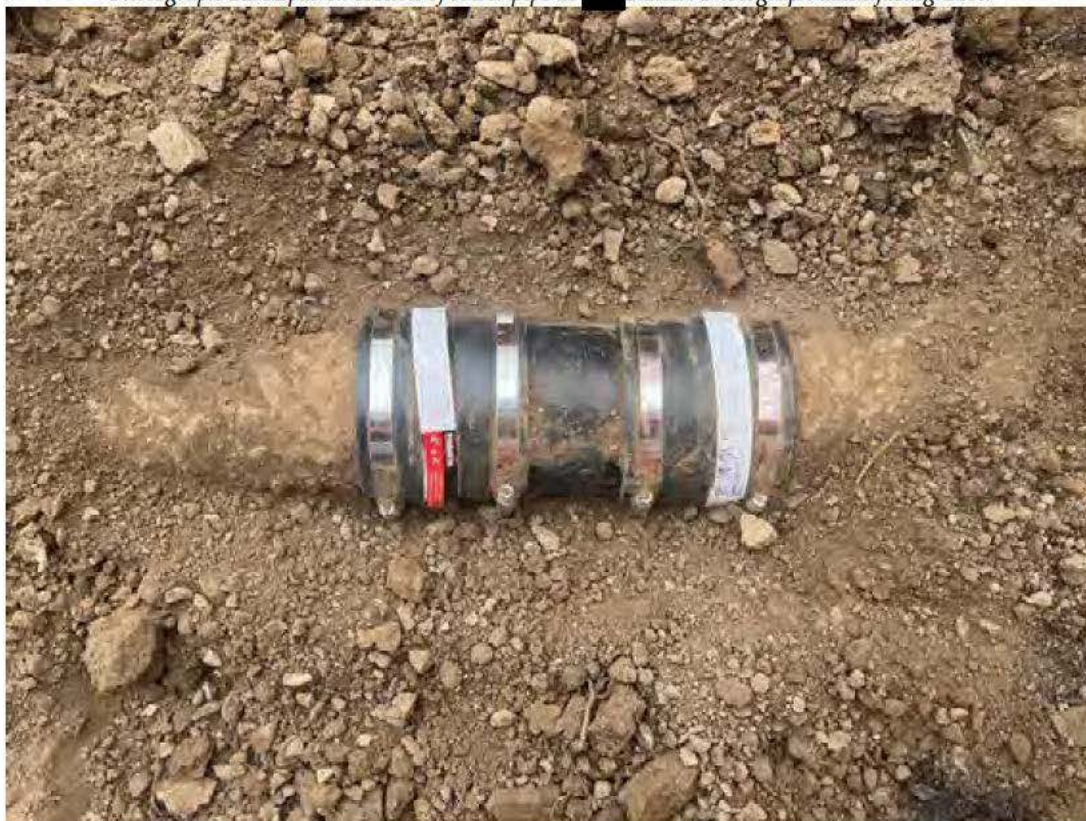
Photograph 14. Repaired section of sewer pipe at [REDACTED] Baxter. Photograph taken facing west.

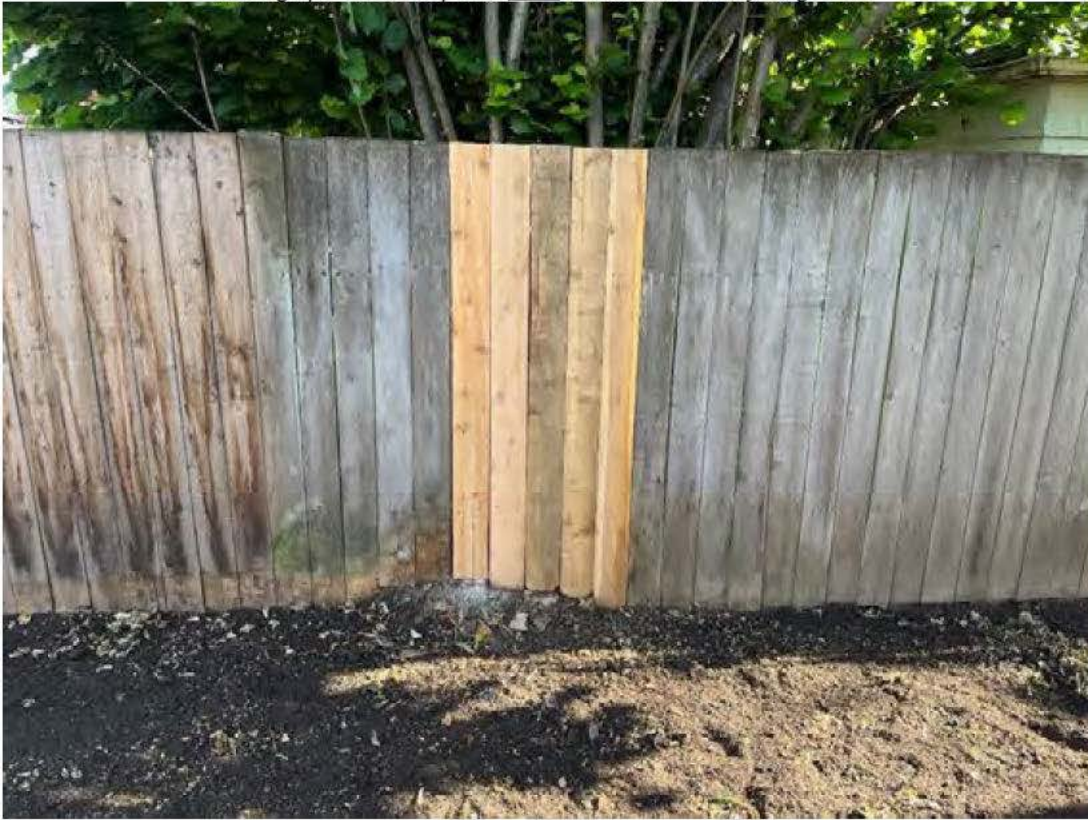
Photograph 5. Fence repair at [REDACTED] Baxter. Photo taken facing north.

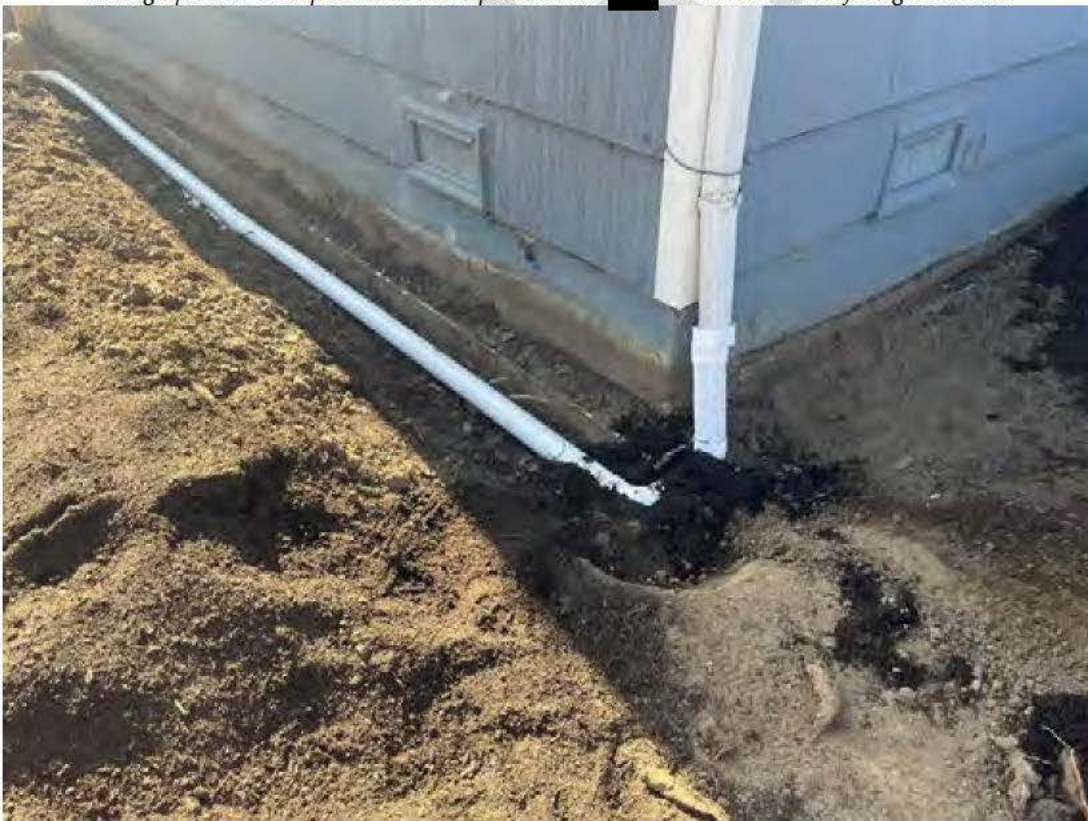
Photograph 10. Downspout drain line replacement at [REDACTED] Baxter. Photo taken facing southeast.

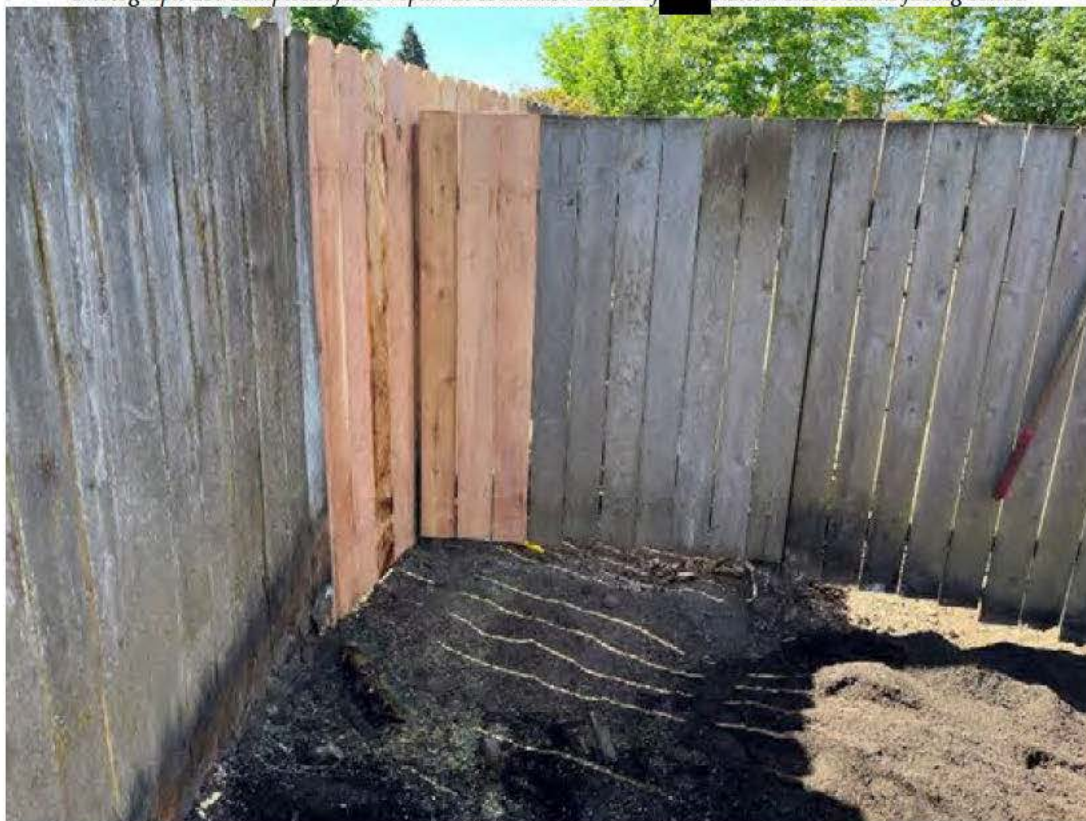
Photograph 13. Completed fence repair at southeast corner of [REDACTED] Baxter. Photo taken facing south.

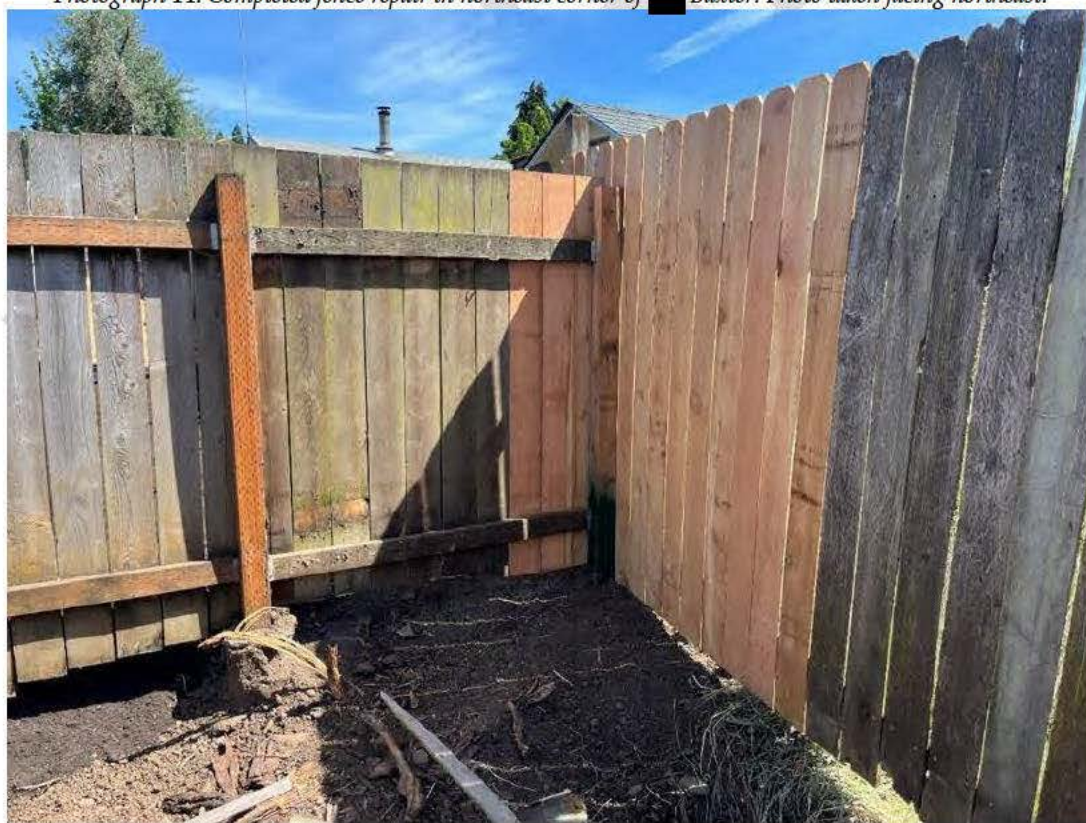
Photograph 14. Completed fence repair in northeast corner of [REDACTED] Baxter. Photo taken facing northeast.

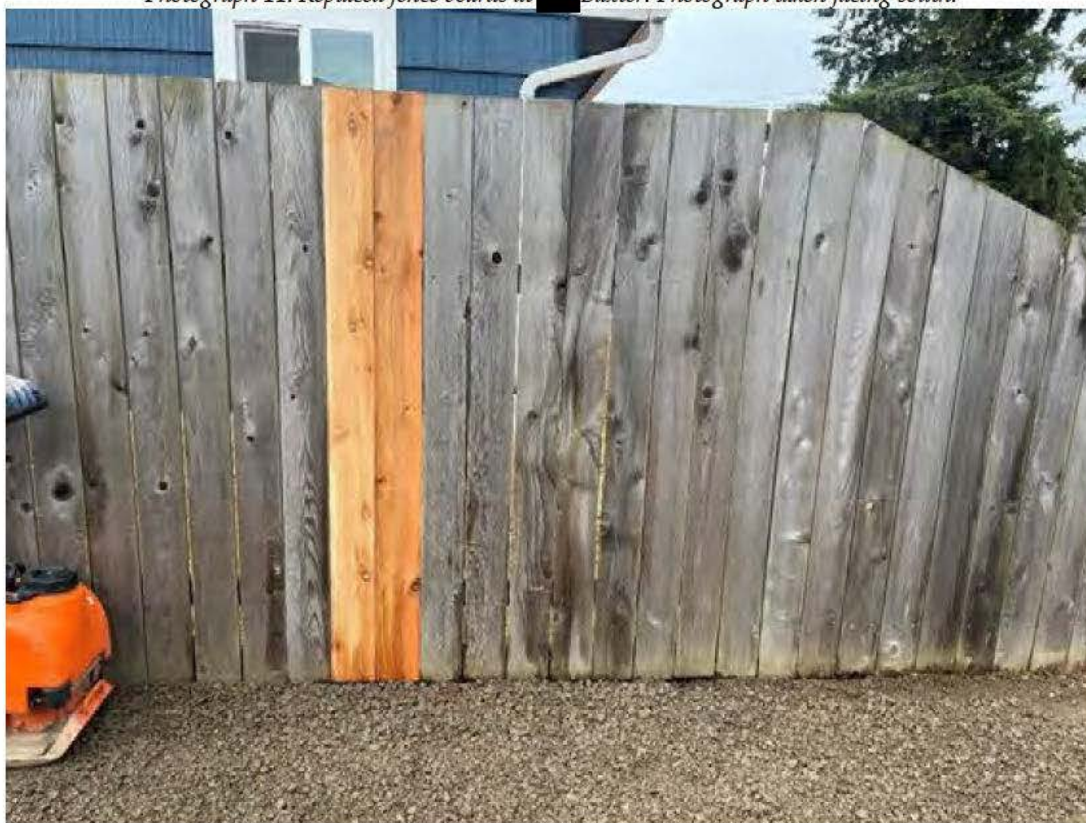
Photograph 11. Replaced fence boards at [REDACTED] Baxter. Photograph taken facing south.

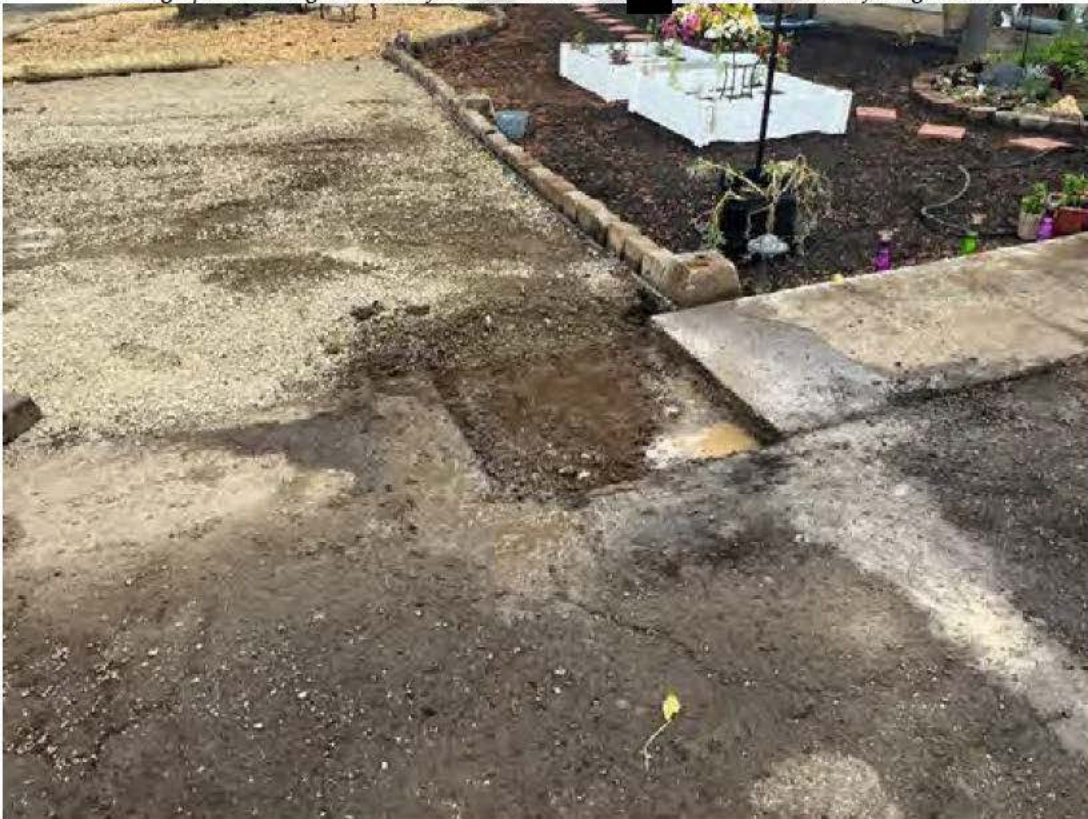
Photograph 8. Damaged section of concrete cut out at [REDACTED] Baxter. Photo taken facing south.

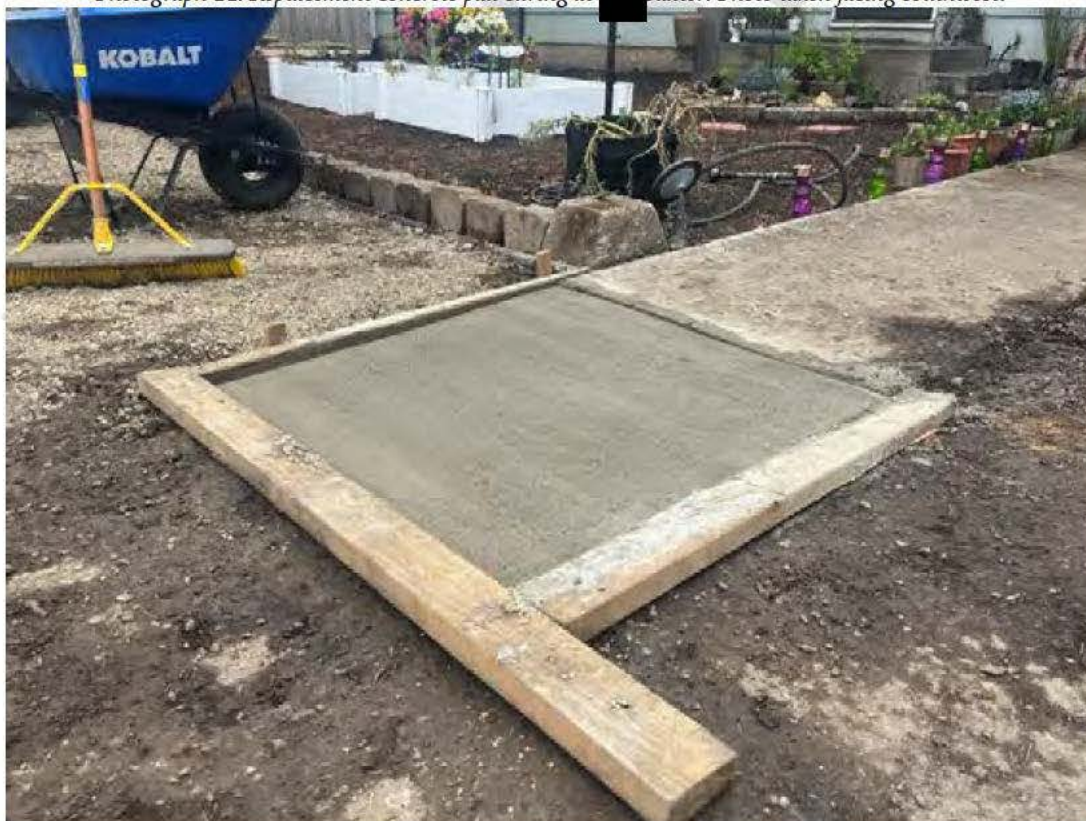
Photograph 14. Replacement concrete pad curing at [REDACTED] Baxter. Photo taken facing southwest.
