**2008 (Year 1) Monitoring Report
Santosh Landfill
Wetland Mitigation Project
Scappoose, Oregon**

**Prepared for
Oregon Department of
Environmental Quality**

**November 21, 2008
15563-02/Task 4**

Prepared by
Hart Crowser, Inc.

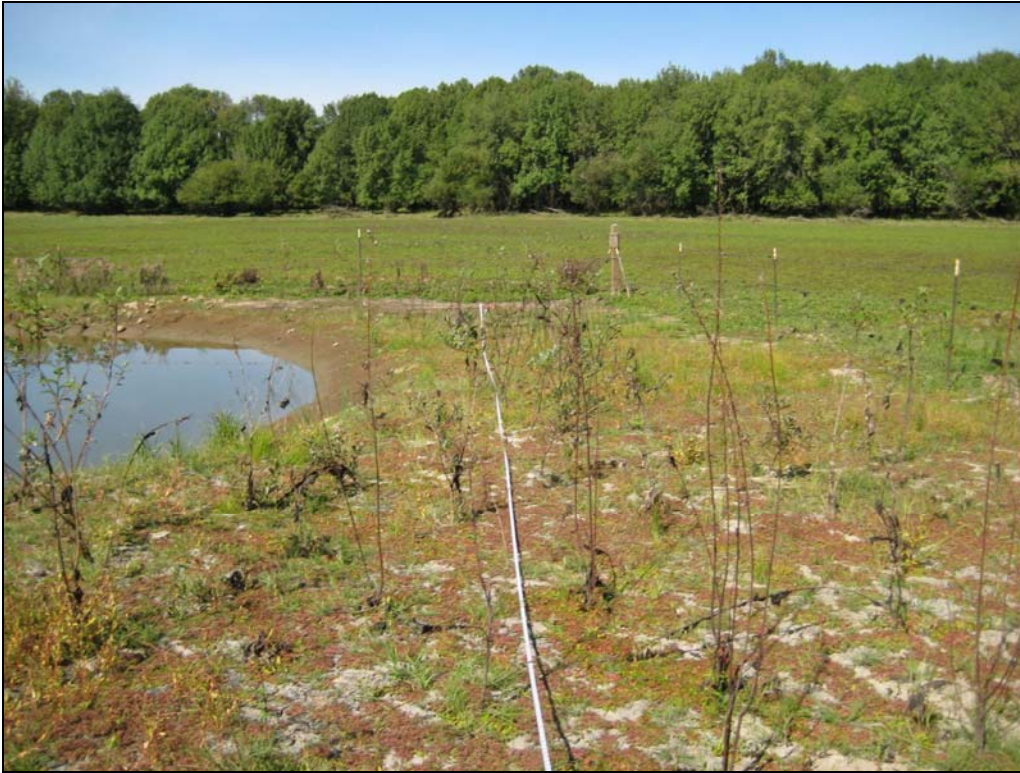
Photograph 1 – Forested and scrub/shrub vegetation at monitoring Transect T2 (view looking northwest).

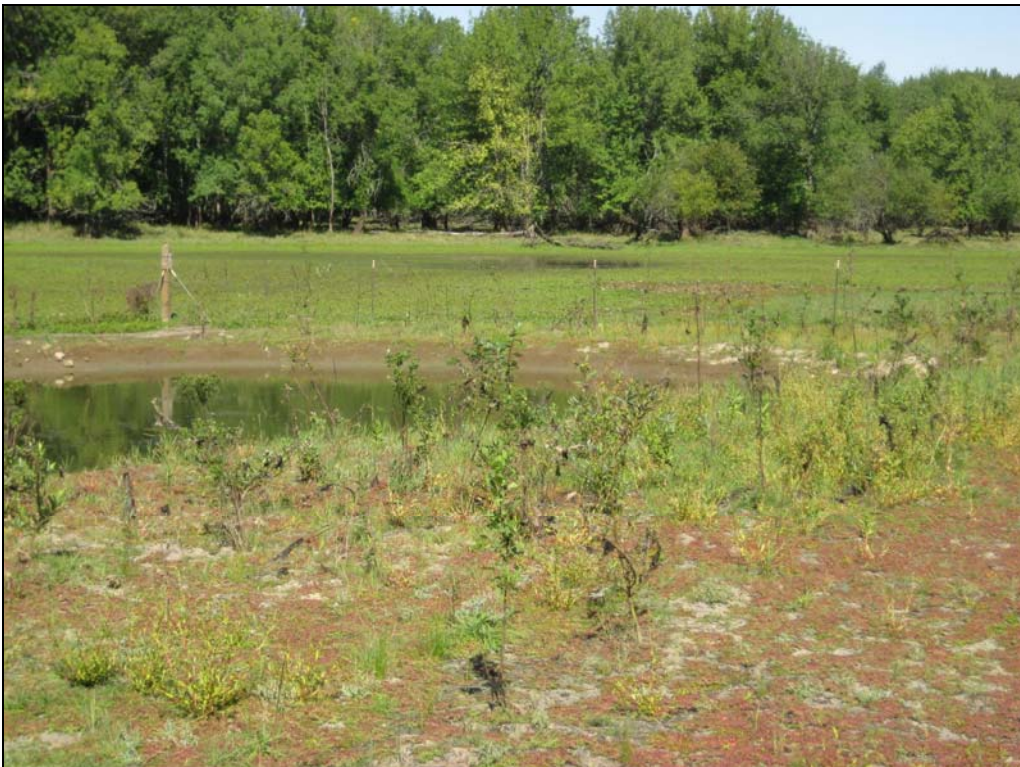
Photograph 2 – This photo shows the emergent portion of the wetland with a forested riparian area in the background, in contrast to the developing forested and scrub/shrub plant community in the mitigation area (taken from Photo Point P1, view looking north).

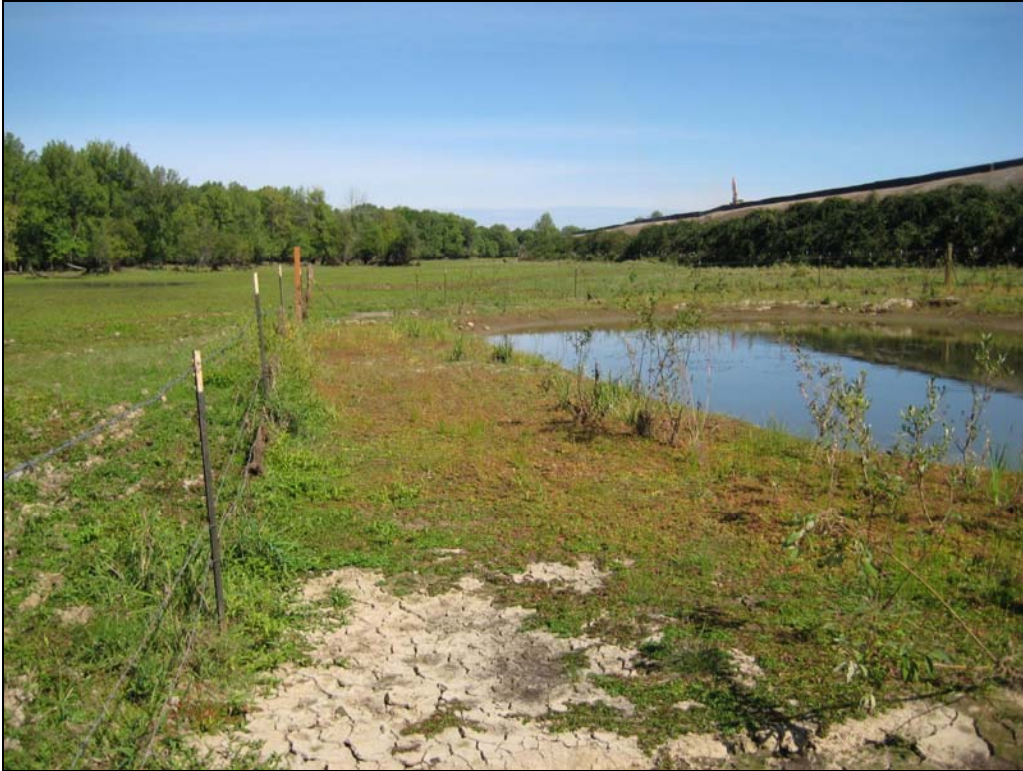
Photograph 3 – The primarily emergent plant community along the edge of the open water from photo point P2 (view looking northeast).

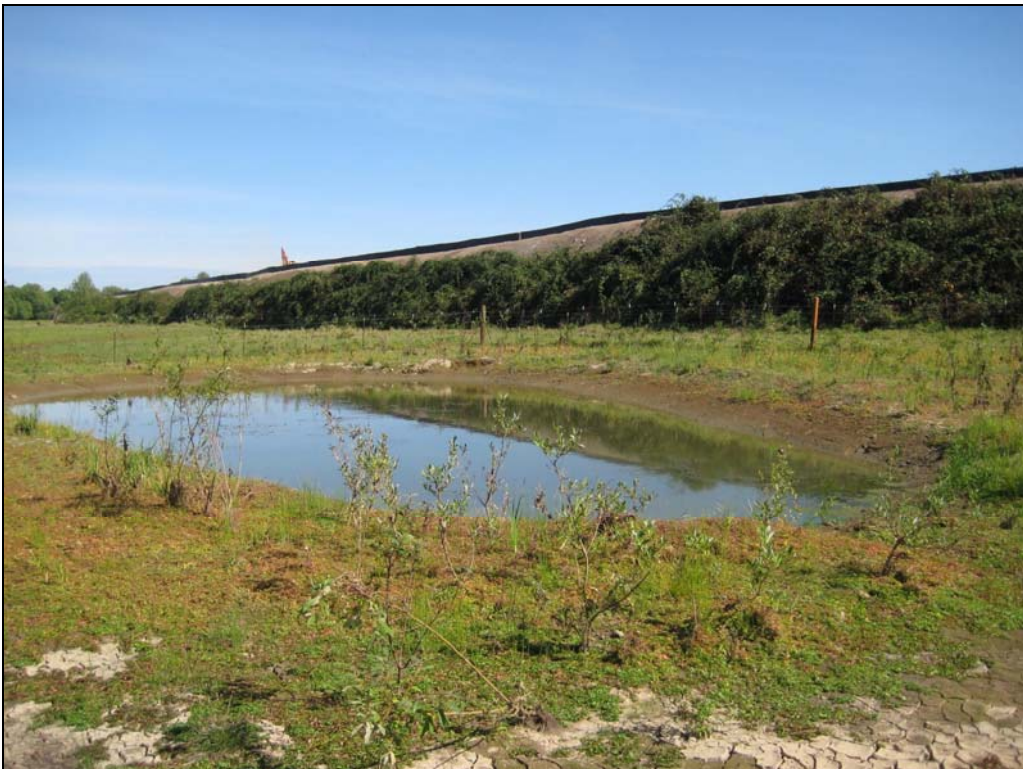
Photograph 4 – An overview of the mitigation site from photo point P2 (view looking east).
