**2010 (Year 3) Monitoring Report
Santosh Landfill
Wetland Mitigation Project
Scappoose, Oregon**

**Prepared for
Oregon Department of
Environmental Quality**

**December 28, 2010
15563-03/Task 2**

Prepared by
Hart Crowser, Inc.

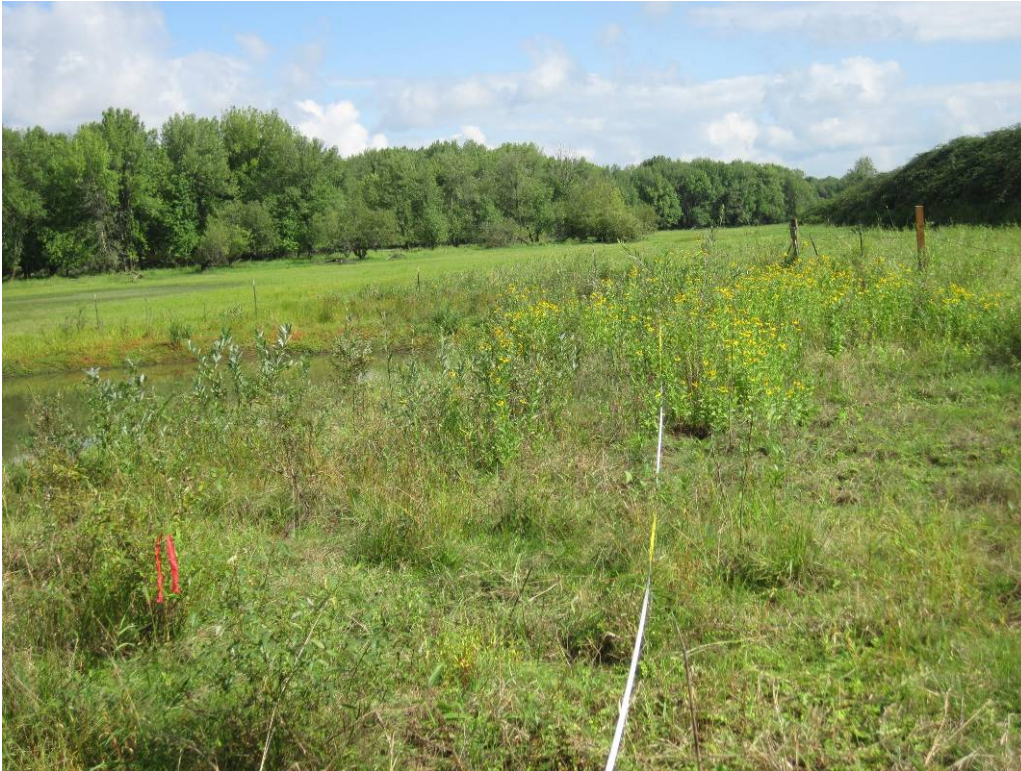
Photograph 1 – Forested and scrub/shrub vegetation is growing and spreading at monitoring Transect T2 (view looking northwest).

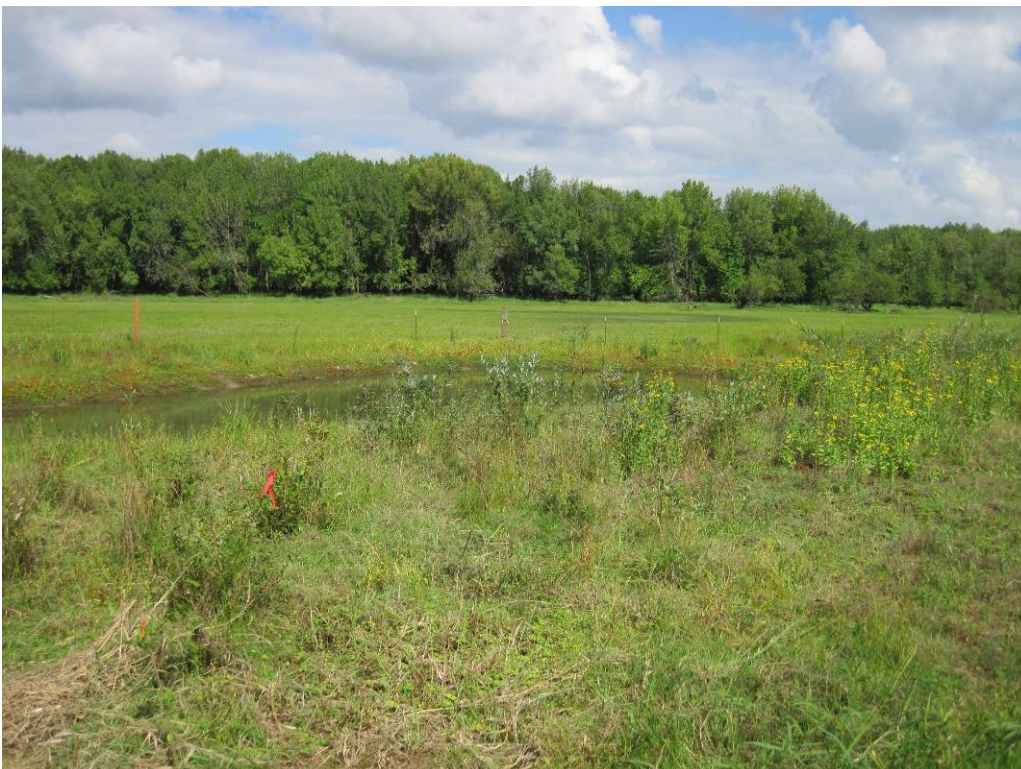
Photograph 2 – Emergent area of wetland with a forested riparian area developing in the foreground, in contrast to the established forested and scrub/shrub plant community in the background (taken from Photo Point P1, view looking north).

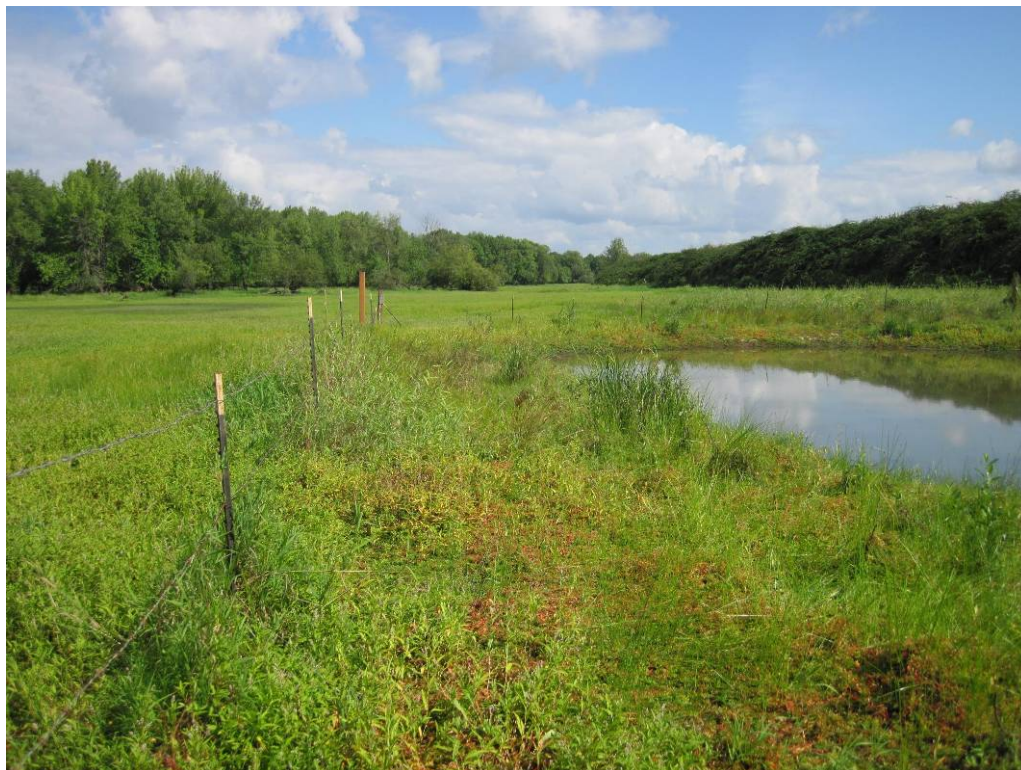
Photograph 3 – The primarily emergent plant community along the edge of the open water from photo point P2 (view looking northeast).

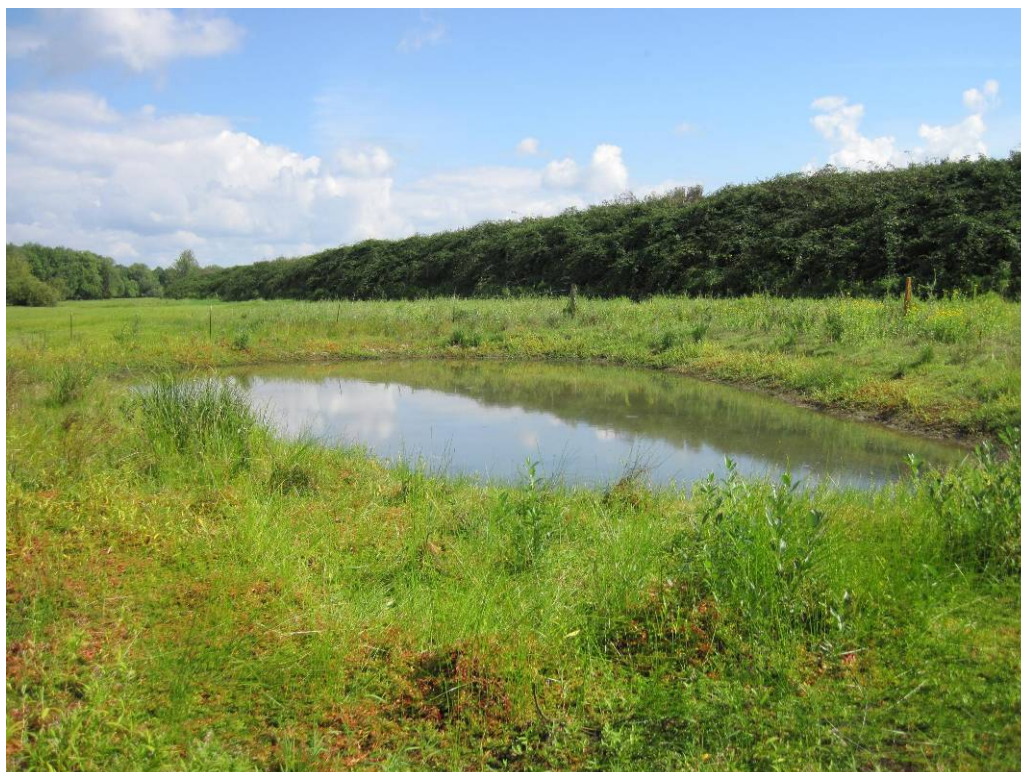
Photograph 4 – An overview of the mitigation site from photo point P2 (view looking east).
