## TECHNICAL MEMORANDUM

**DATE:** December 14, 2012

**RE:** **Landfill Cap Inspection**  
**Santosh Landfill Site**  
15563-03/Task 3

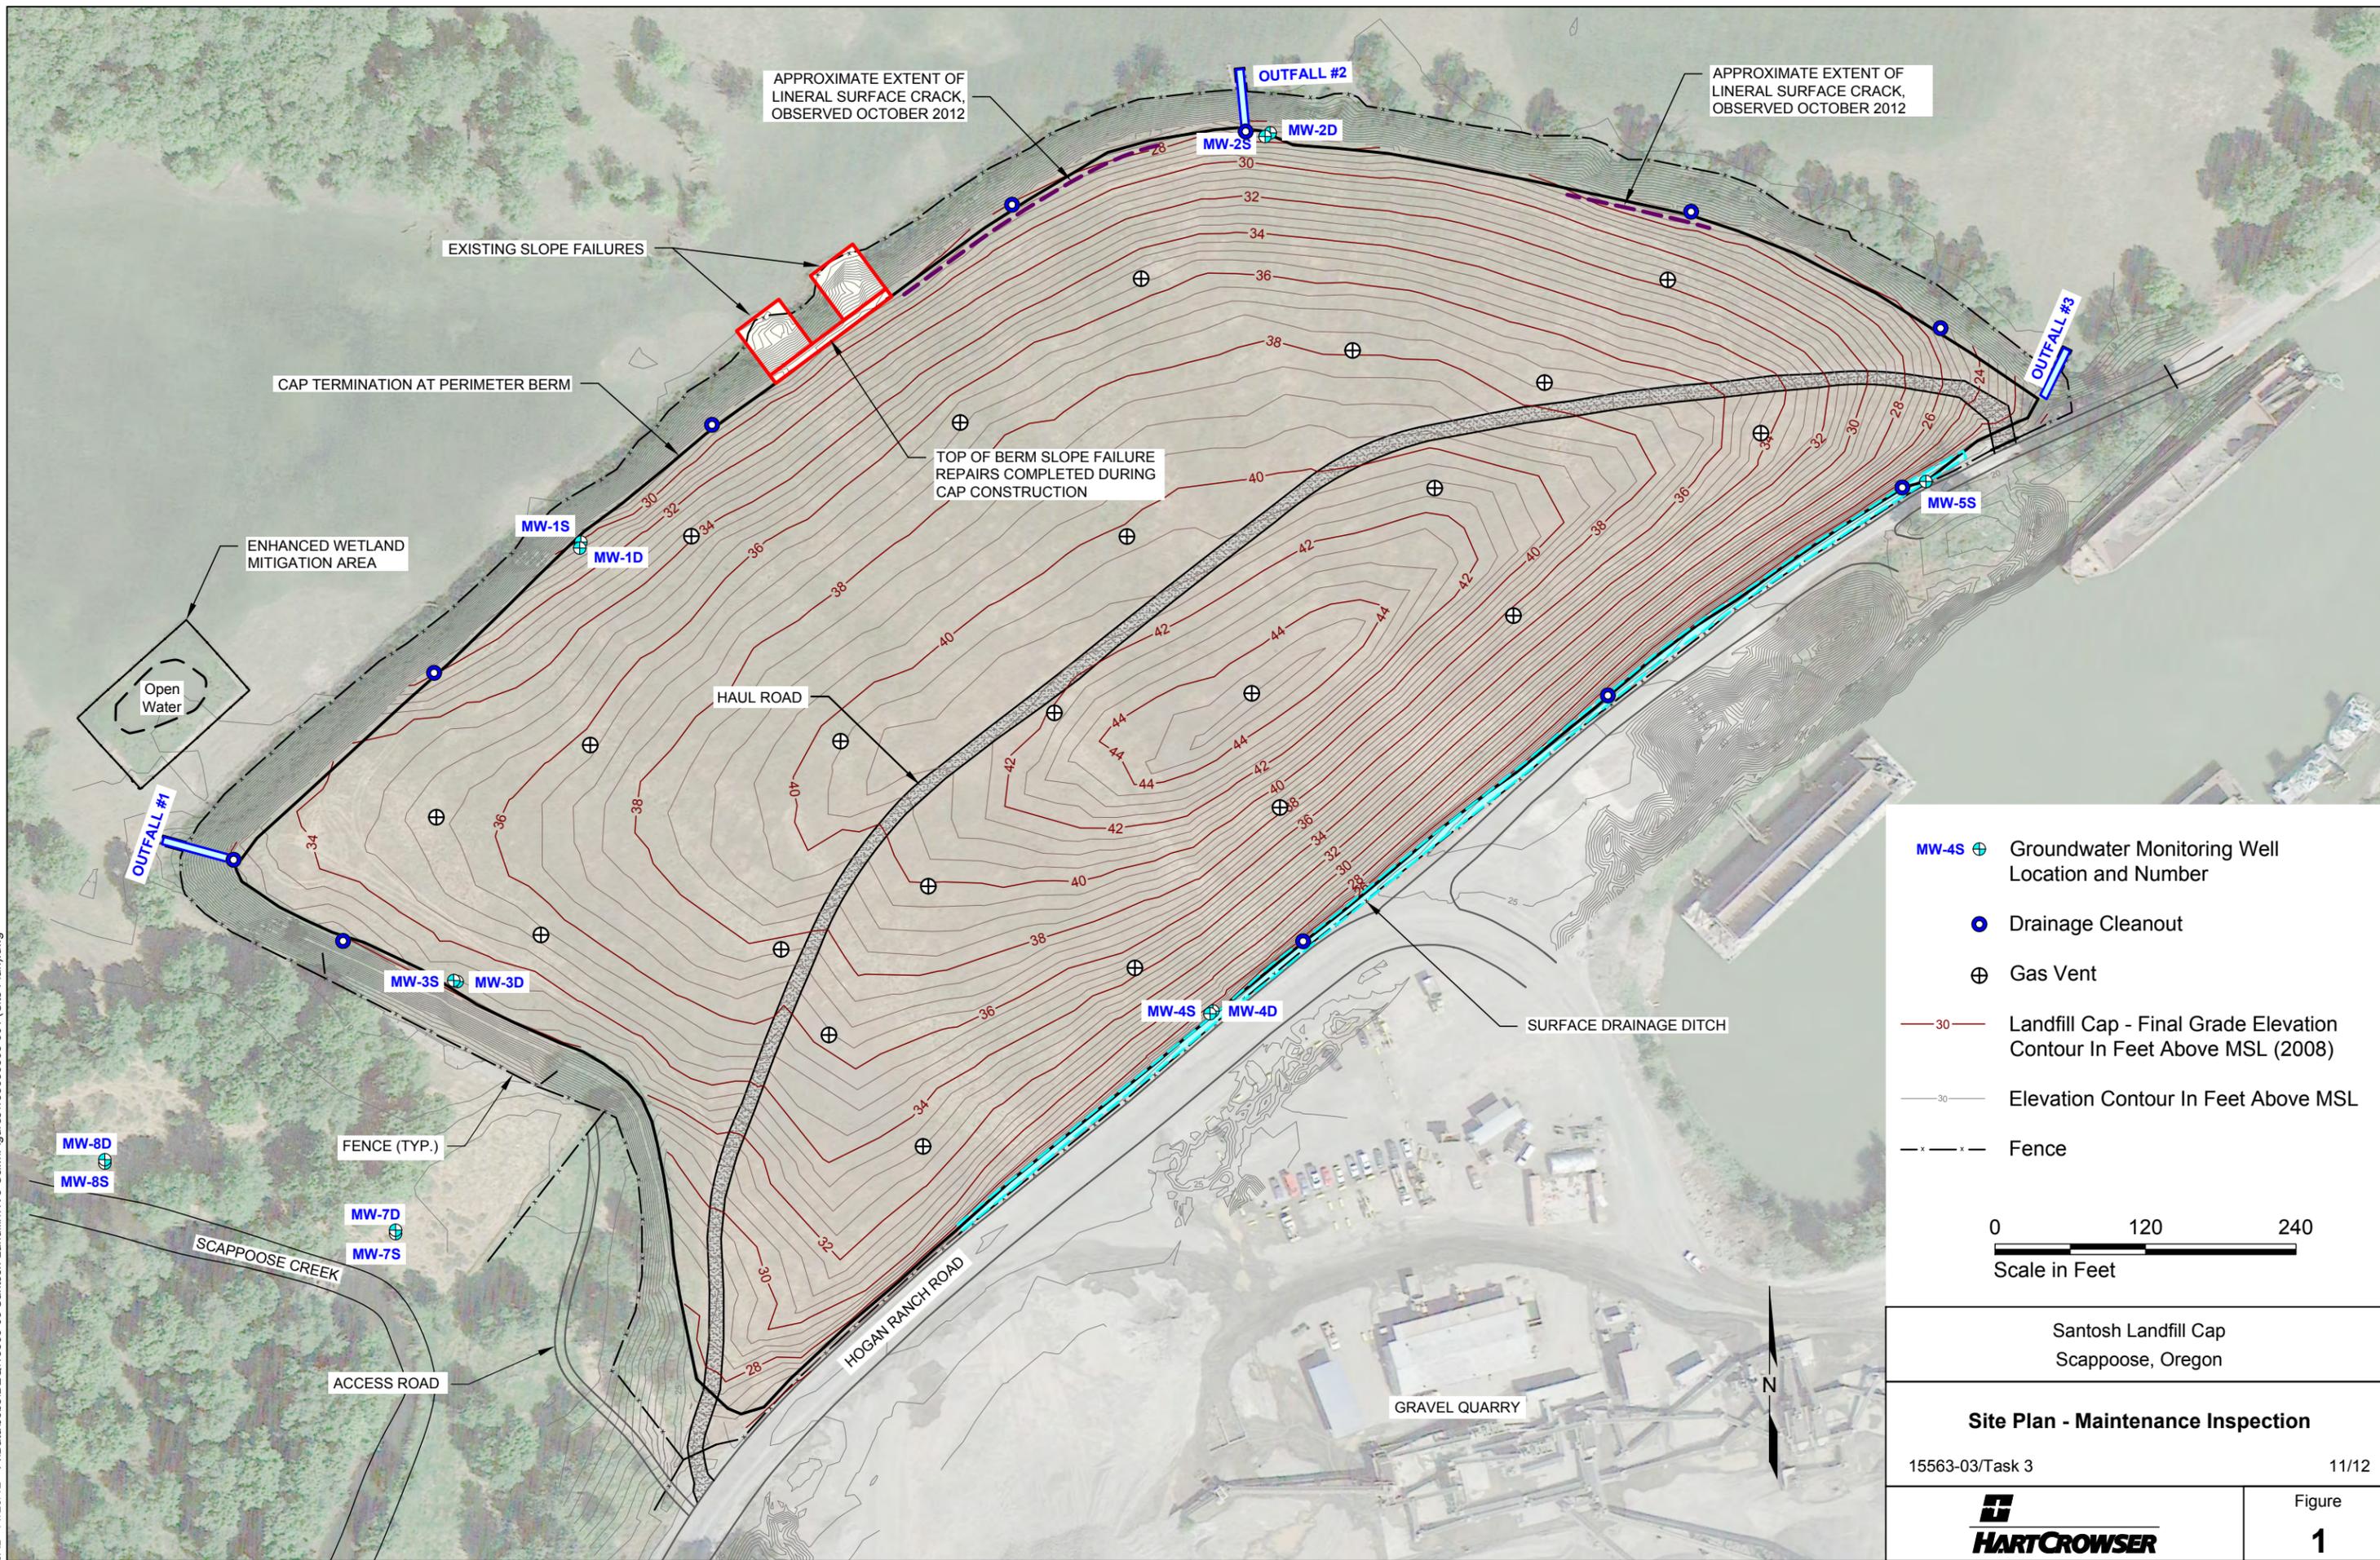
<b>HARTCROWSER</b>	Figure <b>1</b>

Linear cracks on the top of the berm along segments of the northern boundary of the landfill were observed (Figure 1, and Photographs 5 and 6). The cracks run parallel to the landfill boundary approximately two feet back from the top of the berm. These cracks are located where the original construction silt fence was partially buried, and were first observed during removal of the silt fence. A probe indicated that the cracks are up to two feet deep in some areas which is deeper than the silt fence would have been buried. The cracks do not directly indicate an unstable condition in the cap, but they provide a potential for surface water runoff to accumulate at the top of the slope. This could cause the cracks to get wider and deeper, and could therefore create a problem in the future.

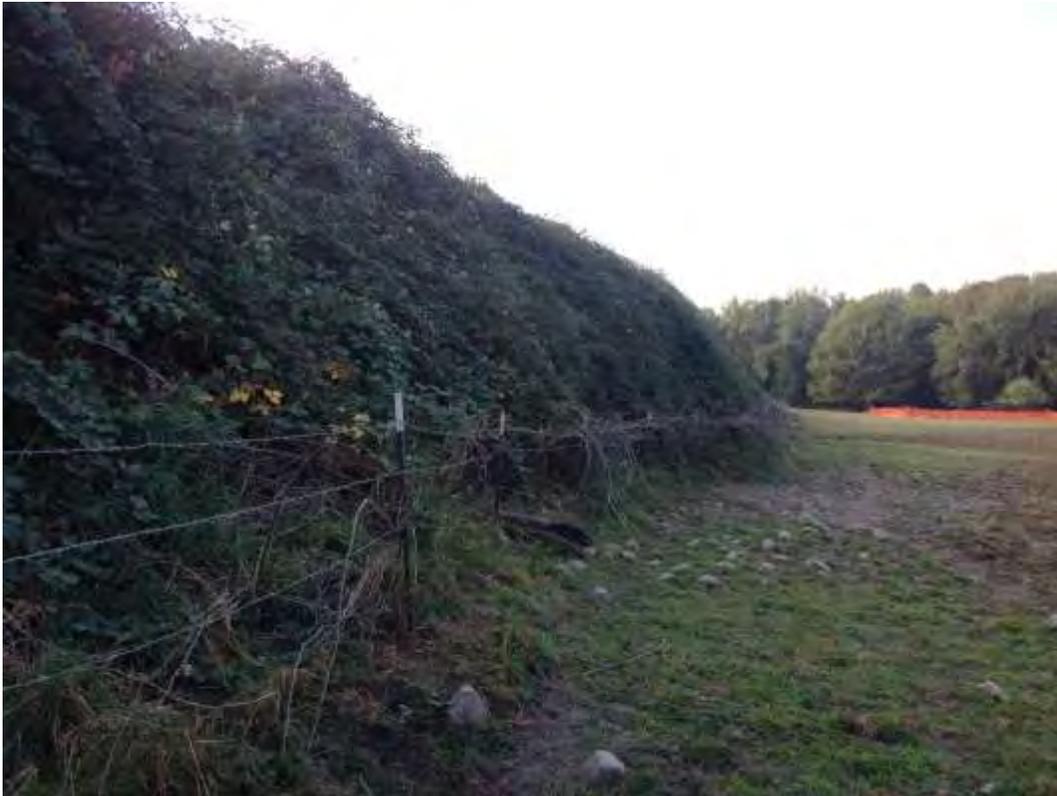
Observers walked along the bottom and around the top of the landfill berm to look for signs of slope instability or failure. Based on observations made during the site visit, the slope appears to be in generally similar condition to that at the end of construction (Photographs 1 and 2). Areas of slope failure were present along the northern boundary of the landfill (Figure 1, and Photograph 2). These failures were present in 2008 prior to the construction of the landfill cap and appear to have remained stable since that time. No evidence of recent slope failures was observed during the visit, although dense brush prevented a complete observation of the entire slope.

Photograph 1 – Typical slope on northern boundary of landfill berm.  
Photograph taken facing west.

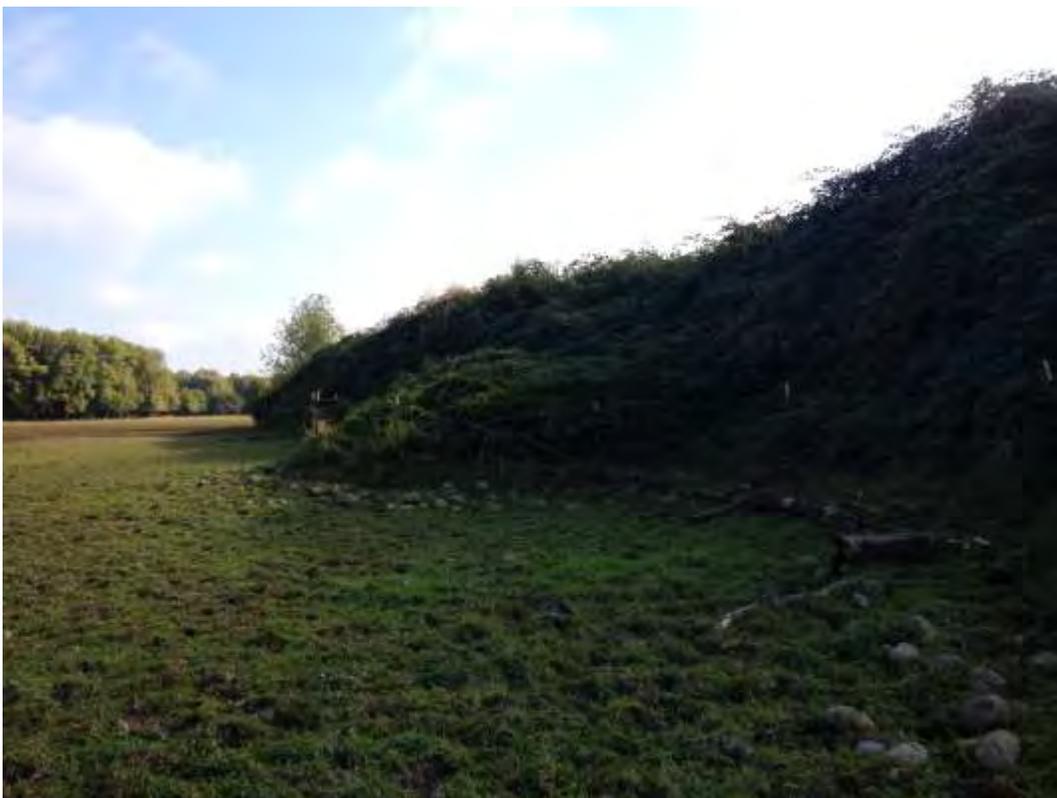
Photograph 2 – Typical slope on northern boundary of landfill berm showing  
existing slope failure. Photograph taken facing east.

If a segment of the linear crack along the northern edge of the landfill cap is observed by field staff during future inspections, it should be filled in with a low permeability material such as clayey soil or bentonite and compacted to the extent practical at that time. Since the inspection, staff from the DEQ and Hart Crowser have visited the site and filled portions of the crack with dry bentonite granules and bentonite slurry although the entire length of the crack could not be observed at that time (Photograph 10). Since the landfill is constructed within a wetland area and water levels can submerge a large portion of the landfill slope, periodic inspections of the slope toe should be conducted after periods of high water.

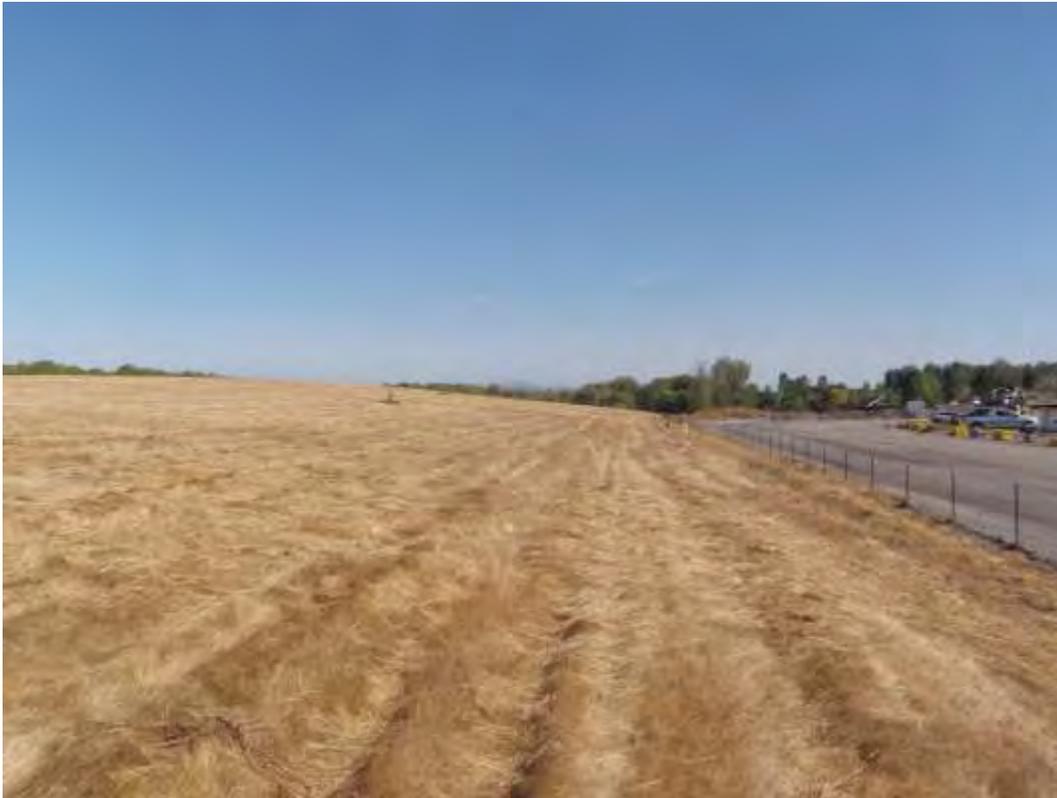
The surface of the landfill cap was inspected for significant surface depressions and tension cracks by the team. The cap was inspected by walking the perimeter and slowly driving through the middle of the landfill. No depressions or tension cracks were observed during the site inspection (Photographs 3 and 4).

Photograph 3 – Typical landfill surface, no depressions observed. Photograph taken facing northeast.

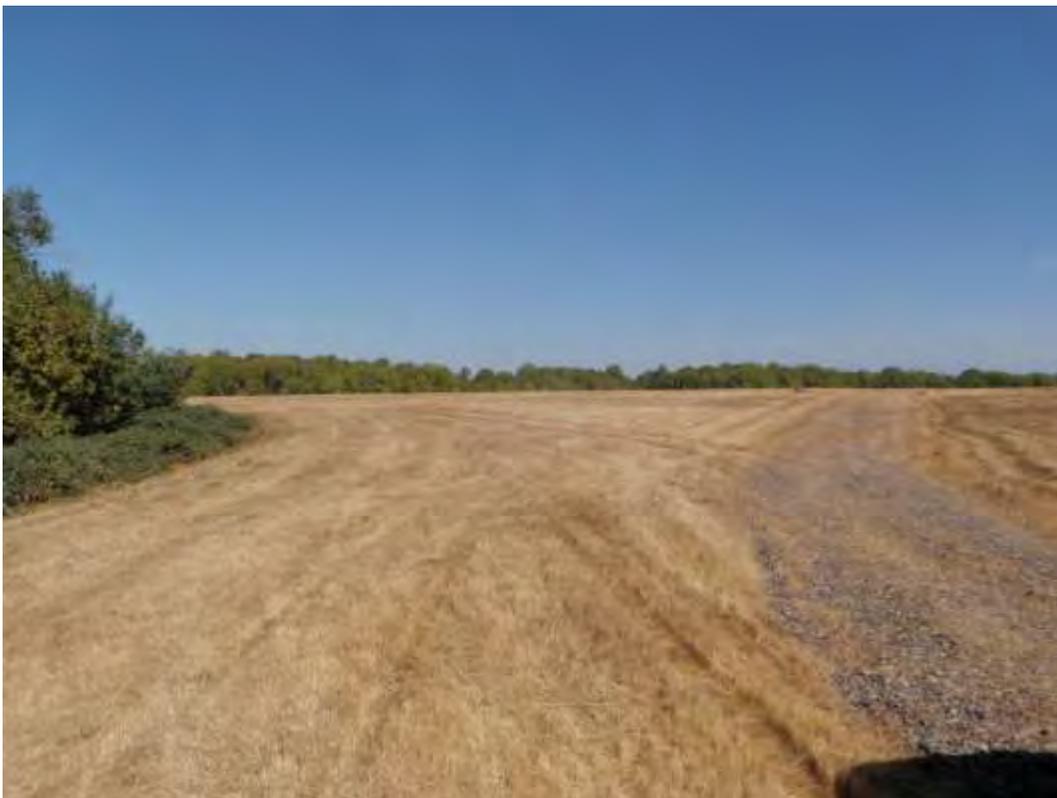
Photograph 4 – Typical landfill surface with haul road to the right. No depressions observed. Photograph taken facing north.

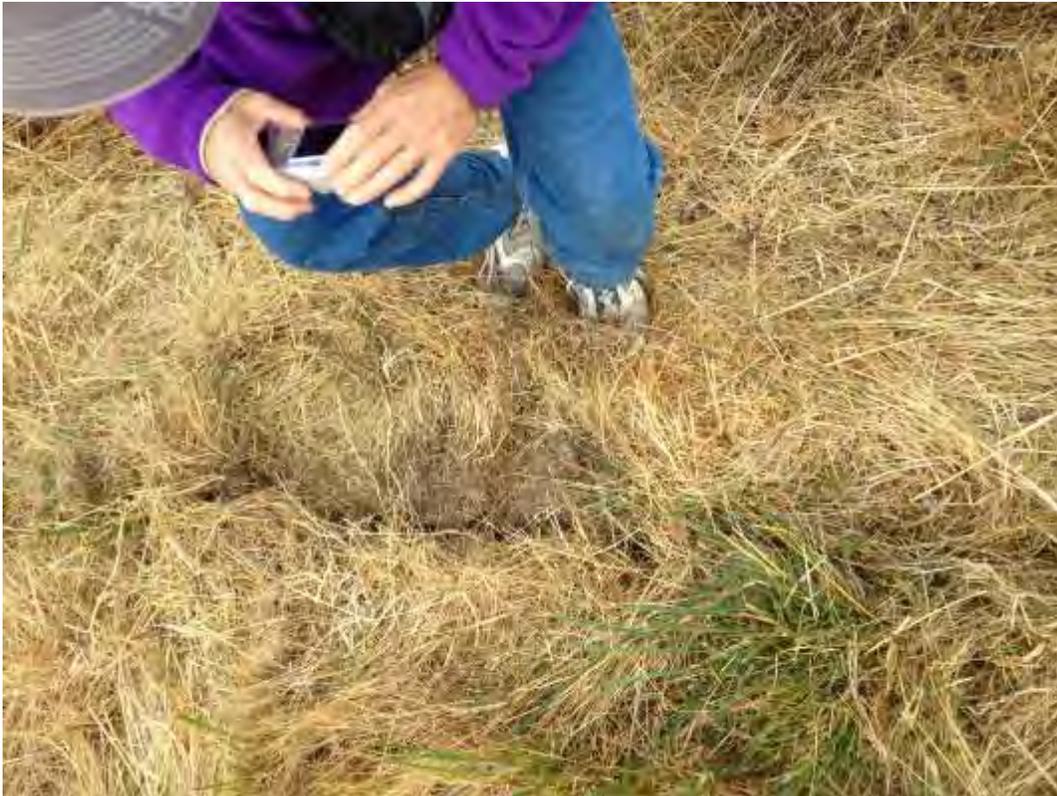
Photograph 5 – Linear surface crack observed along northern landfill boundary.

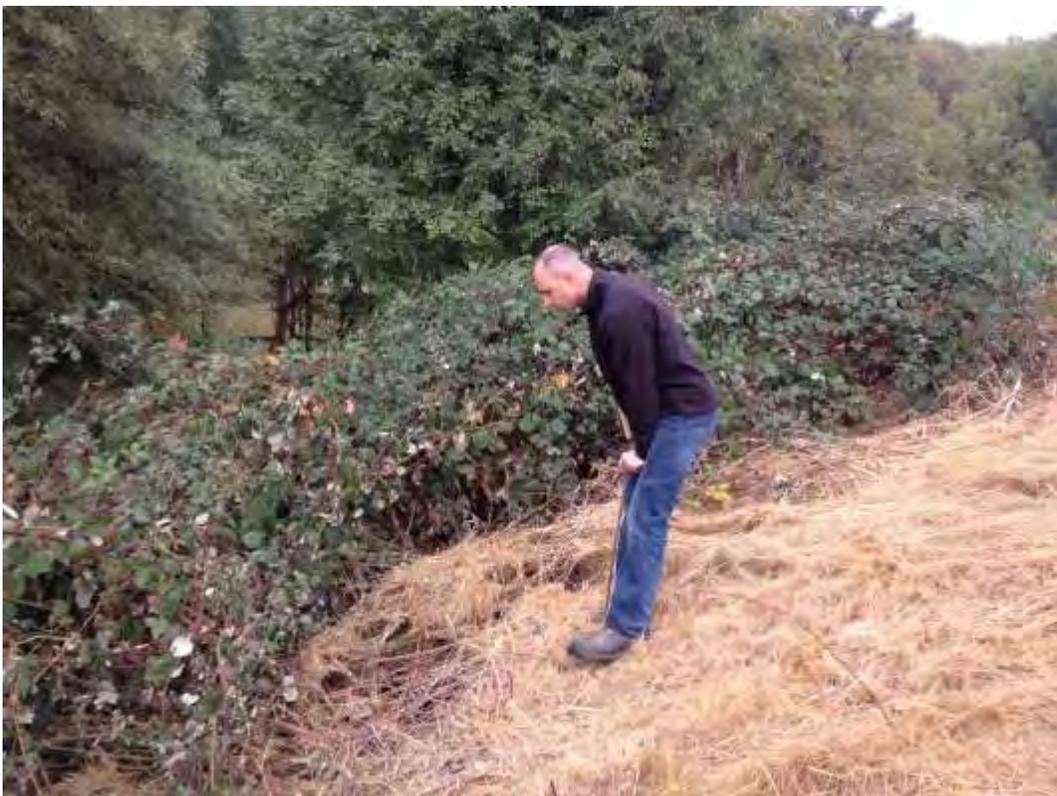
Photograph 6 – Checking soil conditions and the depth of the linear crack using a foundation probe. Photograph taken facing northeast.

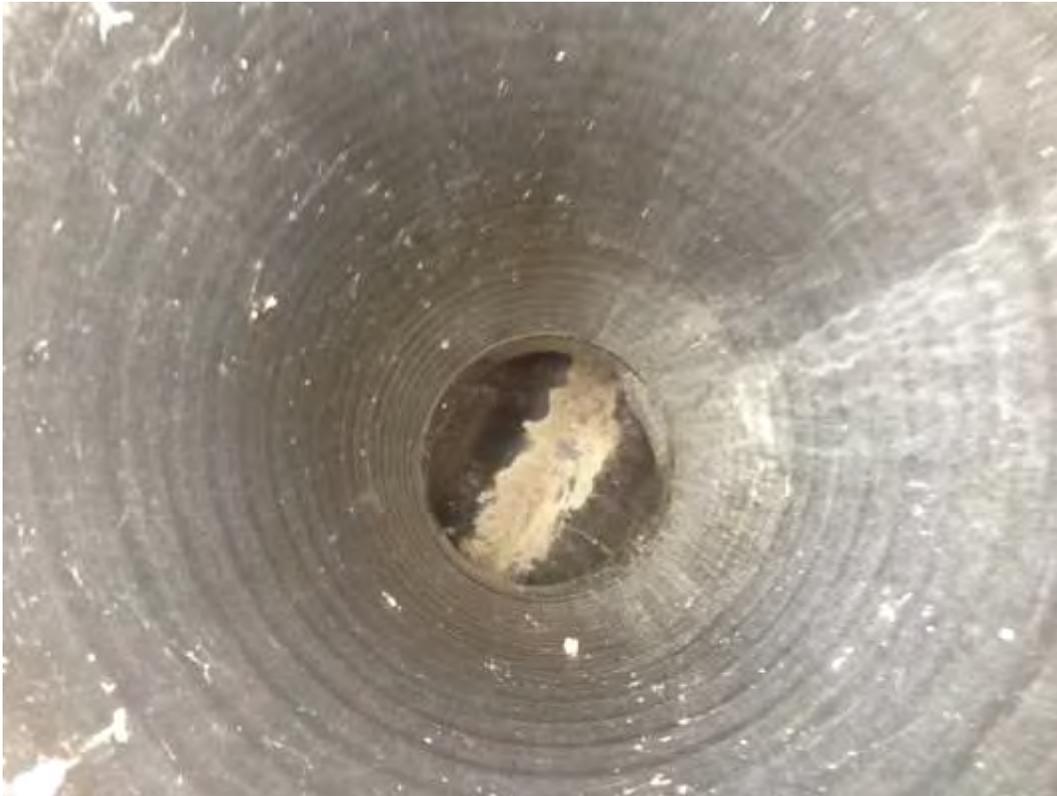
The condition of the drainage system was observed by opening stormwater cleanouts installed on the surface of the landfill to check for sediment accumulation within the conveyance piping. Observers also walked along the open drainage ditch and checked the drainage outfalls for blockage. No signs of failure or blockage within the drainage system were observed during the site inspection (Photographs 7 and 8).

Photograph 7 – Minor sediment accumulation observed within stormwater drainage conveyance system. Photograph taken looking down stormwater drainage system cleanout.

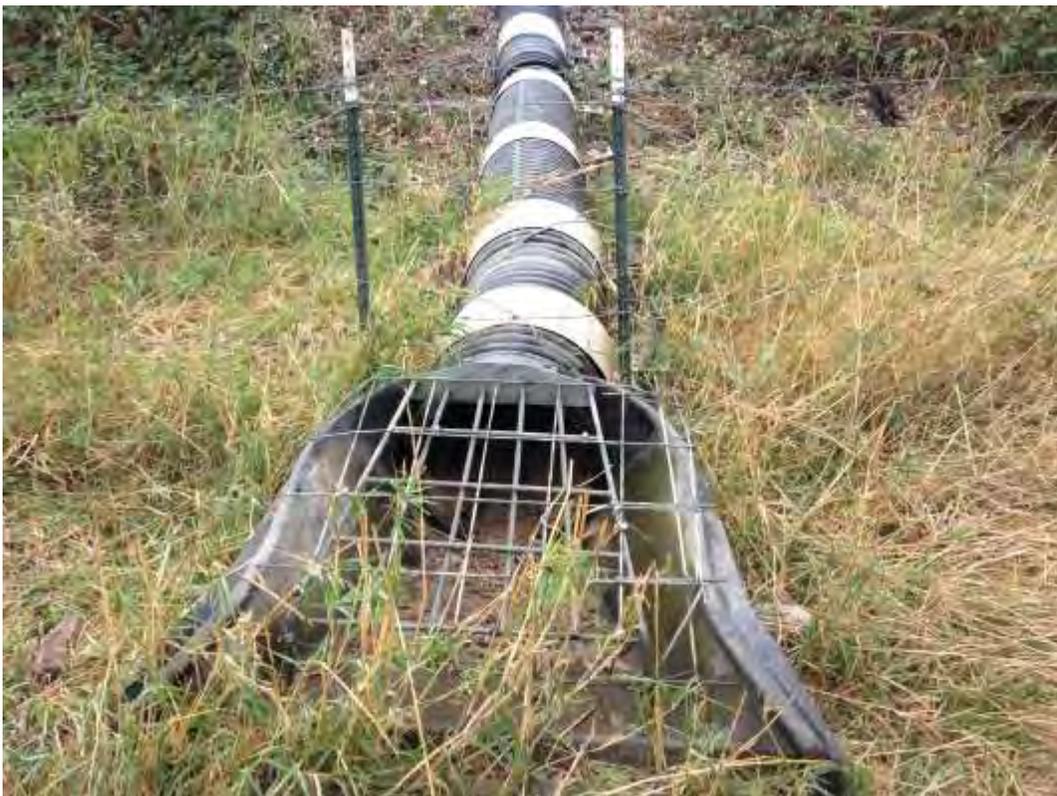
Photograph 8 – Minor accumulation of debris observed at stormwater drainage outfalls. Photograph taken facing south.

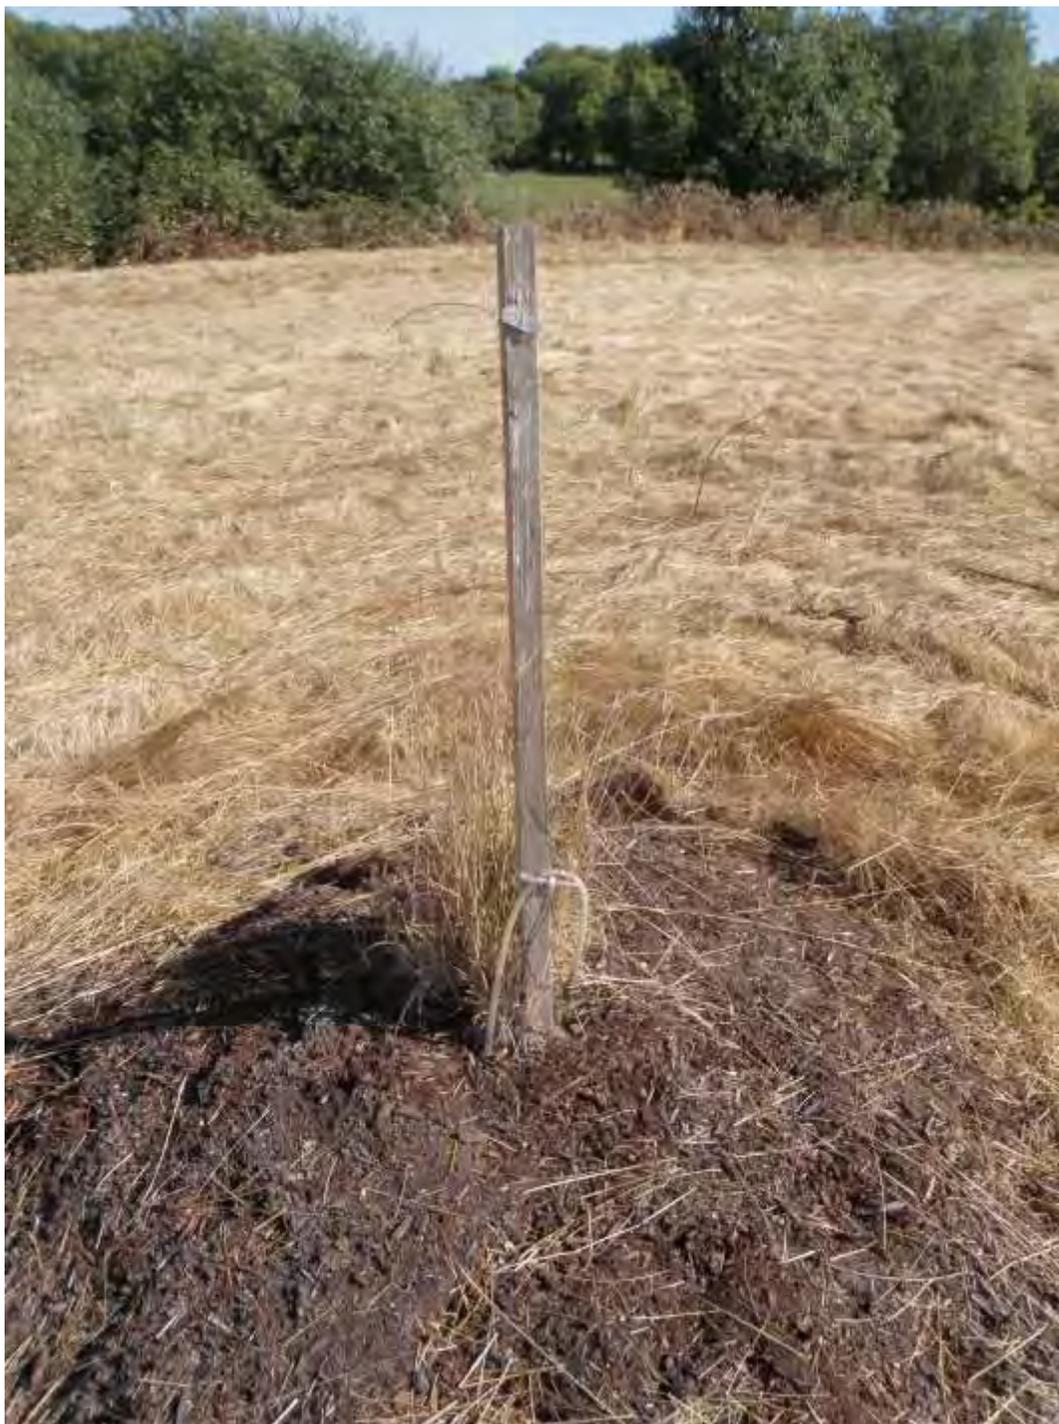
Observation of the methane venting system included checking surface vents for damage and a loss of filter medium. Vents were inspected while the team walked along the landfill cap and while slowly driving across the cap. Only the bark filter medium and sample ports can be observed from the surface. From our inspection of the methane vents, they appear to be in good condition with no damage observed (Photograph 9).

Photograph 9 – Typical methane vent as seen from the surface of the landfill.  
Photograph taken facing east.

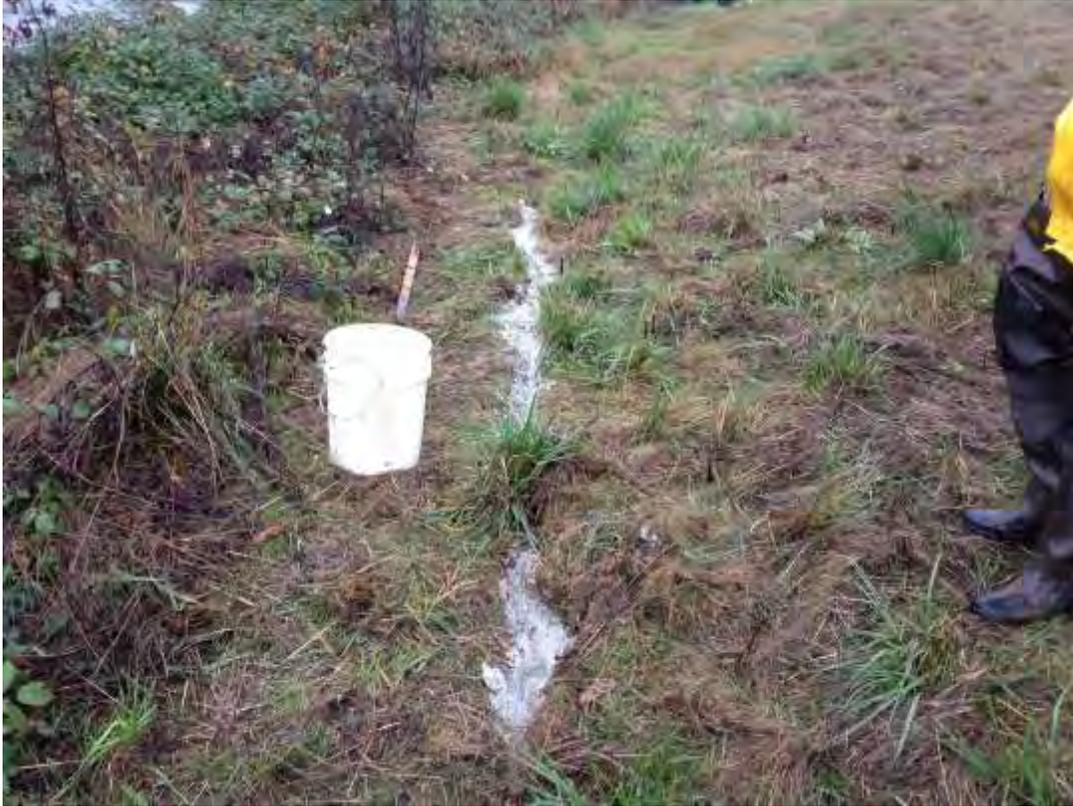
Photograph 10 – Section of linear crack along northern boundary of the landfill with bentonite slurry added. Photograph taken facing east.
