Bethel/Danebo monthly report

Bethel-Danebo Closed Landfill Progress Report

For April 2017

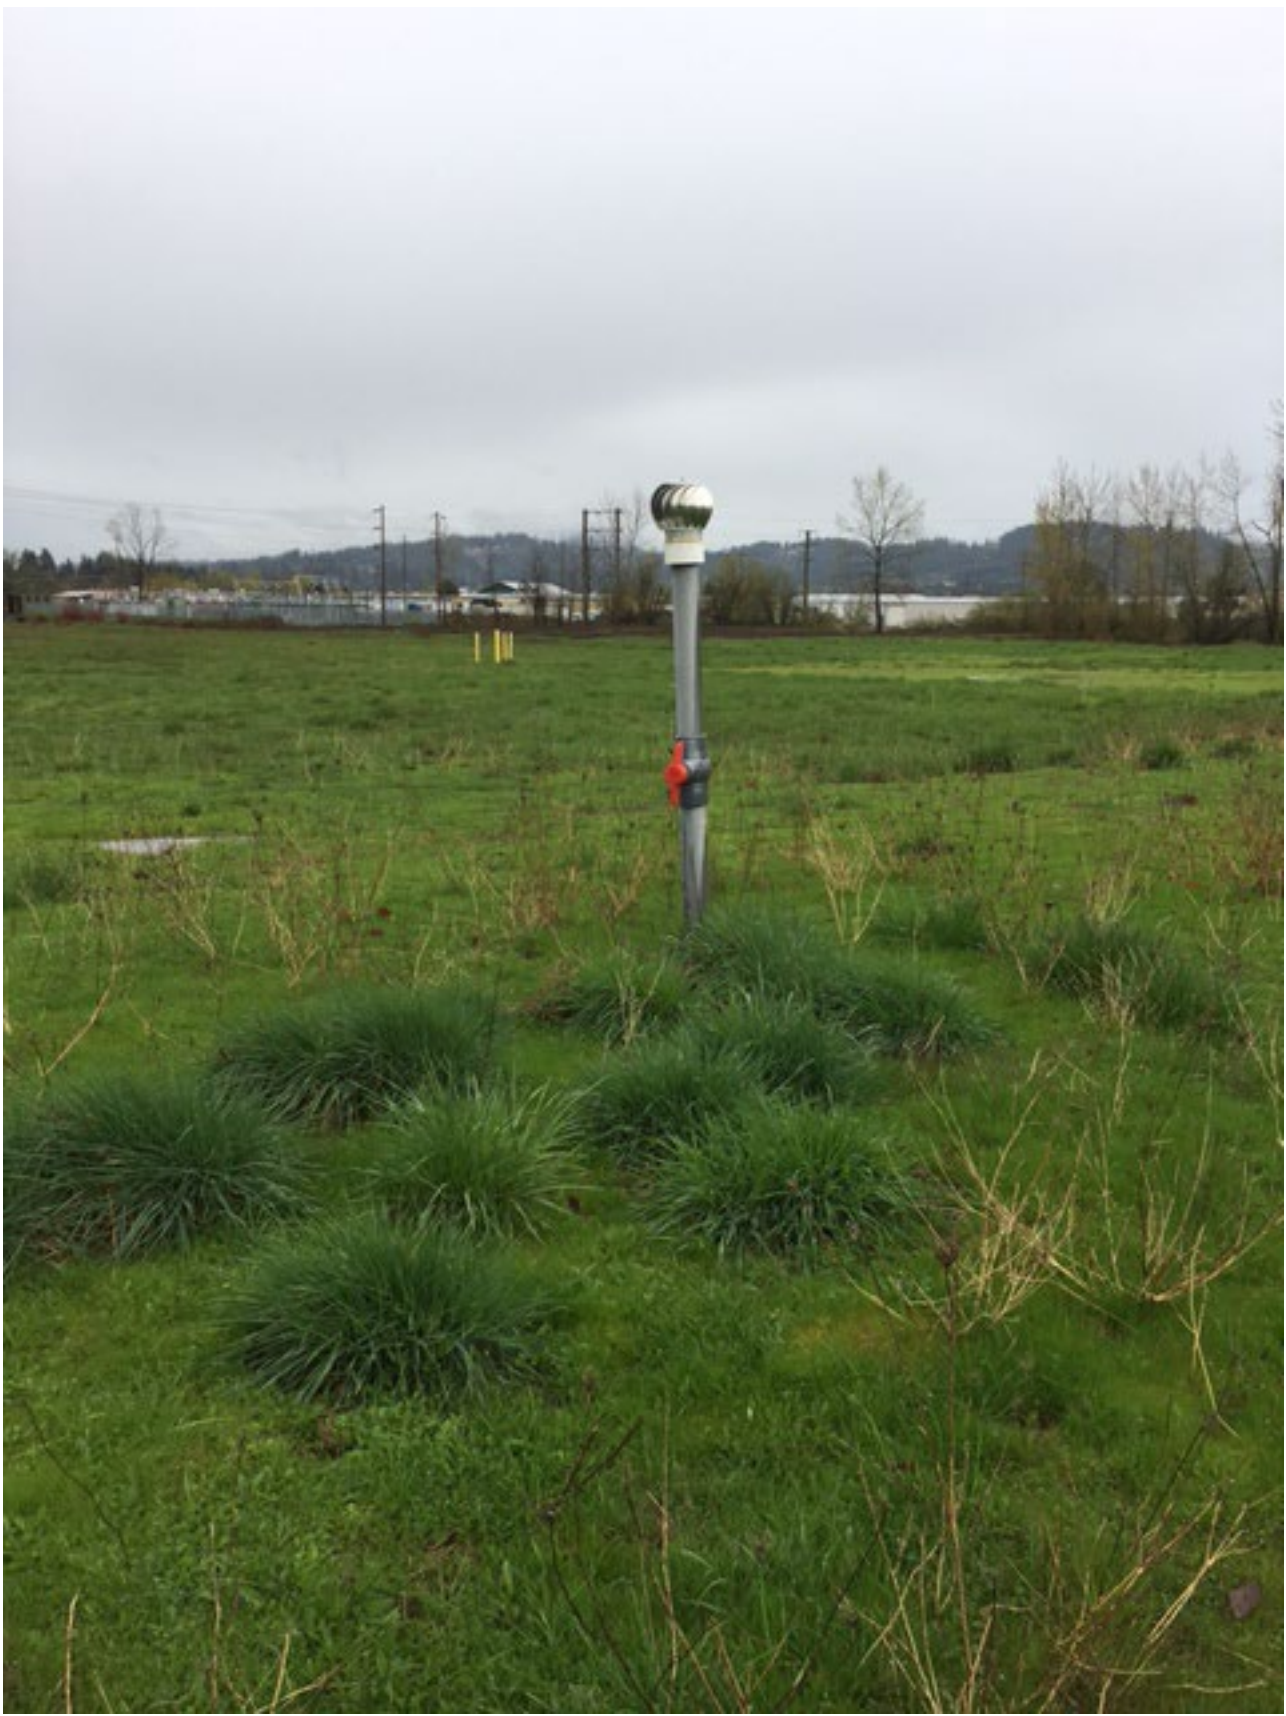
- There was standing water pulled in a large portion of the southern part of the site. Surface mount wells were flooded in the casings.
- One of the passive vent risers on the southern side of the trench had the valve completely open. This reduced vacuum in the trench significantly and could have contributed to higher readings? I am not sure how long the valve was open. We might consider cutting the valves out and capping the risers. It is unlikely that we will passively vent the trench any time in the near future. Picture attached.

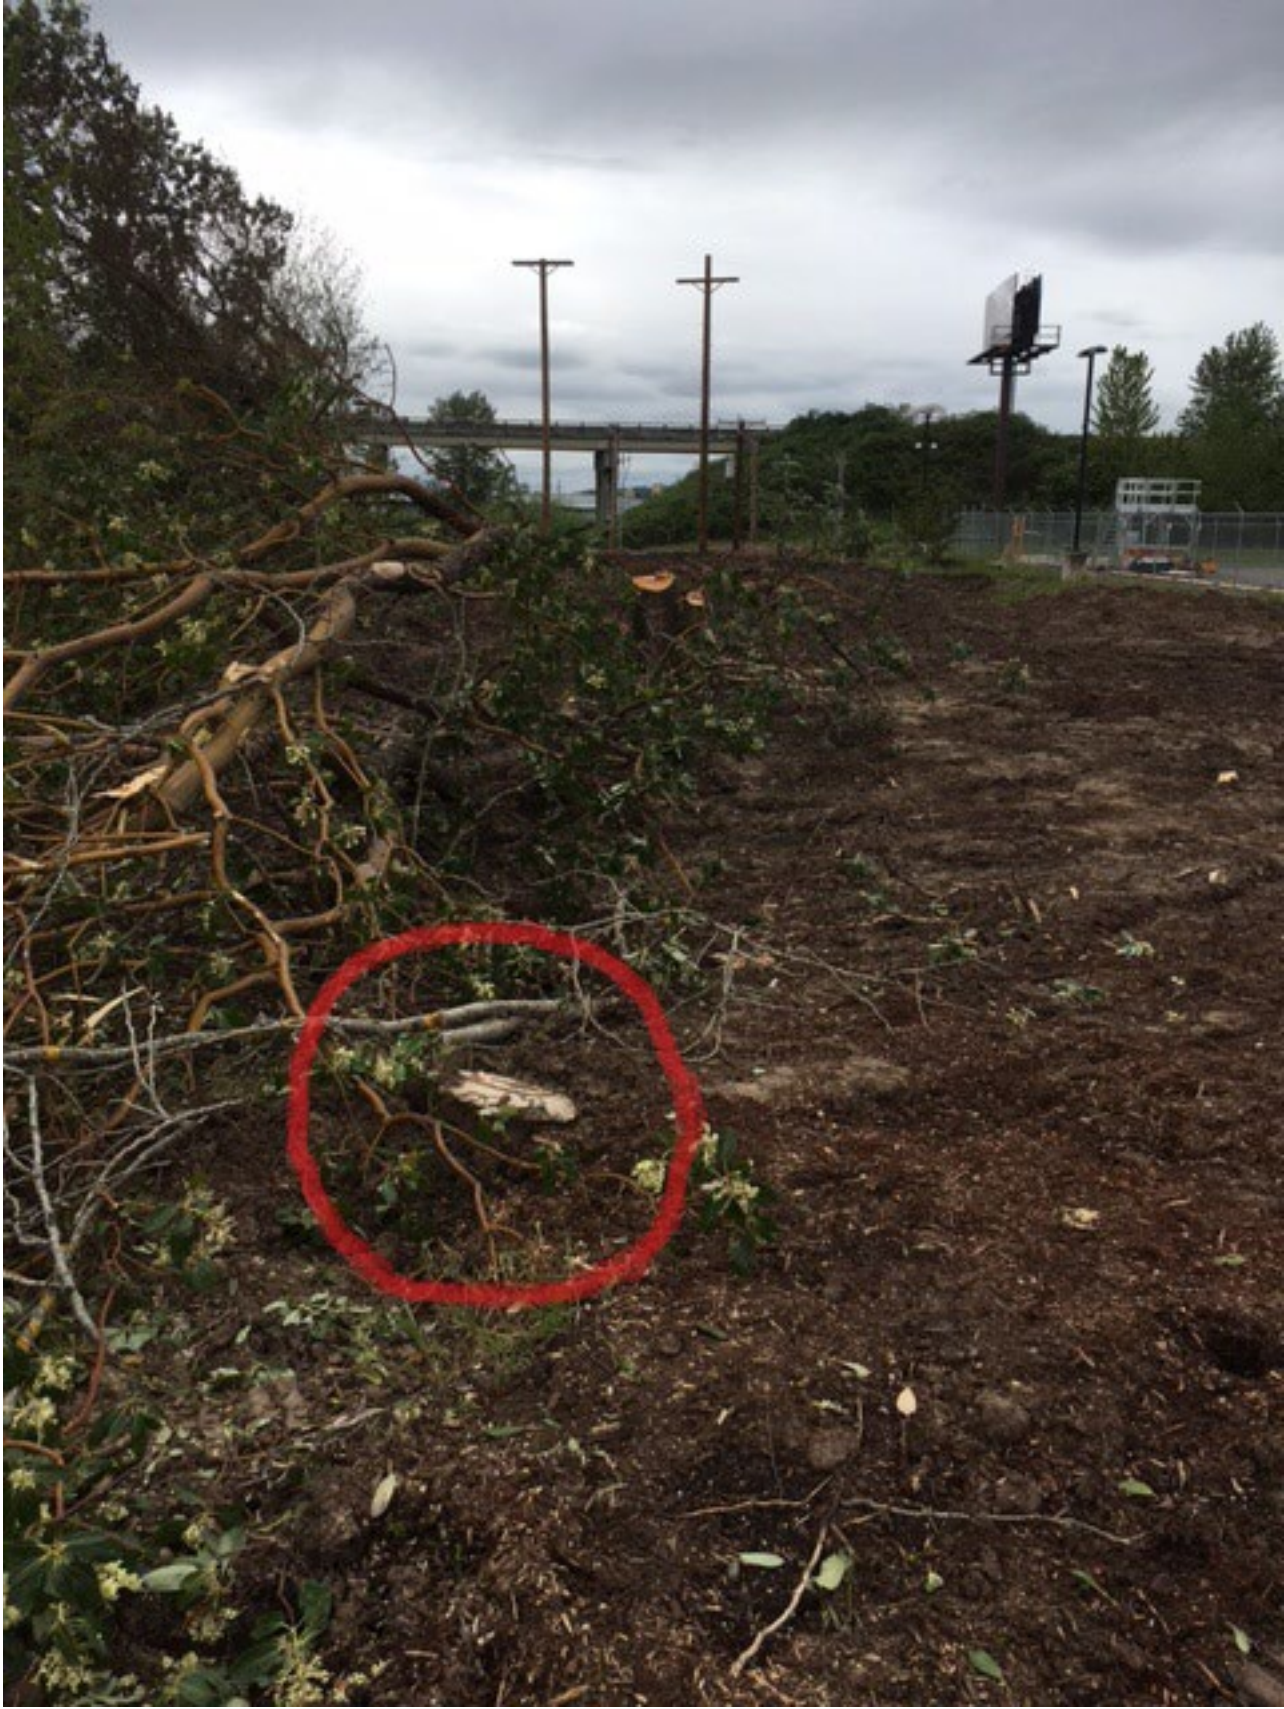
- LC15GP01 was hit with a bulldozer by a EWEB landscape crew falling trees and clearing brush in the area. They also took out a waterline and irrigation. I believe the probe is compromised and should be decommissioned. Picture attached.

- Continue sampling schedule.
- Site review.
- Decommission LC15GP01
- Cap vent risers.
