August 26, 2025

RE: DEQ Review – 2024 Biennial Report  
University of Portland Franz River Campus  
ECSI #277

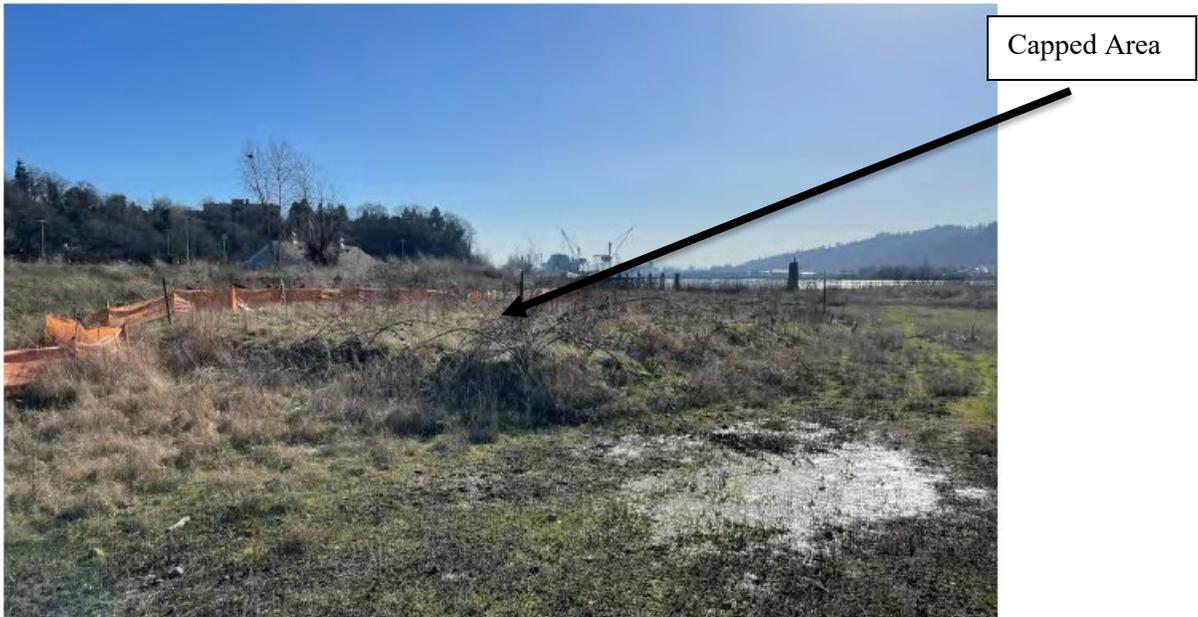
- 3) Cap Monitoring Report, January 28, 2023: Item #4 indicates that no ponding is occurring on capped areas. However, Photo F appears to show ponded water. Please clarify whether Photo F is showing ponding on a capped area.

*Photo F is not showing ponding in a capped area. The capped area in this photo is the higher topographic 'bump' shown in the photo, near but beyond the ponded water.*

Photo F – Upland caps remain undisturbed January 2023

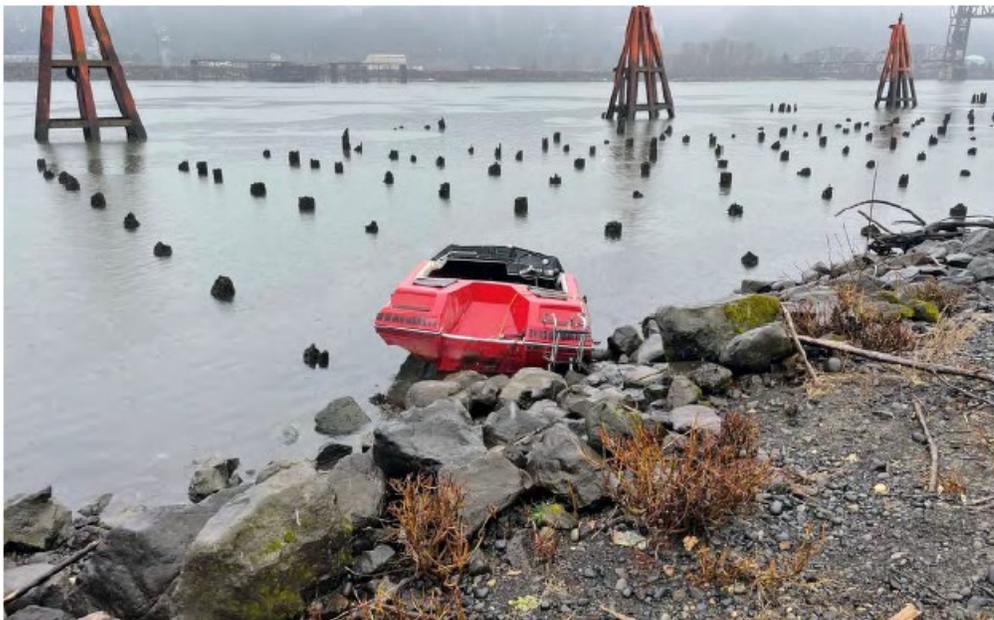
- 4) Cap Monitoring Report, February 29, 2023: Photo B shows an abandoned boat grounded along the shoreline. Please clarify whether the boat resulted in any damage to the shoreline cap, whether any sheen was observed from the boat, what happened to this boat following this monthly inspection, and whether there is a corresponding Oregon Emergency Response System report number.

*No damage was noted and the boat's presence is beyond the toe of the capped area as indicated by the large rock present between the boat and the finer grained material on the shoreline. The boat was not observed after this inspection and presumed to have subsequently drifted back out with the tide if not removed by its owner or other responders from the river.*

Photo B – Abandoned boat grounded on northern bank February 2023

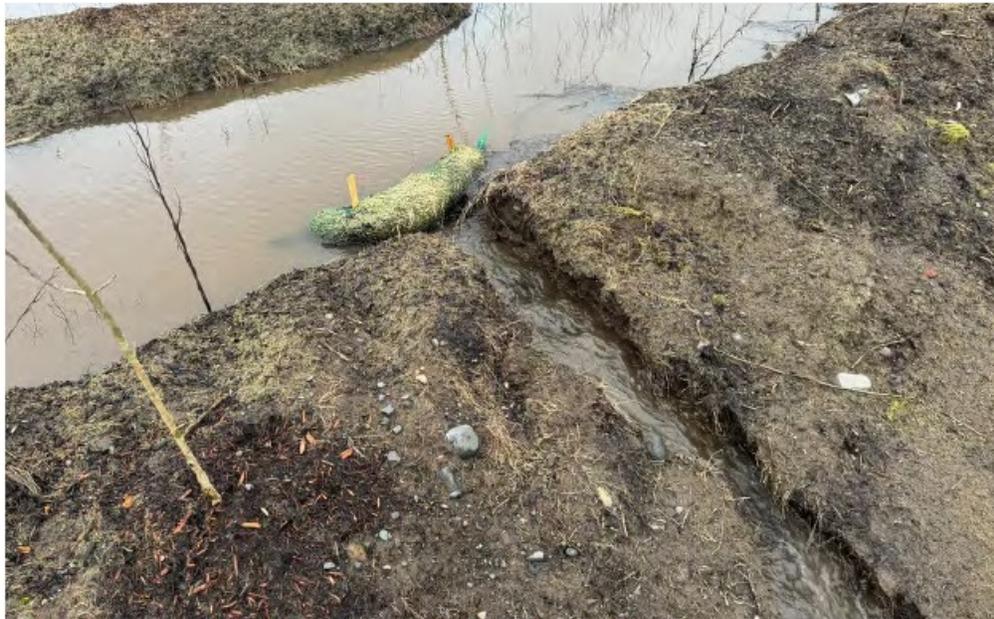
allowing stormwater to move beyond the top of bank and onto the riverbank. It is unclear whether any of that stormwater originated from upland capped areas and more information is needed to verify that is not the case (see General Comment #3 above).

*The photos show where stormwater from uplands outside of capped areas was beginning to run onto capped areas and warranted stormwater BMP improvements in the uplands to prevent damage to caps. As shown in Figure D this was shortly after new plants in the uplands areas were installed and becoming established.*

Photo A – Stormwater rill moving past top of bank February 2024.

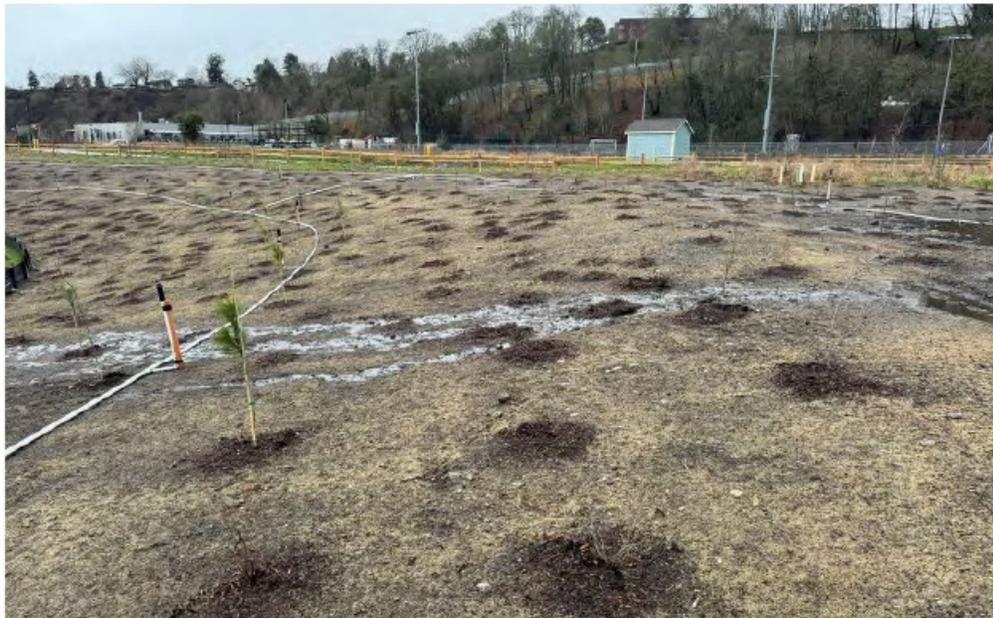
Photo D – Second area of stormwater moving past top of bank February 2024.

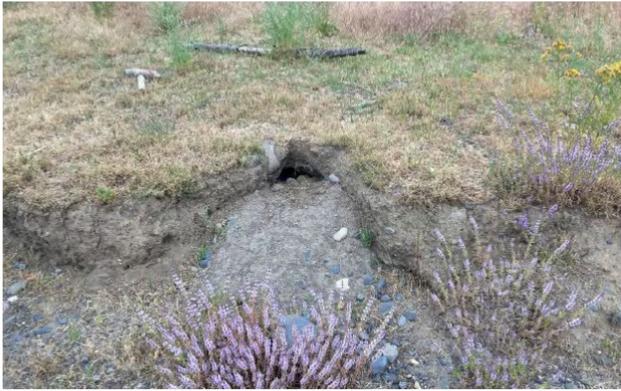
- 15) Cap Monitoring Report, June 28, 2024: This report first notes evidence of burrowing animals impacting the shoreline cap. However, according to subsequent reports, this repair work does not seem to have been completed. Please take action to address damage made to the cap by burrowing animals as soon as possible (see General Comment #2 above).

Burrowing mammal hole formation.

*Conditions remain unchanged and has not been observed to have increased in size. UP will fill the hole with clean sand and DOF will inspect as part of an upcoming inspection. Original photo included below for reference.*

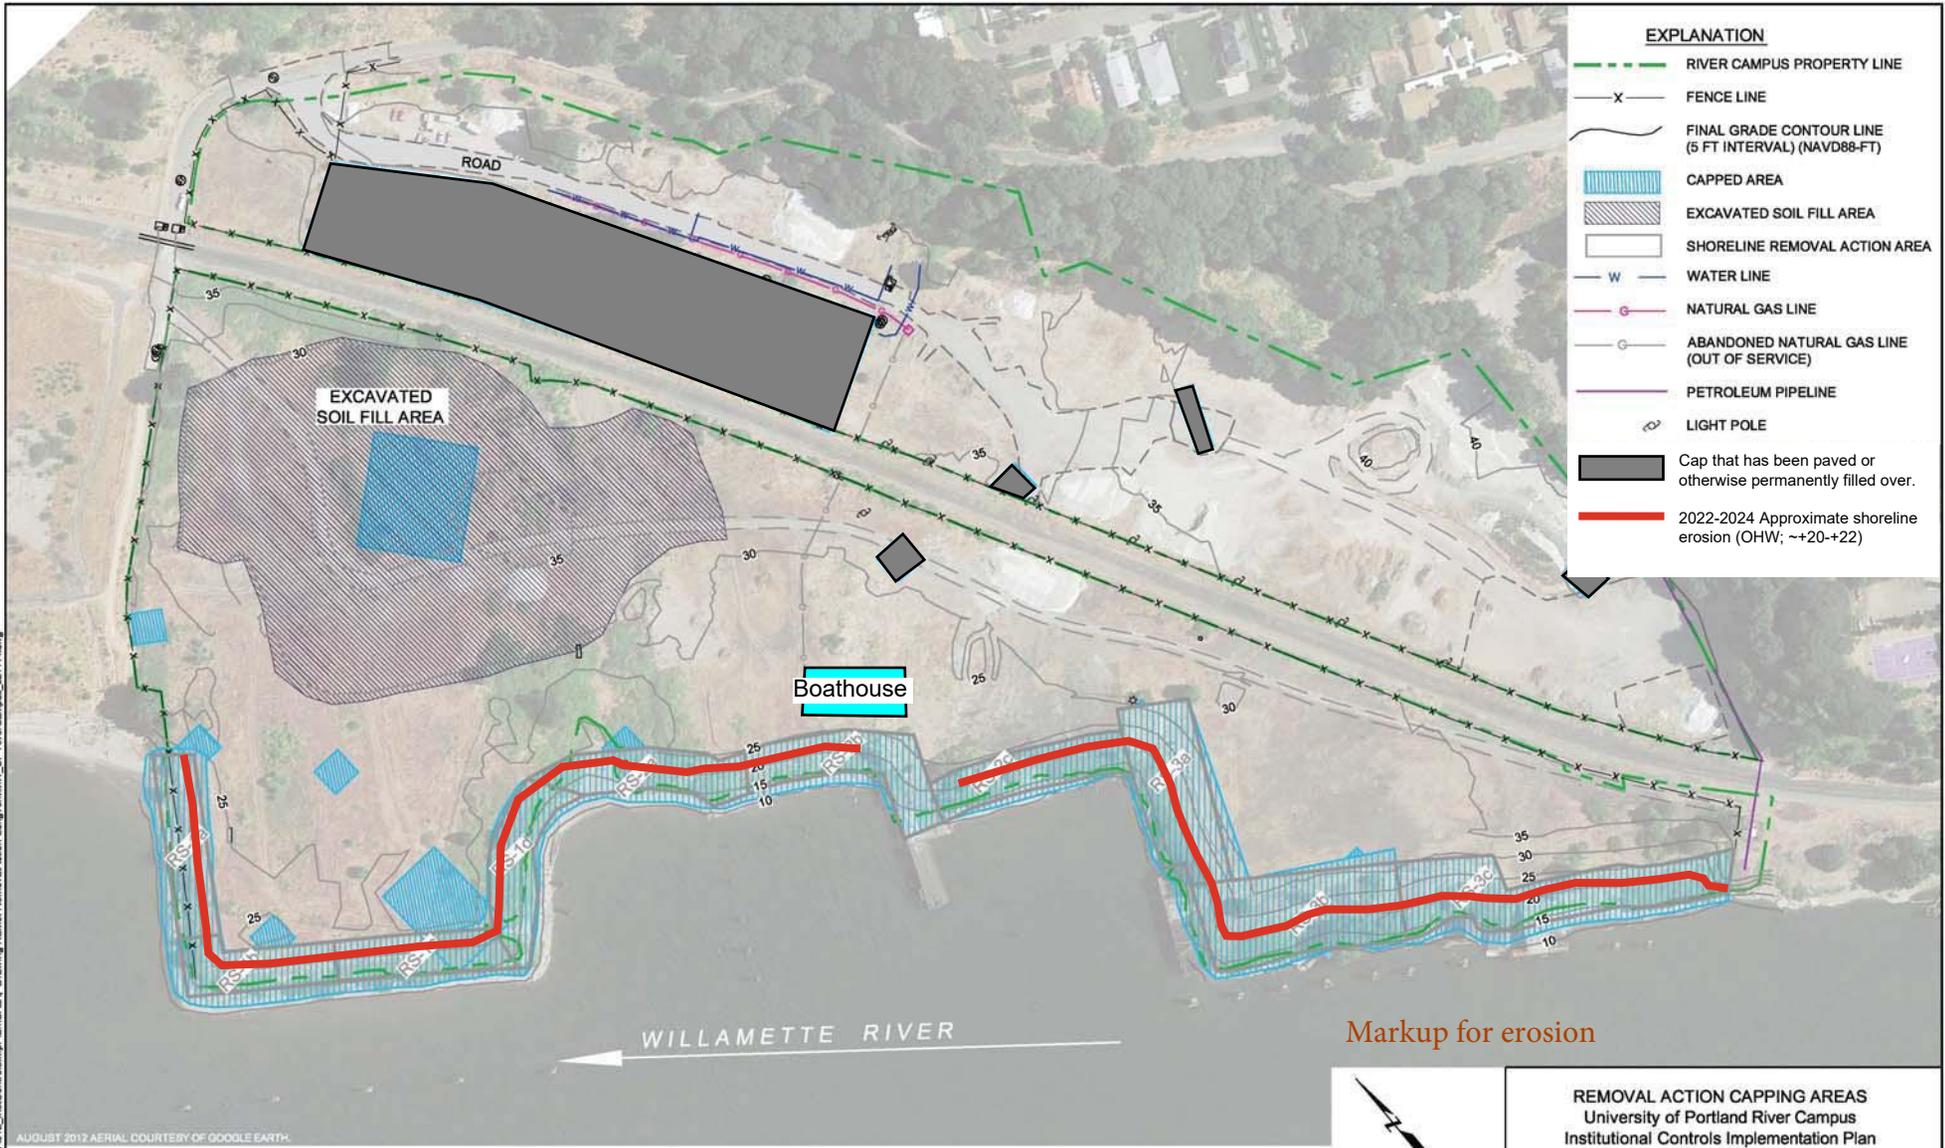
## **Map of approximate primary erosion noted 2022-2024**

*Approximate extent of erosion in the shoreline capped areas noted as of the end of 2022 and 2024 are shown on the attached map based on the visual inspections. Minor changes are noted in the monthly reports but has remained generally consistent over the past few years, with little in the way of observed new erosion.*
