Final Remedial Action Report

Former Astoria Marine Construction Company
DEQ Task Order 067-23-13
ECSI No. 1898
92134 Front Road
Astoria, Oregon

December 22, 2025

Maul Foster & Alongi, Inc.

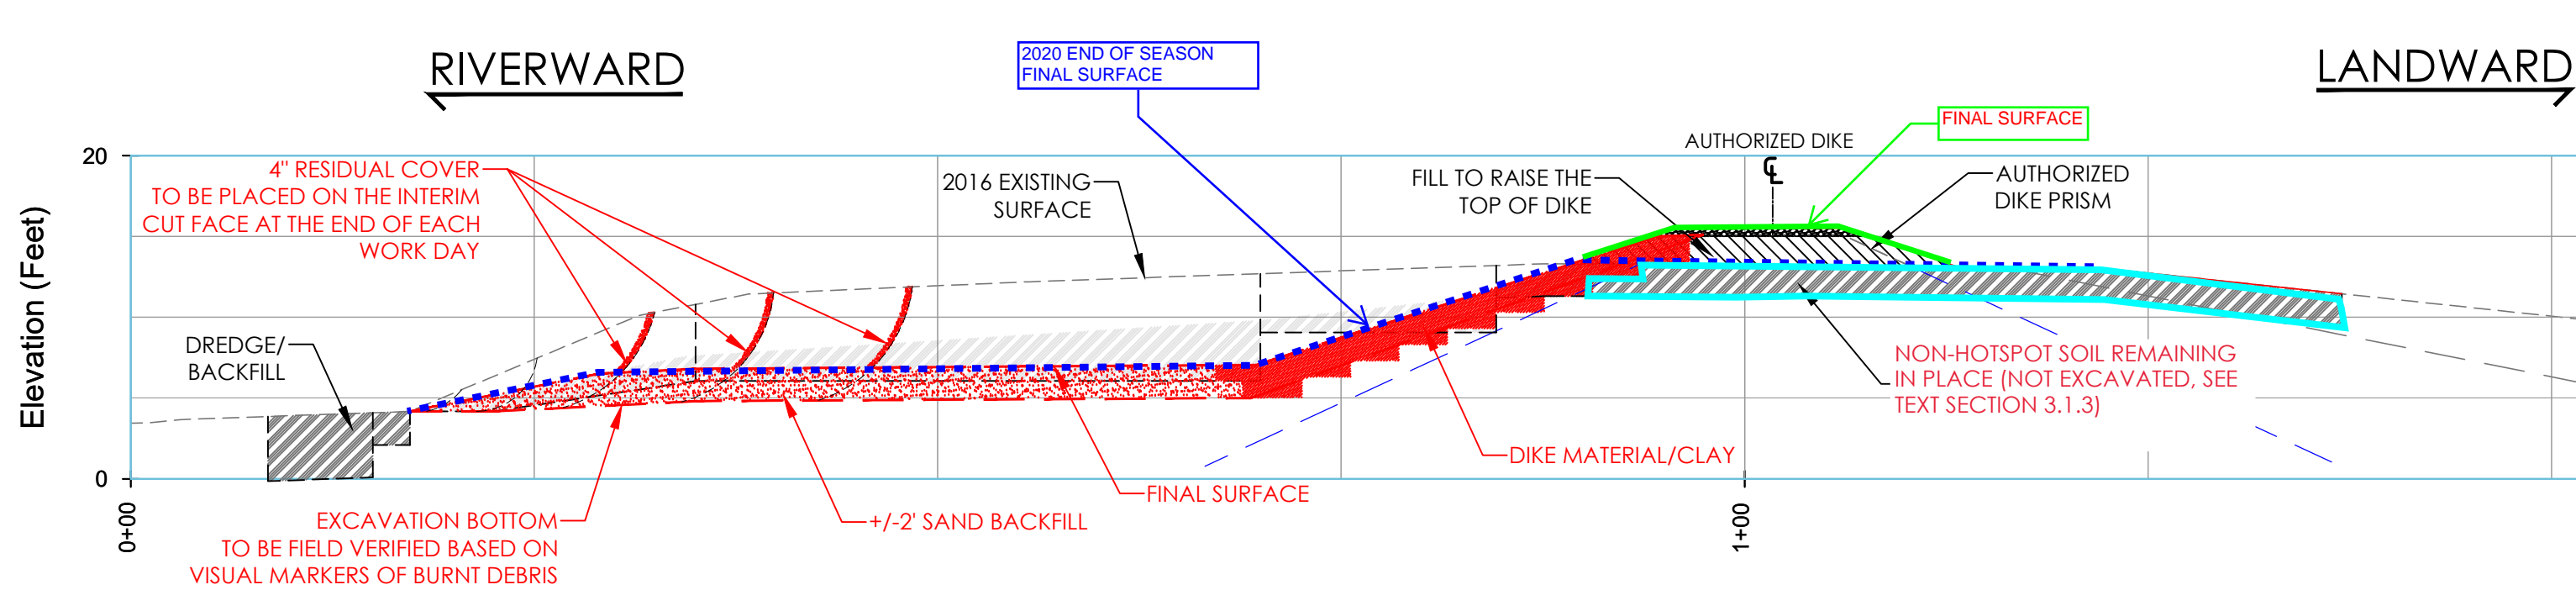
FIGURE 4-1 BURN PIT EXCAVATION DETAIL
 H:1"=10', V:1"=10'

The Upland Contractor initiated excavation from the northwest quadrant along the riverward dike face. Per agreement with DEQ¹, operators used visual markers—burnt debris, changes in soil color, and textural shifts—to guide excavation limits. This approach resulted in expansion of the excavation footprint on the landward side and increased the excavation depth, while maintaining a balance to avoid undermining the dike prism (Appendix A, Sheet C3.0). Encountered material included burnt debris such as cables, metals, and coarse grit. Excavation continued until firm, fine-grained subgrade soils largely free of debris were reached.

Although the design anticipated excavation to approximately 3 feet below grade, field conditions revealed burnt debris extending greater than 6-foot depth. The final excavation bottom was approximately 36 inches below grade and tied into the adjacent sediment hot spot cut at the toe of the dike, with over 10 feet of vertical material removed from the dike surface in some locations. The total volume excavated was approximately 1,600 cy, exceeding the planned 1,400 cy identified in the ROD and design plans.

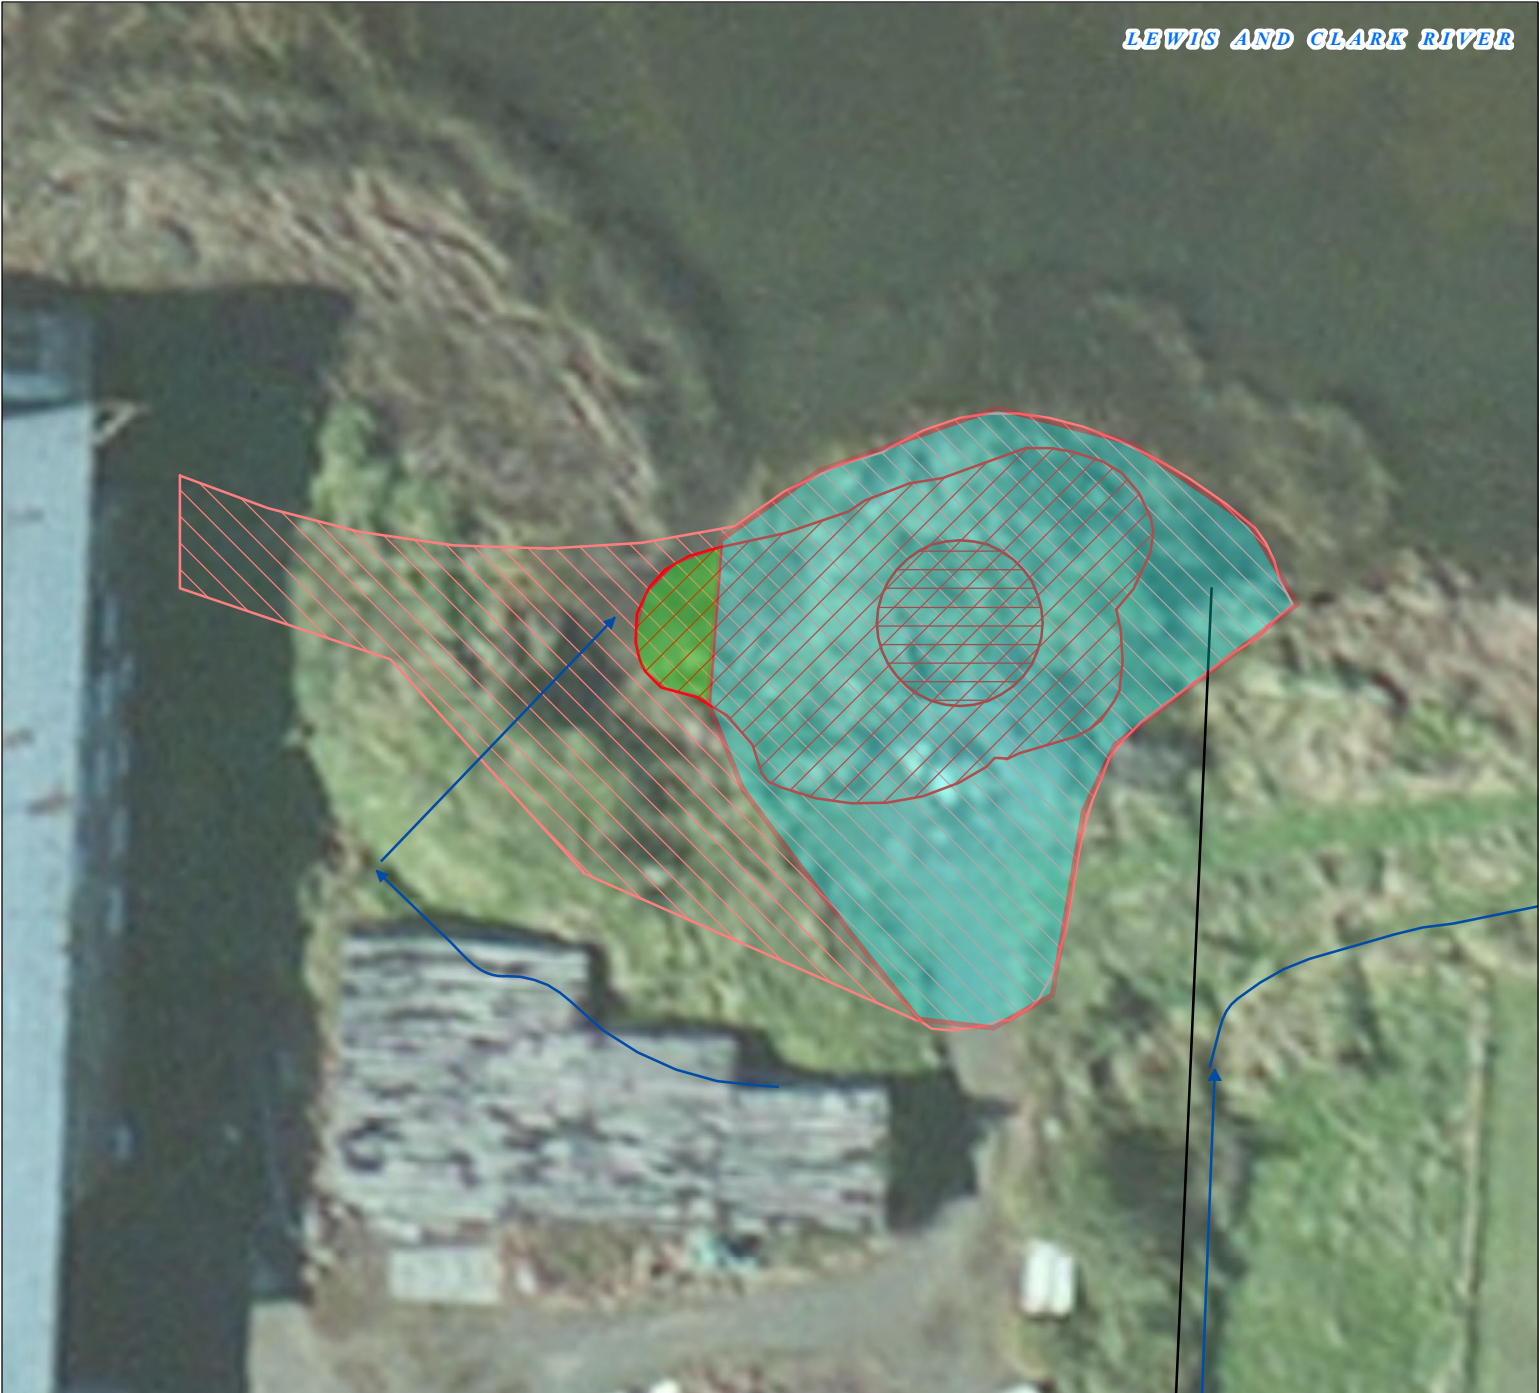
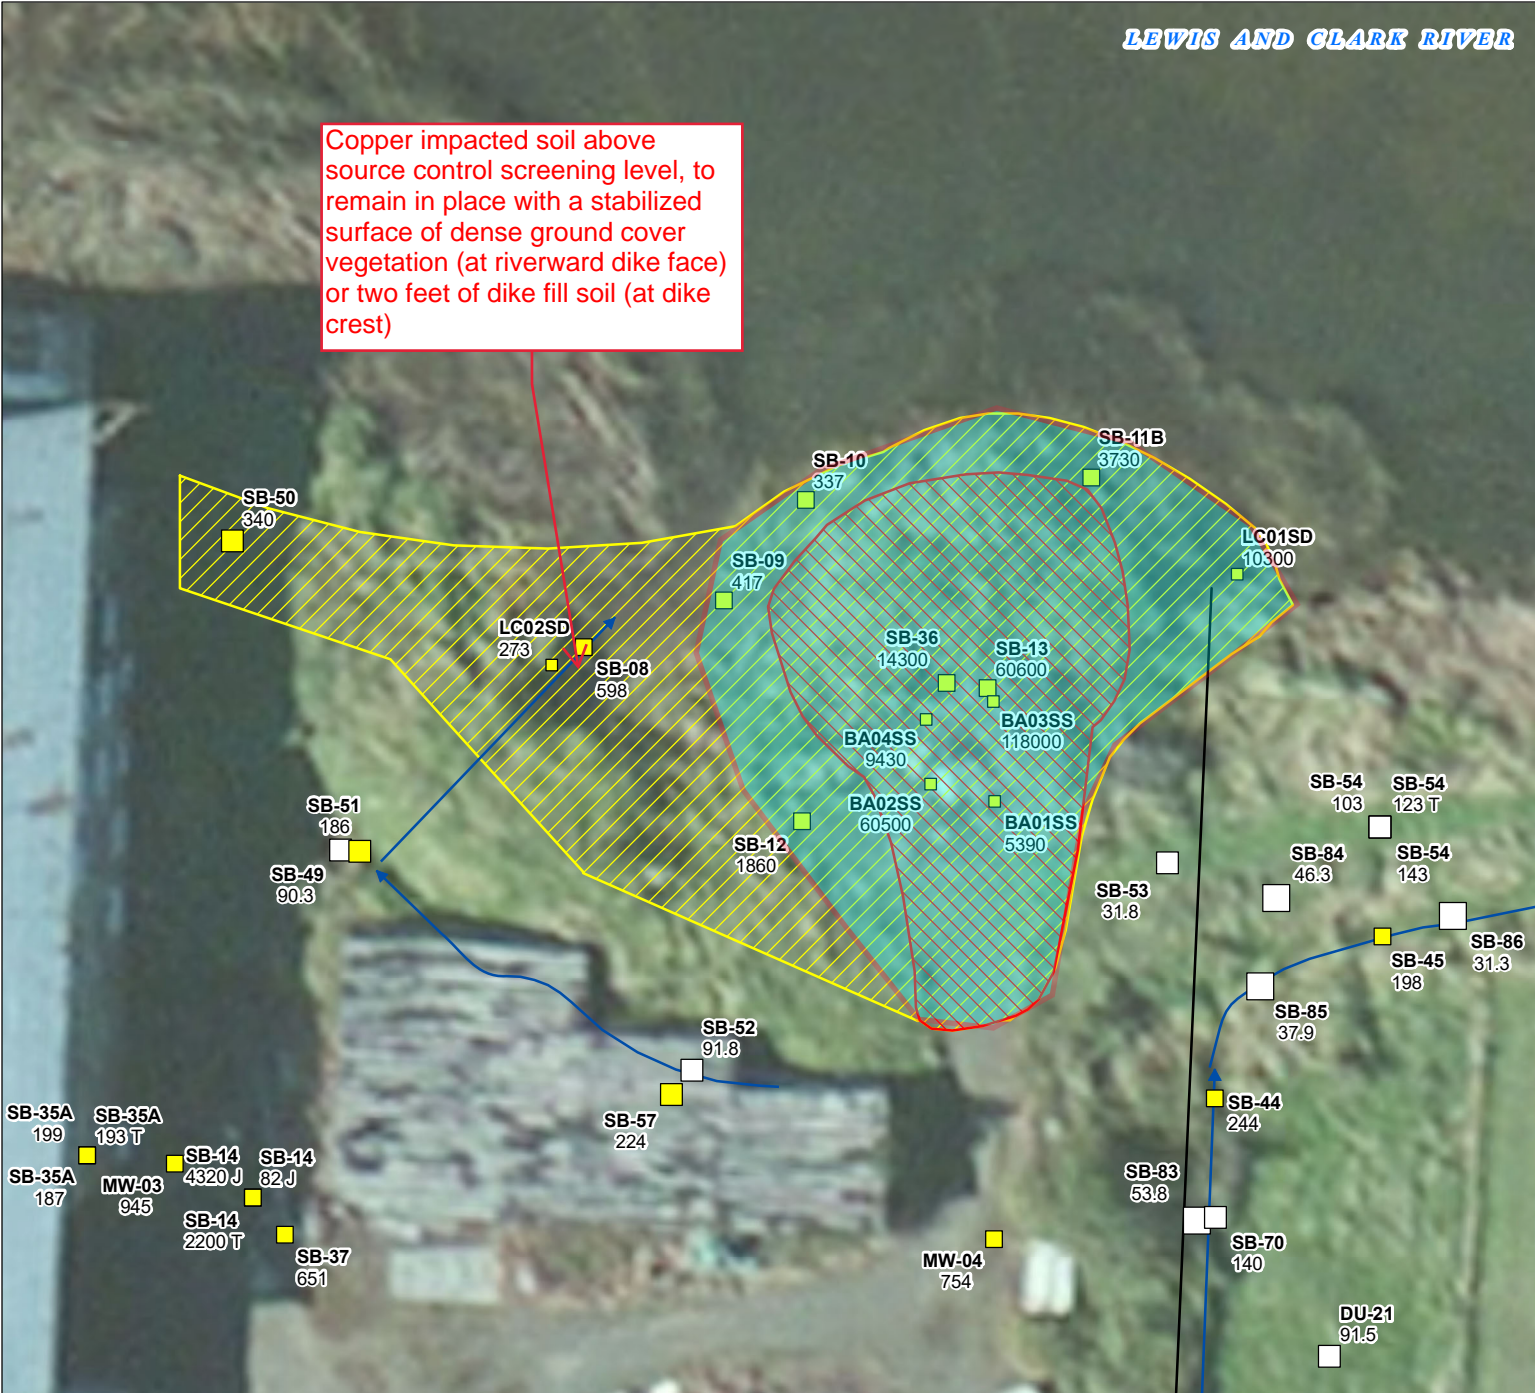
Figure 4-3
Burn Pit

Copper impacted soil above source control screening level, to remain in place with a stabilized surface of dense ground cover vegetation (at riverward dike face) or two feet of dike fill soil (at dike crest)

Copper Source Control
Screening Results in Surface
Soil, 0-1' bgs

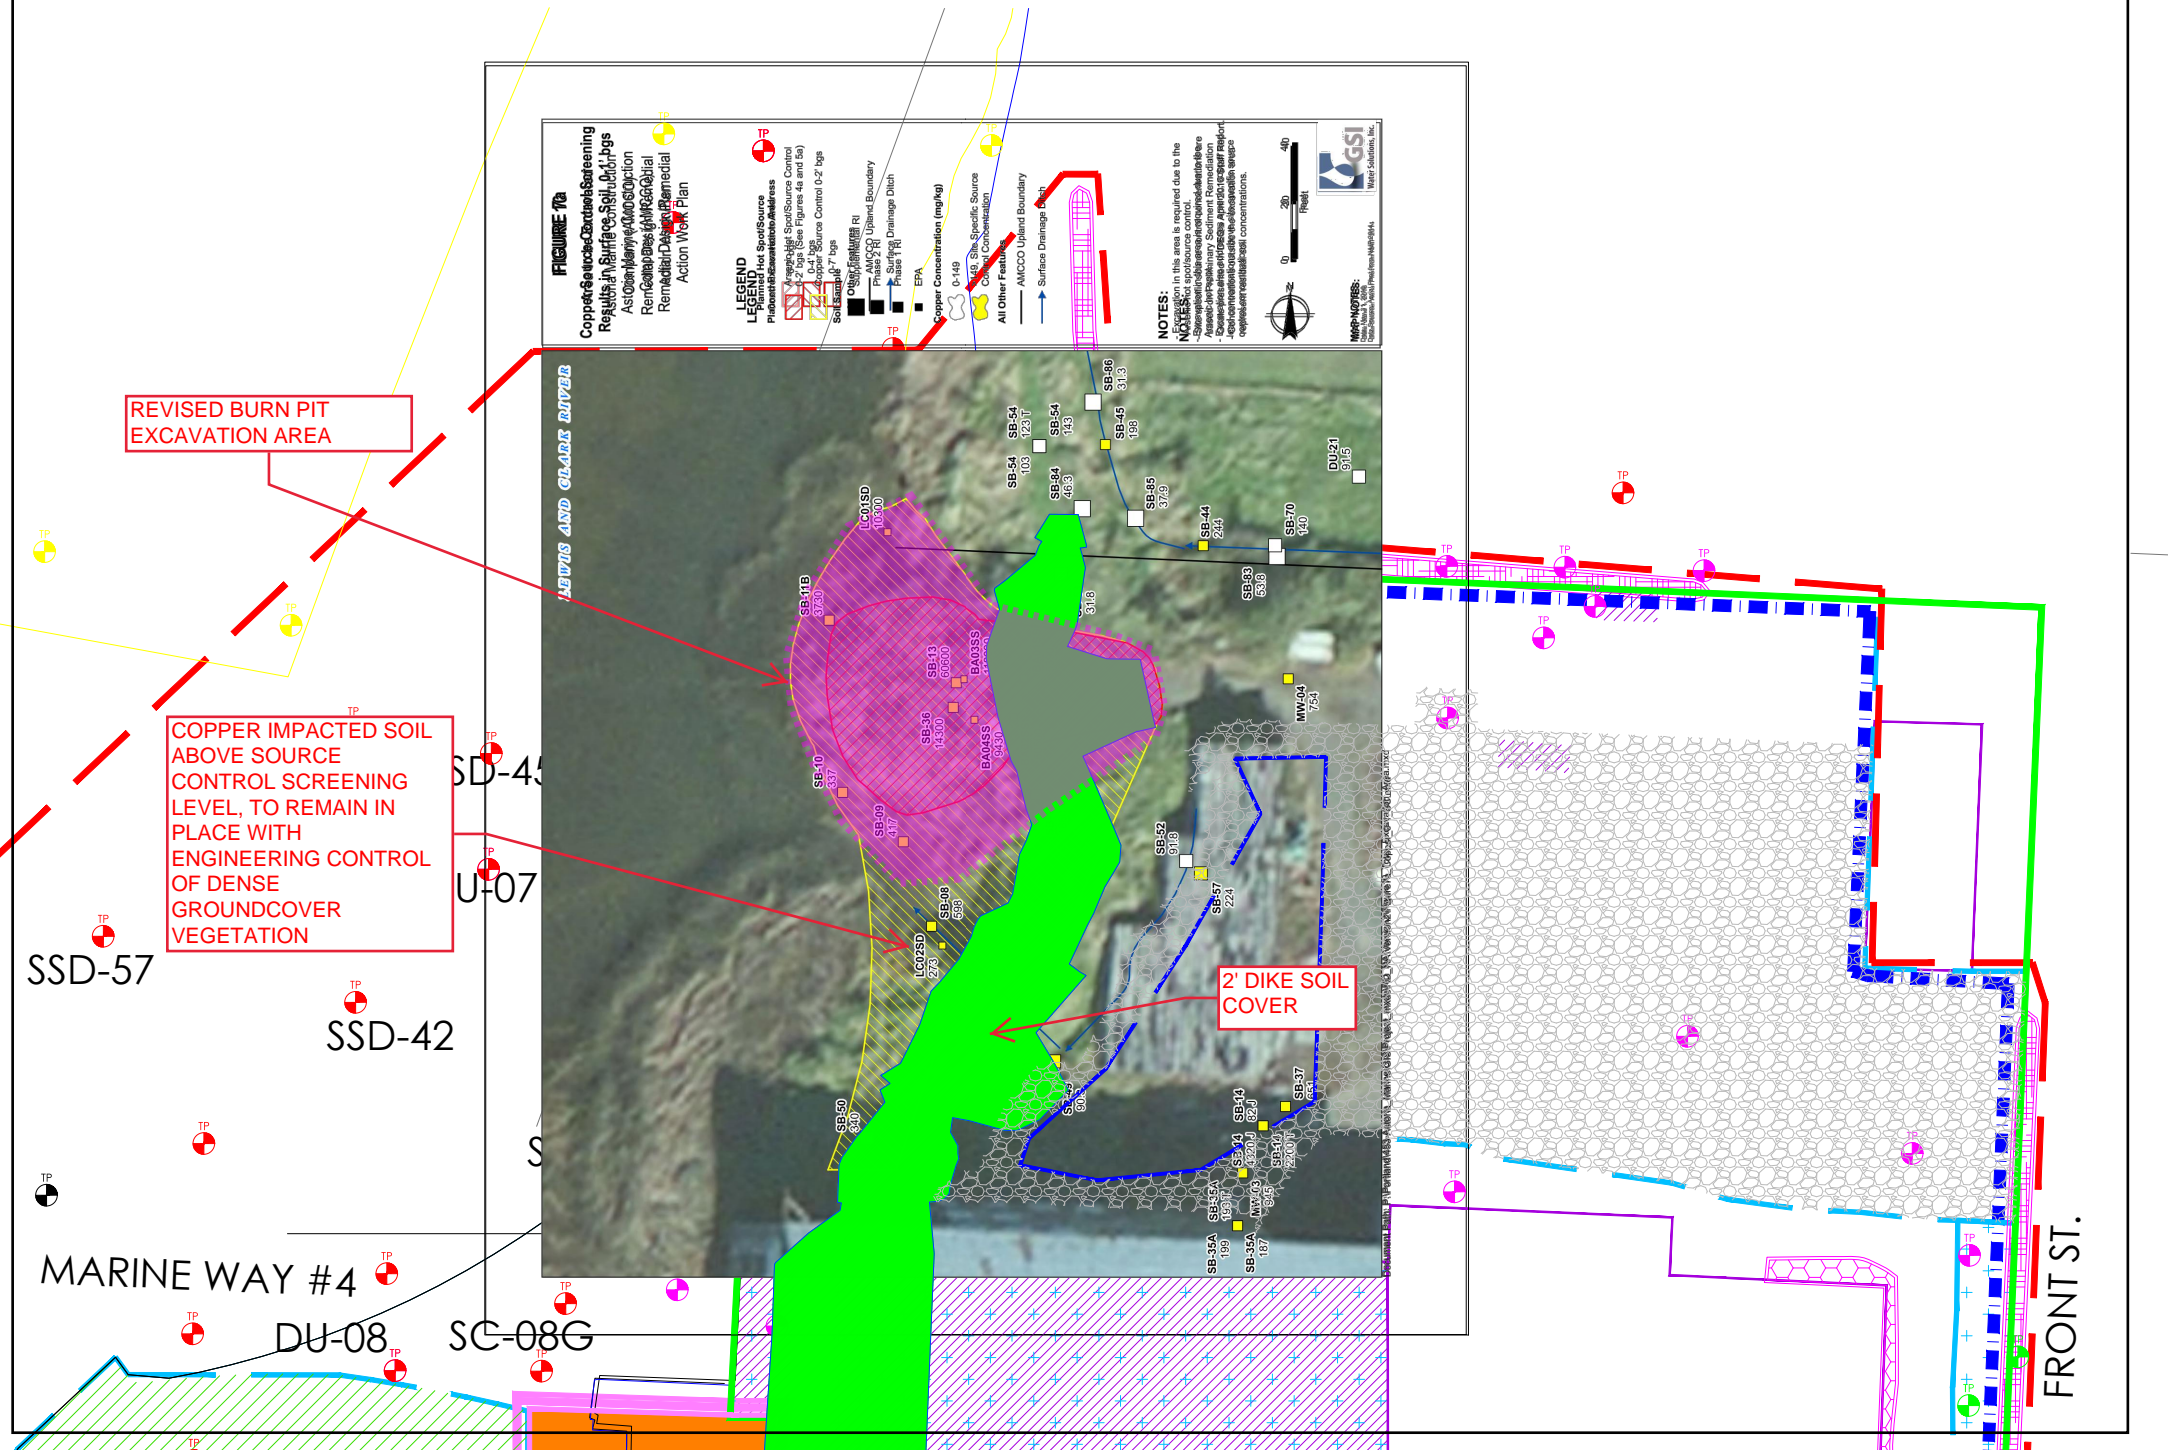
**FIGURE 4-4
BURN PIT RI FIGURE SUPERIMPOSED ON PROPOSED DIKE LINEWORK**

To address the discrepancy between planned and actual excavation volumes, MFA reexamined remedial investigation data and figures from the 2016 Supplemental Remedial Investigation Results (GSI 2016). Figures depicting hot spot and source control exceedances were compiled and incorporated into ROD figures (see Figure 4-2). MFA prepared an analysis recommending that excavation focus on highly contaminated hot spot soils rather than broader areas with residual concentrations above source screening values (MFA 2024). This proposal optimized limited project funding while maximizing environmental benefit.
