Re: 2025 Inspection Summary – Treated Sub-Grade Berm
Portland International Airport
ECSI #2118

This letter, prepared on behalf of the Port of Portland (Port), documents the inspection and reporting associated with the Treated Sub-Grade Berm (Berm) constructed at the Portland International Airport (PDX). Berm management for the period covered by this report (2025) has been in accordance with the Treated Sub-Grade Berm Management Report, dated May 28, 1998.

Treated Sub-Grade Berm
Portland International Airport, Port of Portland
Portland, Oregon

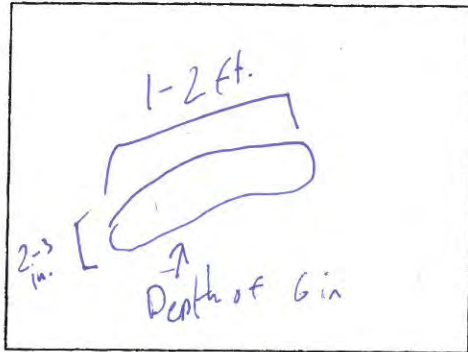
Animal Burrow/Erosion Scar
Found on top of berm approx.
6 inches deep. See photo.

Photo in file indicates location of animal burrow/erosion < 3 in.

Carmen Owens contacted on findings.

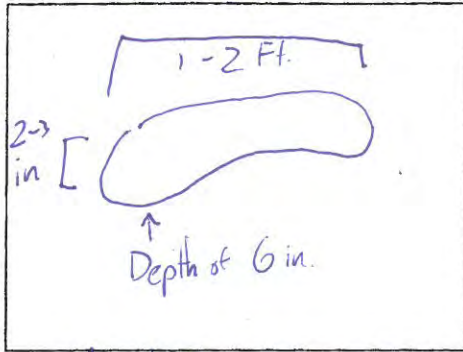
Animal Burrow/Erosion Scar
Found on top of Berm approx.
6 inches Deep See Photo

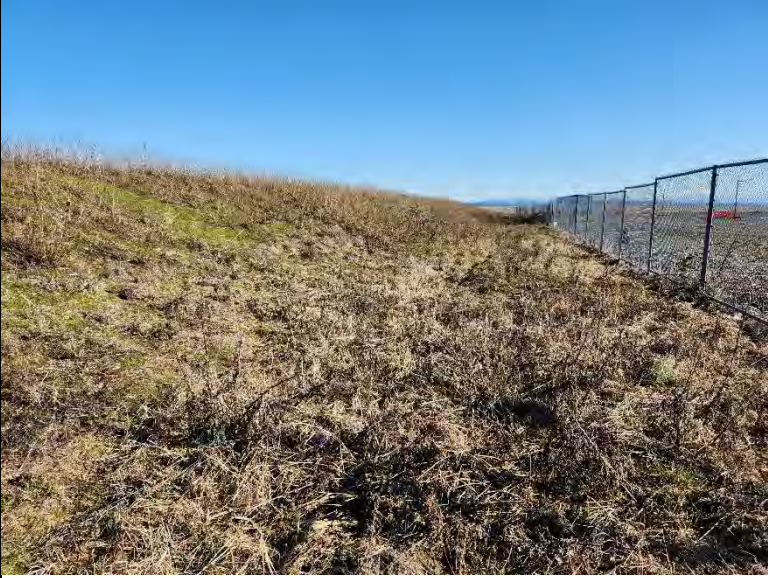
Photo No: 1	
Photo Date: 01/29/2025

Orientation: E	
Description: January 2025 inspection, representative photo south side of the berm.

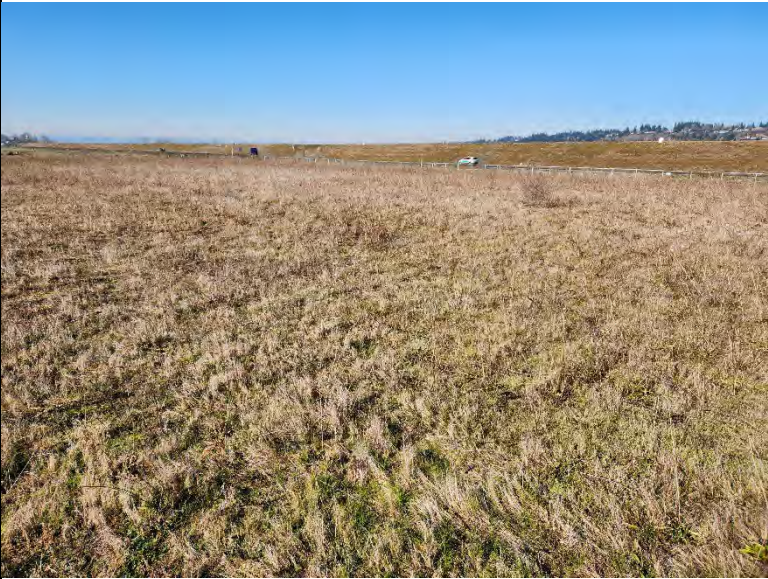
Photo No: 2	
Photo Date: 01/29/2025

Orientation: NW	
Description: January 2025 inspection, representative photo of top of berm.

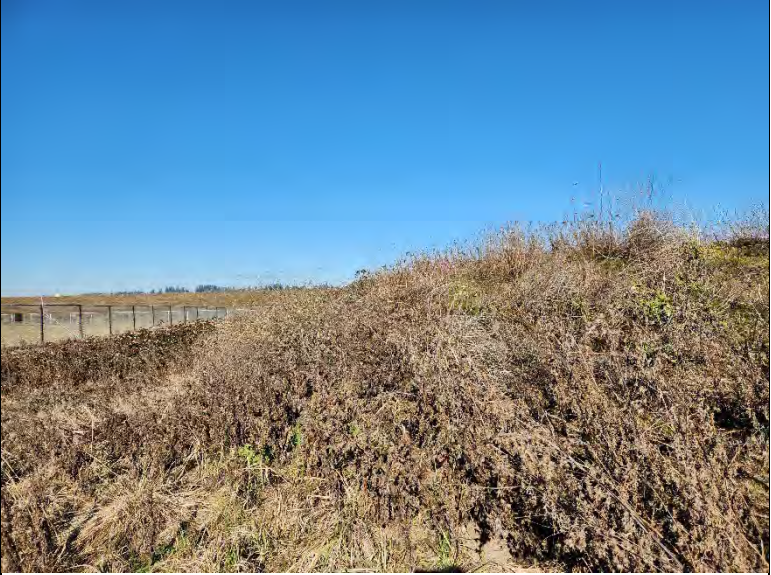
Photo No: 3

Photo Date: 01/29/2025	
Orientation: N	
Description: January 2025 inspection, representative photo of southwest side of berm and fencing.

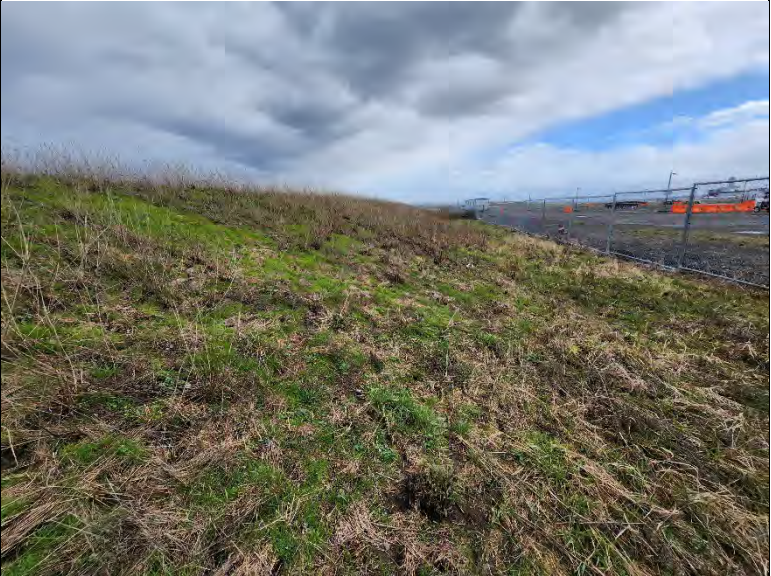
Photo No: 4

Photo Date: 02/25/2025	
Orientation: E	
Description: February 2025 inspection, representative of the south side of the berm.

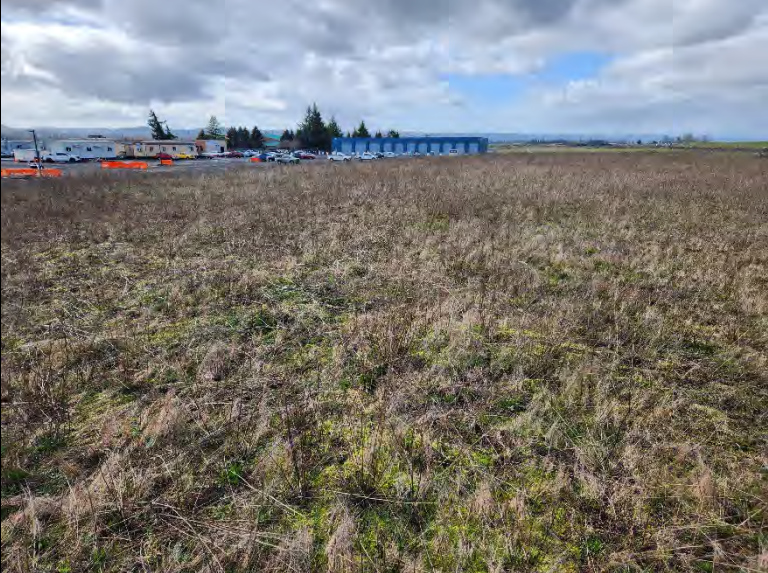
Photo No: 5

Photo Date: 02/25/2025	
Orientation: SW	
Description: February 2025 inspection, representative photo of top of the berm.

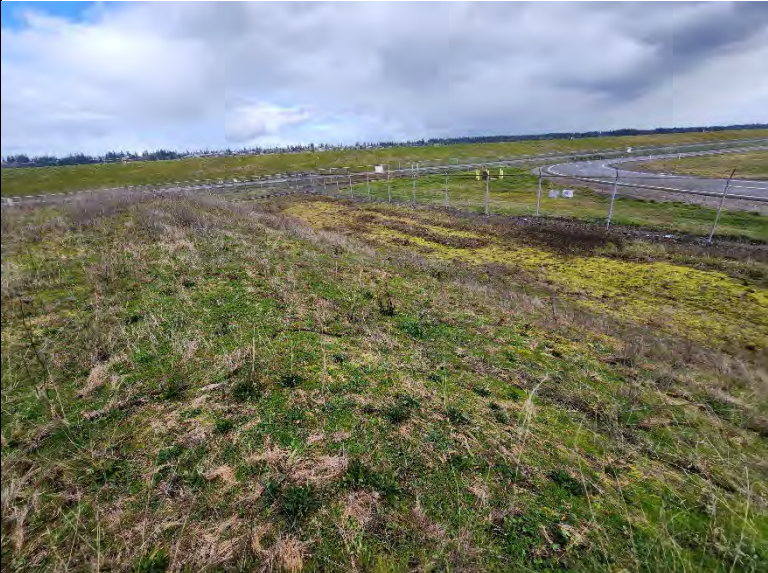
Photo No: 6

Photo Date: 02/25/2025	
Orientation: N	
Description: February 2025 inspection, representative photo of east side of the berm and fencing from top of the berm.

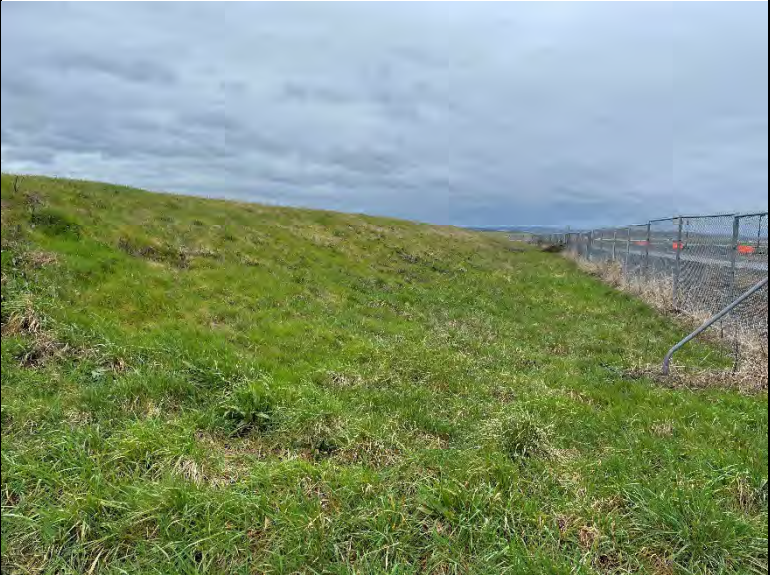
Photo No: 7

Photo Date: 03/26/2025	
Orientation: E	
Description: March 2025 inspection, representative photo of south side of berm looking east.

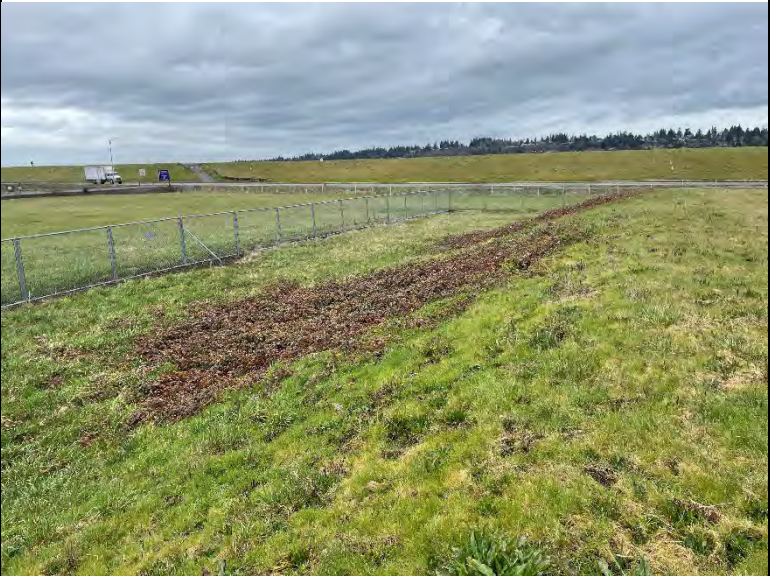
Photo No: 8

Photo Date: 03/26/2025	
Orientation: N	
Description: March 2025 inspection, representative photo of the west end of the berm looking north.

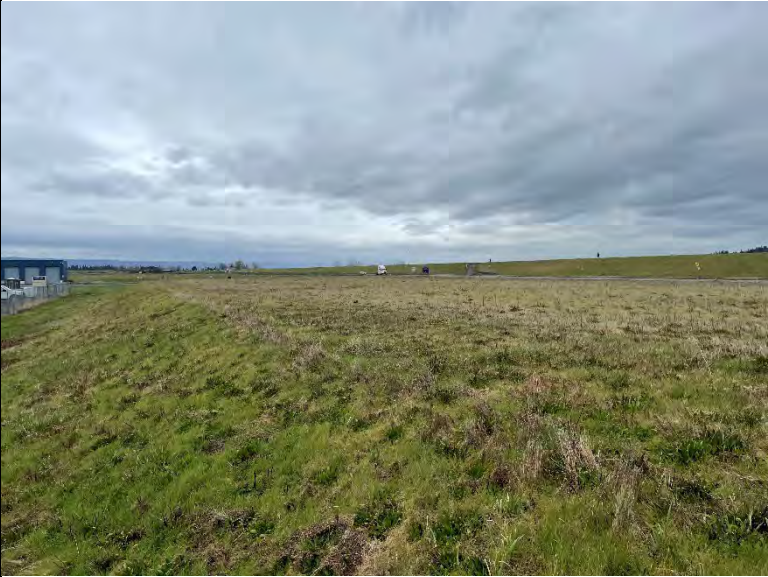
Photo No: 9

Photo Date: 03/26/2025	
Orientation: W	
Description: March 2025 inspection, representative photo of berm looking west.

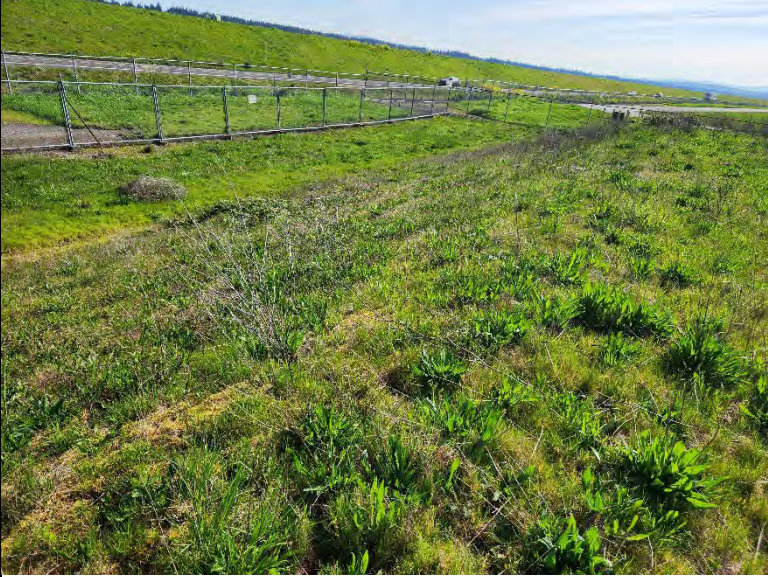
Photo No: 10

Photo Date: 04/15/2025	
Orientation: NE	
Description: April 2025 inspection, representative photo of the north side of the berm. View looking from top of the berm.

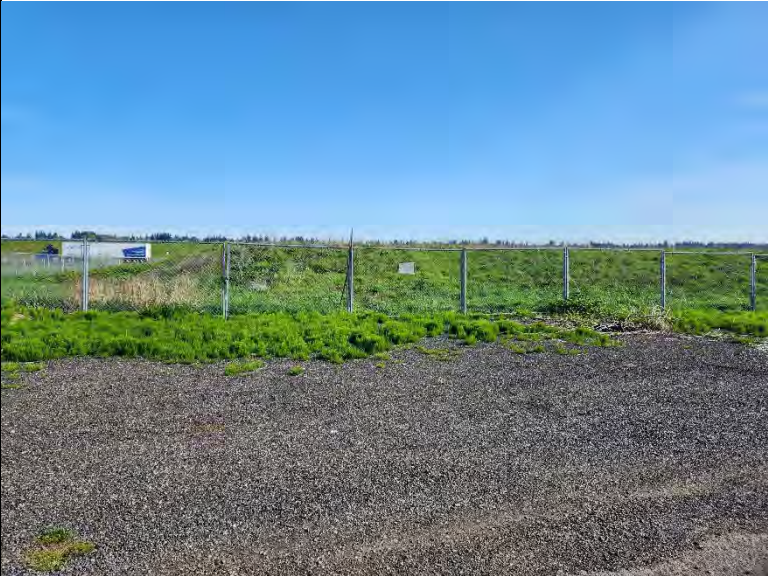
Photo No: 12	
Photo Date: 04/15/2025

Orientation: N	
Description: April 2025 inspection, representative photo of the south side fence and berm.

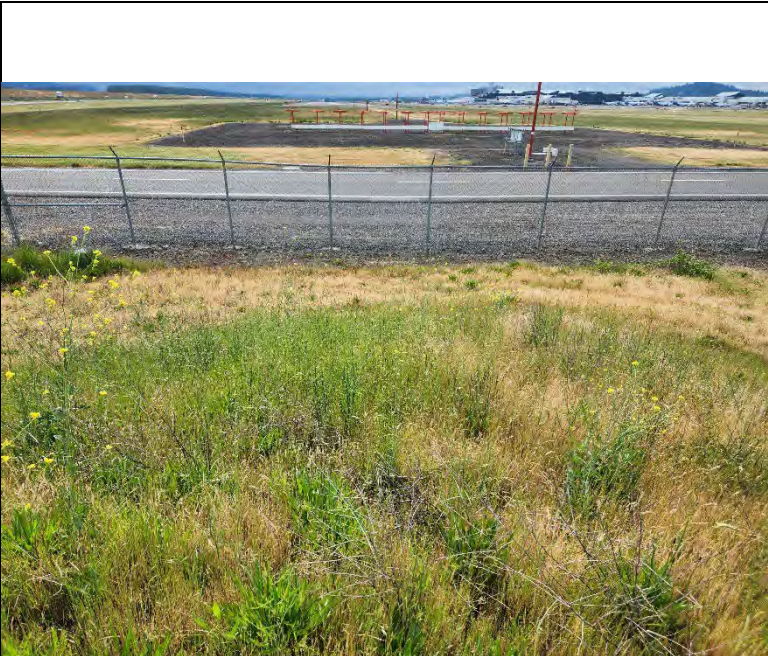
Photo No: 13

Photo Date: 05/22/2025	
Orientation: E	
Description: May 2025 inspection, representative photo of the east side of the berm. View from top of the berm facing east.

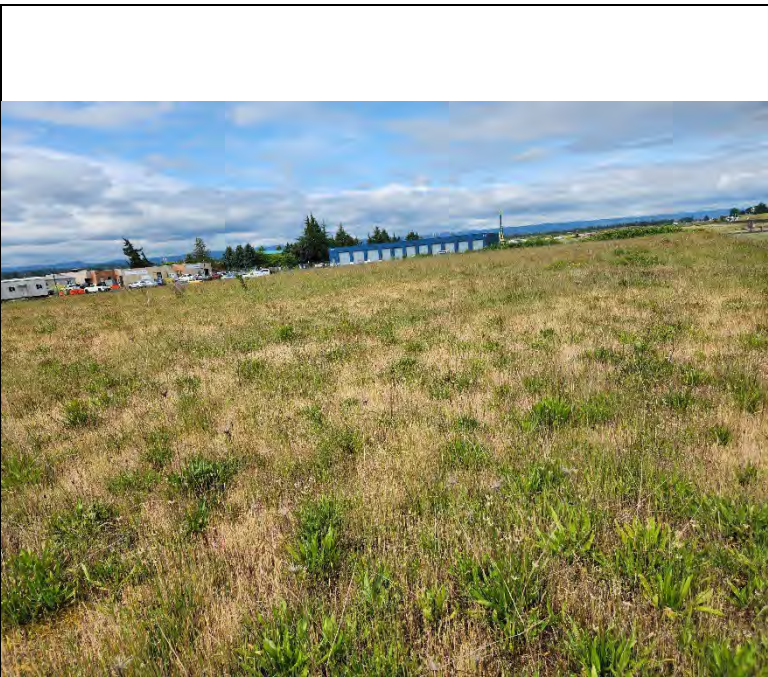
Photo No: 14

Photo Date: 05/25/2025	
Orientation: W	
Description: May 2025 inspection, representative photo of the top of the berm.

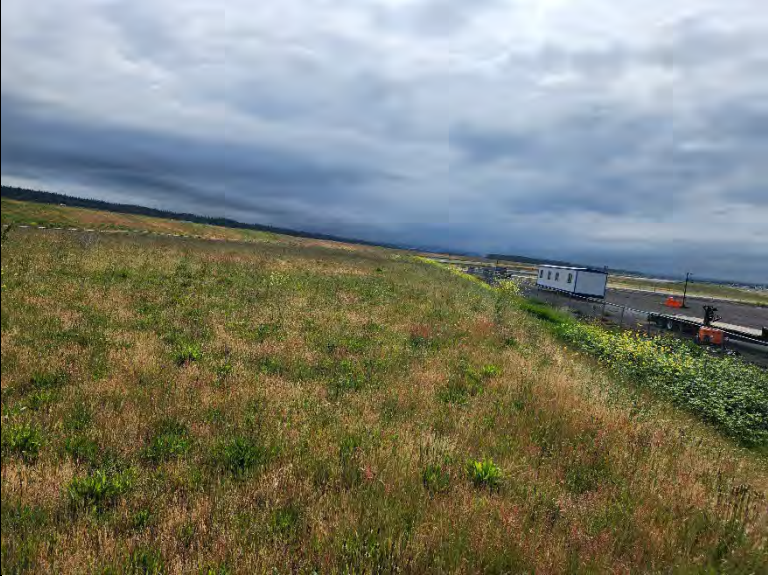
Photo No: 15	
Photo Date: 05/22/2025

Orientation: E	
Description: May 2025 inspection, representative photo of the south side of the berm.

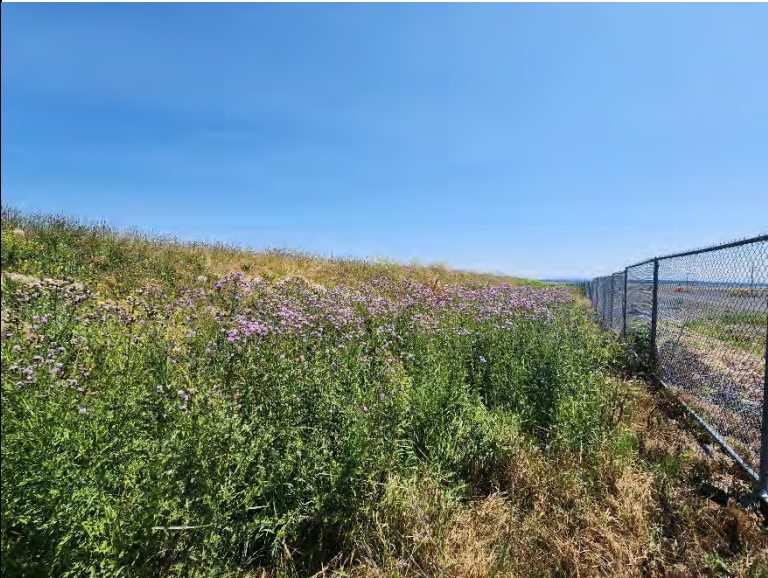
Photo No: 16	
Photo Date: 06/24/2025

Orientation: E	
Description: June 2025 inspection, representative photo of the south side of the berm.

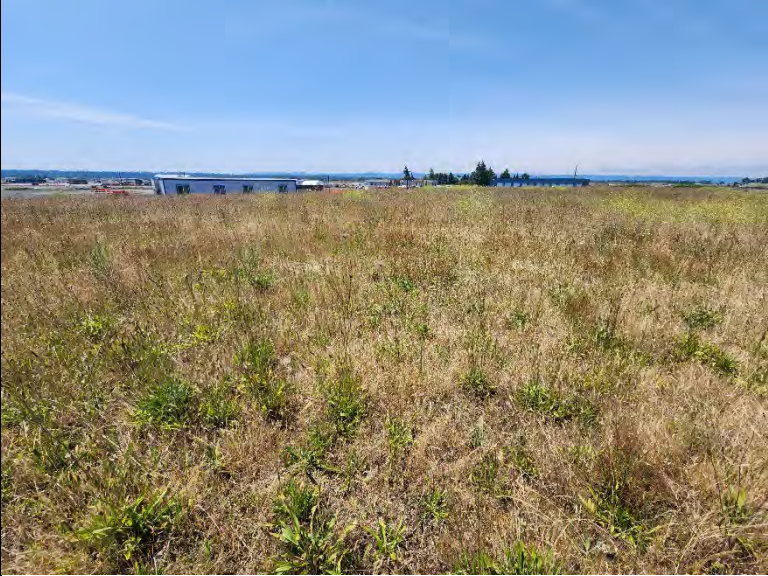
Photo No: 17

Photo Date: 06/24/2025	
Orientation: SW	
Description: June 2025 inspection, representative photo of the top of the berm.

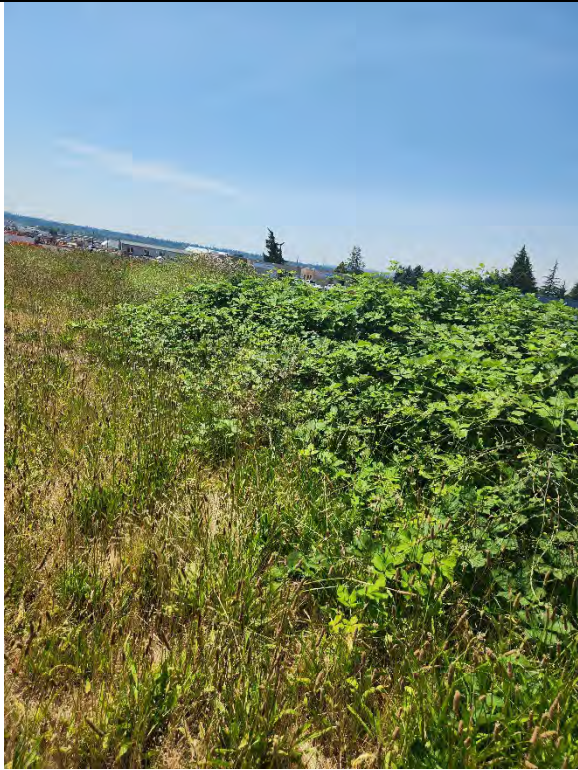
Photo No: 18

No failures of the soil cover were recorded in 2025. The vegetation cover remains well established and areas of active erosion were not noted. Port Airport Maintenance performs periodic mowing of the vegetative cover. Mowing occasionally creates shallow scars in the cover material, usually on the slope transitions on the Berm. No significant scarring was noted during the 2025 inspection period. Vole activity on the Berm has remained persistent over the past year and continues to be noted during the inspections. Vole abatement activities are undertaken for the Berm to coincide with similar activities on the greater PDX airfield. Himalayan blackberries periodically become part of the vegetation on the berm as they grow more quickly than other species, particularly in the fall and winter when other plants are dormant. The routine mowing removes most of the blackberries and allows other types of vegetation to grow.

Photo Date: 06/24/2025	
Orientation: S	
Description: June 2025 inspection, representative photo of the east end of the berm. View of observed blackberry growth.

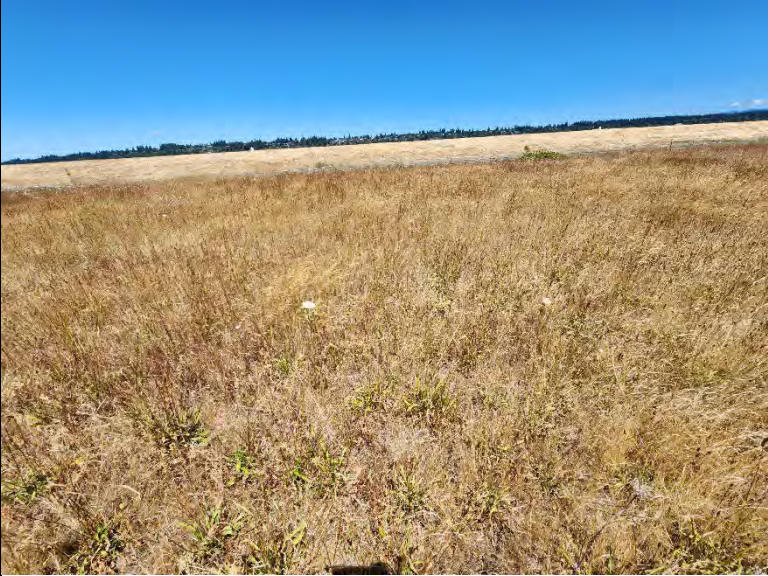
Photo No: 19	
Photo Date: 07/25/2025

Orientation: N	
Description: July 2025 inspection, representative photo of top of the berm.

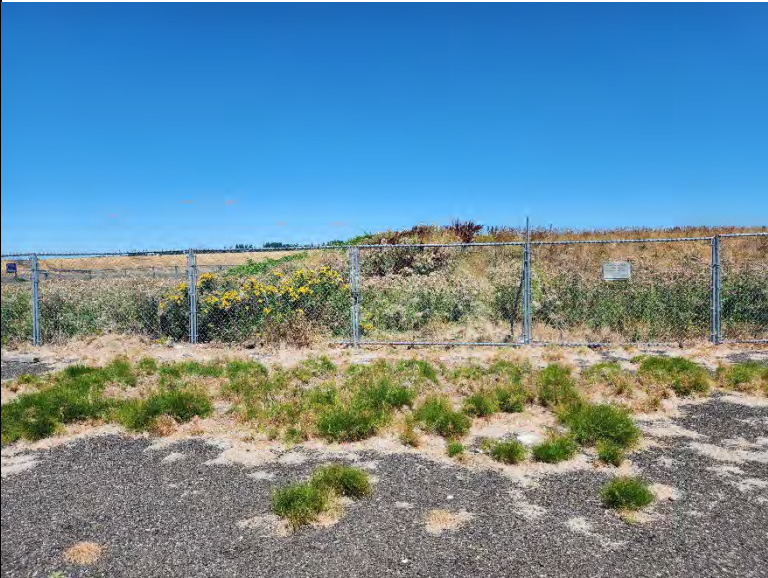
Photo No: 20	
Photo Date: 07/25/2025

Orientation: N	
Description: July 2025 inspection, representative photo of the south fence and the southwest corner of the berm.

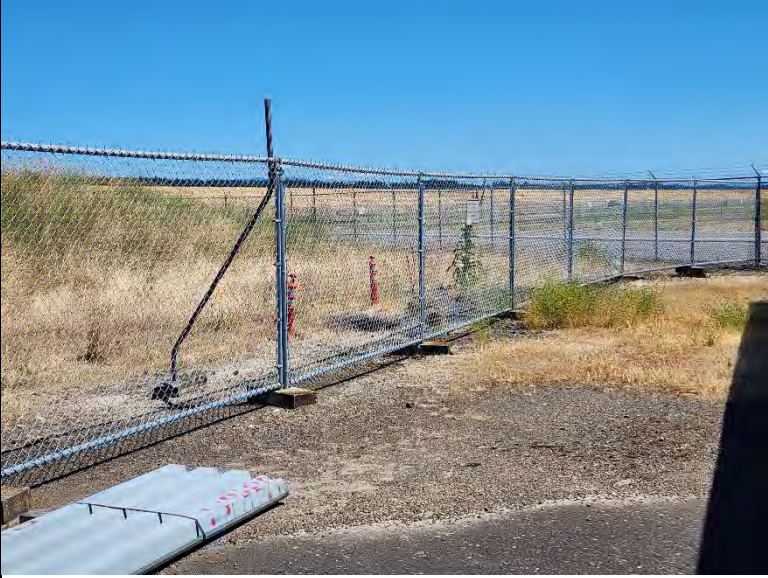
Photo No: 21	
Photo Date: 07/25/2025

Orientation: NE	
Description: July 2025 inspection, representative photo of the southeast corner of the berm and fence.

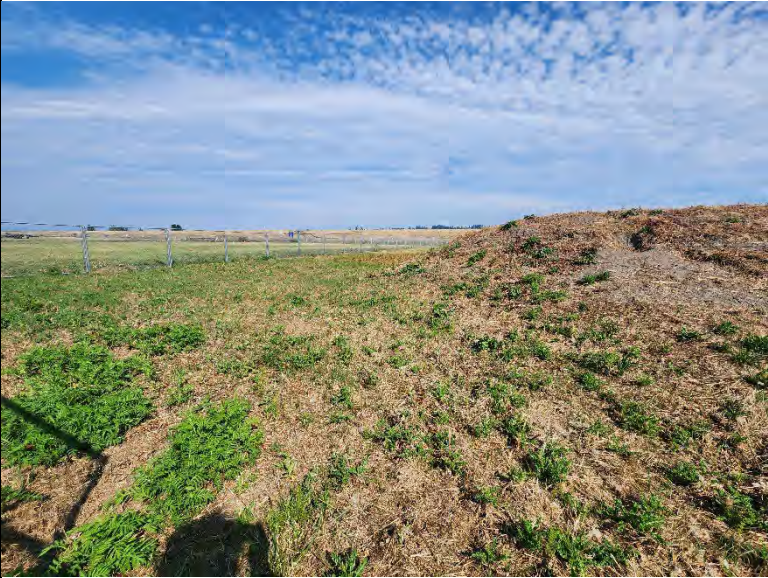
Photo No: 22	
Photo Date: 08/28/2025

Orientation: NW	
Description: August 2025 inspection, photo of the southwest corner of the berm. Scarring and lack of vegetation present.

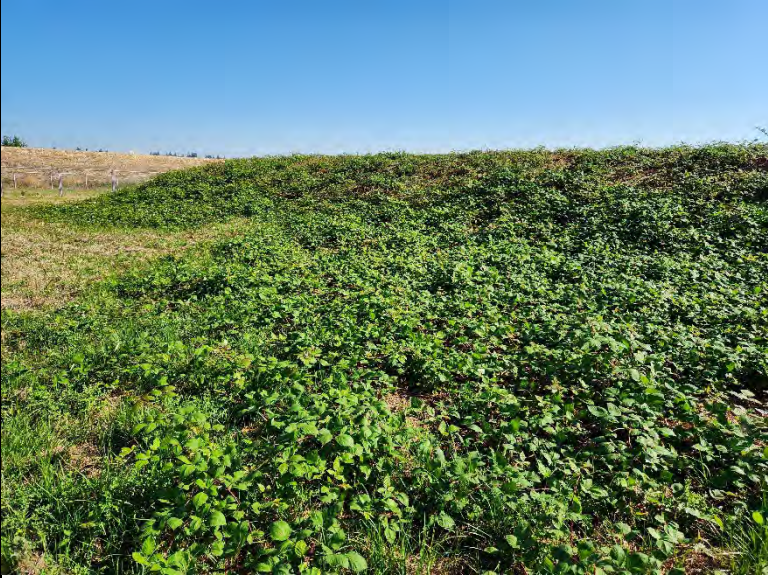
Photo No: 25	
Photo Date: 09/24/2025

Orientation: NE	
Description: September 2025 inspection, representative photo of the west side of the berm.

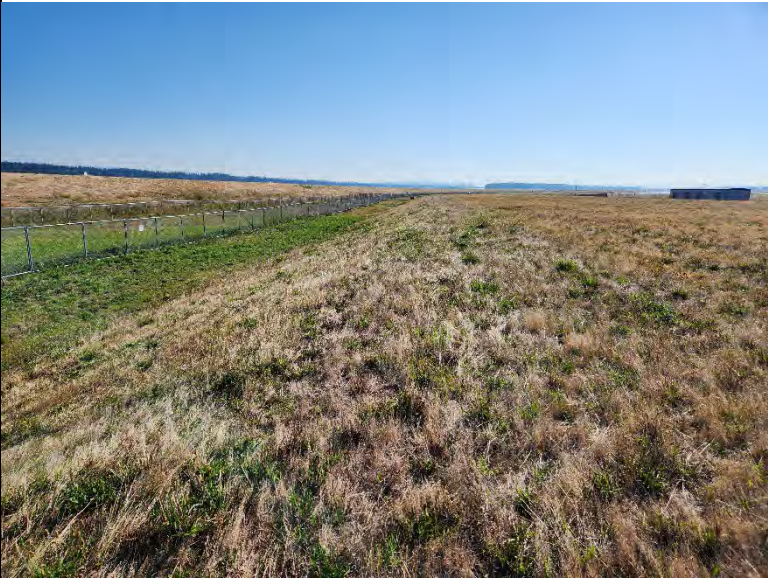
Photo No: 26	
Photo Date: 09/24/2025

Orientation: E	
Description: September 2025 inspection, representative photo of the top and north side of the berm.

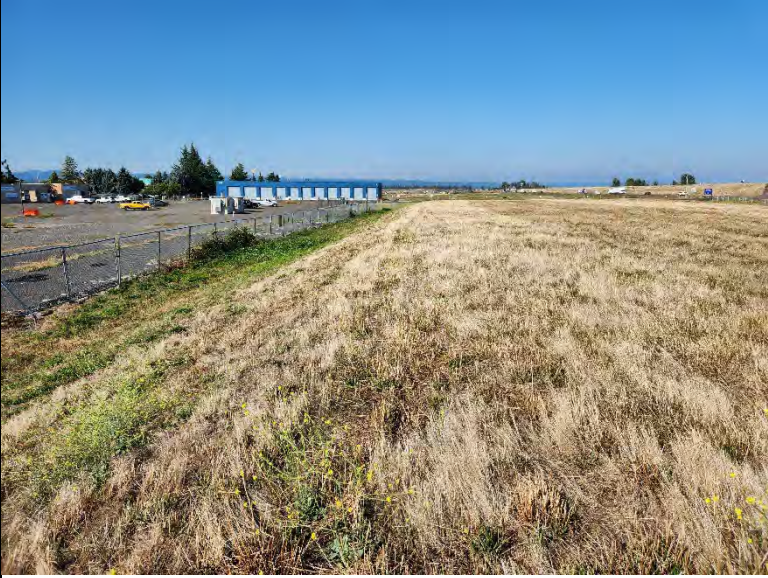
Photo No: 27	
Photo Date: 09/24/2025

Orientation: W	
Description: September 2025 inspection, representative photo of the top and south side of the berm.

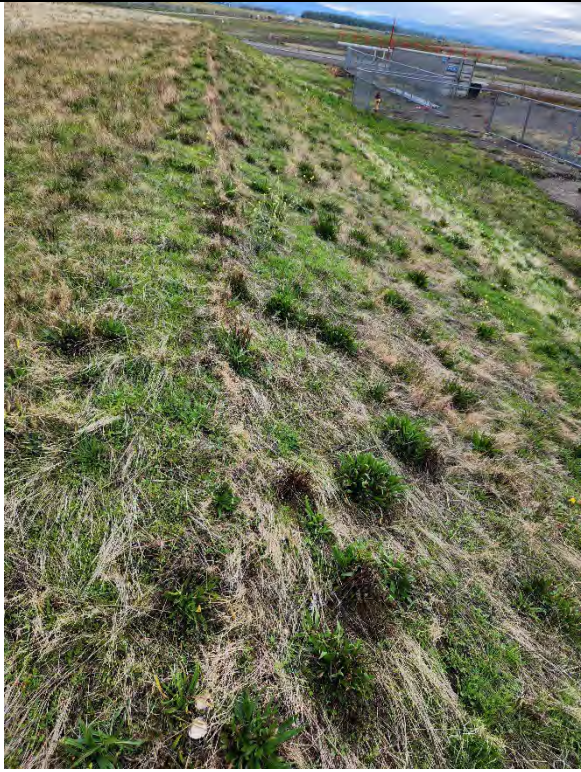
Photo No: 28

Photo Date: 10/28/2025	
Orientation: E	
Description: October 2025 inspection, representative photo of the south side of the berm.

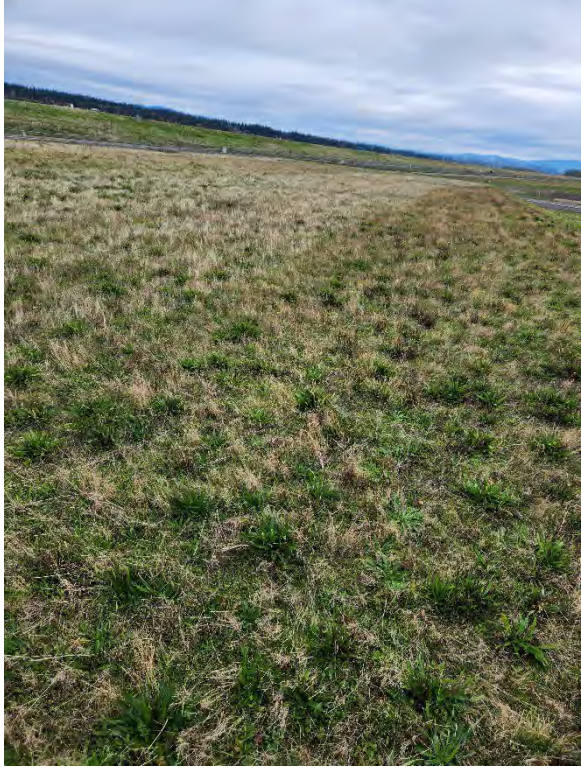
Photo No: 29

Photo Date: 10/28/2025	
Orientation: E	
Description: October 2025 inspection, representative photo of the top of the berm.

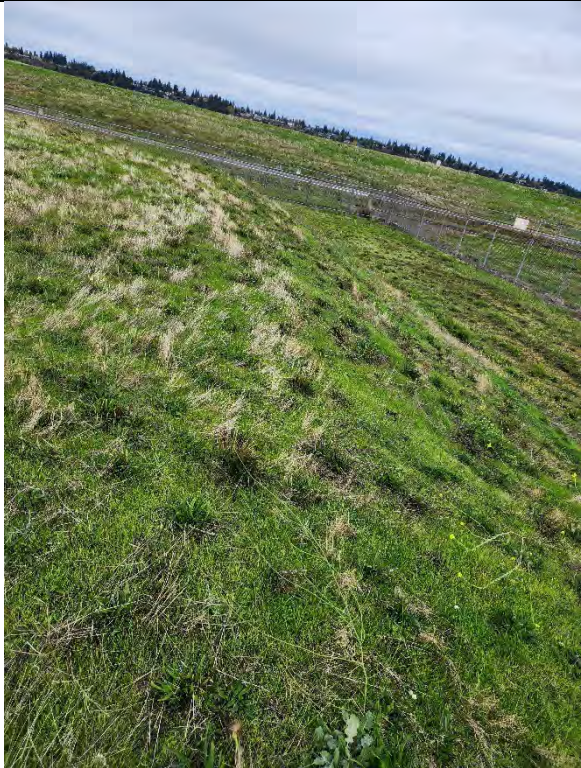
Photo No: 30

Photo Date: 10/28/2025	
Orientation: N	
Description: October 2025 inspection, representative photo of the east end of the berm. View from the top of the berm.

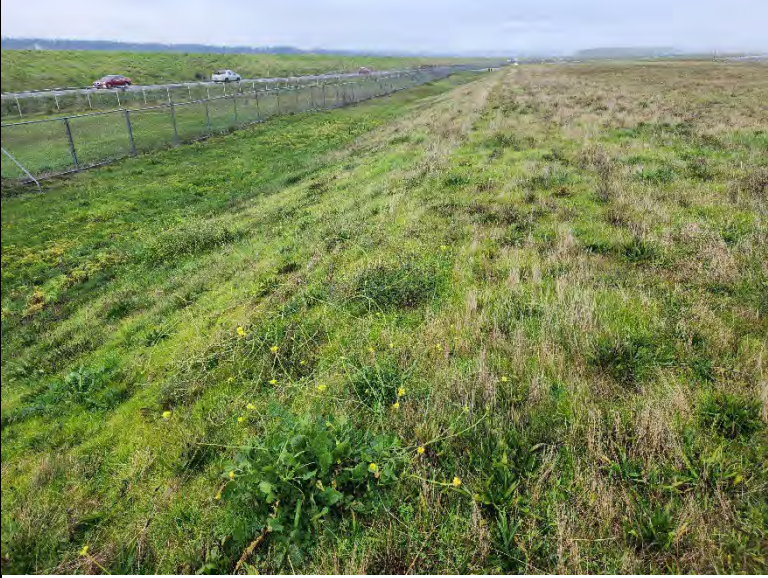
Photo No: 31

Photo Date: 11/24/2025	
Orientation: E	
Description: November 2025 inspection, representative photo of the north side of the berm.

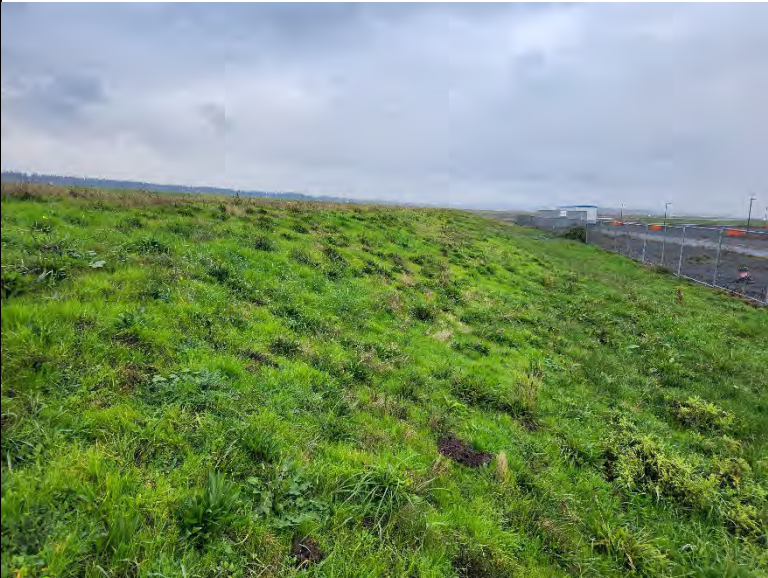
Photo No: 32

Photo Date: 11/24/2025	
Orientation: E	
Description: November 2025 inspection, representative photo of the south side of the berm.

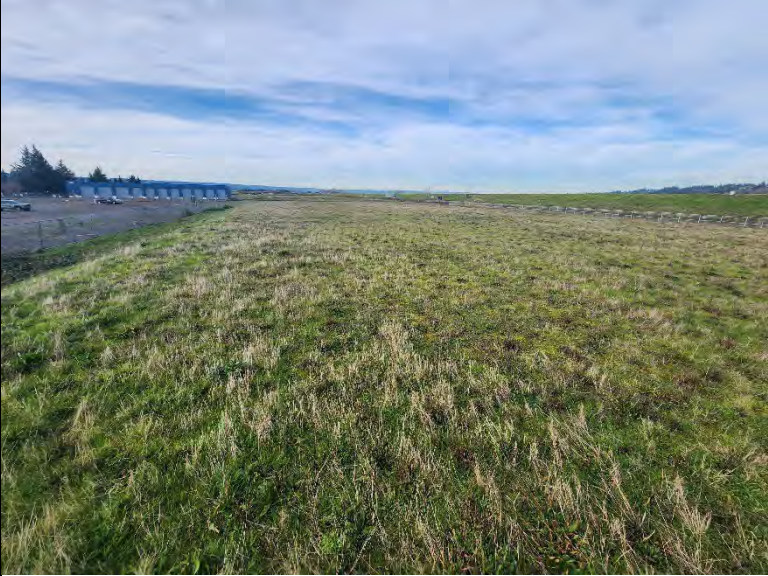
Photo No: 35

Photo Date: 12/29/2025	
Orientation: W	
Description: December 2025 inspection, representative photo of the top of the berm.

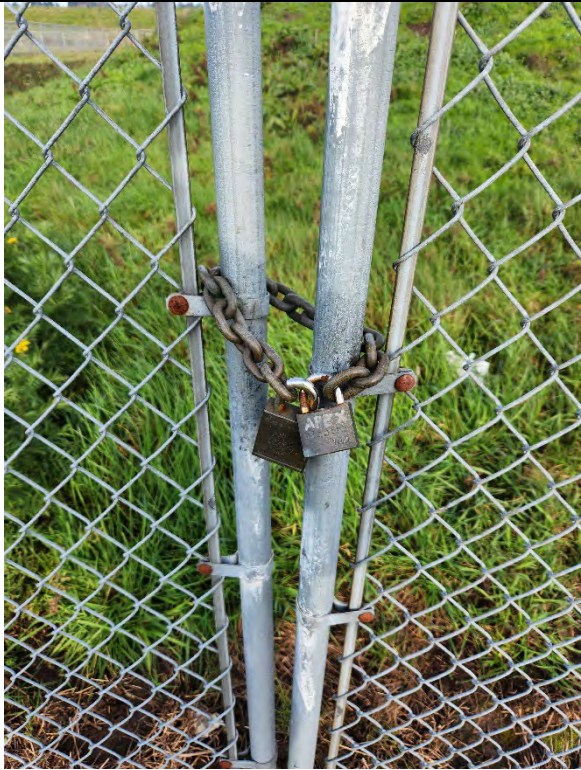
Photo No: 36

Photo Date: 12/29/2025	
Orientation: W	
Description: December 2025 inspection, photo of locked gate.
