Operation and Maintenance Report
January 2014 to December 2014

McCormick and Baxter Superfund Site

Portland, Oregon

July 6, 2015
15670-10/Task 4

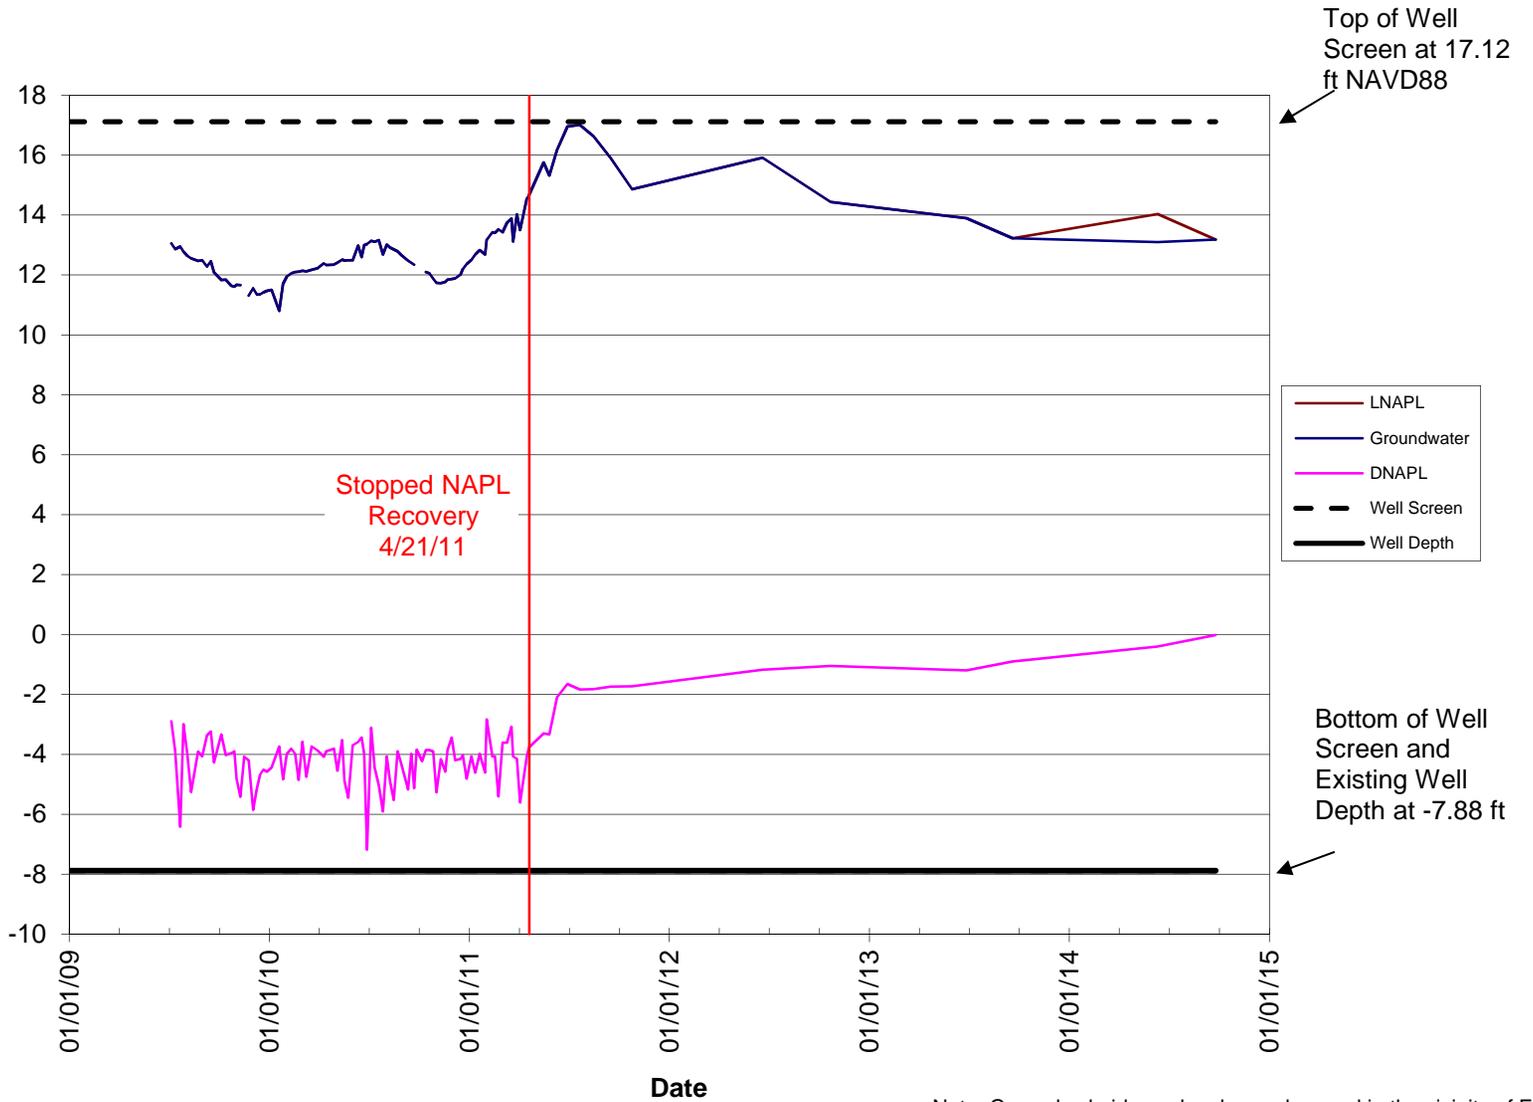
McCormick and Baxter Superfund Site Portland, Oregon	
	2009 to 2014 NAPL Thickness Plot for Well EW-1s	
4-21	Figure 7/15

Monitoring well EW-1s was recorded as having a LNAPL thickness of 0.9 foot during the June 11, 2014, semiannual monitoring event. Despite a handful of trace LNAPL readings in the past, this is the first measurable LNAPL thickness observed in this well (Figure 4-21). The DNAPL thickness in well EW-1s (Figure 4-21) has been increasing slowly to a thickness of approximately 8 feet since mid-2011, after termination of a temporary recovery period in April 2011.

Note: Ground subsidence has been observed in the vicinity of EW-1s and the well casing has sunk over time. The screened interval and total well depth have been referenced to the most recent ground survey from September 2009. Given that the elevations are changing with time, the elevations shown are approximate.

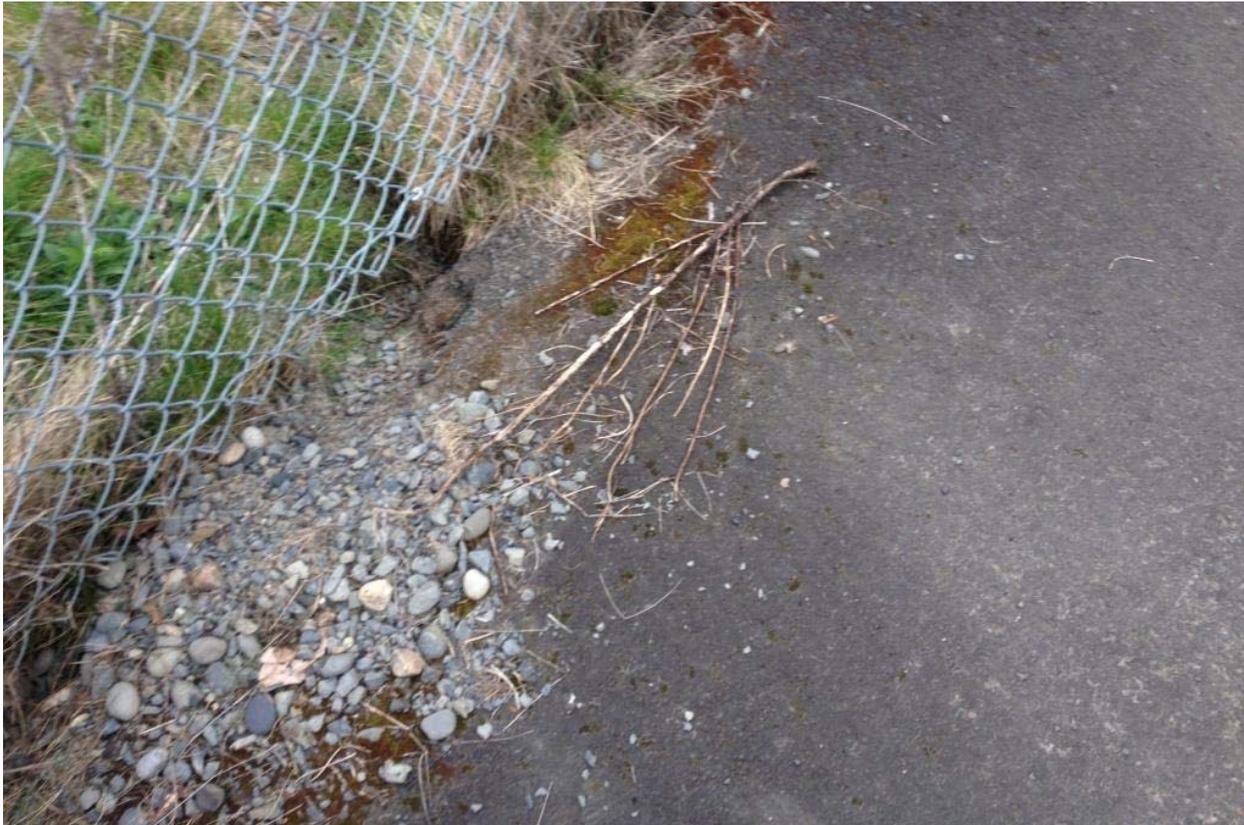
The upland soil cap provides habitat for rabbits, ground squirrels, Canada geese, several other species of birds, and coyotes. Despite placing gravel to fill gaps under the fence around the upland portion of the site, periodic burrowing continues to be observed under the fence and along the perimeter road. These burrows are filled as necessary and are not of major concern (Photograph 1, Appendix A).

Photograph 1 – Typical animal burrow underneath the site perimeter fence. Photograph taken near the entrance to the Support Facility.

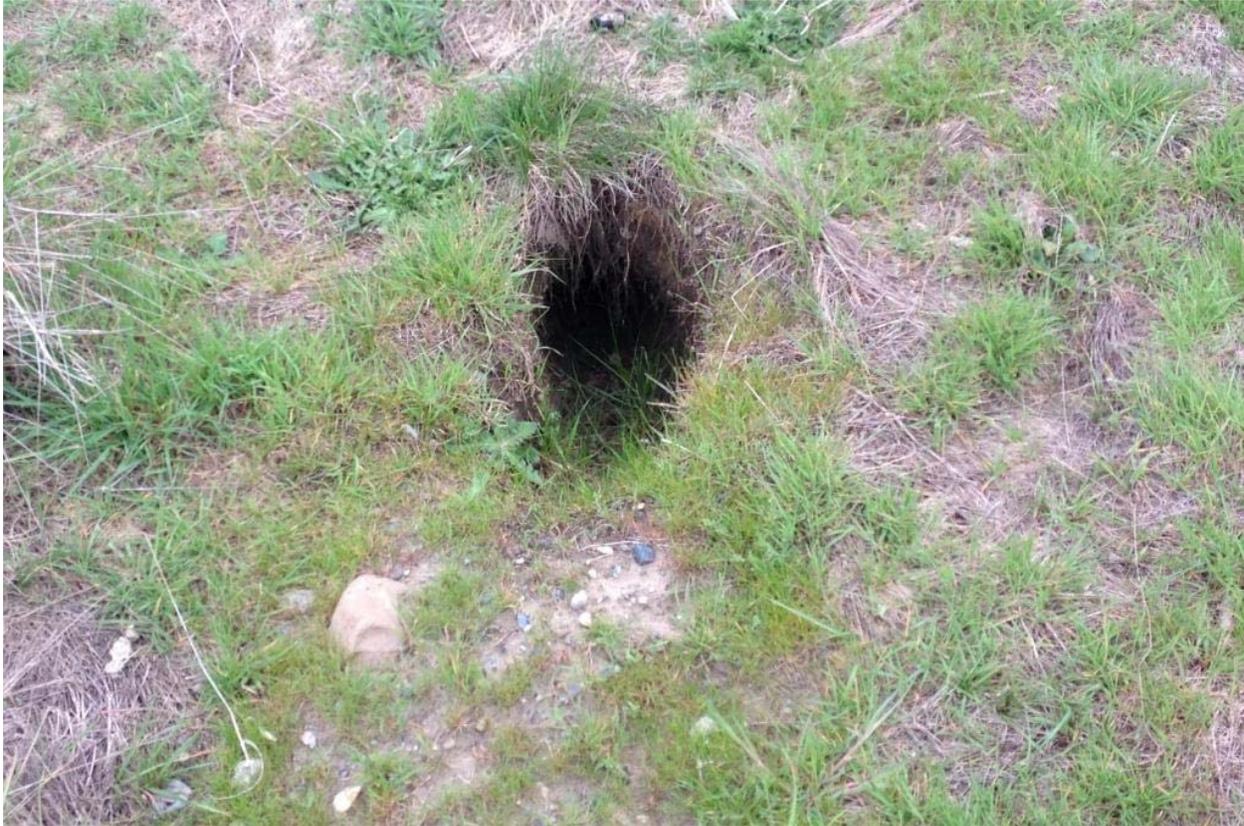
Photograph 2 – Slightly larger animal burrow observed on the earthen cap.

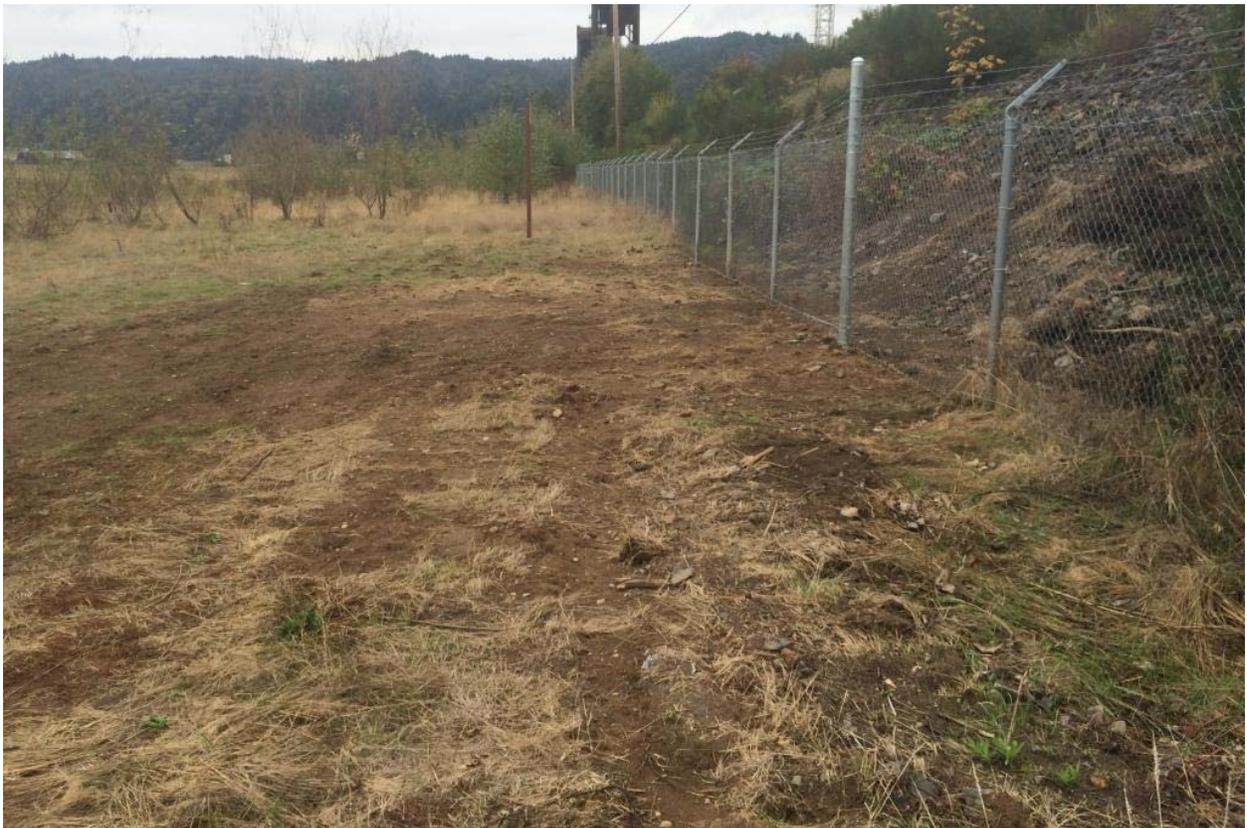
Photograph 12 – Location of the gas line work following decommissioning. Perimeter fence has been repaired. Photograph taken facing southwest.

A portion of the site perimeter fence was removed to access the gas line. At the end of each work day, temporary fence was placed around the excavation and was secured to the perimeter fence to limit access to the site. The perimeter fence was restored to previous conditions once the gas line abandonment was complete.

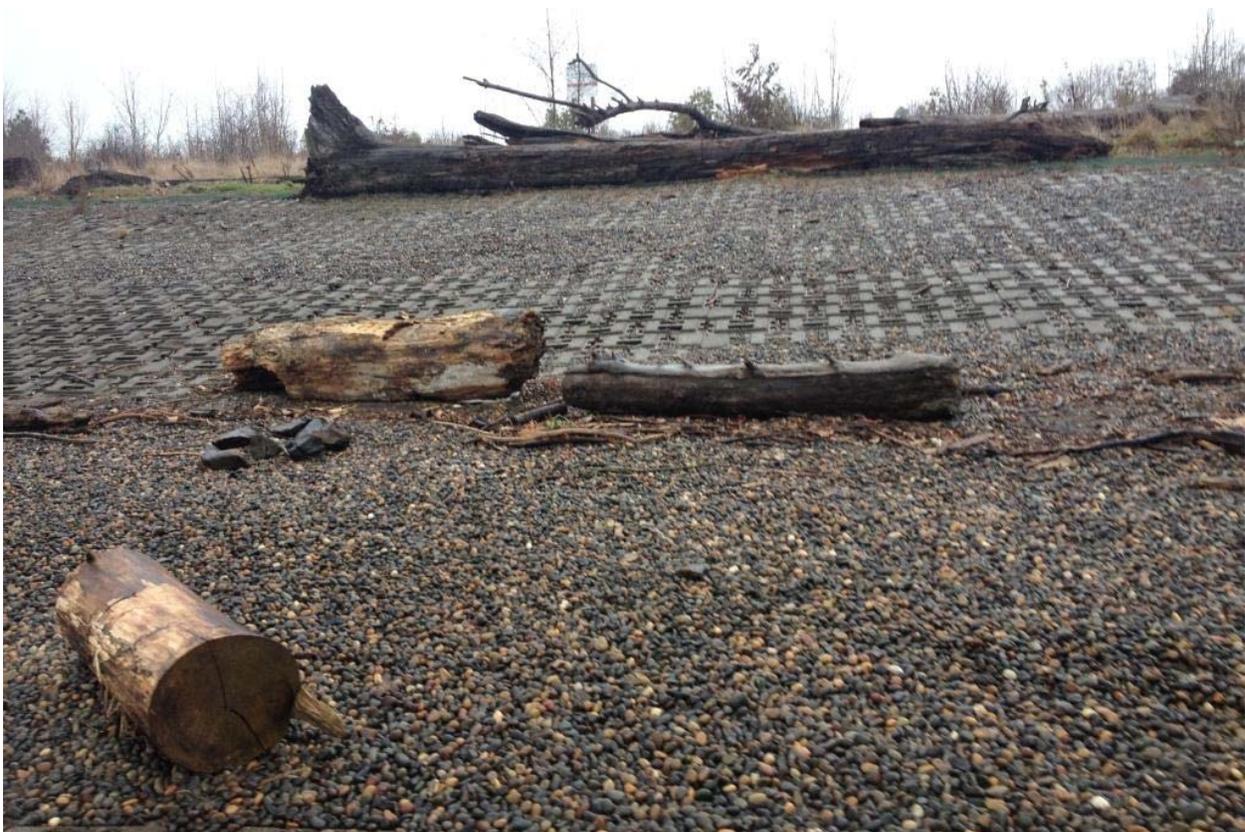
Photograph 14 – Photograph showing variation in habitat gravel cover as it settled into ACB armorment along the shoreline. Photograph taken facing northeast.

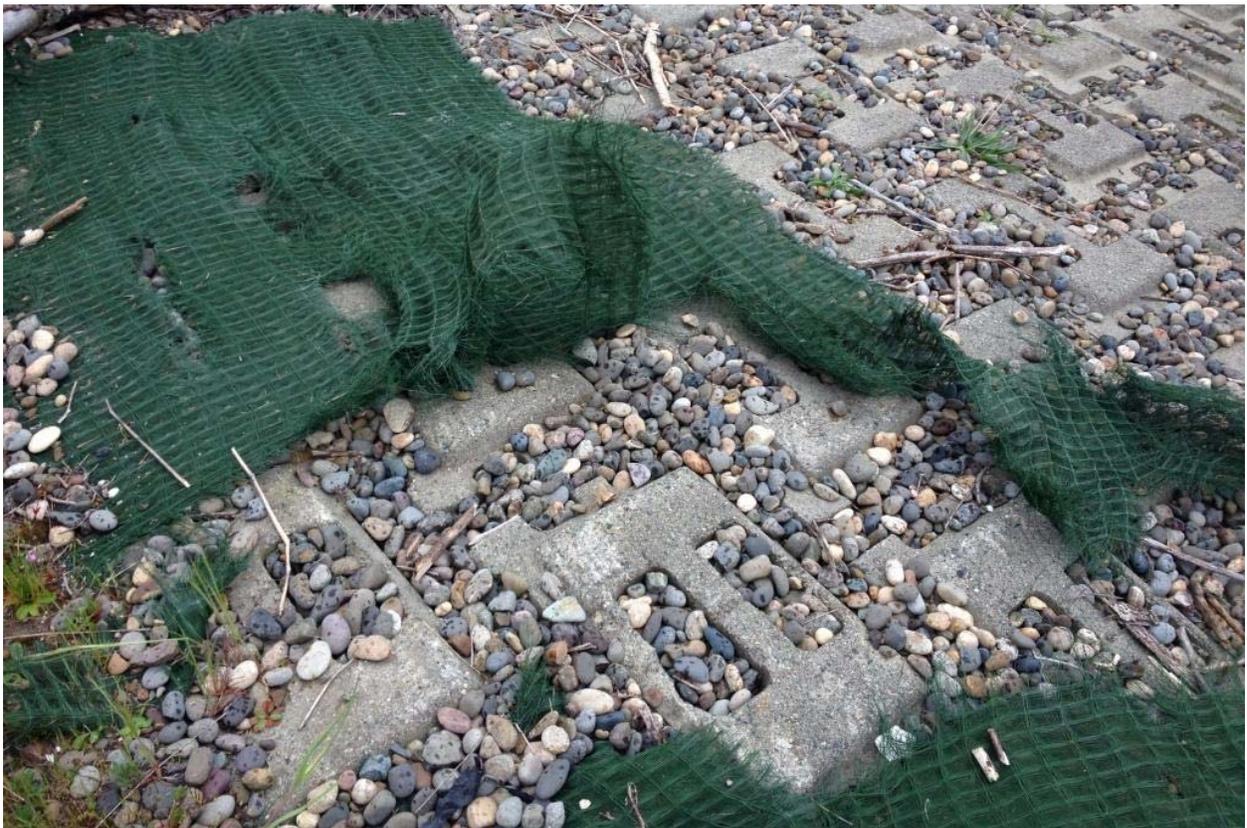
Photograph 16 – Typical damage to TRM at the lower Riparian Area where TRM meets ACB armoring. Photograph taken facing south.

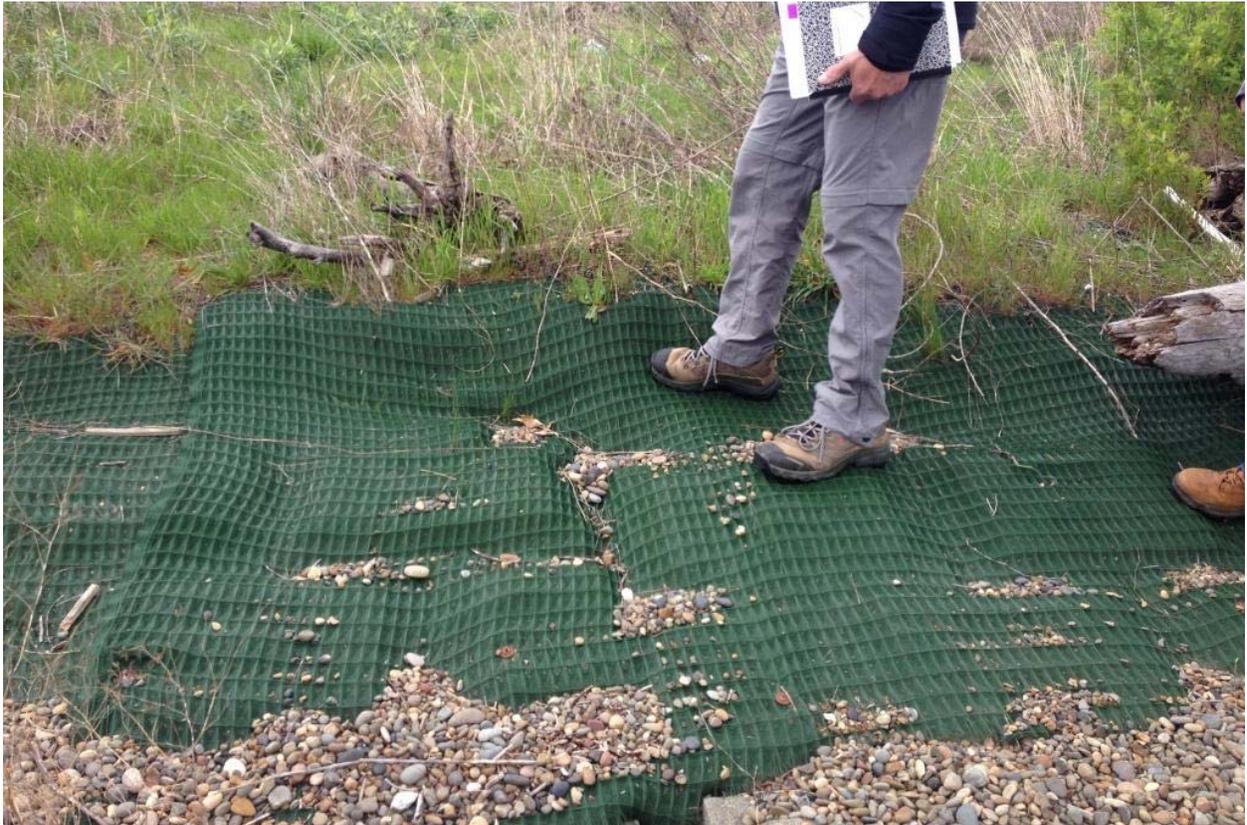
Photograph 17 – Photograph showing TRM overlapping ACB at lower Riparian Area. Void spaces have grown in some areas under the TRM. Photograph taken facing northeast.

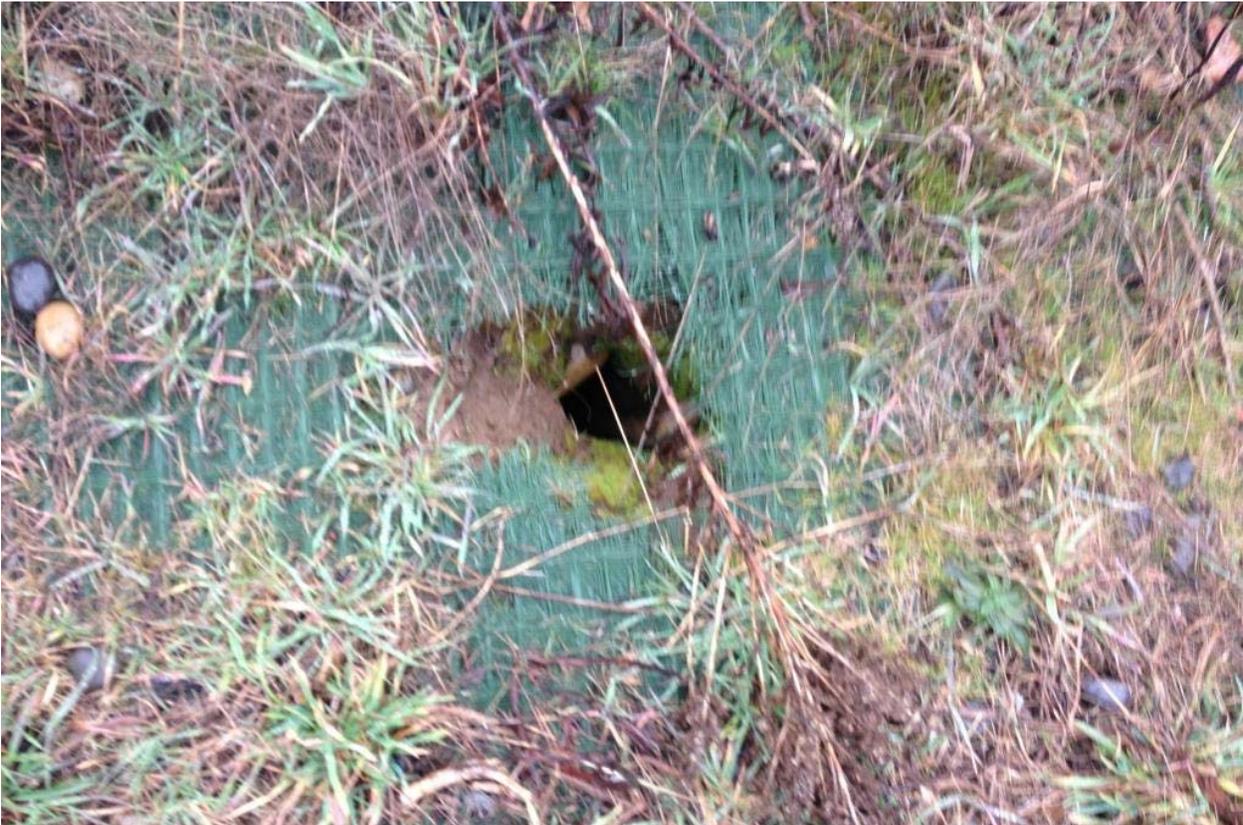
Photograph 19 – Typical burrowing observed through TRM in the Riparian Area.

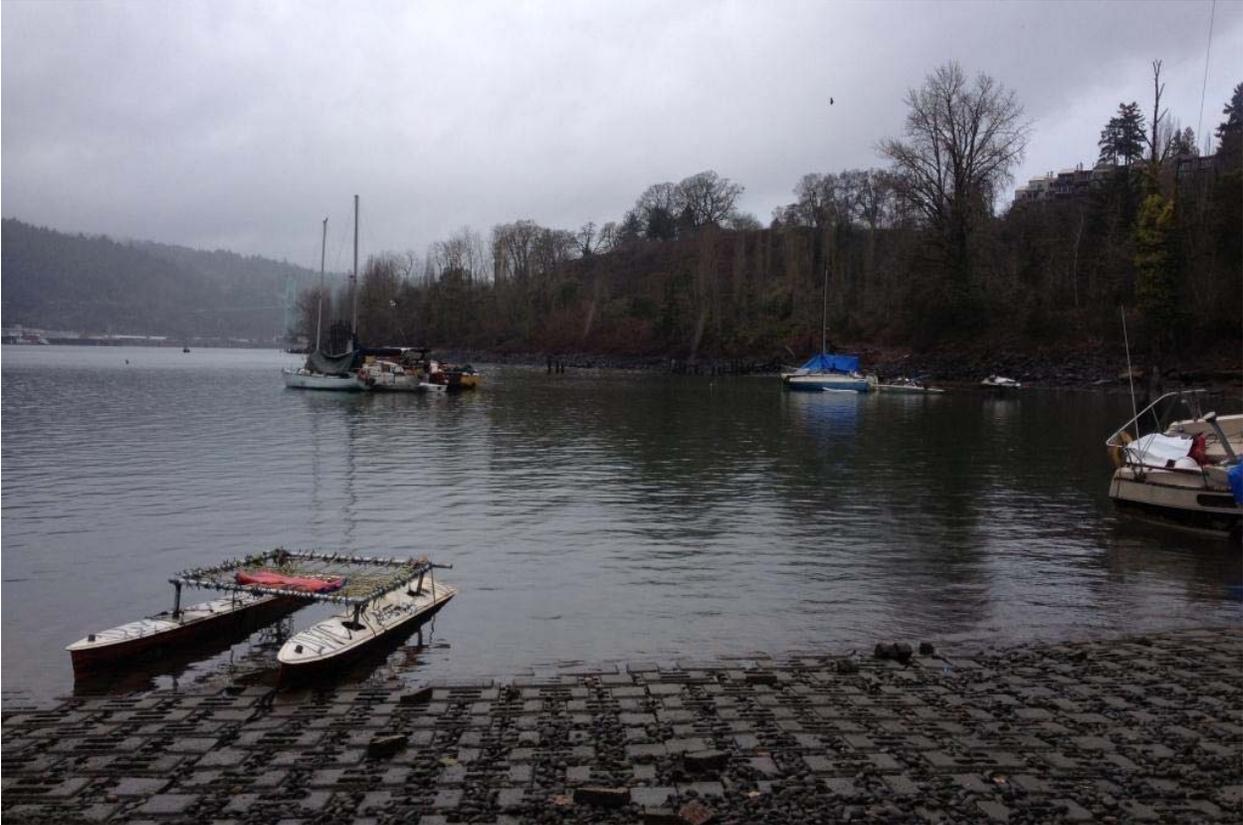
Numerous dilapidated boats (used as dwellings) were seen anchored in the Willamette Cove during every site visit (Photographs 20 and 21, Appendix A). No effects to the sediment cap were observed from mooring or from physical contact with these boats on the sediment cap. Although no damage to

Photograph 20 – Transient boats observed in Willamette Cove. Photograph taken facing west.

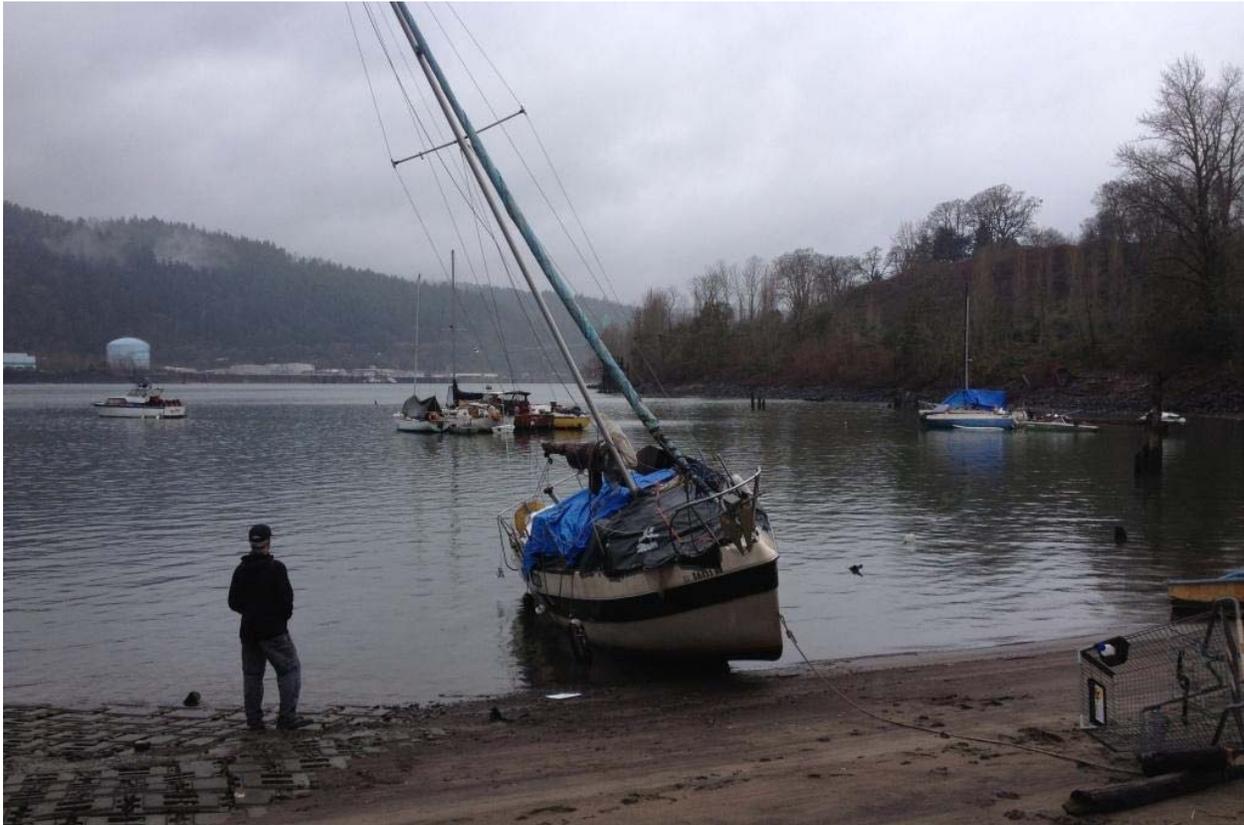
Photograph 21 – Transient boat moored and resting on the edge of the sediment cap. Photograph taken facing west.

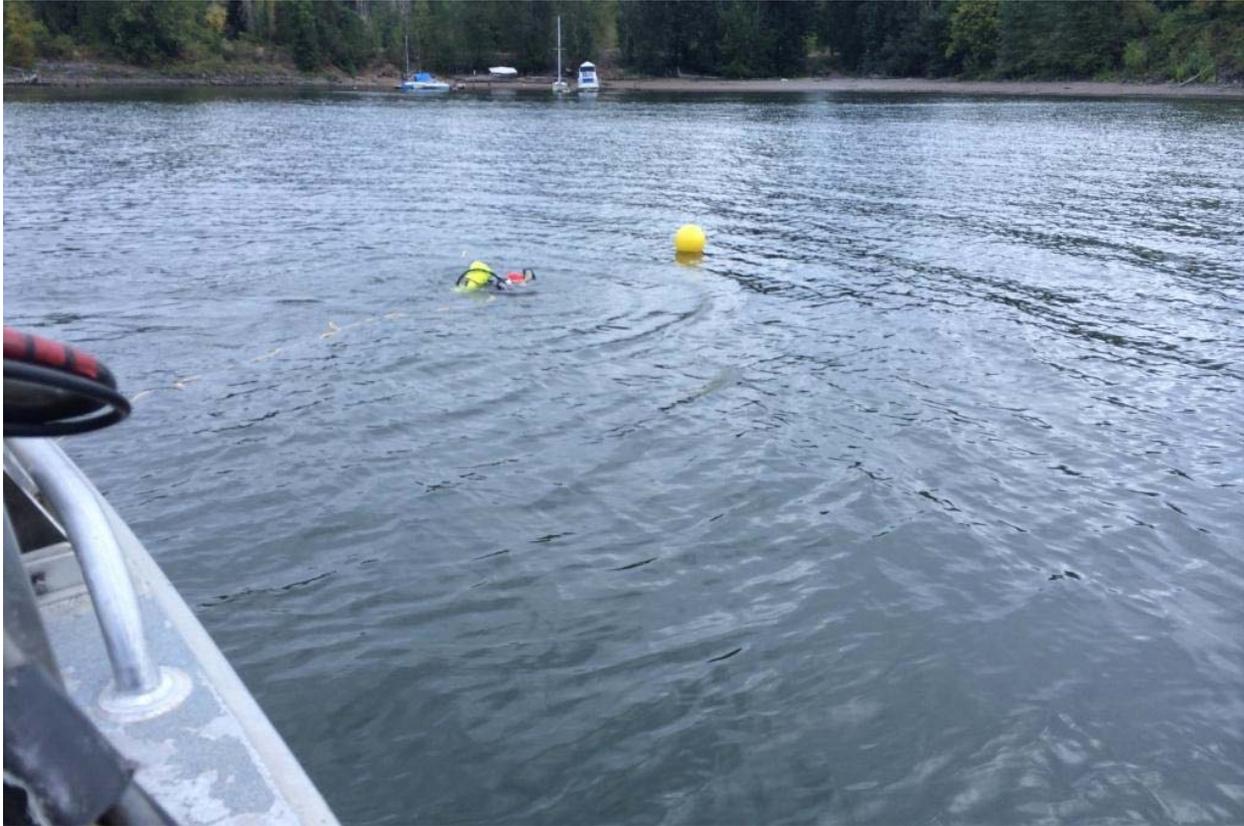
Five permanent buoys were installed in August 2011 along the perimeter of the sediment cap warning boaters of navigational hazards. During the January 2014 site inspection, it was observed that Buoy #4 was missing. This was confirmed during site inspections in April and July 2014. An underwater inspection of the buoy location was conducted in September 2014 as described below.

Photograph 22 – Diver searching for missing Buoy #4 at Willamette Cove. Photograph taken facing northeast.

On September 10, 2014, Hart Crowser and Ballard Underwater Construction (Ballard) mobilized to the site to determine the circumstances regarding the missing buoy. Prior to the inspection, it was unclear whether the buoy was submerged or completely missing. The buoy anchor (concrete ecology block) was located with no hardware attached. The buoy, the buoy chain, and securing hardware were all missing. The diver also inspected the sediment cap armoring around the anchor for damage. The 6-inch minus armoring around Buoy #4 appeared to be in good condition with no scour observed. After determining that the buoy was missing, a replacement buoy was ordered. The buoy is the same model and manufacturer as the original buoy. The buoy has been ordered and is expected to be delivered to Ballard in February 2015. Hart Crowser and Ballard will install the buoy upon its delivery.

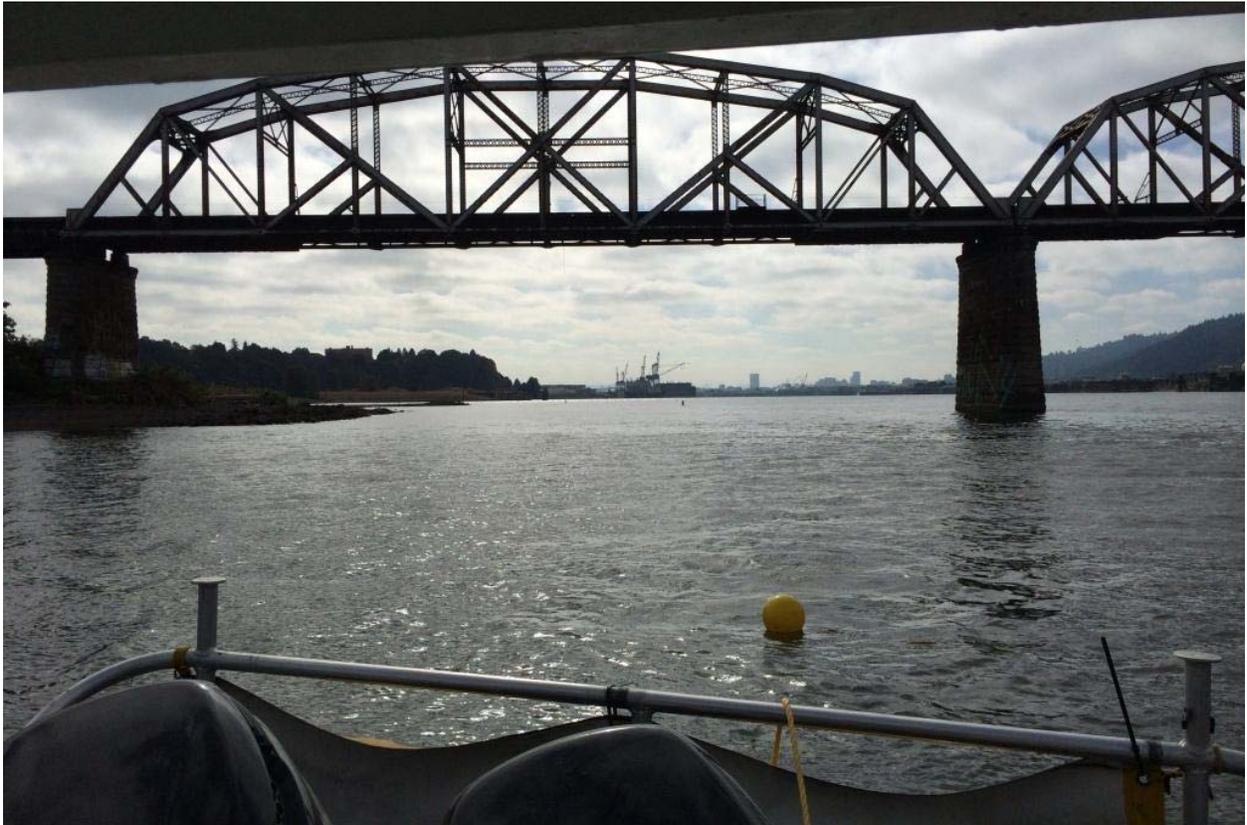
Photograph 23 – Yellow buoy is attached to the missing Buoy #4 anchor block. Photograph taken facing southeast.

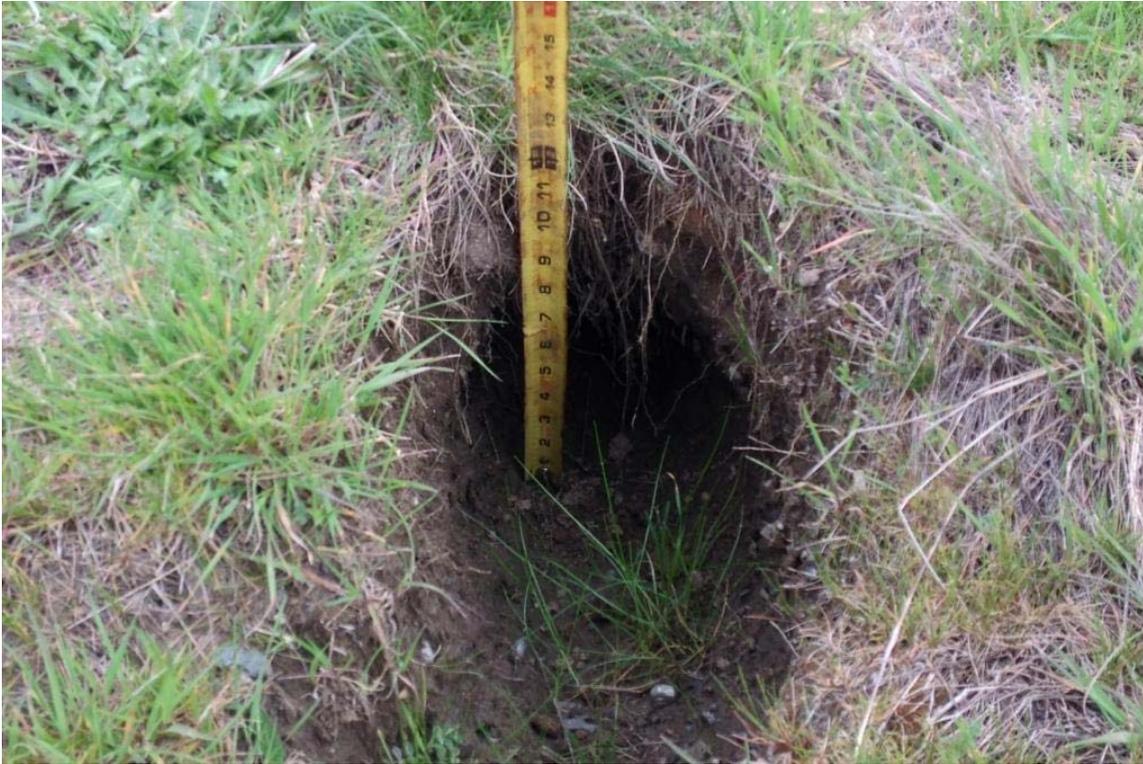
Photograph 1 – Slightly larger than typical burrow observed in the earthen cap area. (April 2014)

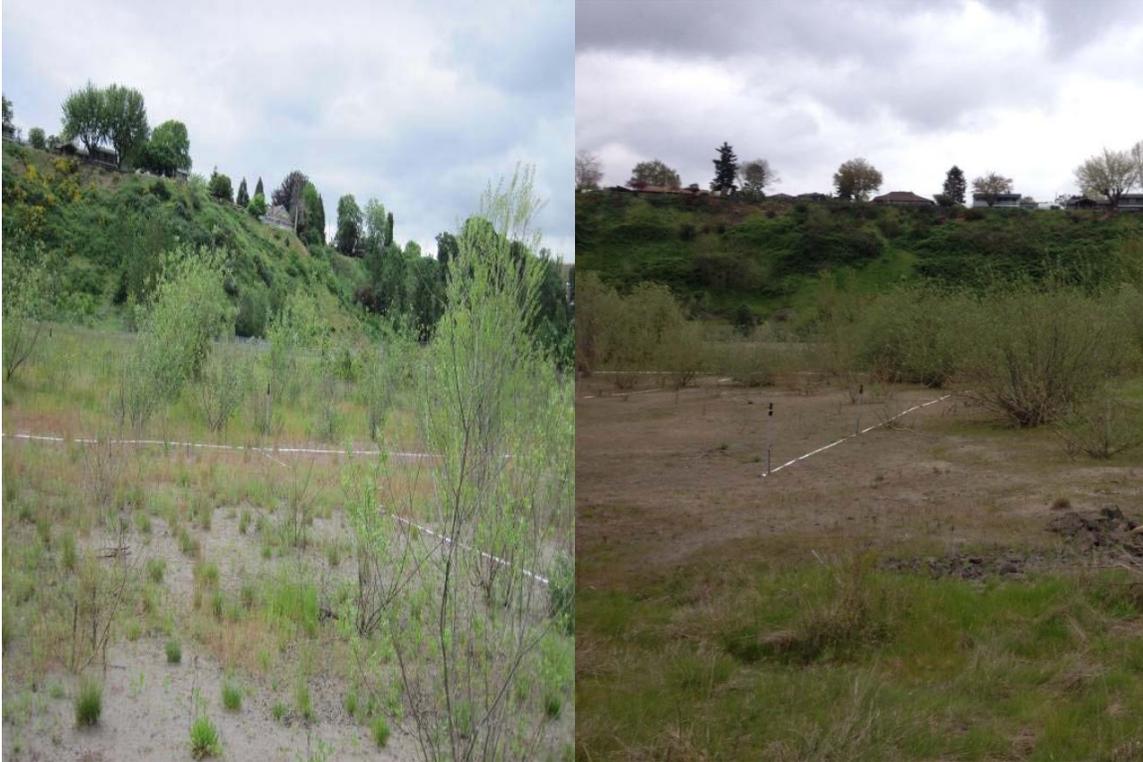
Photograph 5 – Stormwater pond scarcely vegetated although willow and alder continue to survive. Taken looking northeast from Photograph Location 4 comparing baseline and current conditions. (Left - June 2011, Right – June 2014)

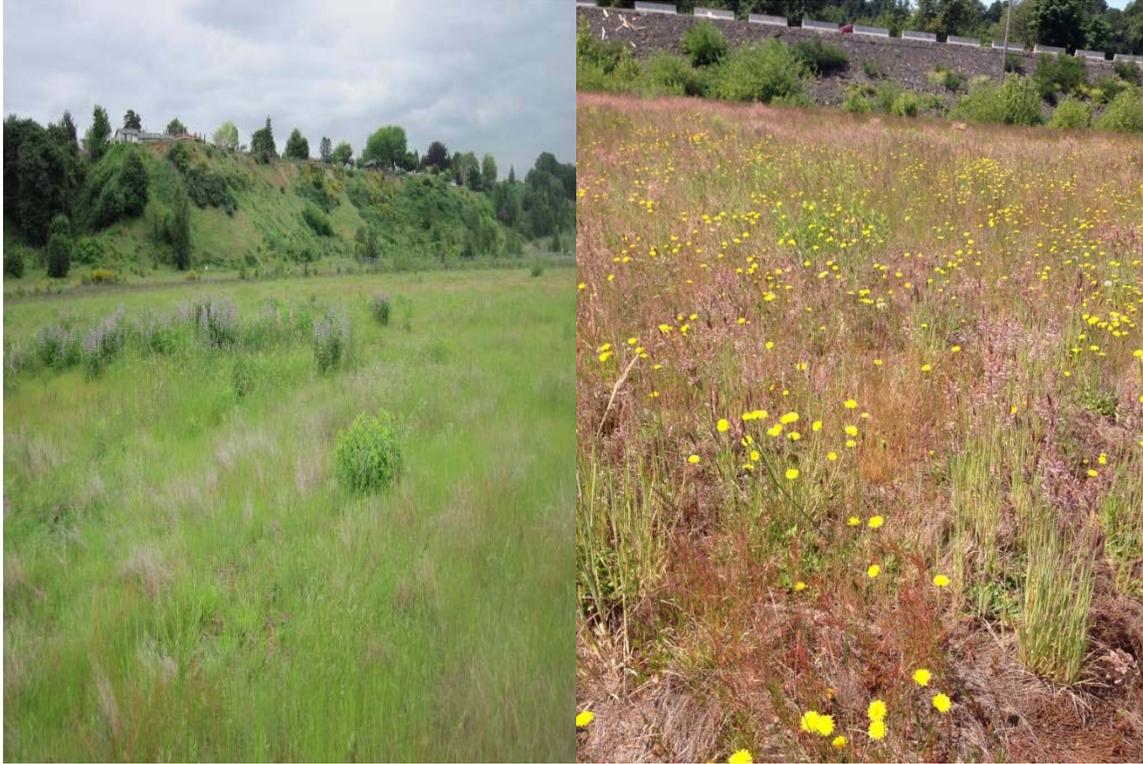
Photograph 7 – Impermeable cap dominated by grasses and herbaceous vegetation. Baseline photograph on the left taken looking east from Photograph Location 6 (June – 2011). Current conditions (Right – June 2014) show skeletonweed established on the impermeable cap.
