Attached is a copy of the Annual Cap Inspection Report for Tanner Springs Park (ESCI ID 1080). Please feel free to contact me if you have any questions.

Site: Tanner Springs Park

Inspection Date: 10/21/2025

Tanner Springs Park – 2025 Annual Cap Inspection Photo Log

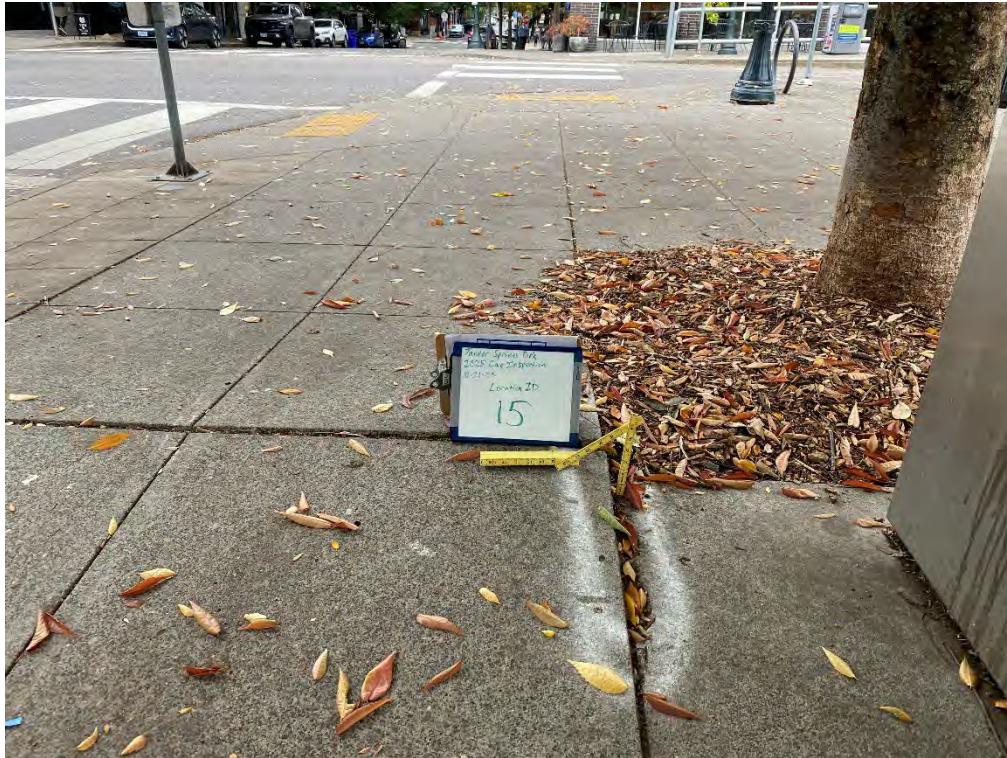
Photo Point #15

Several minor serviceable cracks in concrete were documented in the attached photo log and accompanying map. These cracks were documented in previous years inspection reports and have nominally changed in thickness. Several areas of minor separation (0.5 to 1.5 inches) were noted within the cobblestone path (photo points 6-8, and 11, 12 & 14. The separation appears to be the result of minor heave related to seasonal freeze-thaw cycles. Weathering has impacted caulked seams in the cobblestone paths and caulking was missing in a few places; however, the caulked seams were in fair condition. None of these cracks have compromised the cap or have allowed subsurface soil to be exposed. No patching is currently recommended. Photo point (15) is located where a concrete sidewalk panel is being lifted due to street tree roots. This inspection found no changes from last year at photo point (15).
