**SUBJECT: 2026 Environmental Cap Inspection at Cosmopolitan on the Park  
Condominium 1075 NW Northrup Street, Portland, Oregon**

**Site Photographs**

Annual Cap Inspection  
Cosmopolitan on the Park  
1075 NW Northrup Street, Portland, Oregon

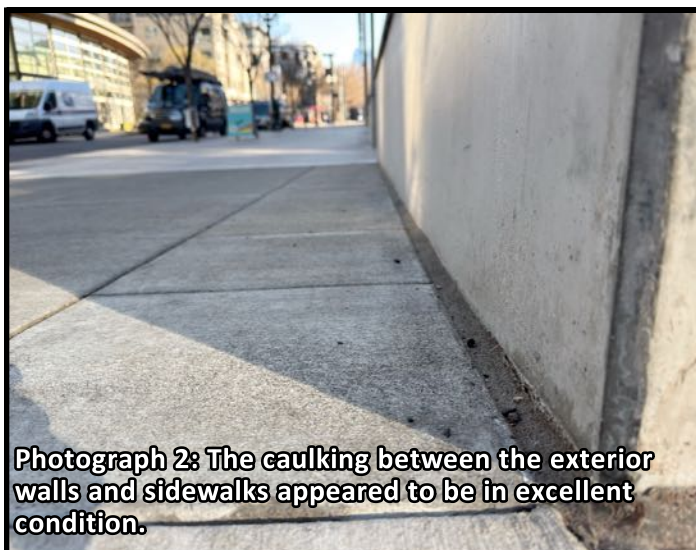
**Photograph 2: The caulking between the exterior walls and sidewalks appeared to be in excellent condition.**

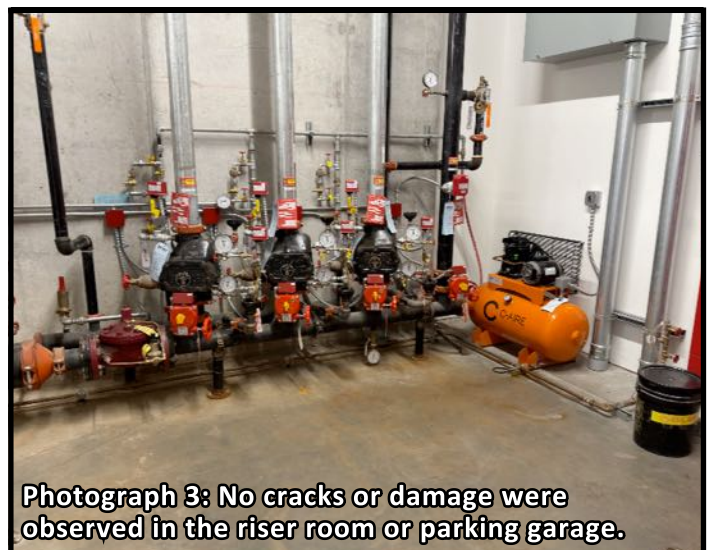
**Photograph 3: No cracks or damage were observed in the riser room or parking garage.**

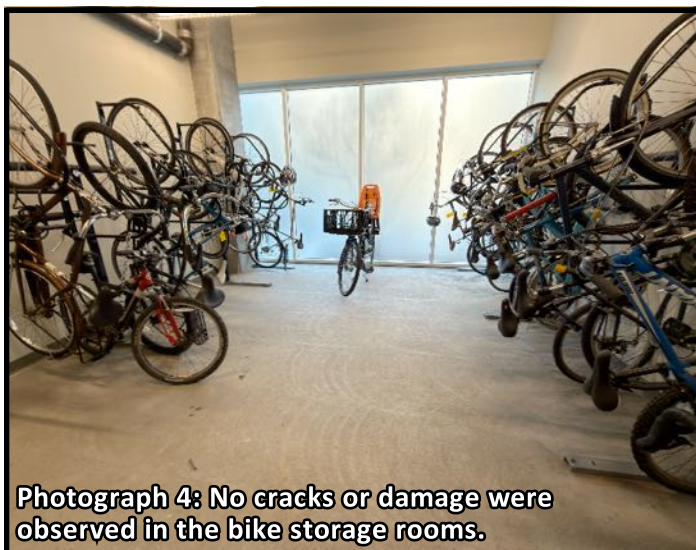
**Photograph 4: No cracks or damage were observed in the bike storage rooms.**

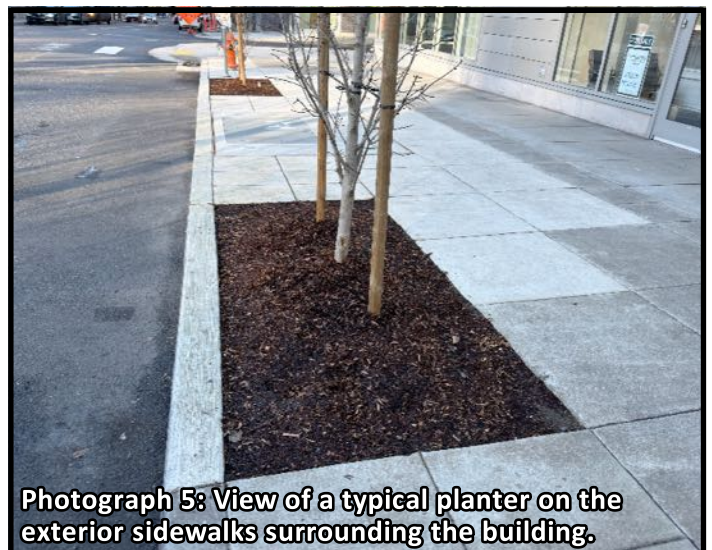
**Photograph 5: View of a typical planter on the exterior sidewalks surrounding the building.**
