February 18, 2026

**SUBJECT: 2026 Environmental Cap Inspection at The Encore Condominiums,
949 NW Overton Street, Portland, Oregon 97209**

Annual Cap Inspection
Encore Condominiums
949 NW Overton Street, Portland, Oregon

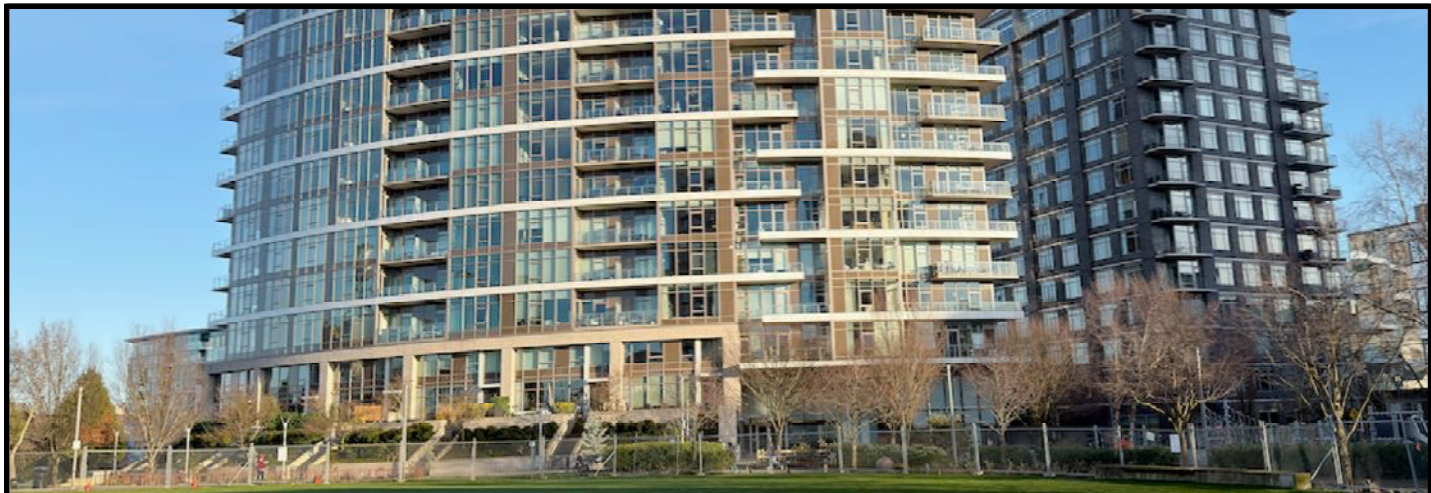
Photograph 1: Wide-angle view of the southeastern exterior of the Encore Condominiums

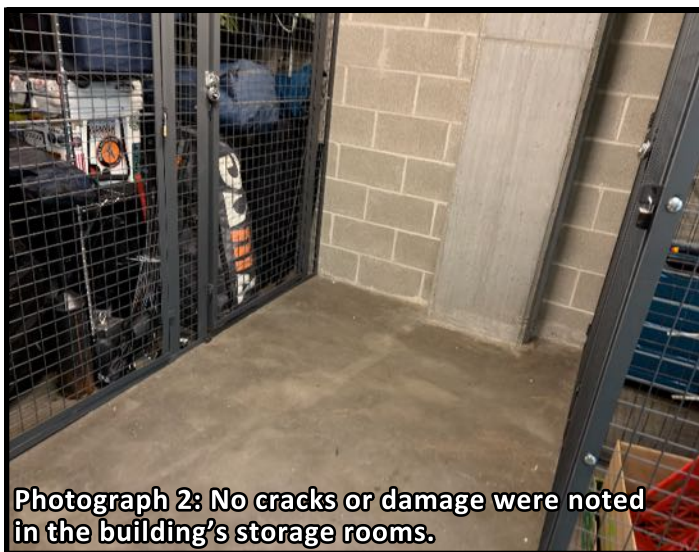
Photograph 2: No cracks or damage were noted in the building's storage rooms.

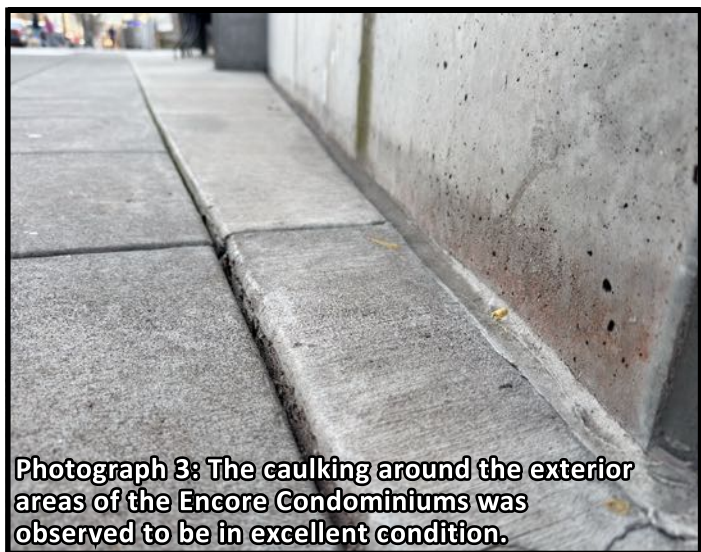
Photograph 3: The caulking around the exterior areas of the Encore Condominiums was observed to be in excellent condition.

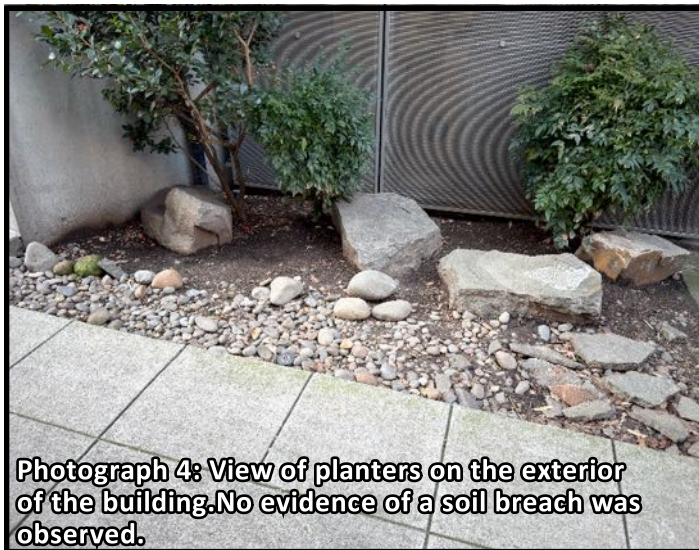
Photograph 4: View of planters on the exterior of the building. No evidence of a soil breach was observed.

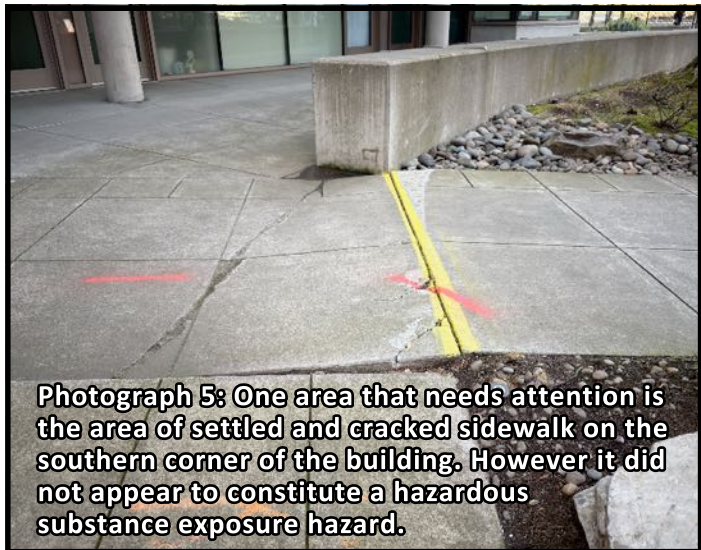
Cracks and/or Settlement in vertical cement or flatwork? Y/N	Exposure Hazard? Y/N	Repair Required? Y/N
Some settlement and cracking was observed in the outdoor sidewalk area at the southern corner of the building near the intersection of NW 9 th Avenue and NW Overton Street.	Despite the cracked and settled condition of the sidewalk, no apparent exposed soil or groundwater seepage was observed, so no exposure hazard was evident.	It is recommended that the sidewalk area be repaired.
Holes or Penetrations? Y/N	Exposure Hazard? Y/N	Repair Required? Y/N
No holes or penetrations were observed.	No	No
Exposed Soil or Fabric Y/N?	Exposure Hazard? Y/N	Repair Required? Y/N
Soil was visible in planters, but no geotextile barrier was observed.	No	No
Problematic Surface Water Drainage Features?	Exposure Hazard? Y/N	Repair Required? Y/N
Problematic surface water drainage features were not observed.	No	No
Cracked or Missing Caulking?	Exposure Hazard? Y/N	Repair Required? Y/N

Photograph 5: One area that needs attention is the area of settled and cracked sidewalk on the southern corner of the building. However it did not appear to constitute a hazardous substance exposure hazard.

Some settlement and cracking was observed in the outdoor sidewalk area at the southern corner of the building near the intersection of NW 9th Avenue and NW Overton Street. Although, no apparent exposed soil or groundwater seepage was observed and no exposure hazard was evident, it is recommended that the sidewalk area be repaired.
