SUBJECT: 2026 Environmental Cap Inspection at Vibrant! Apartments, 1620 NW 14th Avenue, Portland, Oregon 97209

Annual Cap Inspection
Vibrant! Apartments
1620 NW 14th Avenue, Portland, Oregon

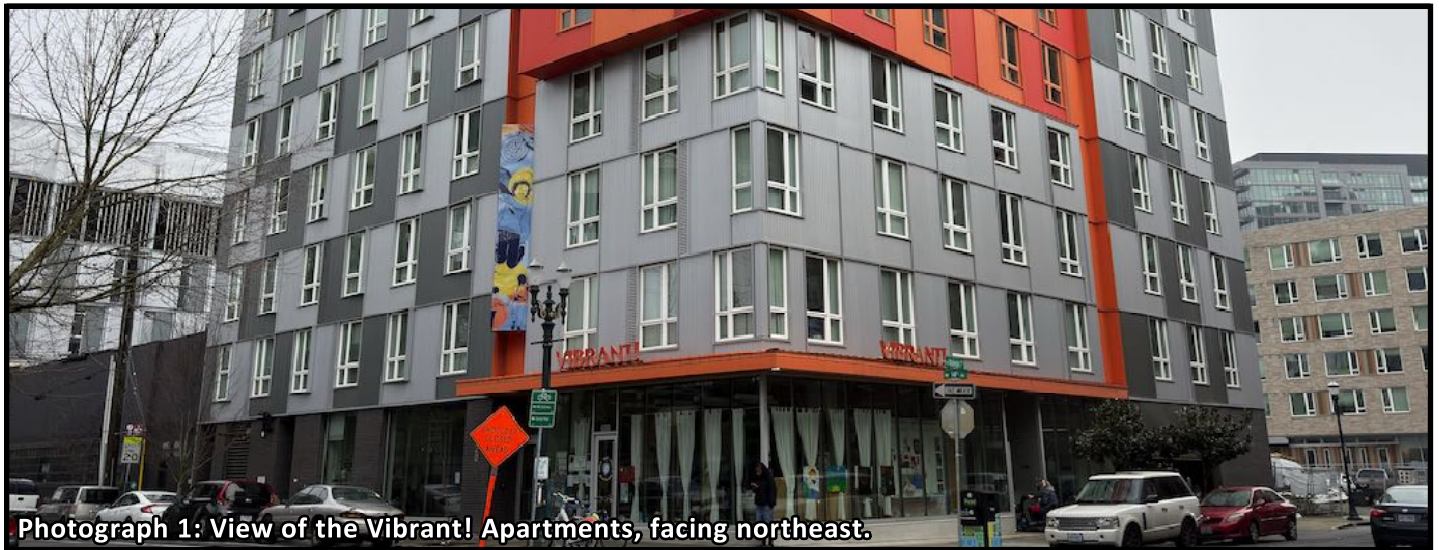
Photograph 1: View of the Vibrant! Apartments, facing northeast.

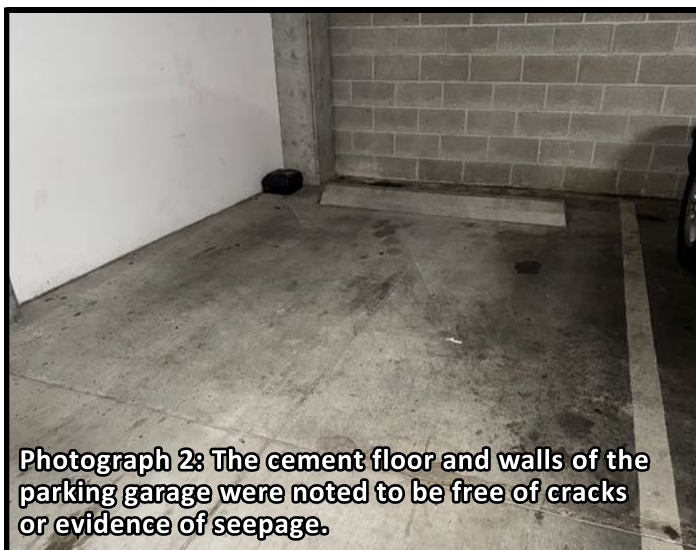
It is my professional opinion that there were no areas where the soil cap or the geotextile membrane used to delineate the top of the cap were visible at any of the inspection points. The silicone caulking between the building and sidewalk was observed to be intact and undamaged, and no areas of groundwater seepage were noted in the walls or floors of the basement parking garage.

Photograph 2: The cement floor and walls of the parking garage were noted to be free of cracks or evidence of seepage.

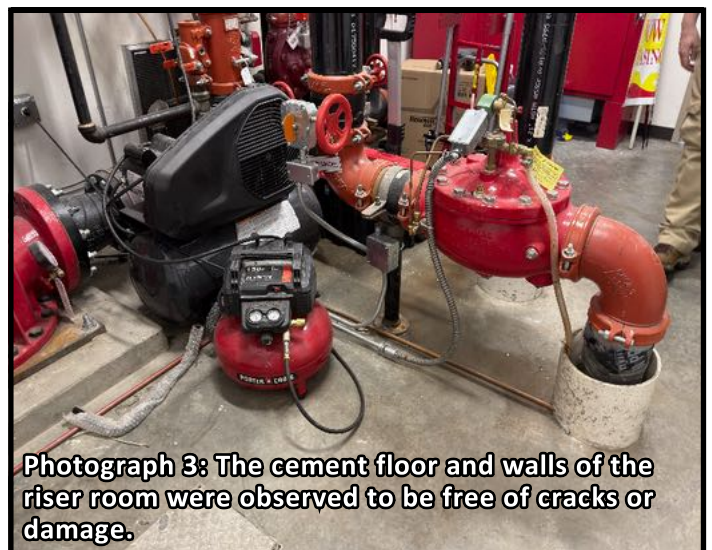
Photograph 3: The cement floor and walls of the riser room were observed to be free of cracks or damage.

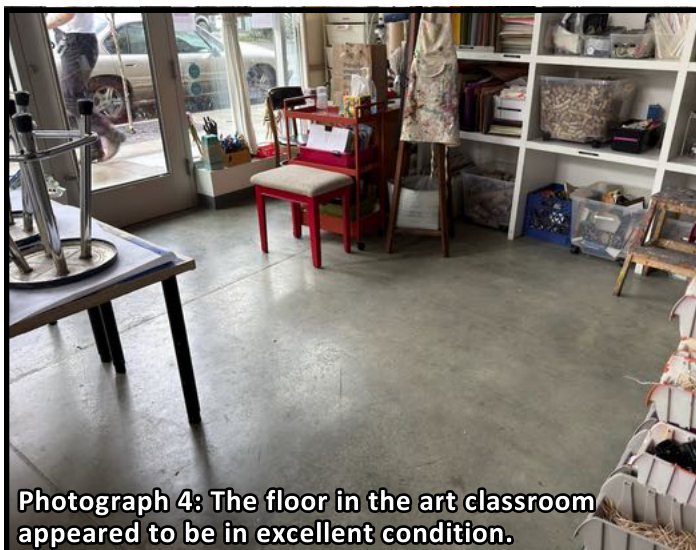
Photograph 4: The floor in the art classroom appeared to be in excellent condition.

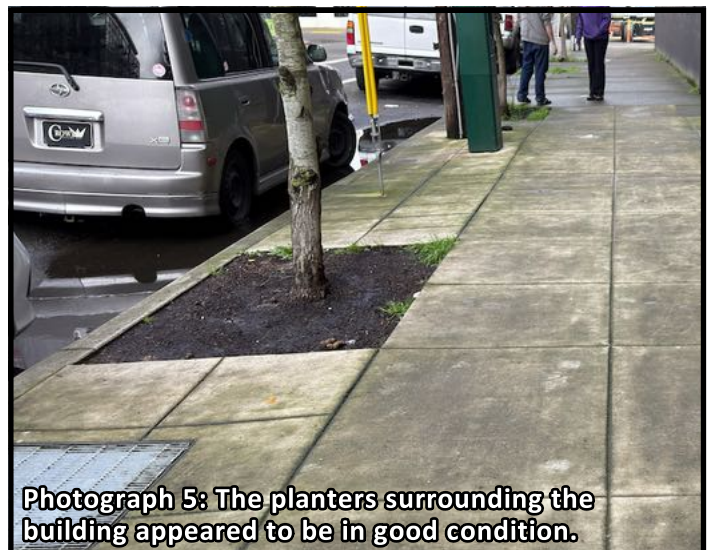
Photograph 5: The planters surrounding the building appeared to be in good condition.
