Site: The Fields Neighborhood Park

Inspection Date: 10/21/2025

2025 Cap Inspection

The Fields Park - 2025 Annual Cap Inspection Photo Log

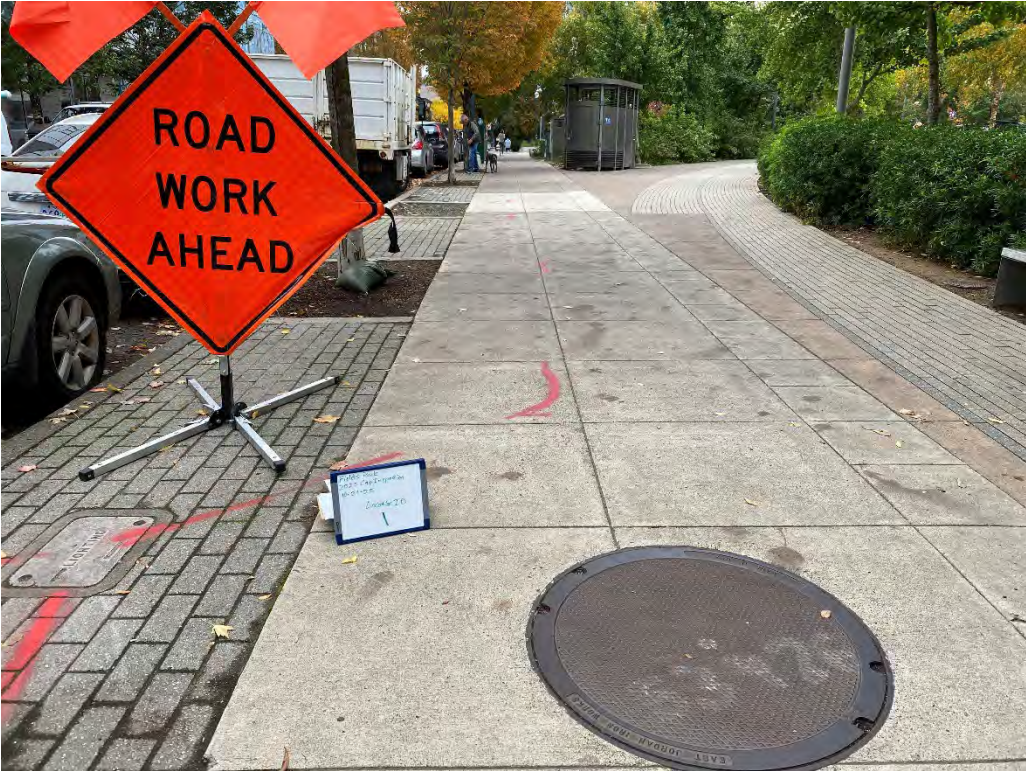
Photo Point #1

Minor surficial cracking and evidence of settling was observed in the concrete sidewalks on the perimeter of the park (photo points 1-3 and 6-13). The minor cracks (generally <0.5 inches) were observed in previous inspections and do not penetrate the cap.

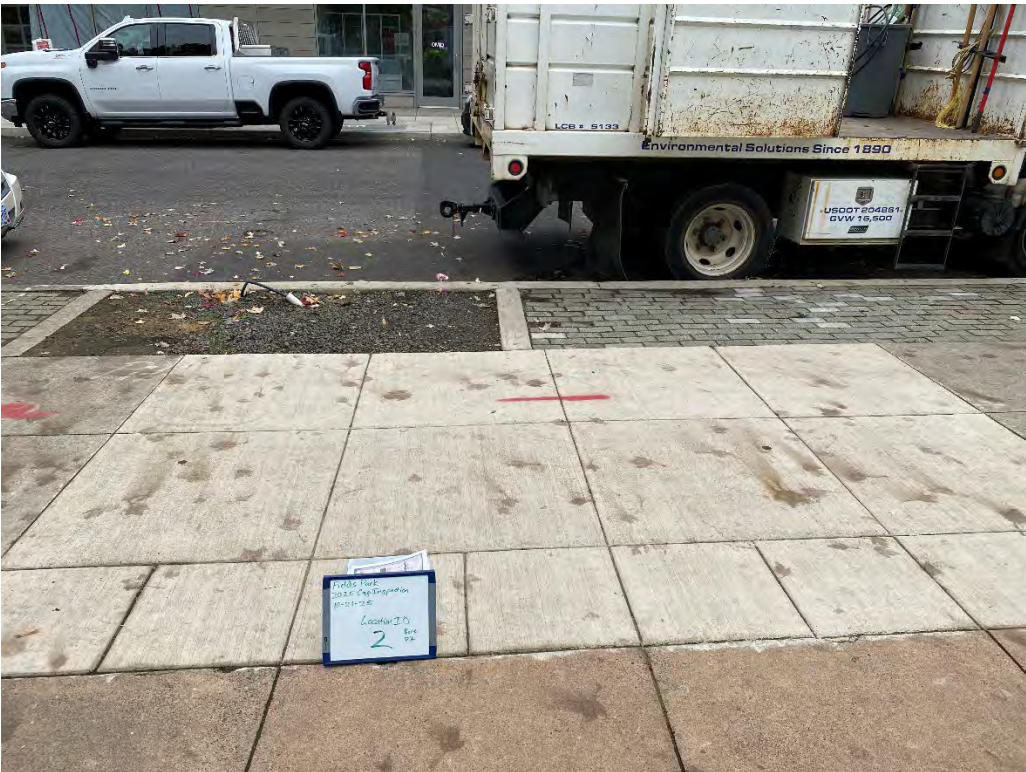
Photo Point #2

The concrete sidewalk panels on the south side of the park on NW Overton St were recently replaced by PacificCorp (Photo Point #2). The panels replaced a section of sidewalk that was removed by PacificCorp to allow for connection to the existing electrical main.

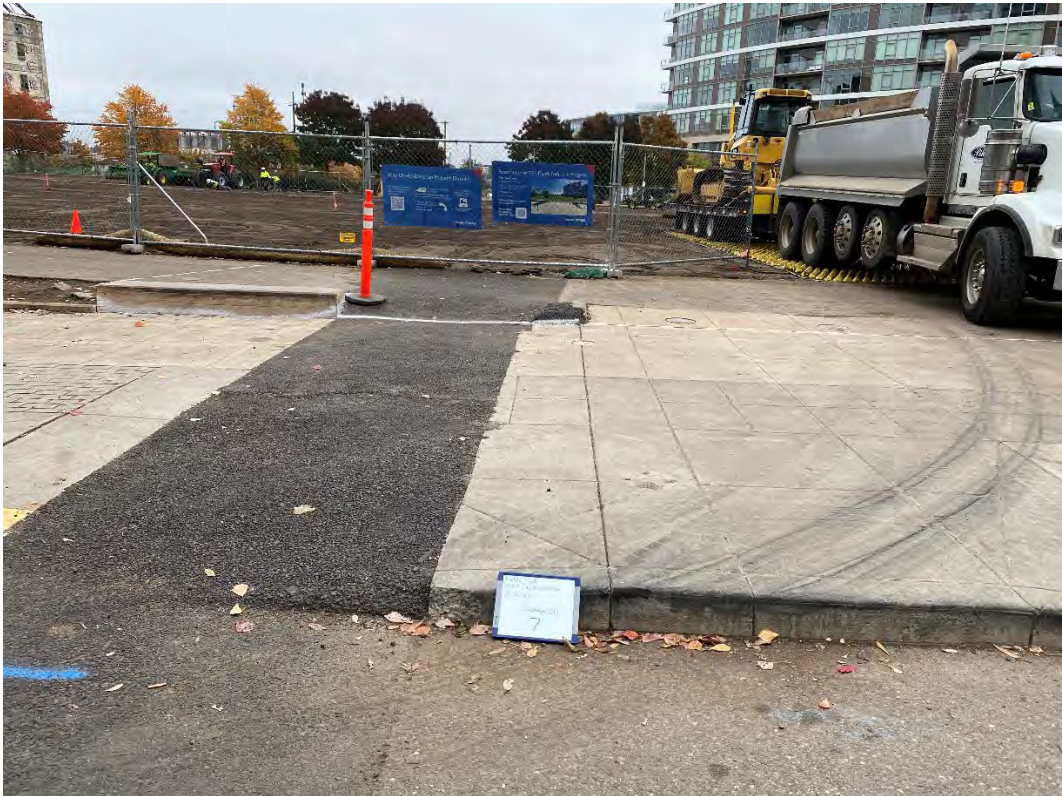
Photo Point #7a

The concrete sidewalk, driveway, and apron at NW Pettygrove St and NW 14th Ave on the western side of the park is damaged because of heavy equipment loading and installation of PacificCorp’s new electrical main (Photo Points #7a and #7b). PacificCorp is planning to replace the temporary asphalt, sidewalk, and driveway with a new concrete surface upon completion of site activates. Parks will continue to meet with DEQ and the PacificCorp construction team to

track repair progress and will continue to monitor and correct cap deficiencies until construction is complete.

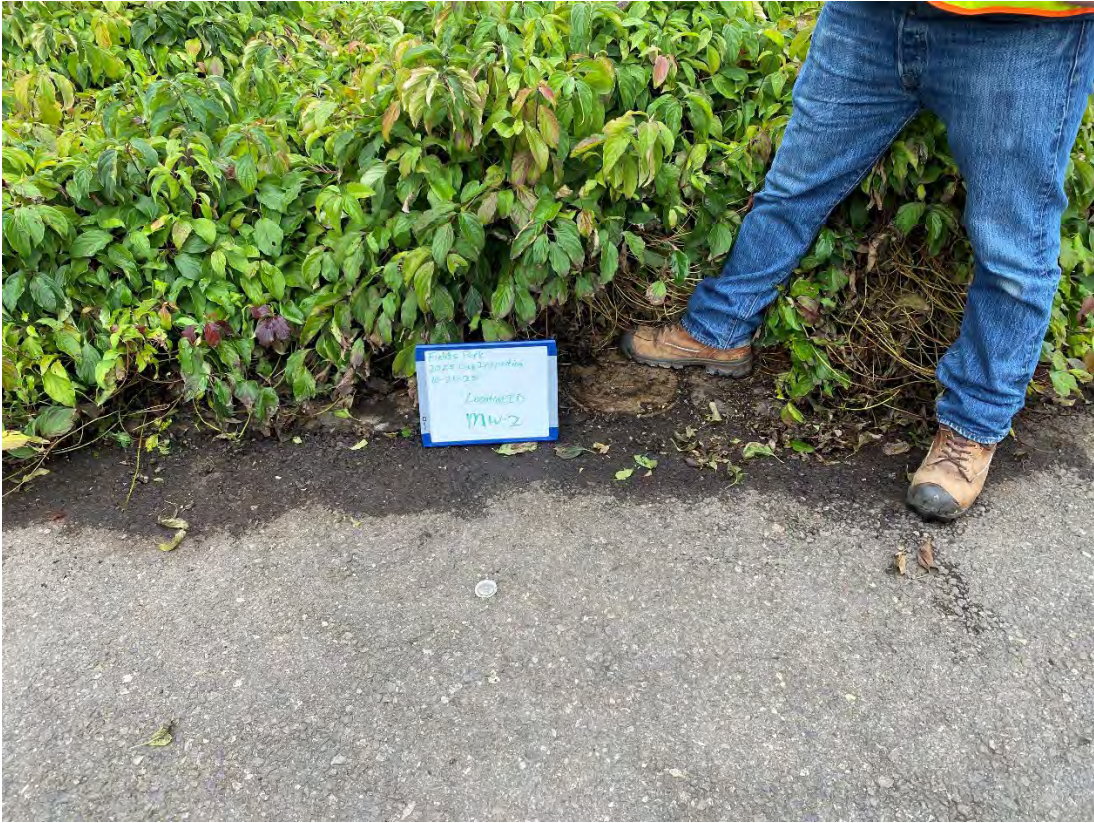
Photo Point MW2

Monitoring wells 2, 3, and 4 were decommissioned in December 2023 by a Burlington Northern Santa Fe (BNSF) contractor. The monument for monitoring well 3 has been completely removed and replaced with a new concrete sidewalk panel. Monitoring wells 2 and 4 have been grouted in place and the monuments remain. The remaining monuments were in good condition. See attached Photo Log for current year inspection photos. Parks will continue to monitor these locations in the future.
