Seismic Vulnerability Assessment Phase 1

Phillips 66 Terminal Portland, Oregon

for Phillips 66 Pipeline LLC

May 30, 2024

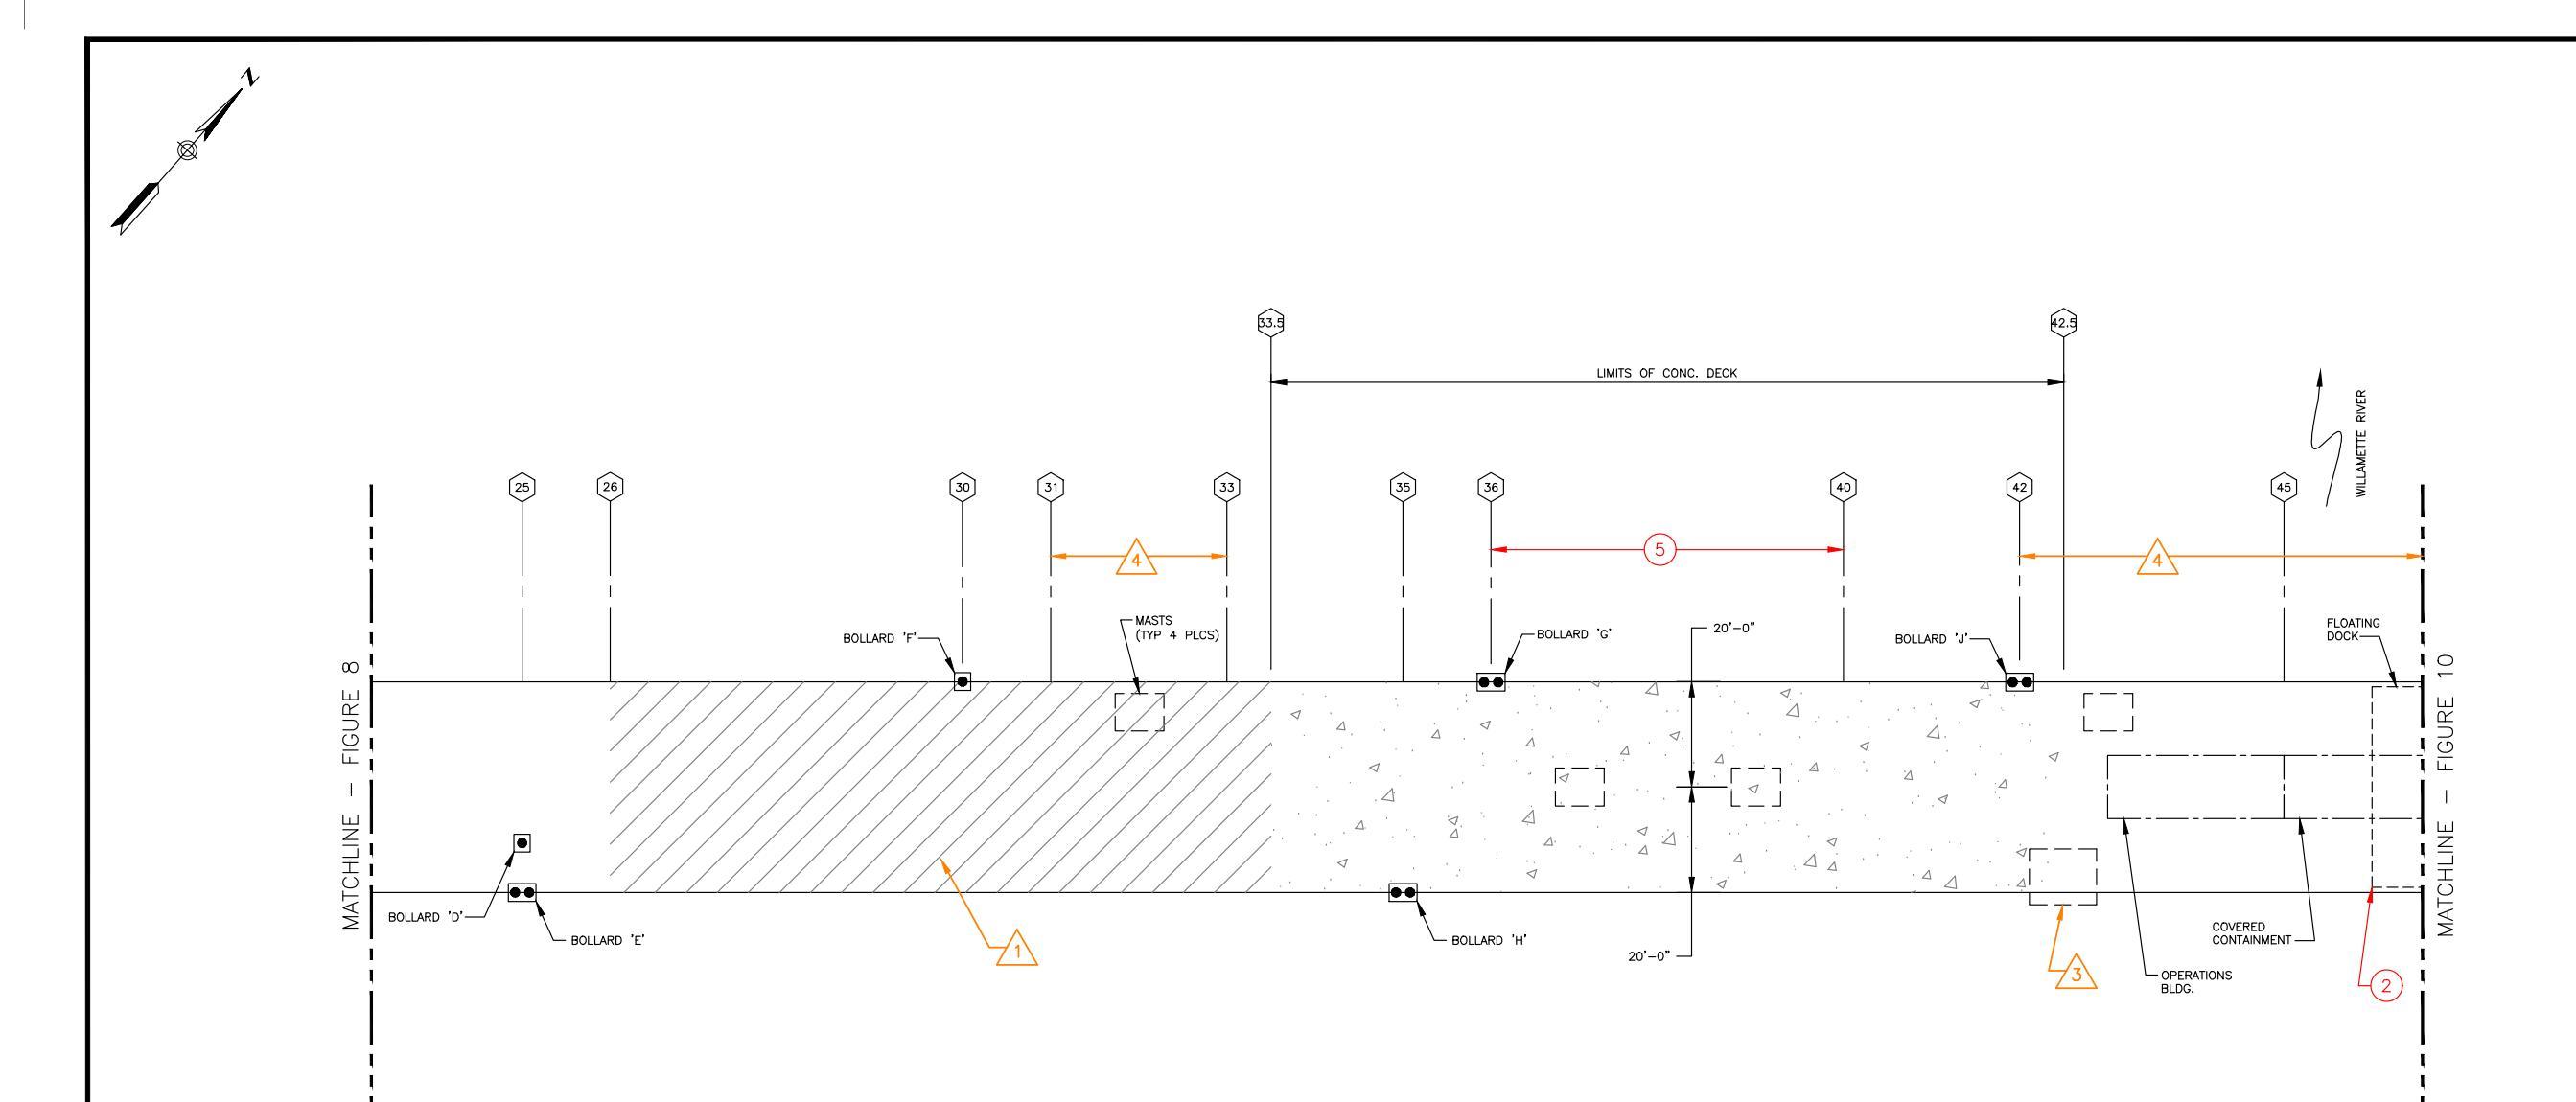
FIGURE 9: PLAN scale: 1/16"=1'-0"

- RATING ITEM #:
- MULTIPLE INDIVIDUAL DECK BOARDS SH SIGNIFICANT ROT AND LOSS OF SECTIO INFESTATION, SWELLING. THE AREA SH SURVEYED FOR BOARD REPLACEMENT. REMAINDER SHOULD BE MONITORED FO DETERIORATION.
- FLOATING DECK ACCESS BELOW DECK: TIMBER STAIR STRINGERS, HANDRAILS, LOWER LEVELS THIS END.
- REPLACE INDIVIDUAL DECK BOARDS ON SUBSTRUCTURE PLATFORM NEAR ACCES GATE.
- 4. BULLRAIL EXHIBITS SPLITTING DAMAGE.
- BULLRAIL EXHIBITS CROSS GRAIN TENS TORSIONAL SPLITTING. REPLACE.

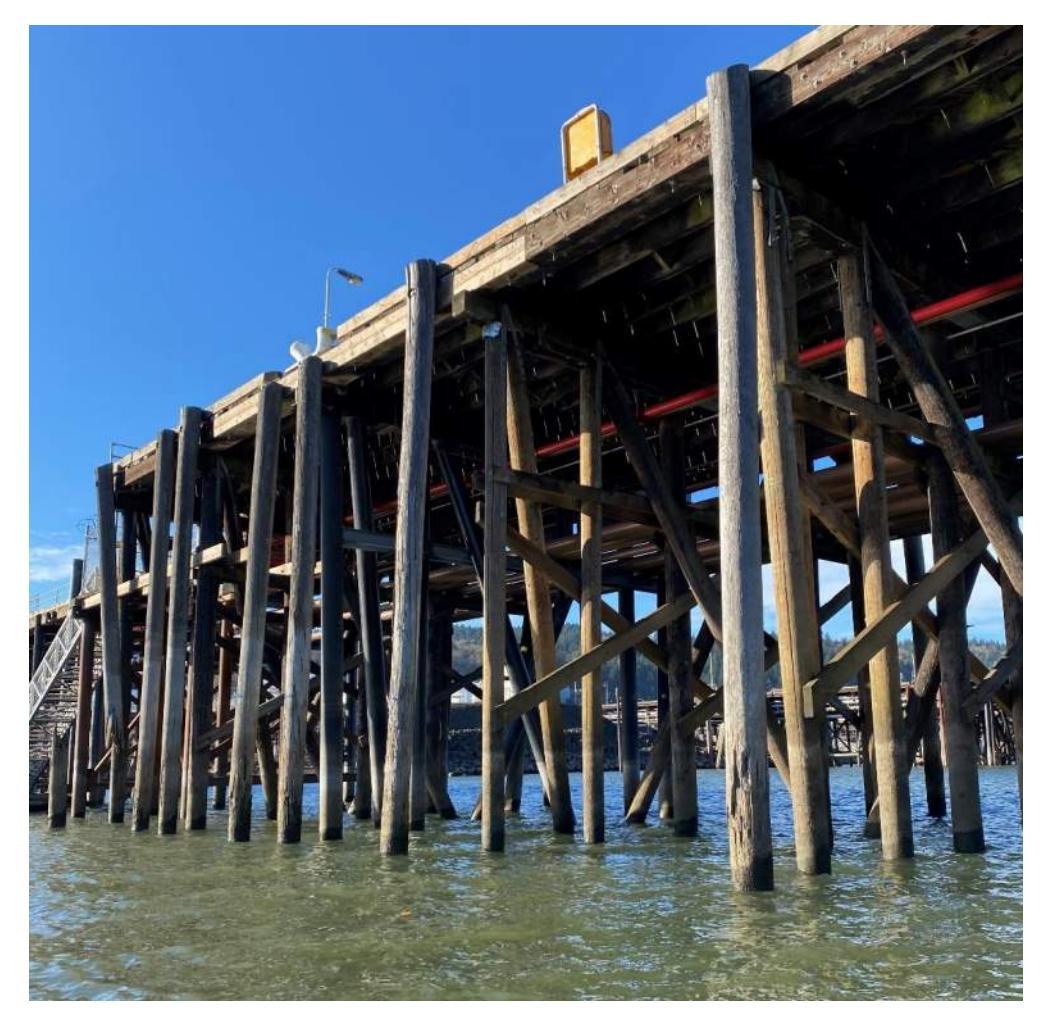
Picture 9. Upstream berth, shoreside. Note the fender piles broken at the water level., dead head.

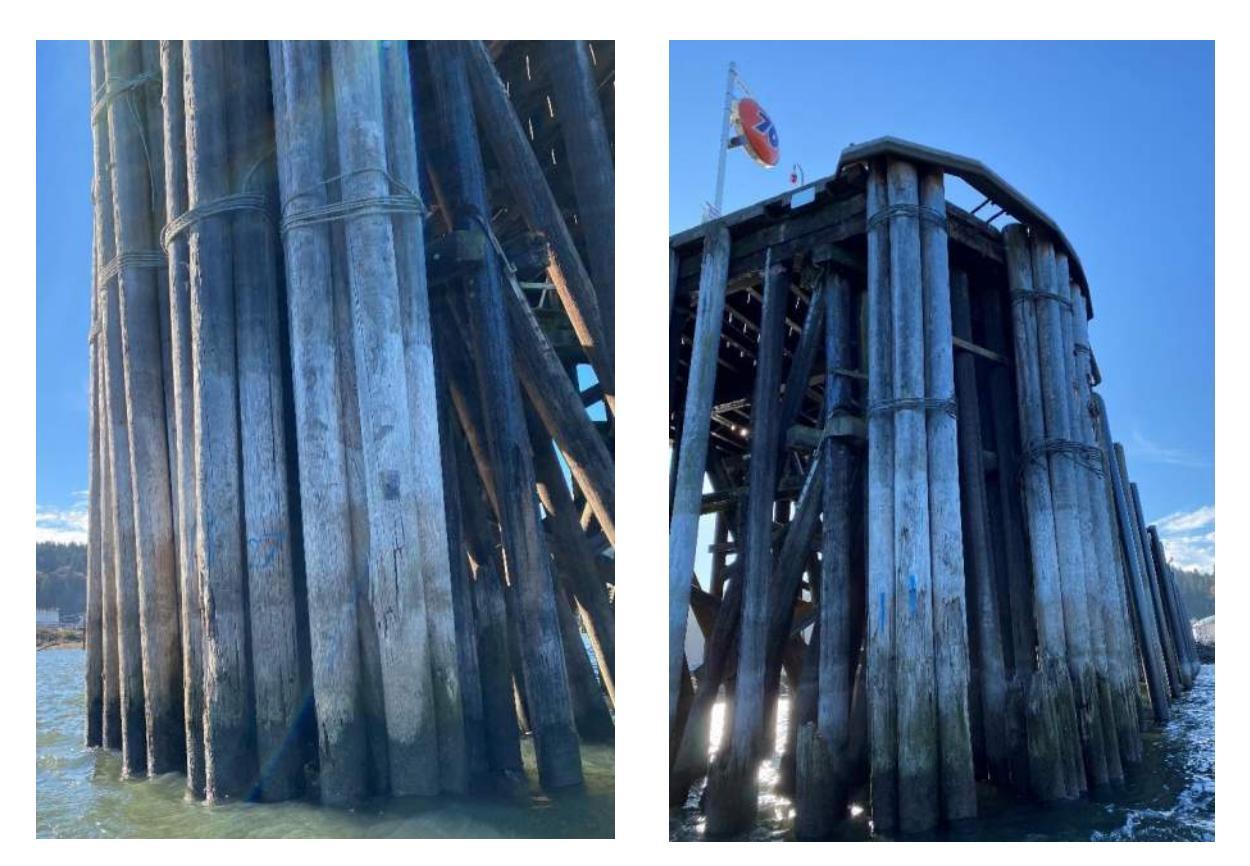
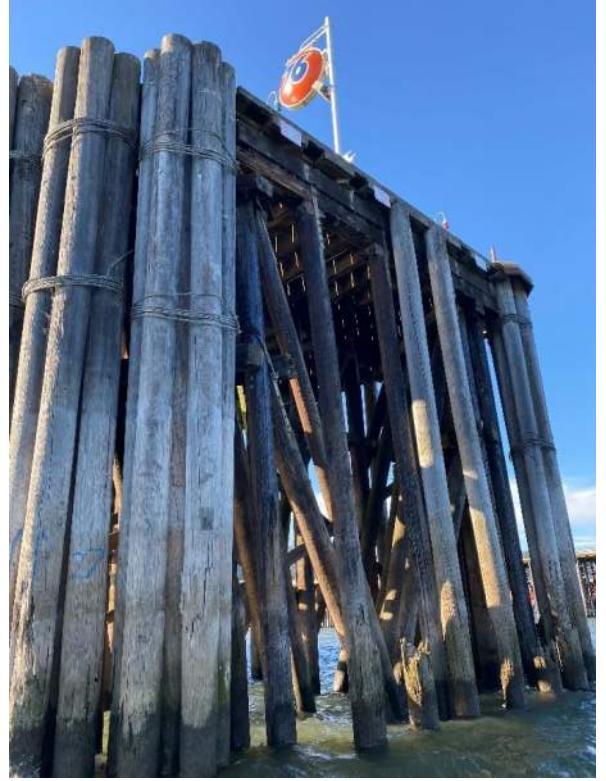
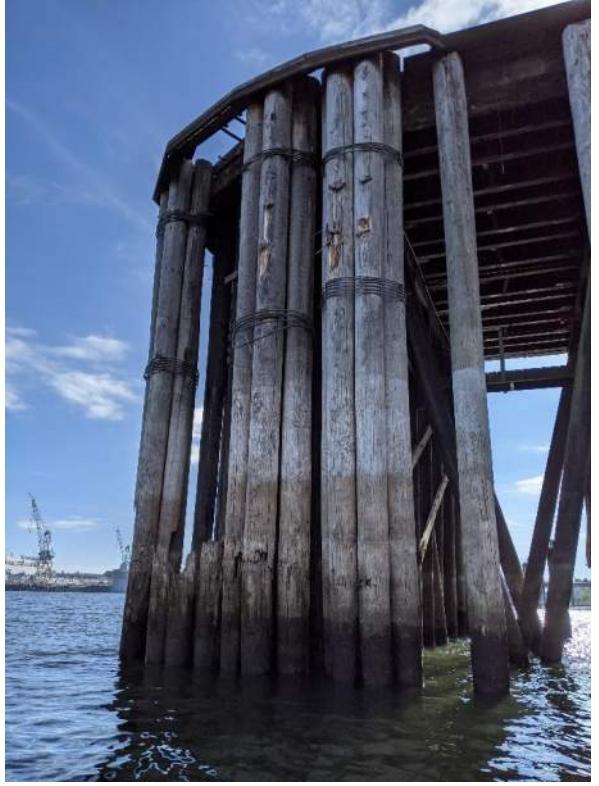
Pictures 11,12, 13, and 14. Pier head cluster piles. Note broken and missing piles, dead heads at either corner, broken and missing piles at head.

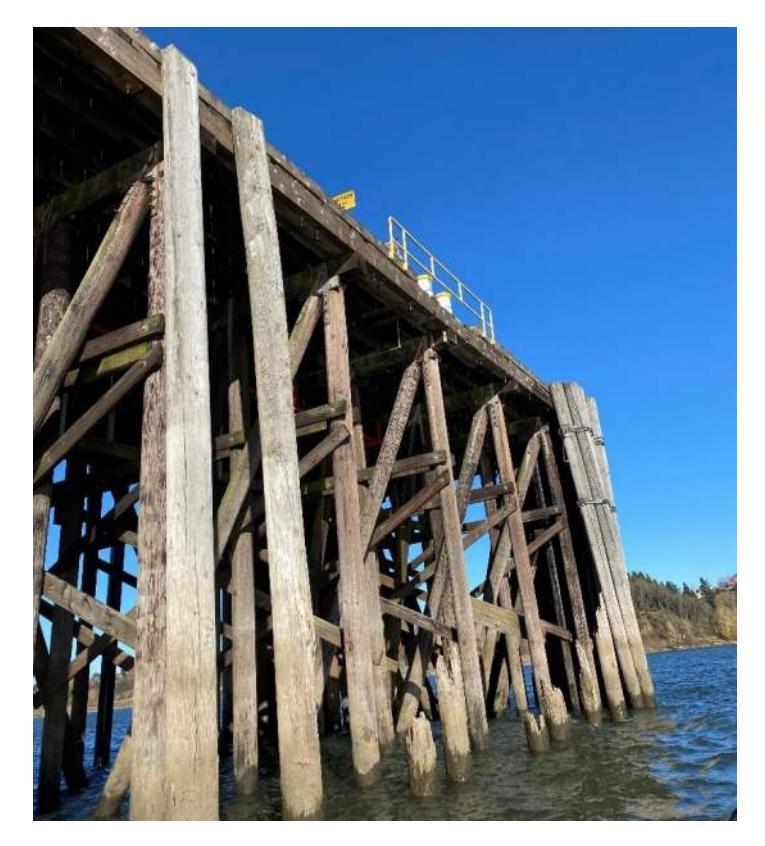
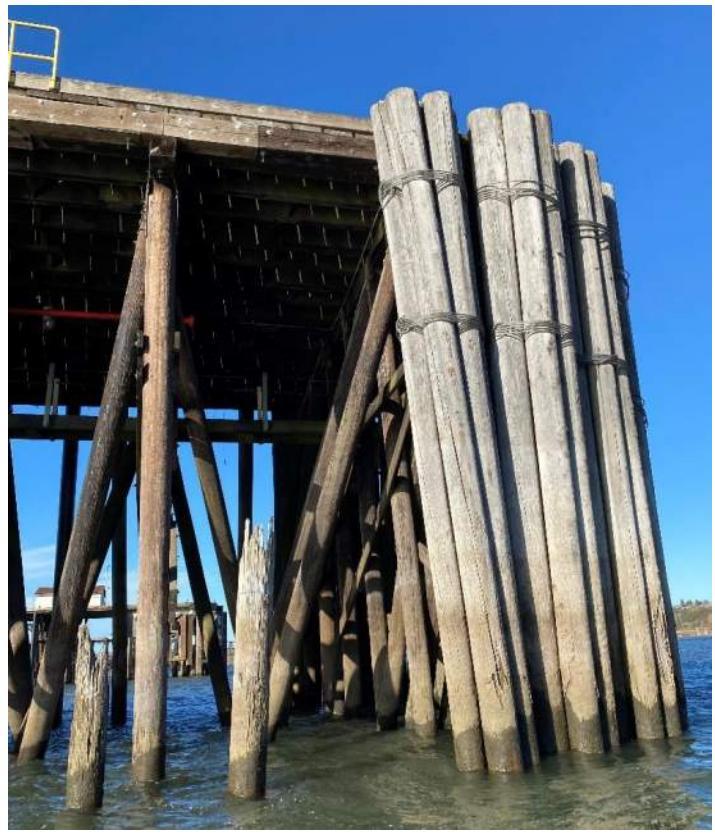
Pictures 15 and 16. Upstream berth, near head. Note broken/missing fender piles, exposed structure.

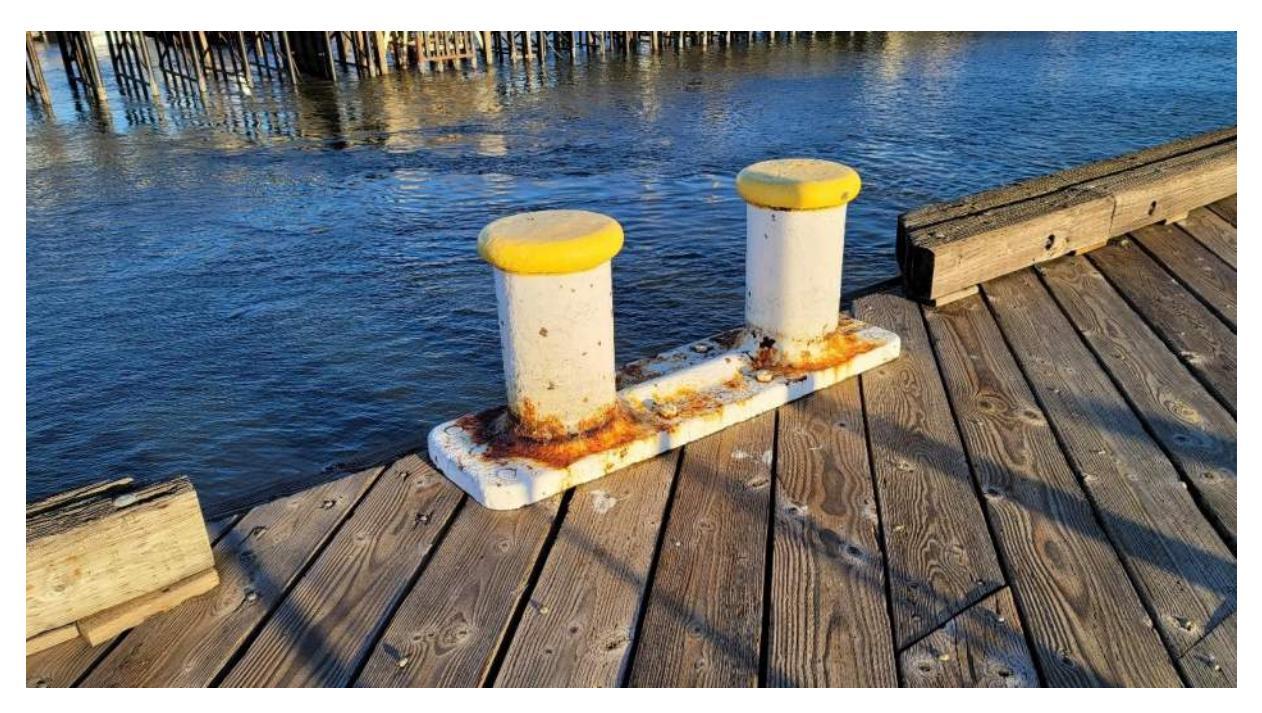
Picture 19. Bollard 'C'. Note wear to coating from line abrasion.

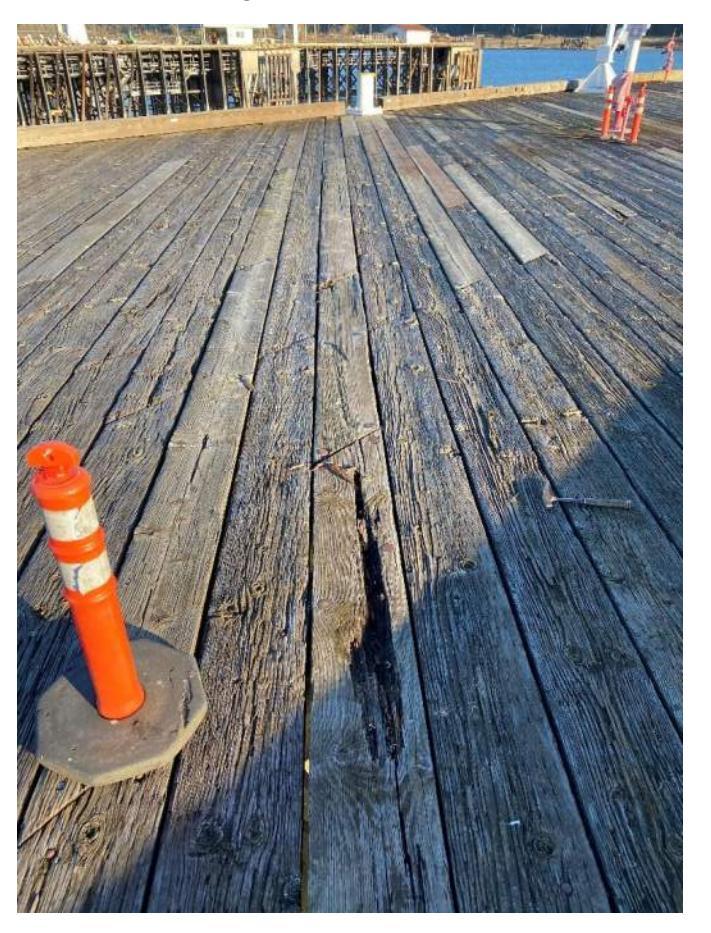
Picture 20. Evidence of significant decay to decking, shoreside of service area.

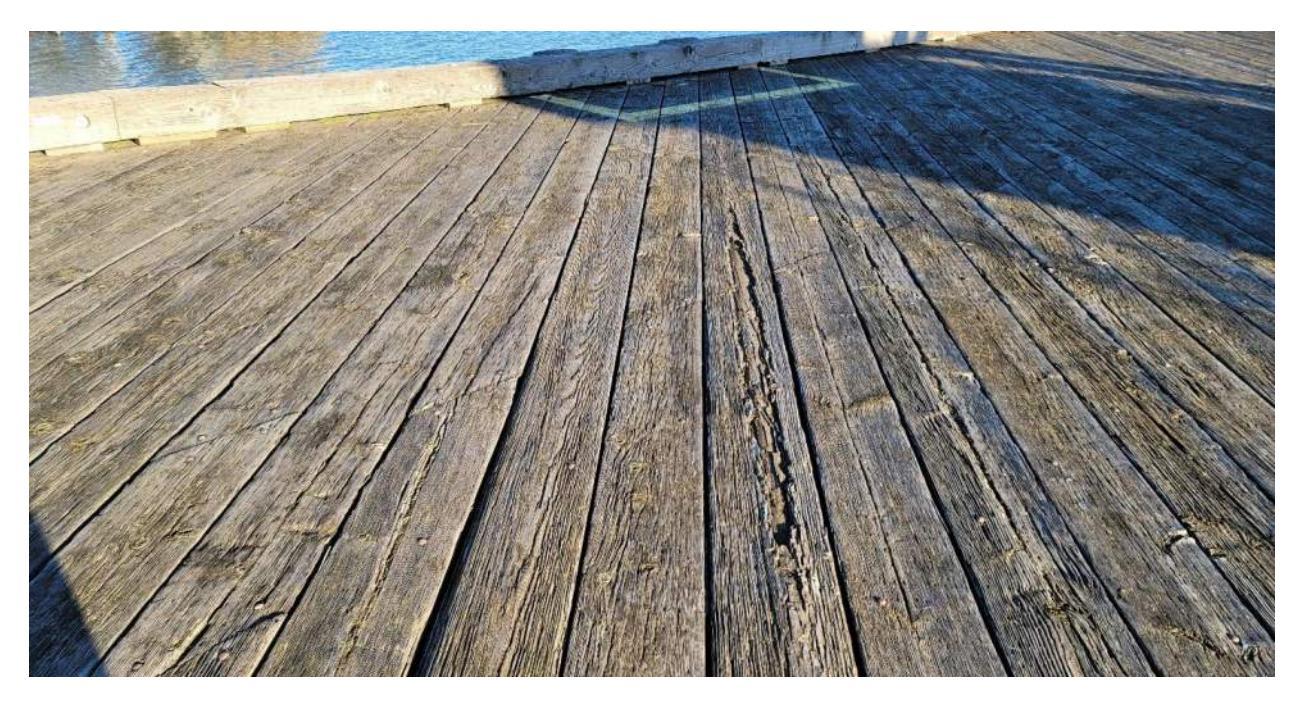
Picture 22. . Evidence of decay, riverside of service area.

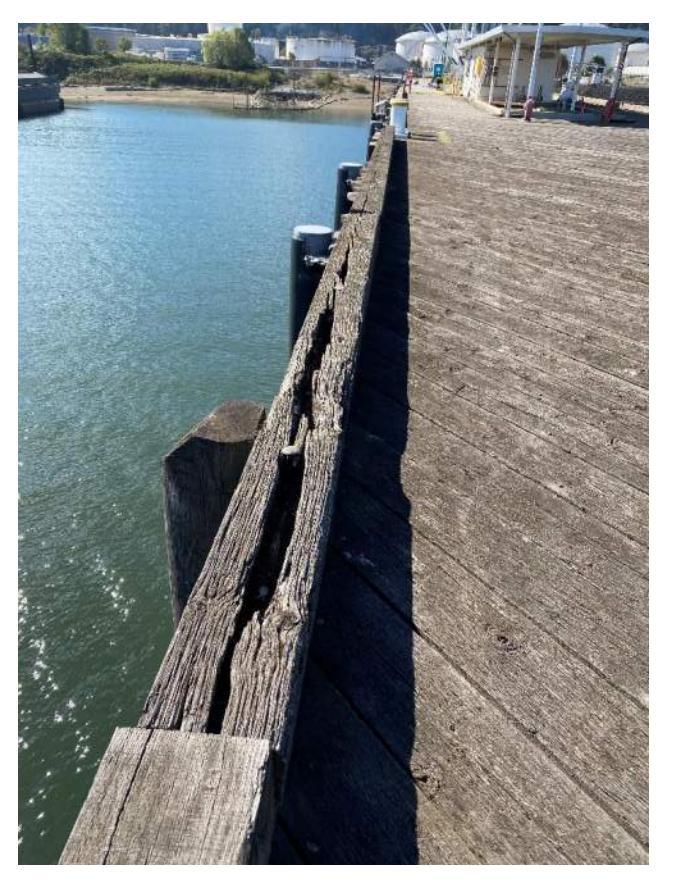
Picture 26. Severe fungal decay in bullrail, upstream berth.

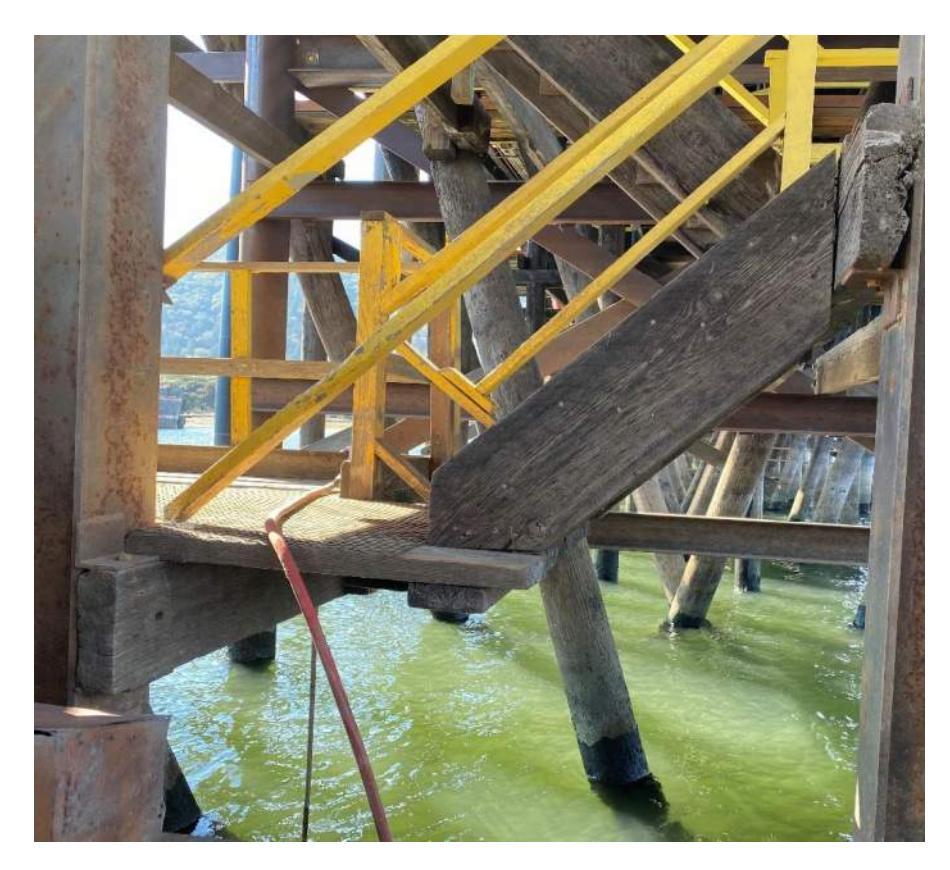
Picture 33. Grid 46, lower stair, taken from the floating deck. Note poor framing not catching base of stairs, evident decay in framing members, gaps forming in connections.

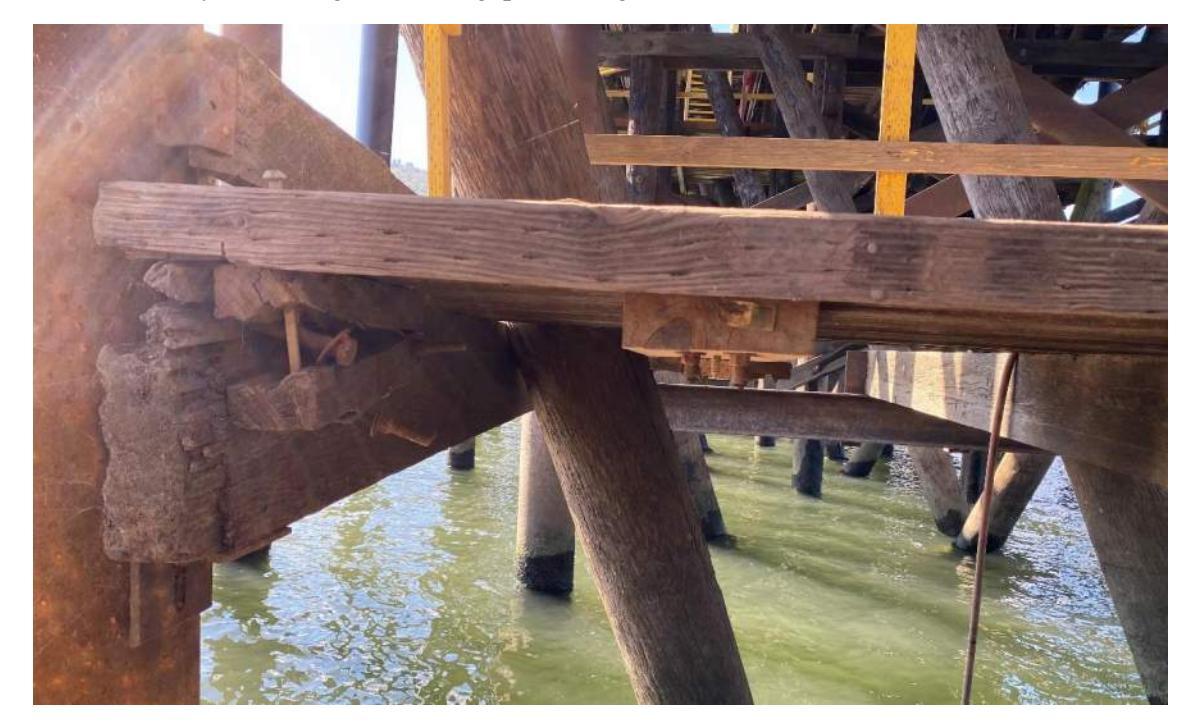
Picture 34. Grid 46, lower platform to floating deck, upstream side. Note significant framing decay and failing connection.

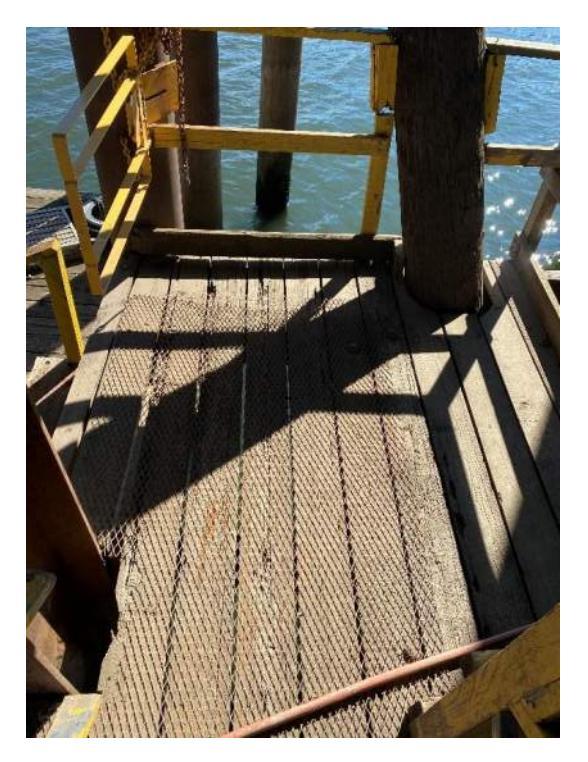
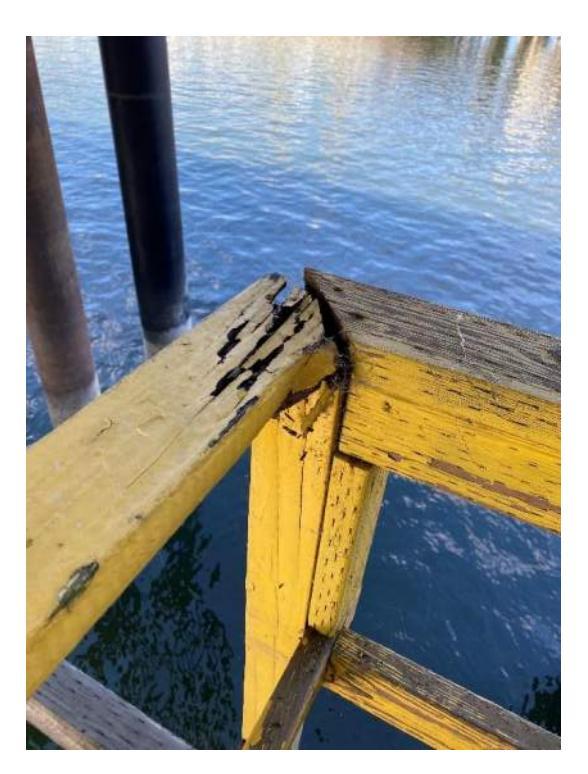
Pictures 35 and 36. Lower platform to floating deck in decay, Grid 46; handrail on third level broken at the corner connection.

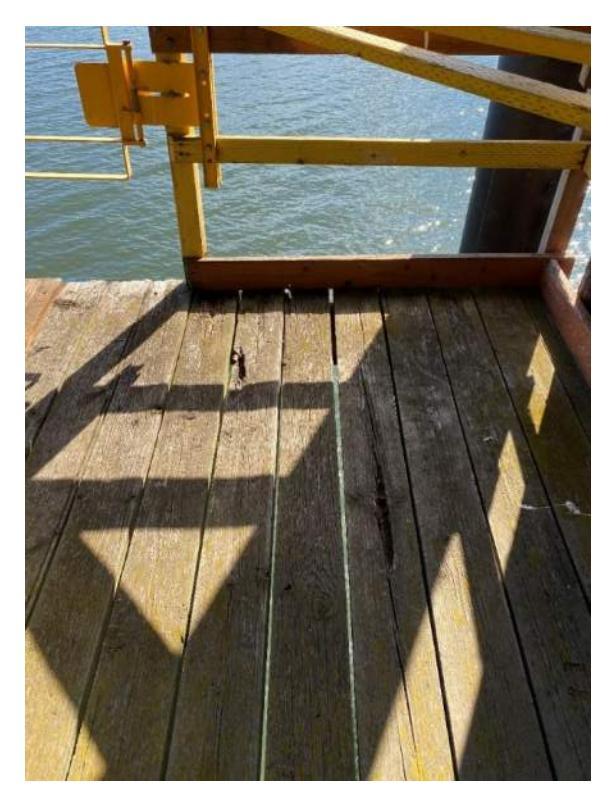
Picture 37. Platform near swing gate, upstream berth Grid 42. Note two deck boards in need of replacement, weathering and decay noted on ends of boards below gate in upper left corner.

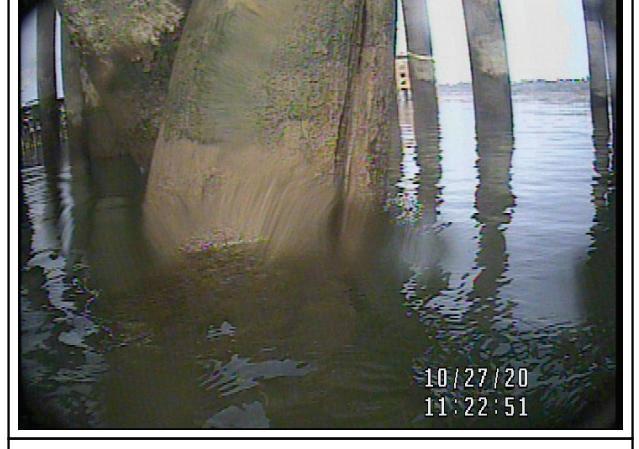
Pile 50 B - Splitting observed.

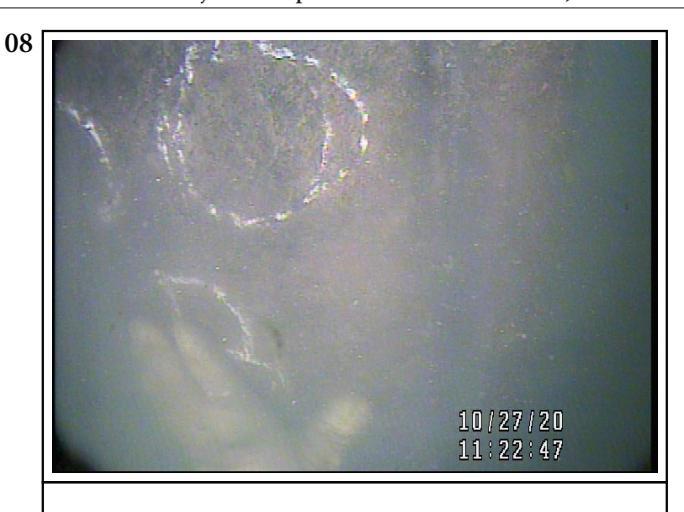
Pile 50 B - Splitting observed.

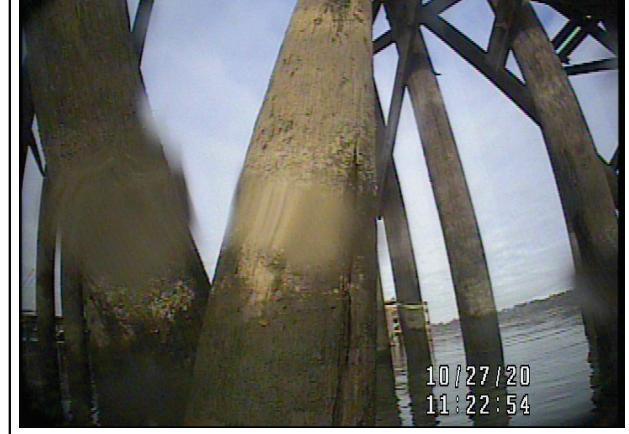
Pile 50 B - Splitting observed.

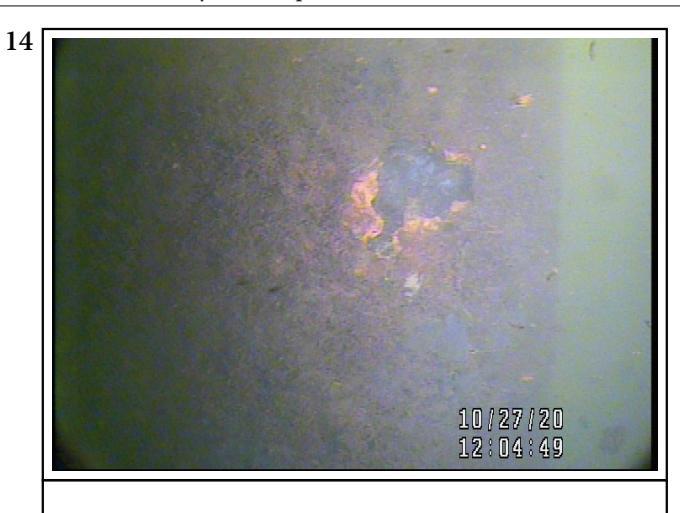
Fender Pile 48 - Minor corrosion sighted.

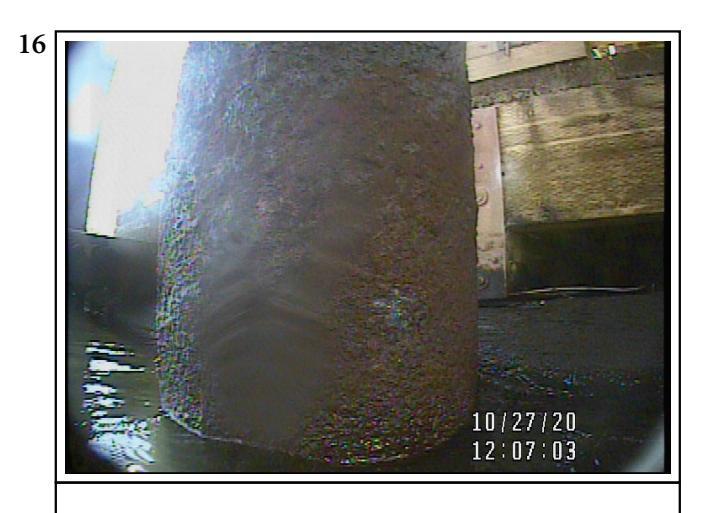
Fender Pile 47 - Minor corrosion sighted.

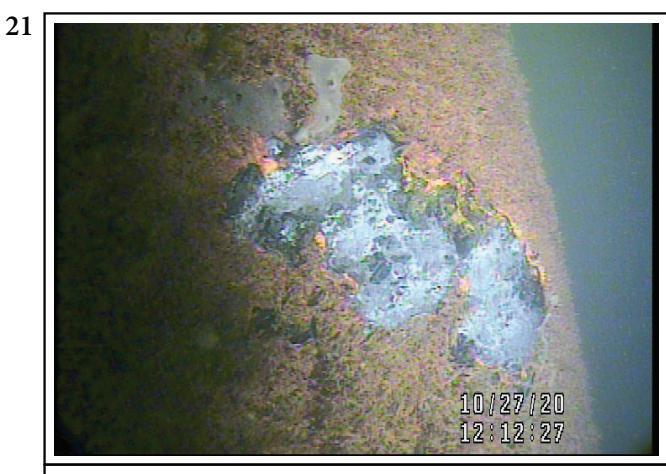
Pile 47 B - Minor corrosion sighted.

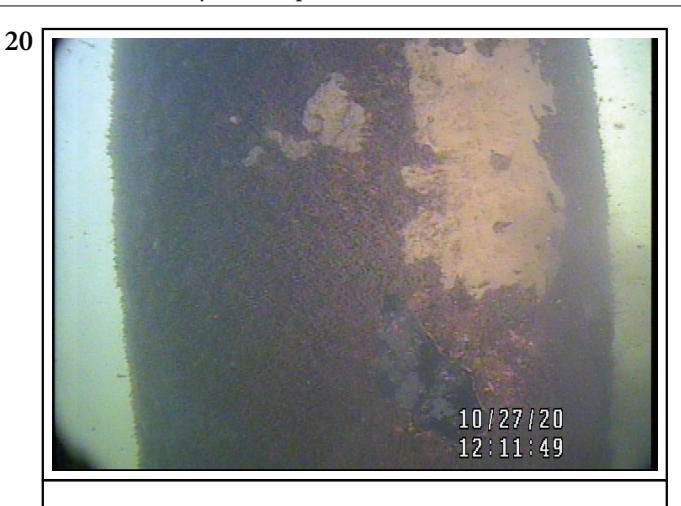
Pile 47 B - Minor corrosion sighted.

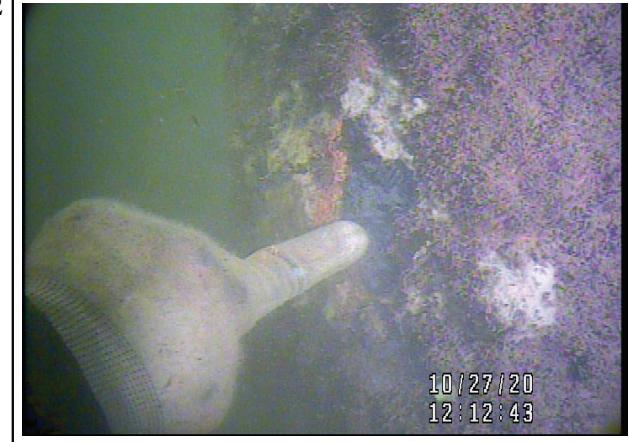
Pile 47 B - Minor corrosion sighted.
