From: Caitlin Bryan and Andrew Vidourek, RG Project No.: M1419.14.007

Re: Quarterly Progress Report for ECSI Site 537—Quarter 4, October to December, 2024

Project Name: Roseburg Forest Products—Medford
Remedial Action Scope of Work Assistance

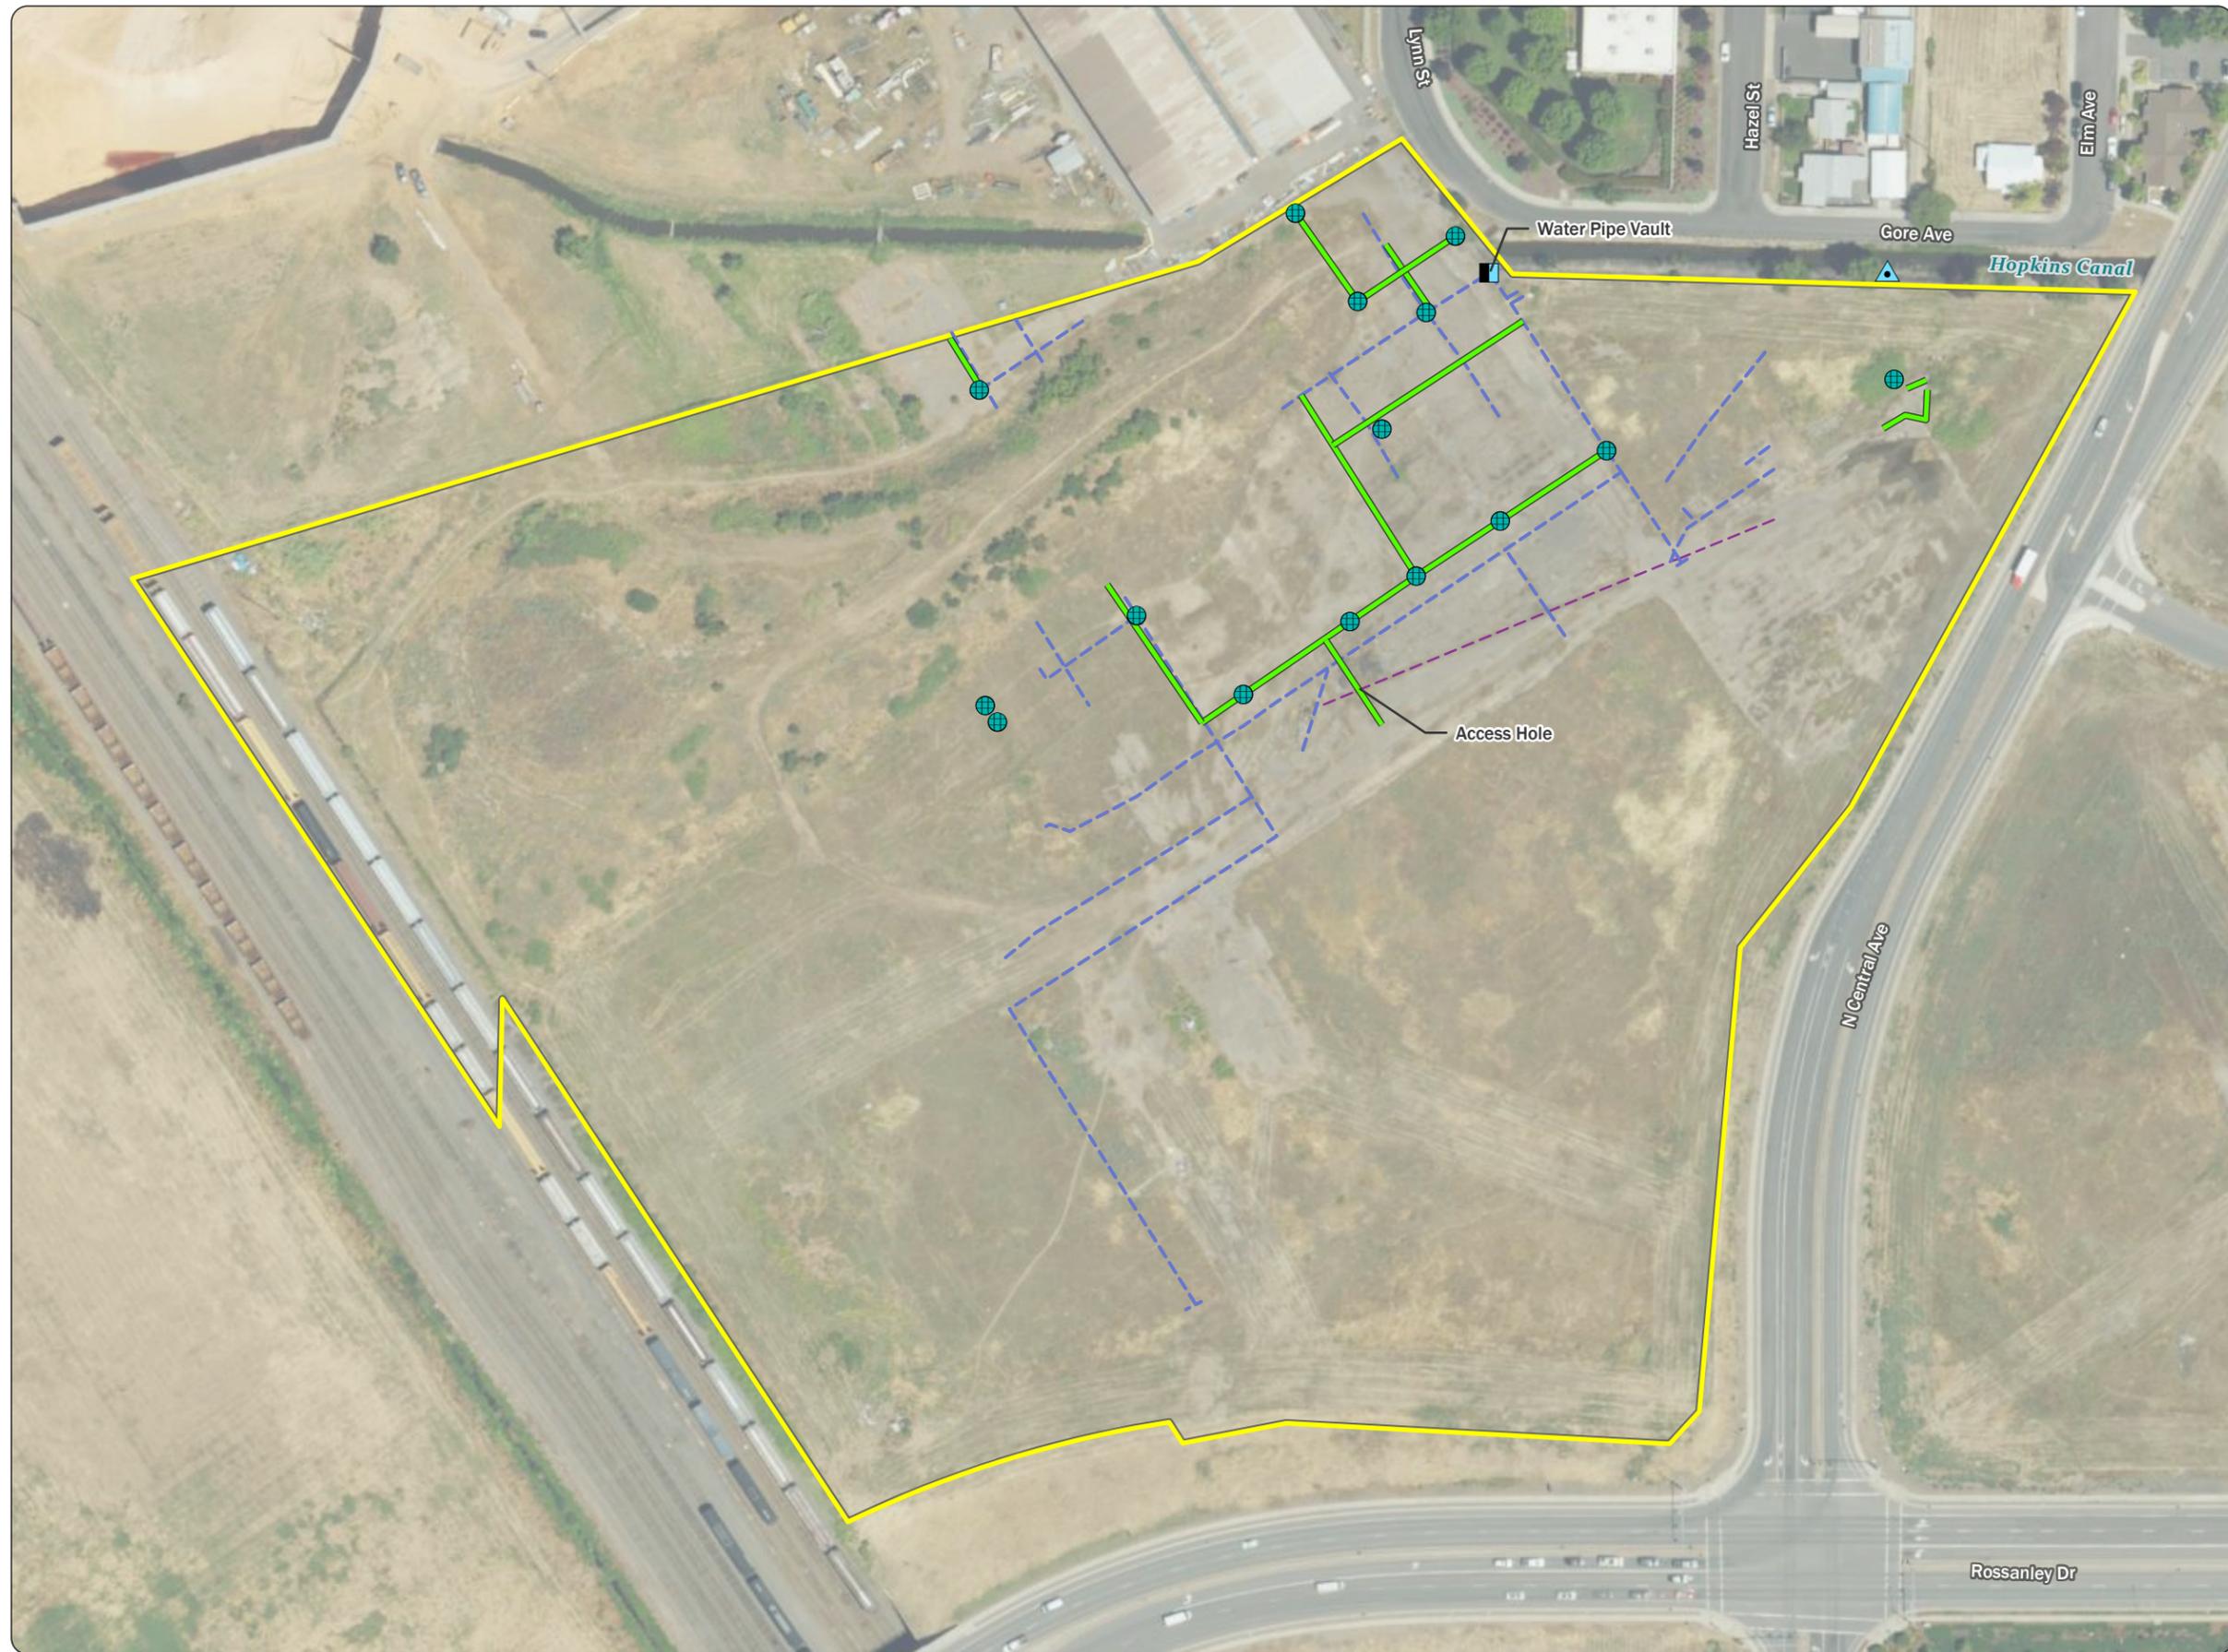
Figure Stormwater System Decommissioning Schematic

Stormwater system piping visually observed in December 2024 was confirmed to be non-metallic concrete (i.e., outfalls and stormwater pipes connected to catch basins). According to RFP personnel on the Property during the December 2024 geophysical survey, to their knowledge, the former stormwater system piping was constructed of concrete. Therefore, based on this information confirming utility line construction, the identified extent of the stormwater system (non-metallic utility lines) and water pipe (metallic utility lines) are depicted accordingly on the attached Figure. Features that may be associated with the former stormwater system are labeled as manhole/vault/catch basin and are slated for decommissioning unless reconnaissance at the time of system decommissioning provides further information (e.g., that the feature is associated with a different utility type, such as the metallic water lines).

Based on the May 2022 and December 2024 geophysical surveys, available documentation, employee knowledge, and visual observations, the extent of the stormwater system appears to be delineated. Therefore, stormwater system decommissioning will be scheduled for Q1 or Q2, 2025.

- As per of the Stormwater System Decommissioning Work Plan dated July 23, 2024, and depending on contractor availability and weather, stormwater system decommissioning will be conducted in Q1 or Q2, 2025
- Landscaping around the perimeter of the Property will be conducted in Q1 or Q2, 2025.
- A water line will be installed in Q1 or Q2, 2025 at the Property to help with fire hazard mitigation and response.

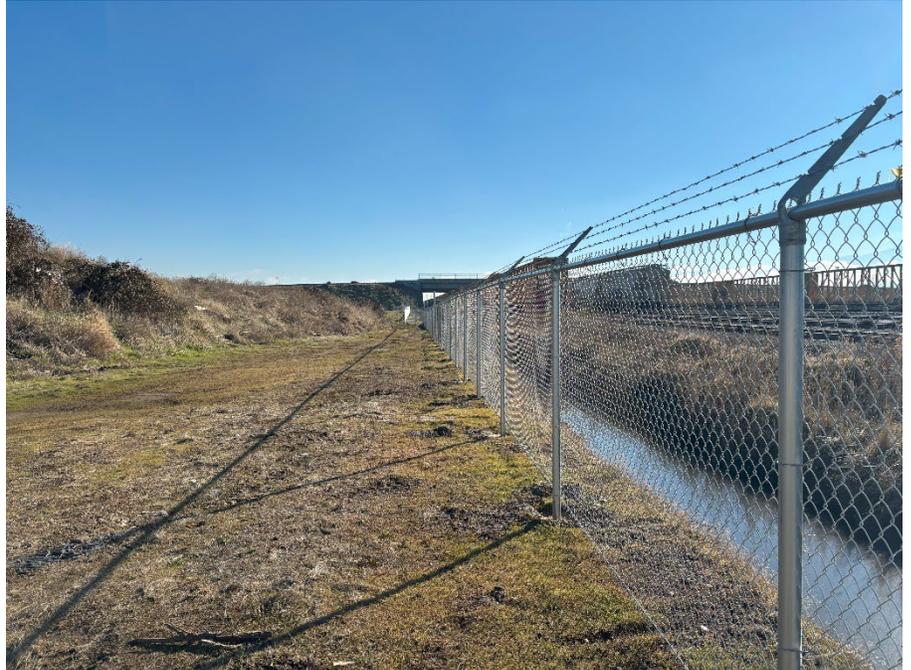
Photo No. 1.

Fence constructed on
the west property
boundary, facing
southeast.

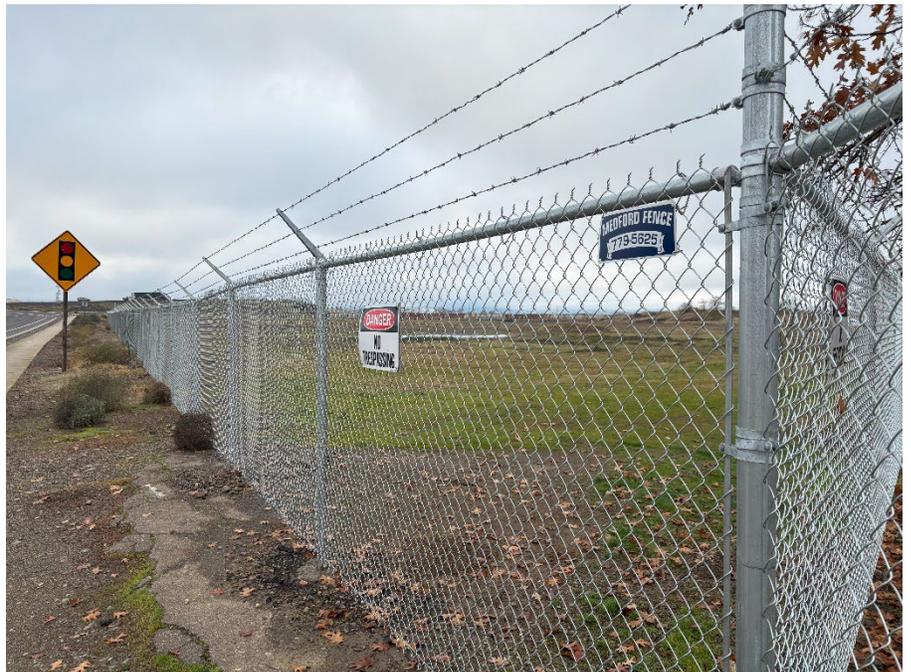
Photo No. 2.

Fence constructed on
the north and east
property boundaries,
facing southwest.

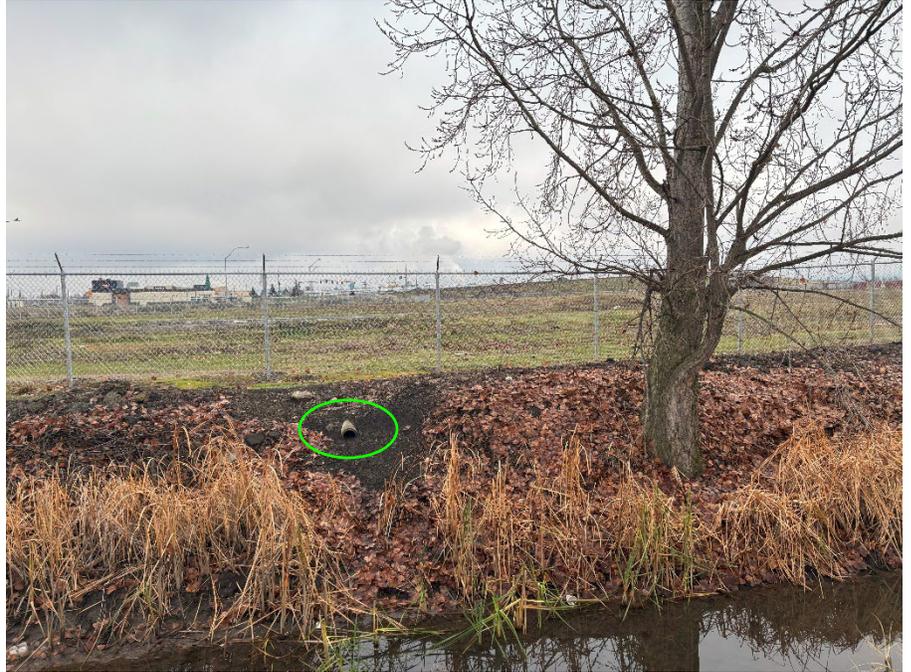
Photo No. 3.

Stormwater pipe discharge location to Hopkins Canal on the northeast portion of the property, facing south (stormwater system to be decommissioned).

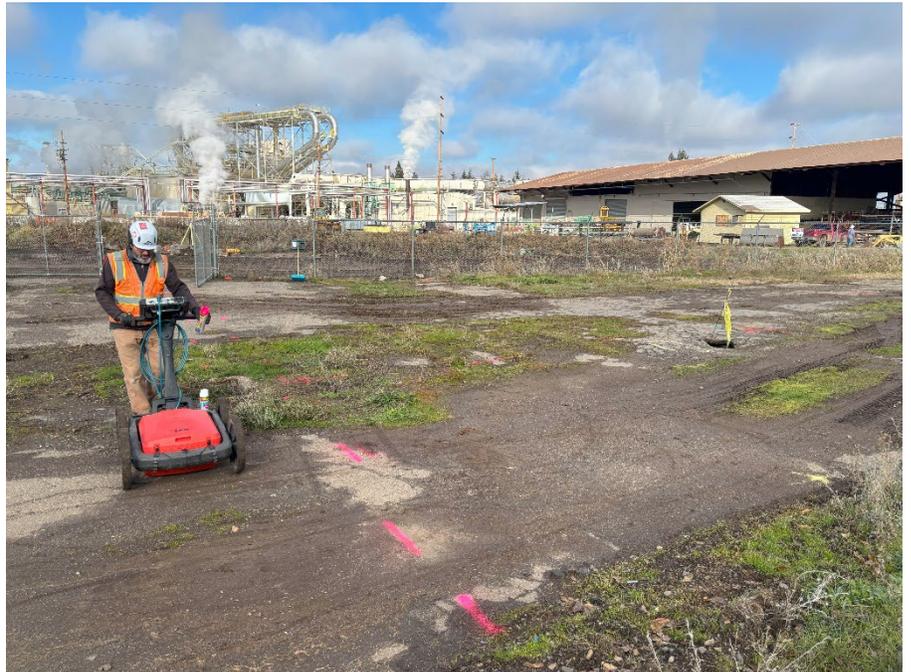
Photo No. 4.

Geophysical survey on the north portion of the property, facing north. Pink markings indicate metallic and non-metallic subsurface features.
