# Memorandum

From: Caitlin Bryan and Andrew Vidourek, RG                      Project No.: M1419.14.007

Re: Quarterly Progress Report for ECSI Site 537—Quarter 1, January to March, 2025

# Figure Completed Remedial Actions

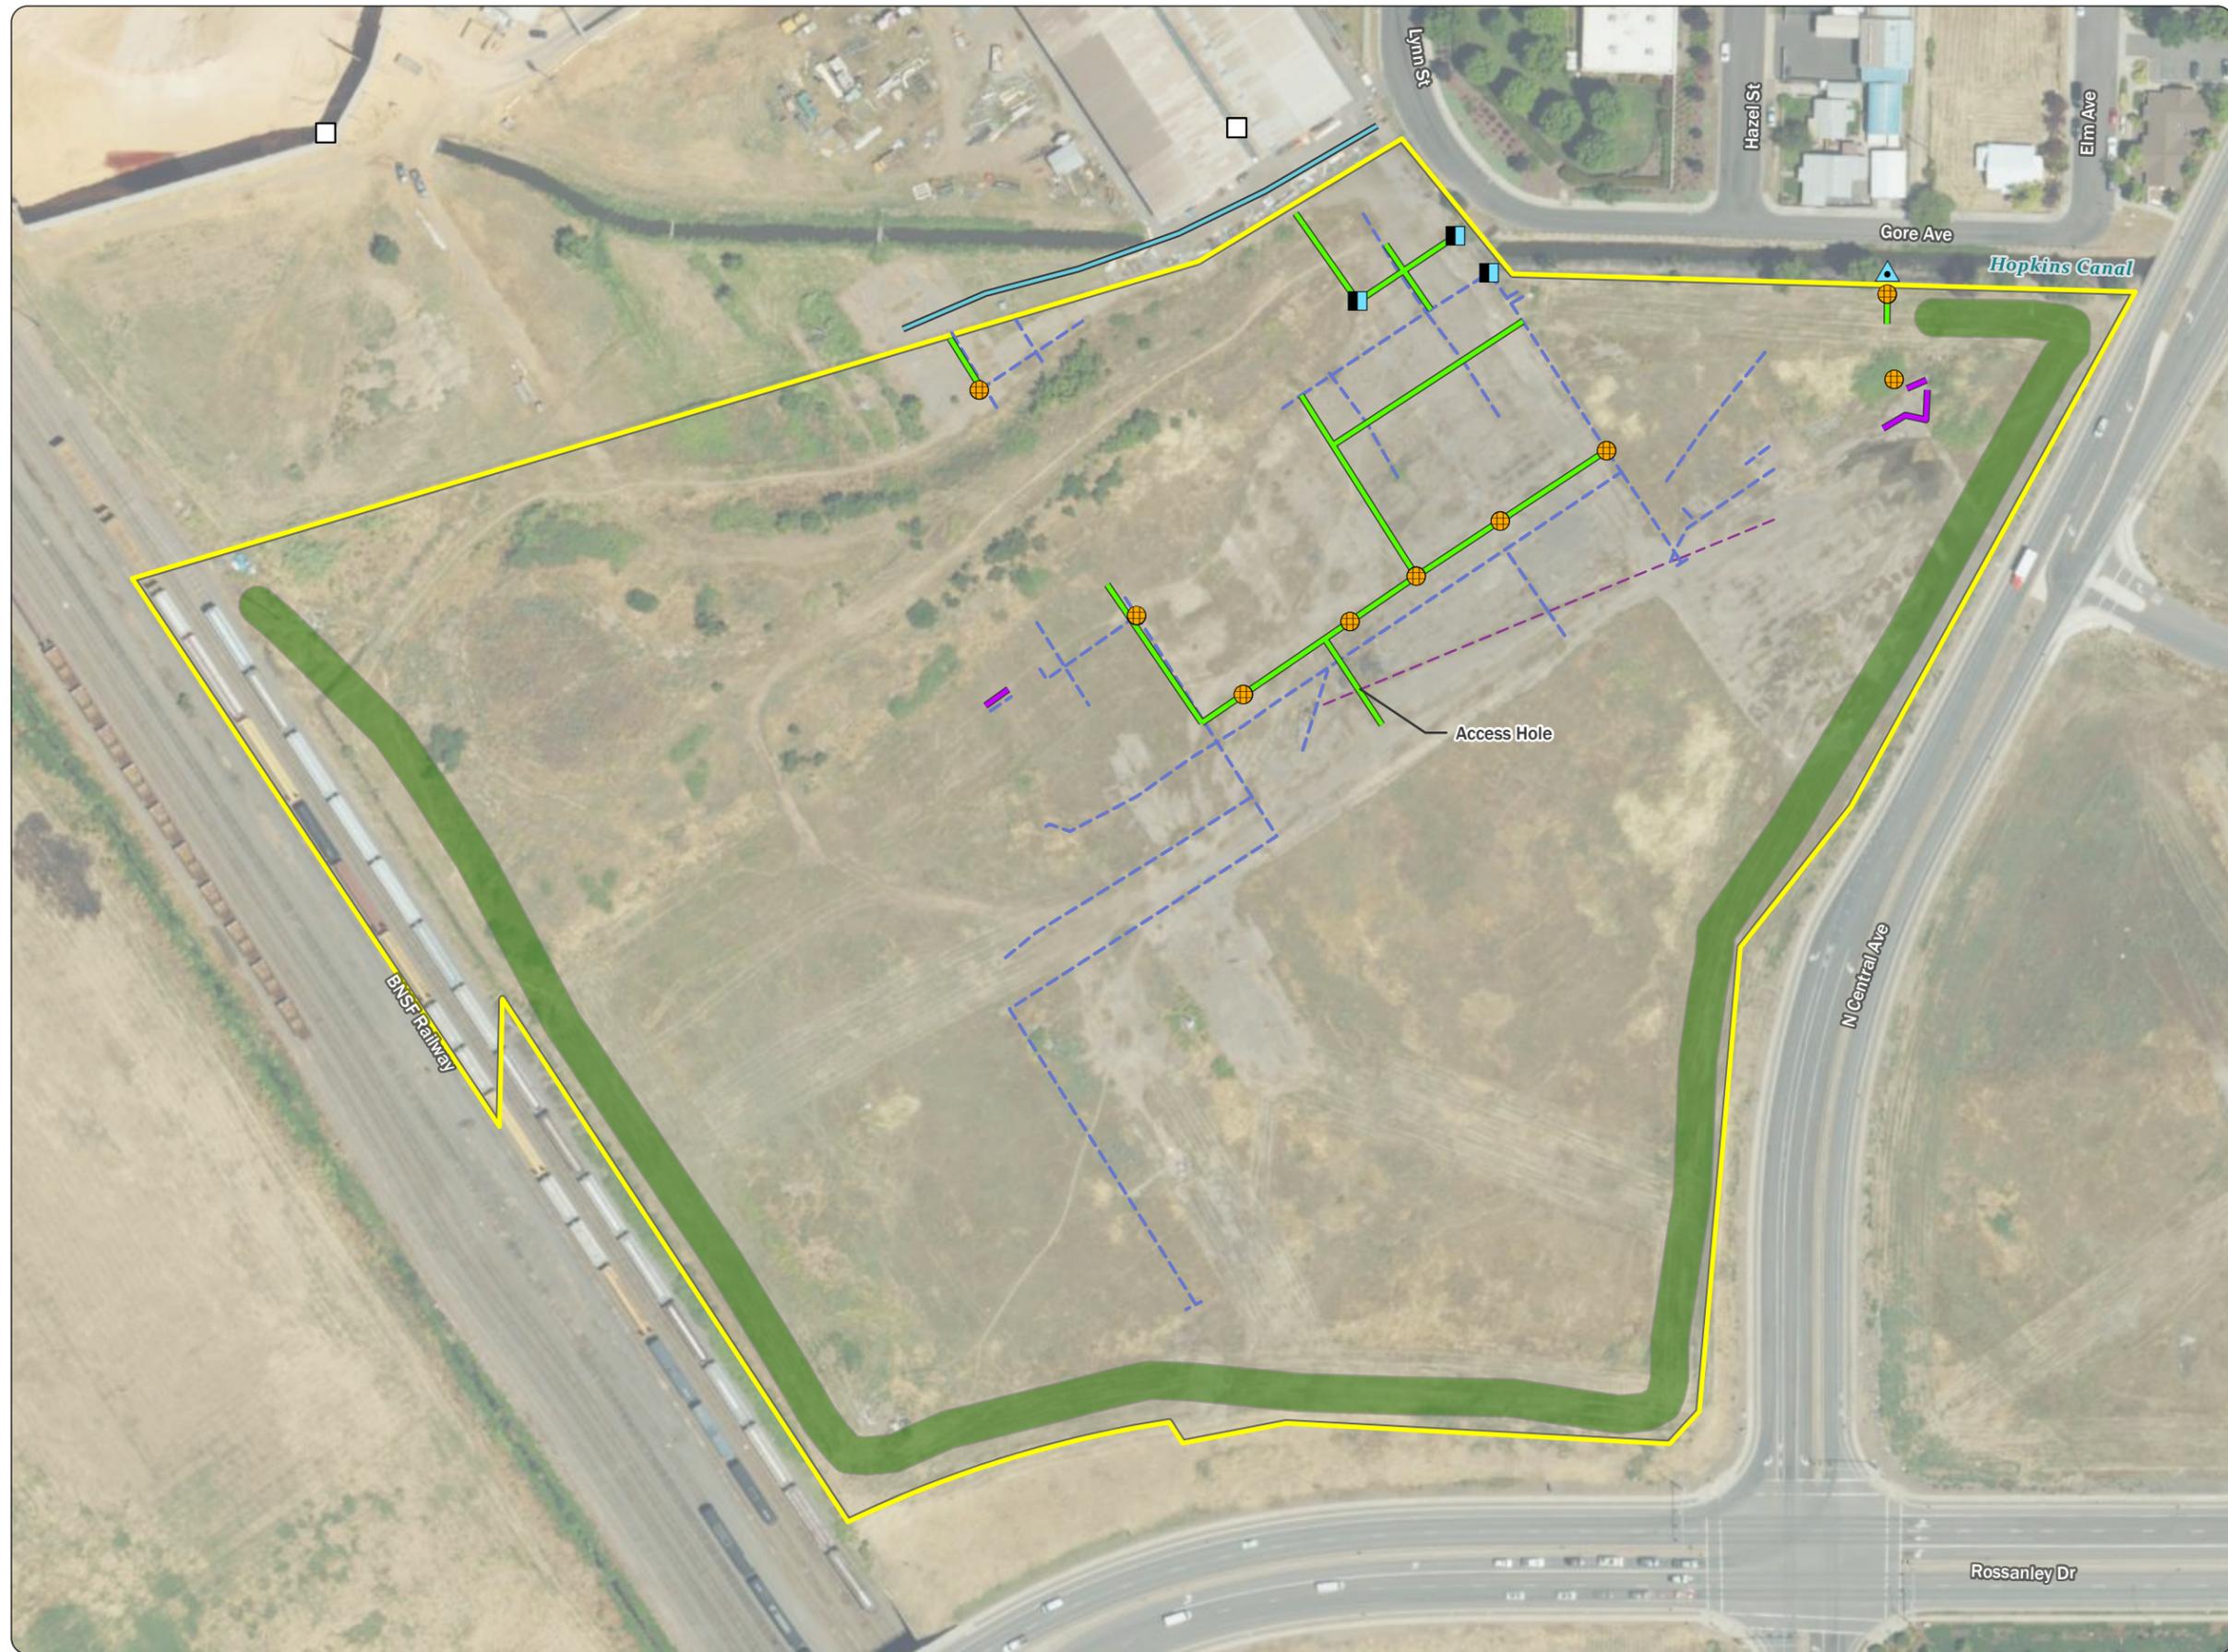
Based on geophysical surveys and visual observations conducted in May 2022 and December 2024, the extent of the stormwater system was delineated. Subsequently, the stormwater system was decommissioned by general contractor, Tom Willis, from February 12 to 14, 2025 as per the DEQ approved work plan. The work was observed and documented by MFA field staff. Soil generated during the work was placed back into the excavations after stormwater features were grouted in place. A summary of stormwater system decommissioning activities and a photograph log will be provided in a forthcoming construction summary report. The locations of decommissioned stormwater features are shown on the attached Figure.

From February 19 to 21, 2025, the RFP Resources Department planted landscape vegetation along the west, south, and east Property boundaries. Additional installation details will be provided in the forthcoming construction summary report. The location of planted landscape vegetation is shown on the attached Figure.

A water line to be used for fire protection at the active portion of the RFP mill facility was installed by general contractor, Tom Willis. The line was constructed just north of the northern Property boundary (see attached Figure). The work began in mid-February and was complete by February 25, 2025.

As an additional security measure beyond the installation of fencing and gates on the perimeter of the Property, two infrared cameras were installed on the active portion of the RFP mill facility to overlook the Property. The cameras were installed by RFP personnel between March 10 and 14, 2025, and their locations are indicated on the attached Figure.
