Department of Environmental Quality

RE: UST Compliance Inspection  
**DEQ UST # 6122 – Arco 5874**  
**DEQ UST # 3985 – Arco 4477**  
**DEQ UST # 3952 – Arco 4192**  
**DEQ UST # 3938 – Arco 889**  
**DEQ UST # 3954 – Arco 4208**

# Inspection Survey

FCI #3938

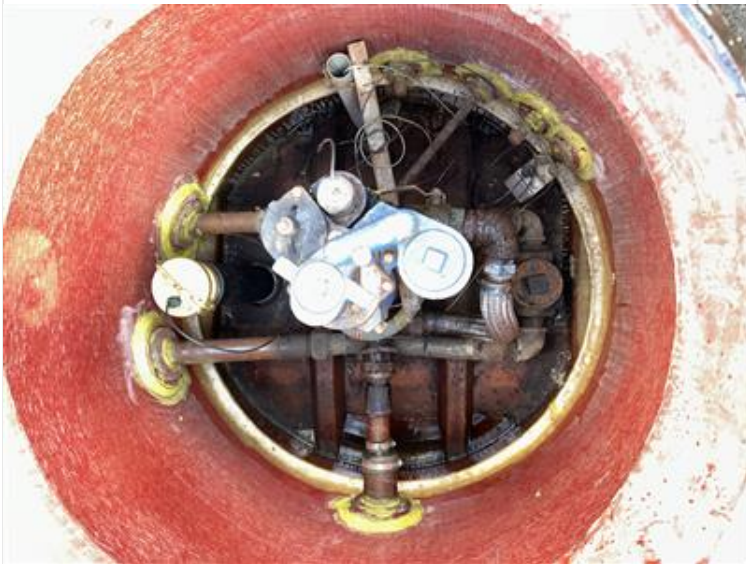
photos-20250709-170845.jpg

**Fuel in both reg. Sumps and sensors needs moved to lowest point**

1. on "Reg" manifold Tank top Sump Liquid fuel observed in sump.  
9/30 ~~9/30~~ Sensor needs moved to ~~test~~ lowest point.
2. on Regular Primers Tank top sump ~~pool~~ Liquid fuel pooled observed in sump.  
Justin @ Belshire to get dispatch to investigate -

1. L2 -Failing to investigate or confirm a suspected release in Both Regular Unleaded STP Sumps

1. Initiate investigation to confirm source of the leak for Regular Unleaded **within 5 days (7/20/25). The product was pooling in each regular unleaded sump.** Submit findings and testing results along with repair documentation to DEQ by 8/15/25.
