HISTORIC LANDMARKS COMMISSION MINUTES

AUGUST 27, 2014

Historic Landmarks Commission Application #145-14 – United Church of Christ Congregational; Request: Approval for the restoration and remodel Phase II project to replace 40 additional windows in both the original historic portion of the building as well as the addition. Property is located at 111 East 5th Street, The Dalles, Oregon, and is further described as Township 1 North, Range 13 East, Map 3 BC, tax lot 6700. Property is zoned “CBC” – Central Business Commercial District. The historic name of the structure is The Congregational United Church. The structure was built in 1936 and is classified as Secondary/Significant in the Commercial Historic District, Inventory #9.

Technical Preservation Services

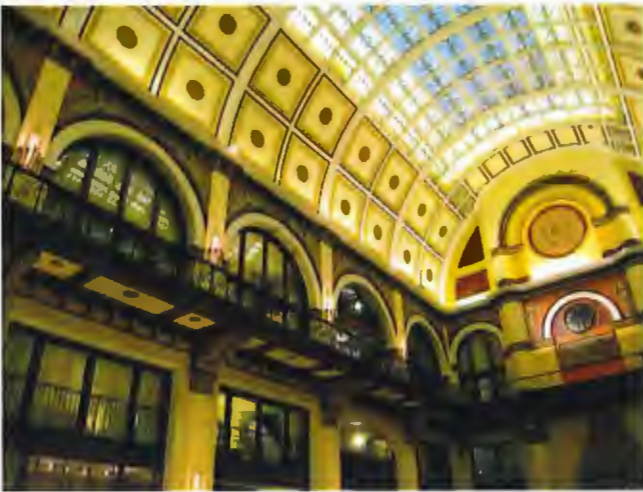
Fig. 1. A decorative, stained glass skylight allows natural daylight into the interior.

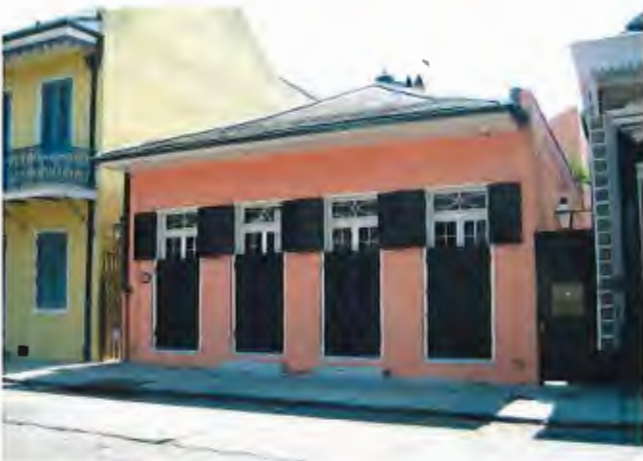
Fig. 2. Upper and lower shutters control daylight and provide privacy.

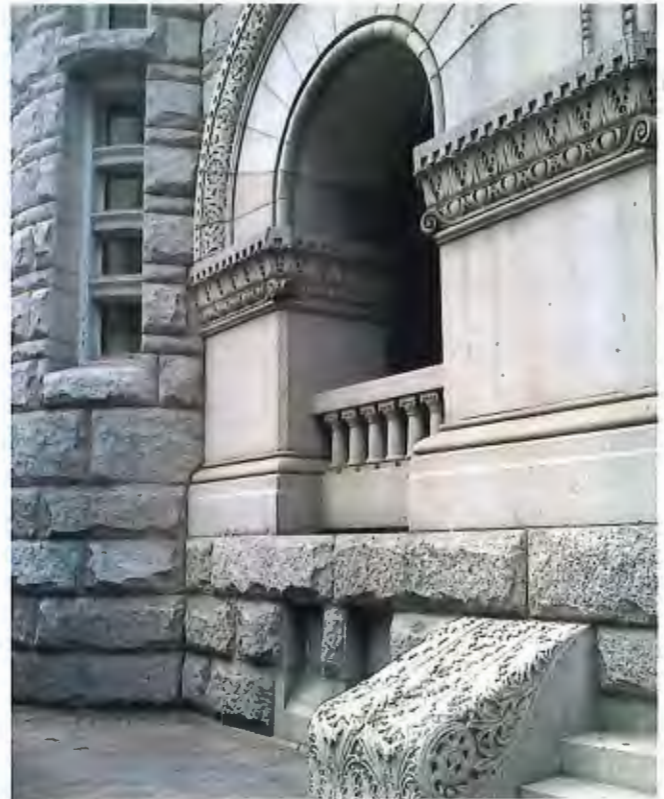
Fig. 3. Stone walls with substantial mass have high thermal inertia.

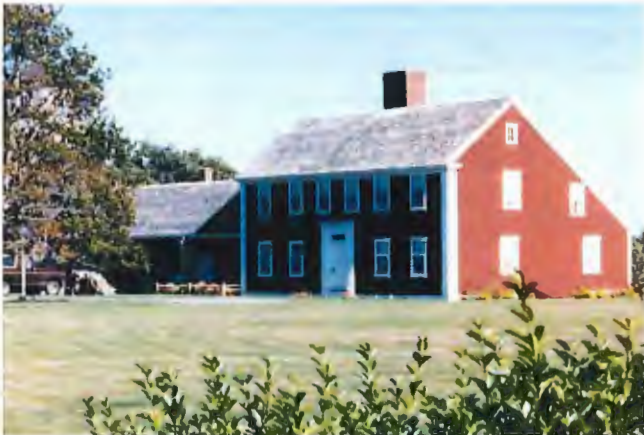
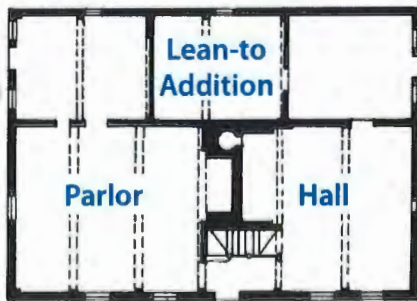
Fig. 4. A typical New England saltbox features a steeply sloping roof to shed snow and a floor plan organized around a central chimney to conserve heat.

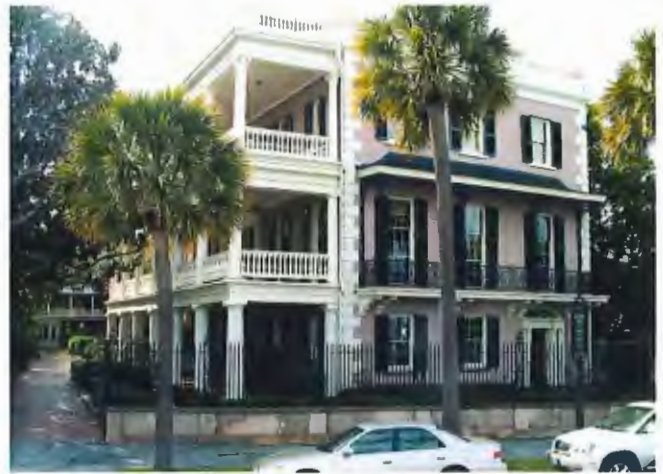
Fig. 5. The side porches of this house in Charleston, SC, shade the large windows and provide outdoor living spaces that take advantage of sea breezes.

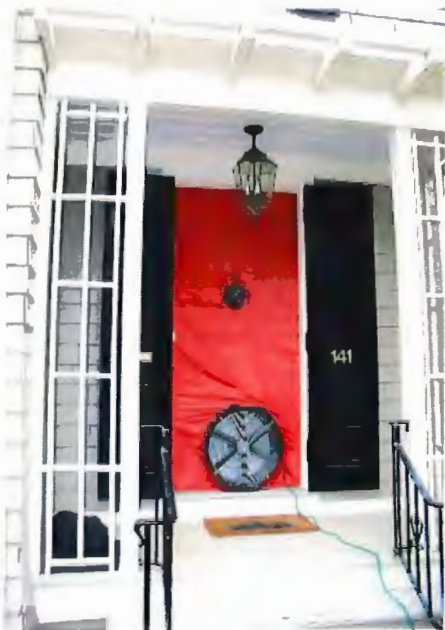
Fig. 6. (left) A blower door is used to depressurize a building by exhausting air at a rate that allows pressure gages and tracer smoke to measure the amount and location of air leakage. Photo: Robert Cagnetta, Heritage Restoration, Inc.

Tools such as a blower door test or infrared thermography are useful to identify specific areas of infiltration, lack of insulation and thermal bridging. Mechanical depressurization along with infrared thermography is extremely useful in identifying locations of air leakage and heat loss followed by the use of tracer smoke to isolate specific air leaks. These tests are often challenging to perform on buildings and must be undertaken by experienced professionals to avoid

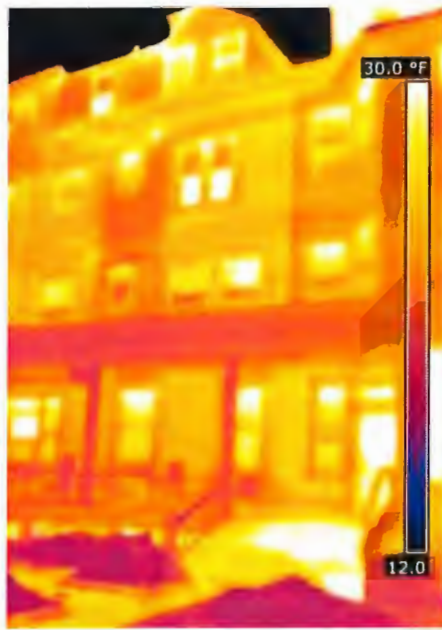
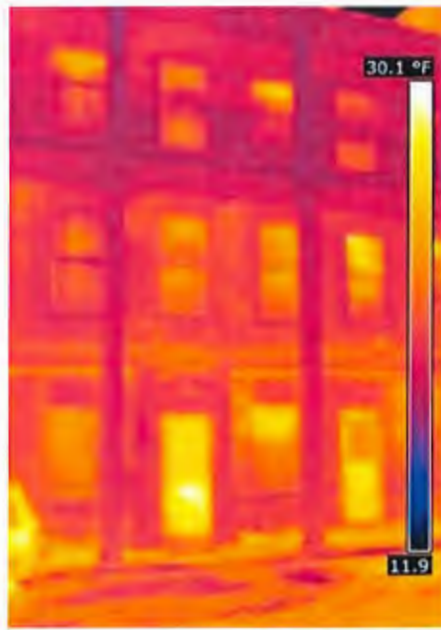
Fig. 7. (center and right) The left thermal image shows the walls of this building before insulating. After insulation was added, the cooler and, thus darker exterior walls evidence how much the heat loss has been reduced. Photos: EYP Architecture & Engineering.

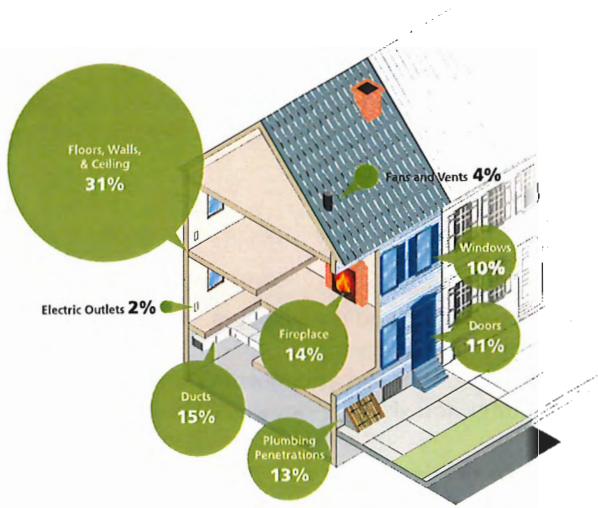
Fig. 8. Where Air Escapes From a House (by percentage) – Image based on data from Energy Savers, U.S. Department of Energy. Illustration: Blank Space LLC.

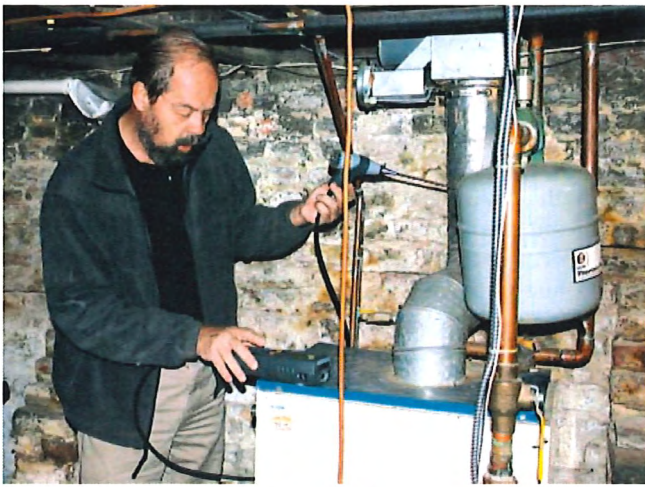
Fig. 9. An energy auditor tests the efficiency of a boiler.

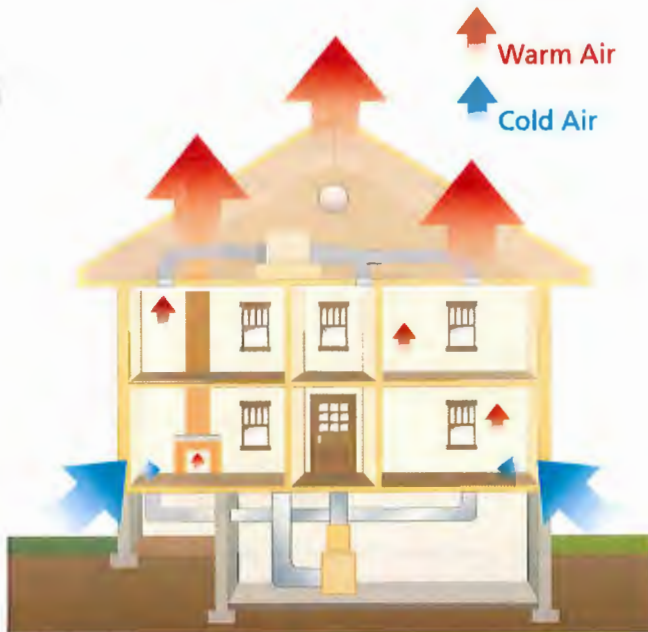
Fig. 10. The pattern of air movement referred to as the "stack effect".
Illustration: Blank Space LLC.

Air flow into and out of buildings is driven by three primary forces: wind pressure, mechanical pressure and the stack effect. Cold outside air that infiltrates the building through big holes, as well as through loose windows, doors, and cracks in the outer shell of the building, causes the heating system to work harder and consume more energy. In a multi-story building, cold air that enters the building at lower levels, including the basement or crawlspace, will travel up through the building and exit out leaky windows, gaps around windows and the attic as a result of temperature and pressure differential. This pattern of air movement

is called the "stack effect." Not only is valuable conditioned air lost, but damaging moisture may also enter the wall cavities and attic spaces. To stop the stack effect, the top and bottom of the exterior walls, inter-floor bypasses, and any existing chases or shafts must be sealed, or "draft proofed." The use of spray foam sealants in basement and attic cracks is a particularly useful technique for reducing air infiltration.

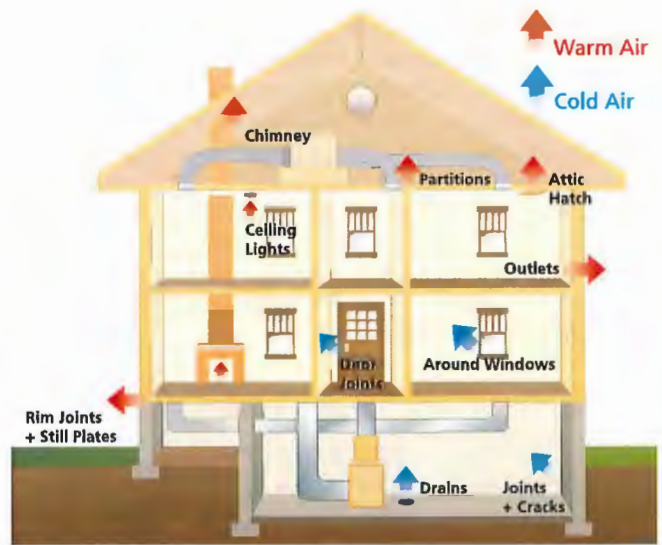
Fig. 11. Air infiltration and exfiltration.
Illustration: Blank Space LLC.

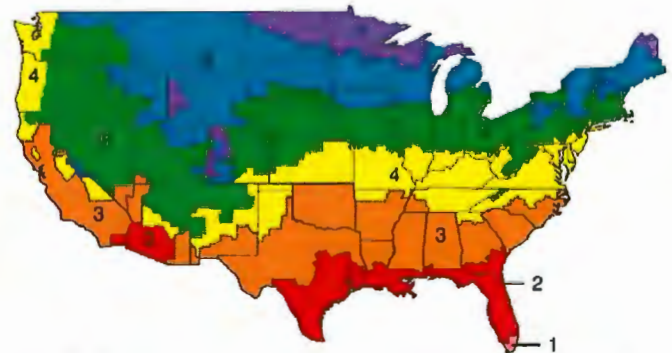
DOE Climate Zone Map

Fig. 12. Recommended energy improvements vary widely based on climate. The information contained in this document is based primarily on the available data for the Northeast and Mid-Atlantic regions.

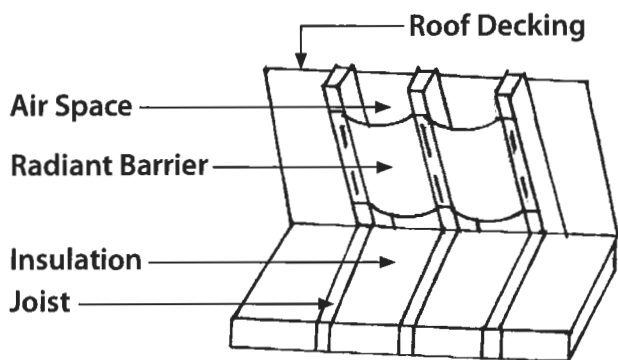
Fig. 13. Sample installation of a radiant barrier.

Radiant barriers may be used in attics to reduce thermal radiation across the air space between the roof deck and the attic floor in order to reduce summer heat gain. They are most beneficial in reducing cooling loads in hot climates and consist of a highly reflective sheet or coating, usually aluminum, applied to one or both sides of a flexible material. They are effective only when the foil surface faces an air space, and as long as the surface remains shiny – that is, free from dirt, dust, condensation and oxidation. Radiant barriers should not be installed directly over insulation on the attic floor, as they can act as vapor retarders and trap moisture in the insulation unless they are perforated. Their placement should be ventilated on both sides.

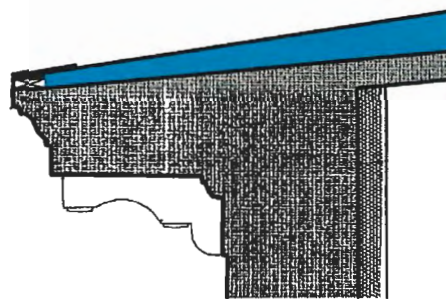
Fig. 14. Sample installation of rigid foam insulation, tapered at the edge to avoid altering the appearance of the roof.

When total roof replacement is required because of deterioration, installing rigid foam insulation on top of the roof deck before laying the new roofing material

can be simple and effective, particularly on low-pitched or flat roofs. However, the added thickness of the roof caused by installing rigid foam can alter the appearance of projecting eaves, dormers, and other features. If this application would significantly alter the appearance of these features, consider other methods.

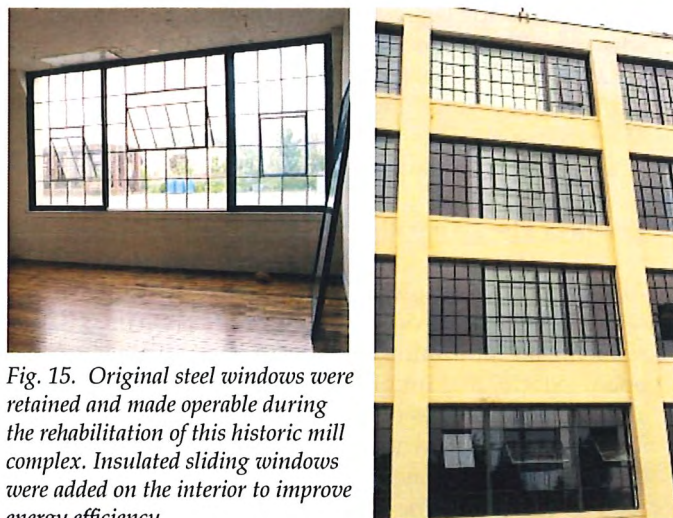
Fig. 15. Original steel windows were retained and made operable during the rehabilitation of this historic mill complex. Insulated sliding windows were added on the interior to improve energy efficiency.

For large, steel industrial windows, the addition of interior, insulated sliding glass windows that align with the primary vertical mullions has proven to be a successful treatment that allows the primary window to remain operable.

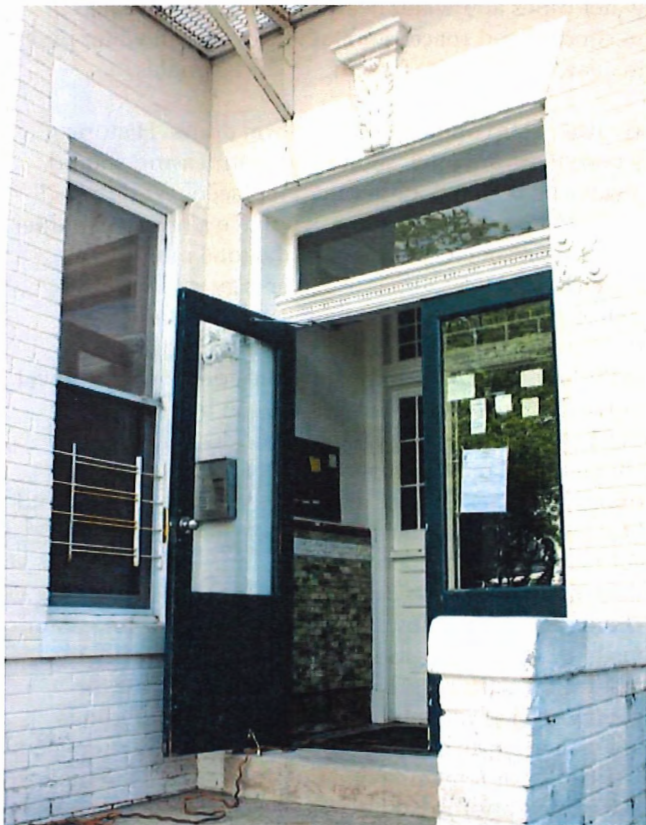
Fig. 16. Historic vestibules retain conditioned air in the living spaces.

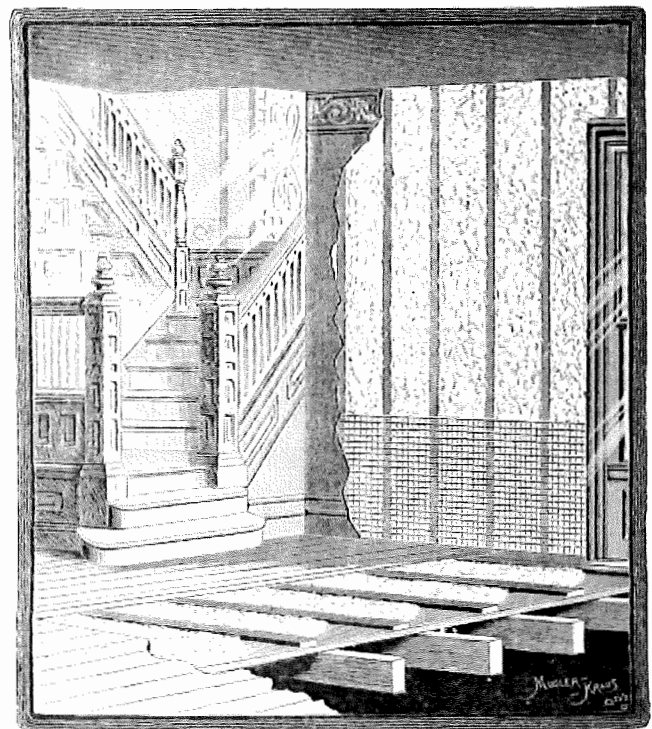
AN INTERIOR

Showing Mineral Wool in Floor, and Walls behind Wire Lath.

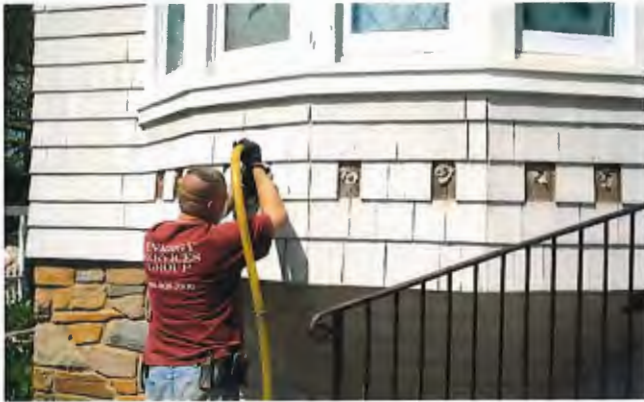
Fig. 18. Dense-packed cellulose insulation is being blown in through holes drilled in the sheathing. Once the operation has been completed, the shingles will be reinstalled. Photo: Edward Minch.

Installing **blown-in insulation**, either dense-packed cellulose or fiberglass, into the wall cavity causes the least amount of damage to historic materials and finishes when there is access to the cavity walls, and it is therefore a common method of insulating wood-frame walls in existing buildings. In most cases, blowing insulation material into the wall cavity requires access through the exterior or interior wall surfaces. When historic plaster, wood paneling, or other interior historic decorative elements are present, accessing the

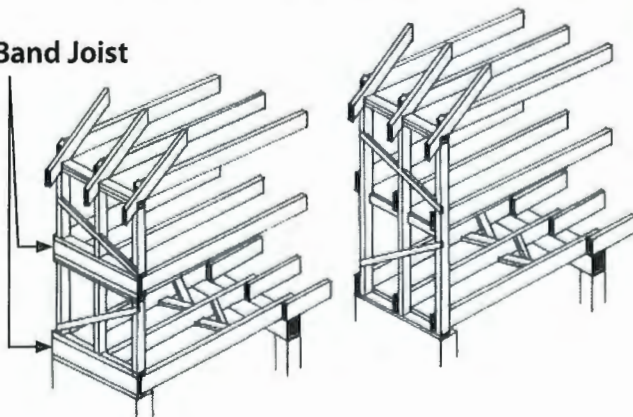
Fig. 19. Platform framing (left) and Balloon framing (right).

the insulation in the adjacent wall cavities. In balloon-framed buildings, the wall cavity is continuous between floors except where fire stops have been inserted.

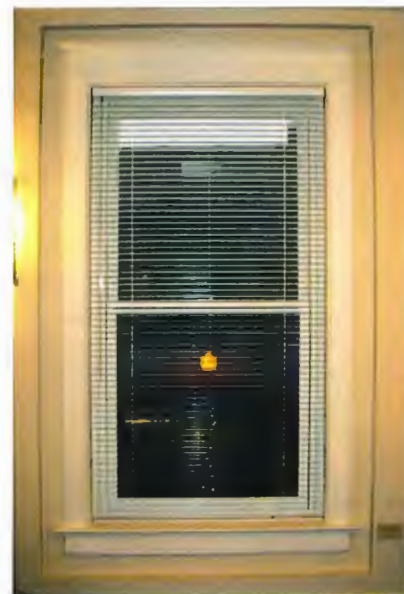
Fig. 20. The walls have been furred out inappropriately around the historic window trim creating an appearance the interior never had historically.

Insulation Installed on Either Side of the Wall: Batt, rigid foam board, and spray foam insulation are commonly added to the interior face of walls in existing buildings by furring-out the walls to accommodate the additional thickness. However, this often requires the destruction or alteration of important architectural features, such as cornices, base boards, and window trim, and the removal or covering of plaster or other historic wall finishes. Insulation installed in this manner is only recommended in buildings where interior spaces and features lack architectural distinction or have lost significance due to previous alterations.

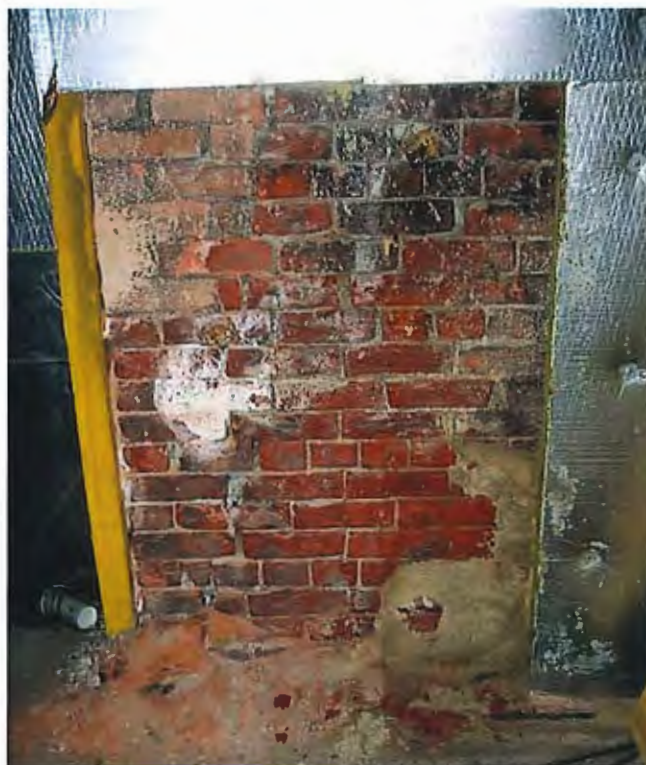
Fig. 21. The interior face of a brick masonry wall shows damage that resulted from the installation of a vapor retardant (foil facing) and thermal insulation. Photo: Simpson Gumpertz & Heger.

Solid Masonry Walls: As with frame buildings, installing insulation on the interior walls of a historic masonry structure should be avoided when it would involve covering or removing important architectural features and finishes, or when the added thickness would significantly alter the historic character of the interior. The addition of insulation on solid masonry walls in cold climates results in a decreased drying rate, an increased frequency of freeze-thaw cycles, and prolonged periods of warmer and colder temperatures of the masonry. These changes can have a direct effect on the durability of materials.

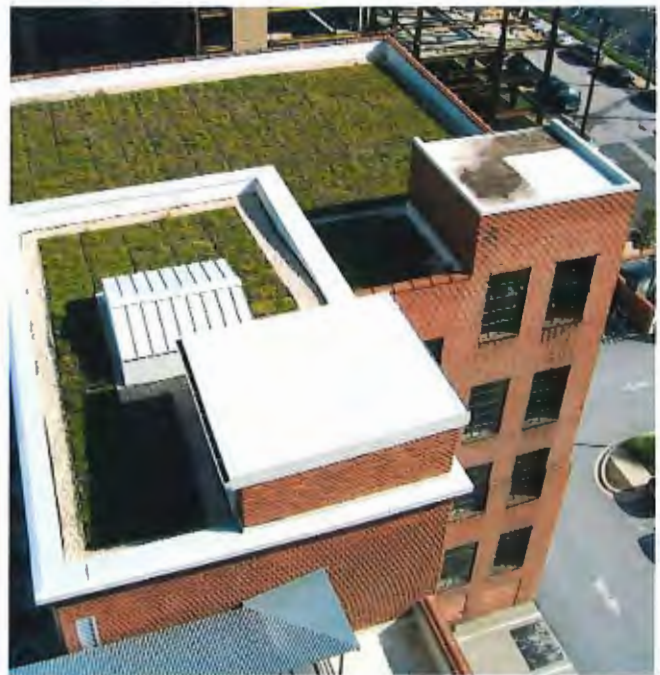
Fig. 22. Installation of both cool and green roofs in an urban environment.

light-colored or white roofs, and fiberglass shingles that have a coating of reflective crystals. All of these roofing materials reflect the sun's radiation away from the building, which lessens heat gain, resulting in a reduction of the cooling load. Cool roofs are generally not practical in northern climates where buildings benefit from the added heat gain of a dark-colored roof during colder months. Cool and green roofs are appropriate for use on historic buildings only when they are compatible with their architectural character, such as flat roofs with no visibility. A white-colored roof that is readily visible is not appropriate for historic metal roofs that were traditionally painted a dark color, such as green or iron oxide red. A white reflective roof is most suitable on flat roofed historic buildings. If a historic building has a slate roof, for example, removing the slate to install a metal roof is not a compatible treatment. It is never appropriate to remove a historic roof if the material is in good or repairable condition to install a cool roof. However, if the roof has previously been changed to an asphalt shingle roof, fiberglass shingles with special reflective granules may be an appropriate replacement.

A green roof consists of a thin layer of vegetation planted over a waterproofing system or in trays installed on top of an existing flat or slightly sloped roof. Green roofs are primarily beneficial in urban contexts to reduce the heat island effect in cities and to control storm water run-off. A green roof also reduces the cooling load of the building and helps cool the surrounding urban environment, filters air, collects and filters storm water, and can provide urban amenities, including vegetable gardens, for building occupants. The impact of increased

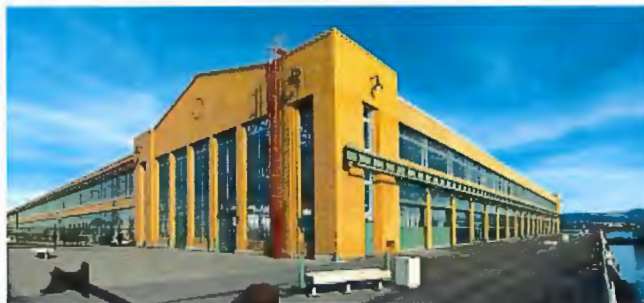
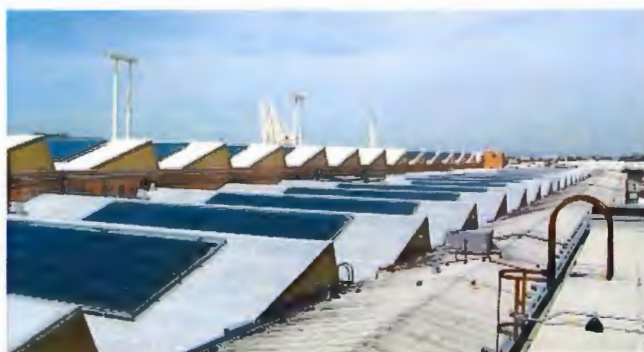
Fig. 23. Solar collectors installed in a compatible manner on low sloping sawtooth monitors. Top Photo: Neil Mishalov, Berkeley, CA.
