# Technical Memorandum – Draft Final

**To:** Georgia Baxter / JH Baxter & Co  
**From:** Josh Bale / GSI Water Solutions, Inc.  
Joe Sherrod / GSI Water Solutions, Inc.  
**Date:** September 3, 2020  
**Re:** Off-site soil sampling investigation

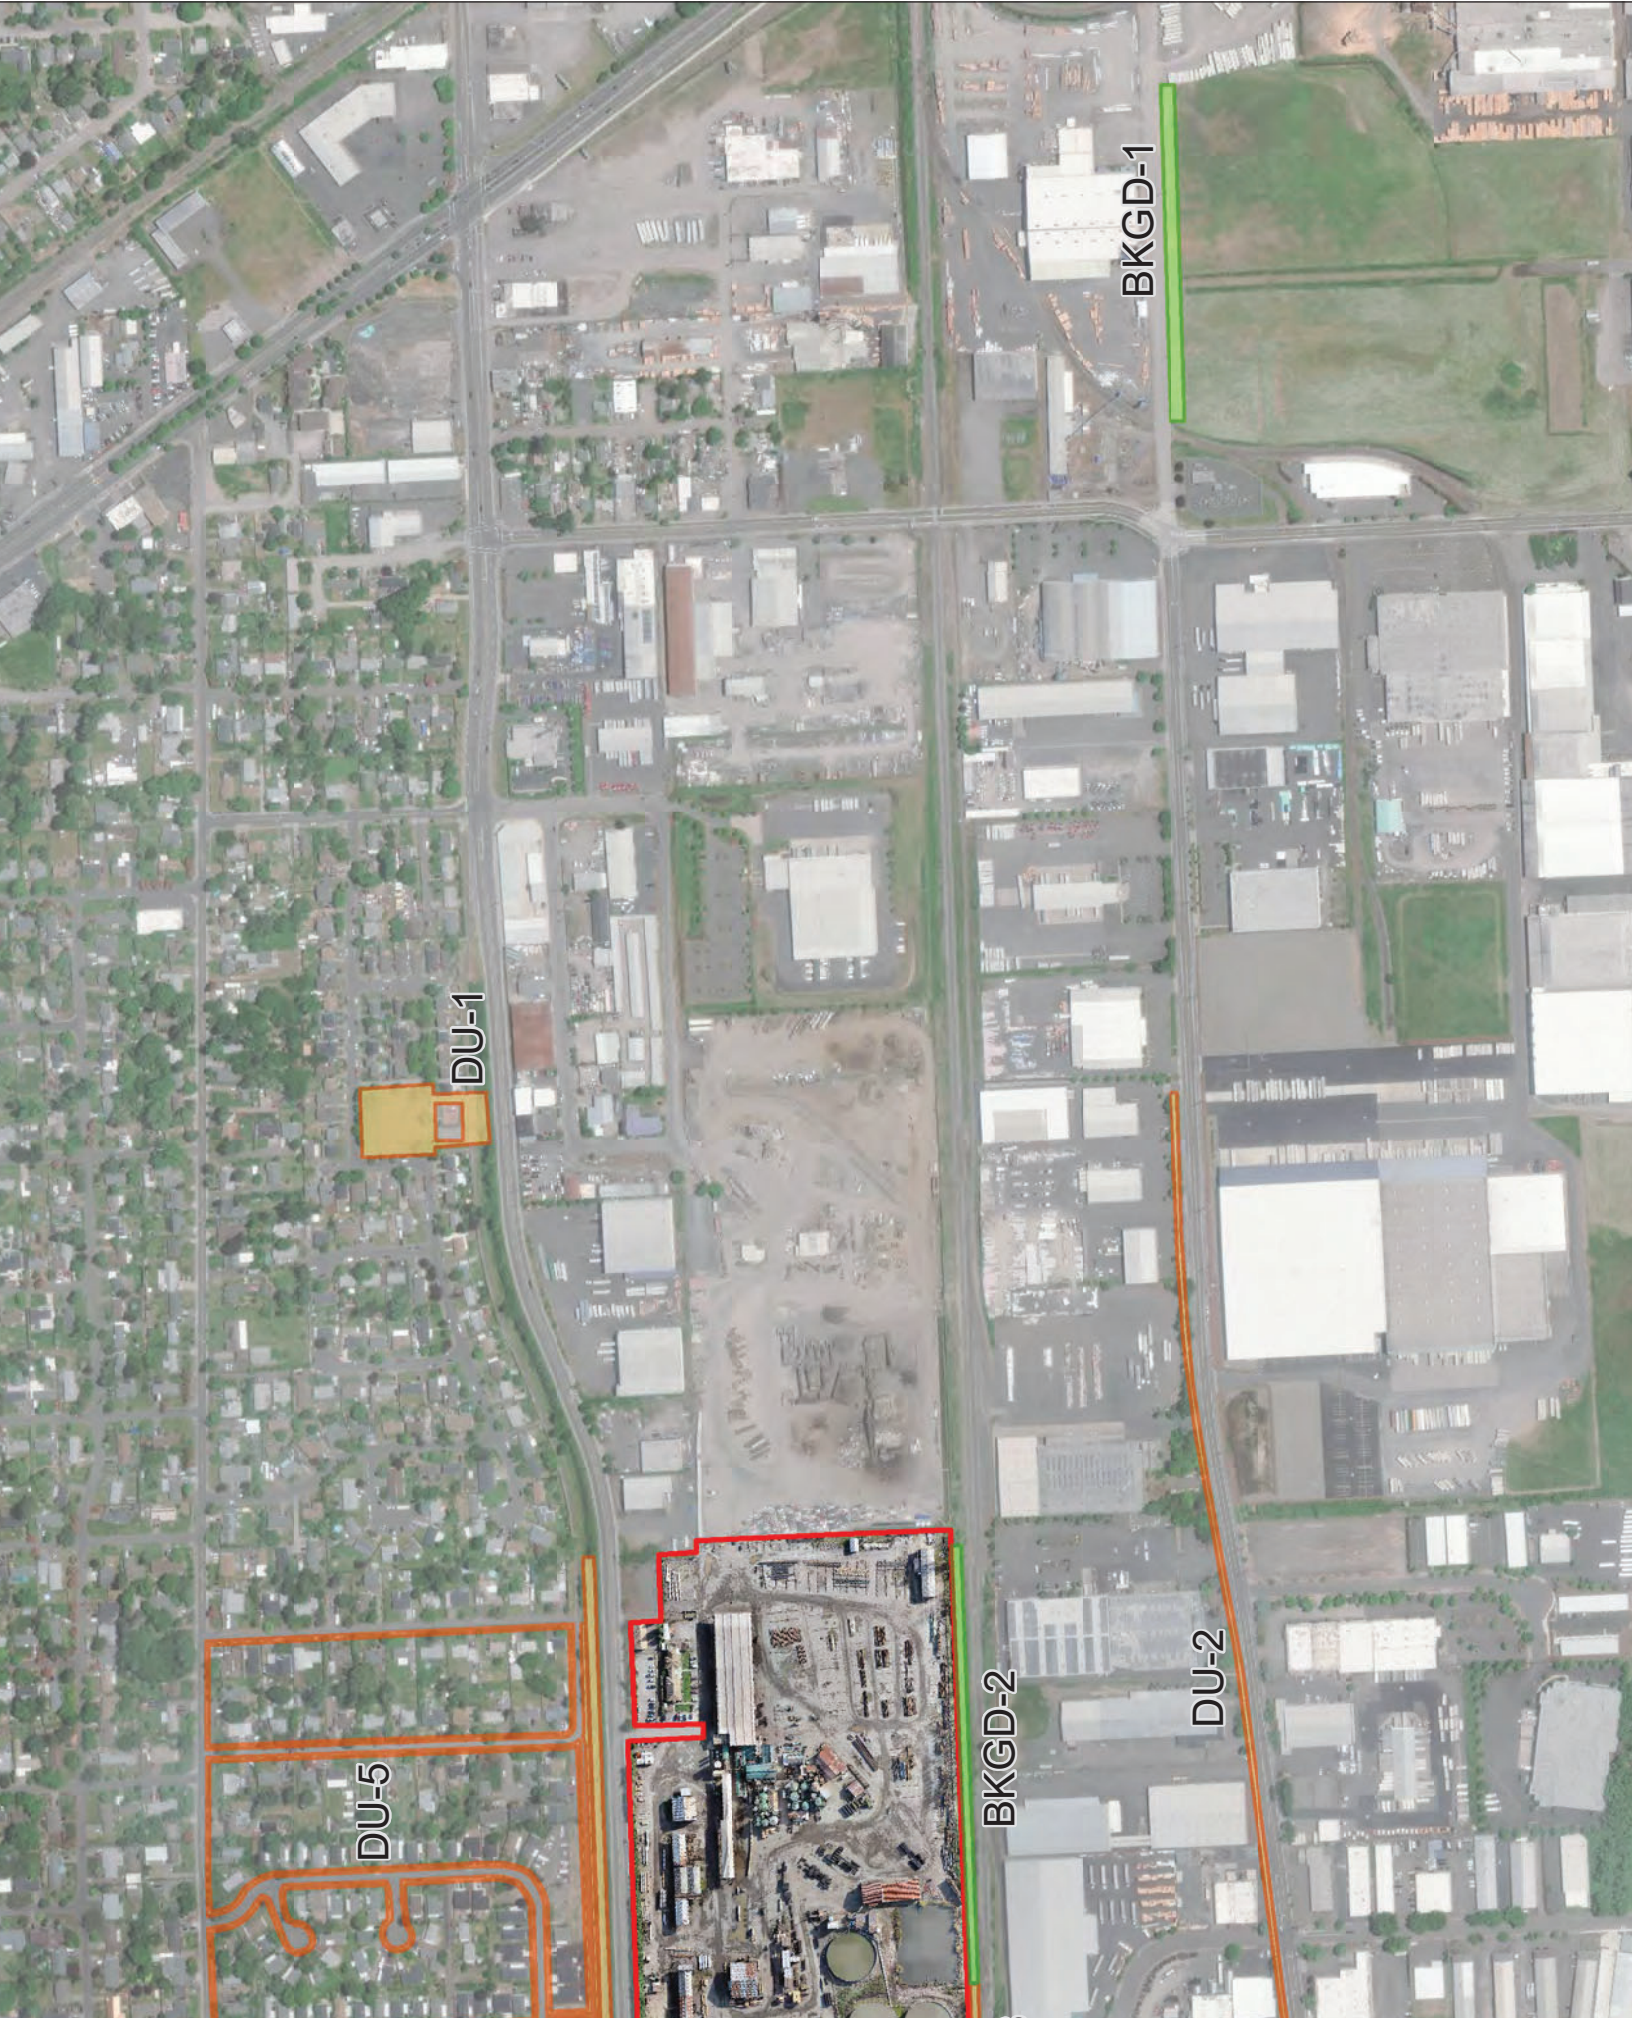
ISM sampling DU boundaries are presented in Figure 1.

Eight DUs, including two background DUs (Figure 2) were delineated in near-site locations; these areas includes the north bank of Roosevelt Channel, public right-of-way (ROW) areas in

neighborhood north of Roosevelt Channel, vegetated surface areas on the north side of West 1<sup>st</sup> Avenue, approximately 400 feet of the discharge channel in the southwest corner of the Site between the west property line and the discharge for Outfall #2, approximately 200 feet of discharge channel west of the Site below Outfall #1, a public park northeast of the Site, a background area within the south drainage channel upstream of where Outfall #2 enters the channel, and an industrial background area south of the Site beyond anticipated air emission impacts.

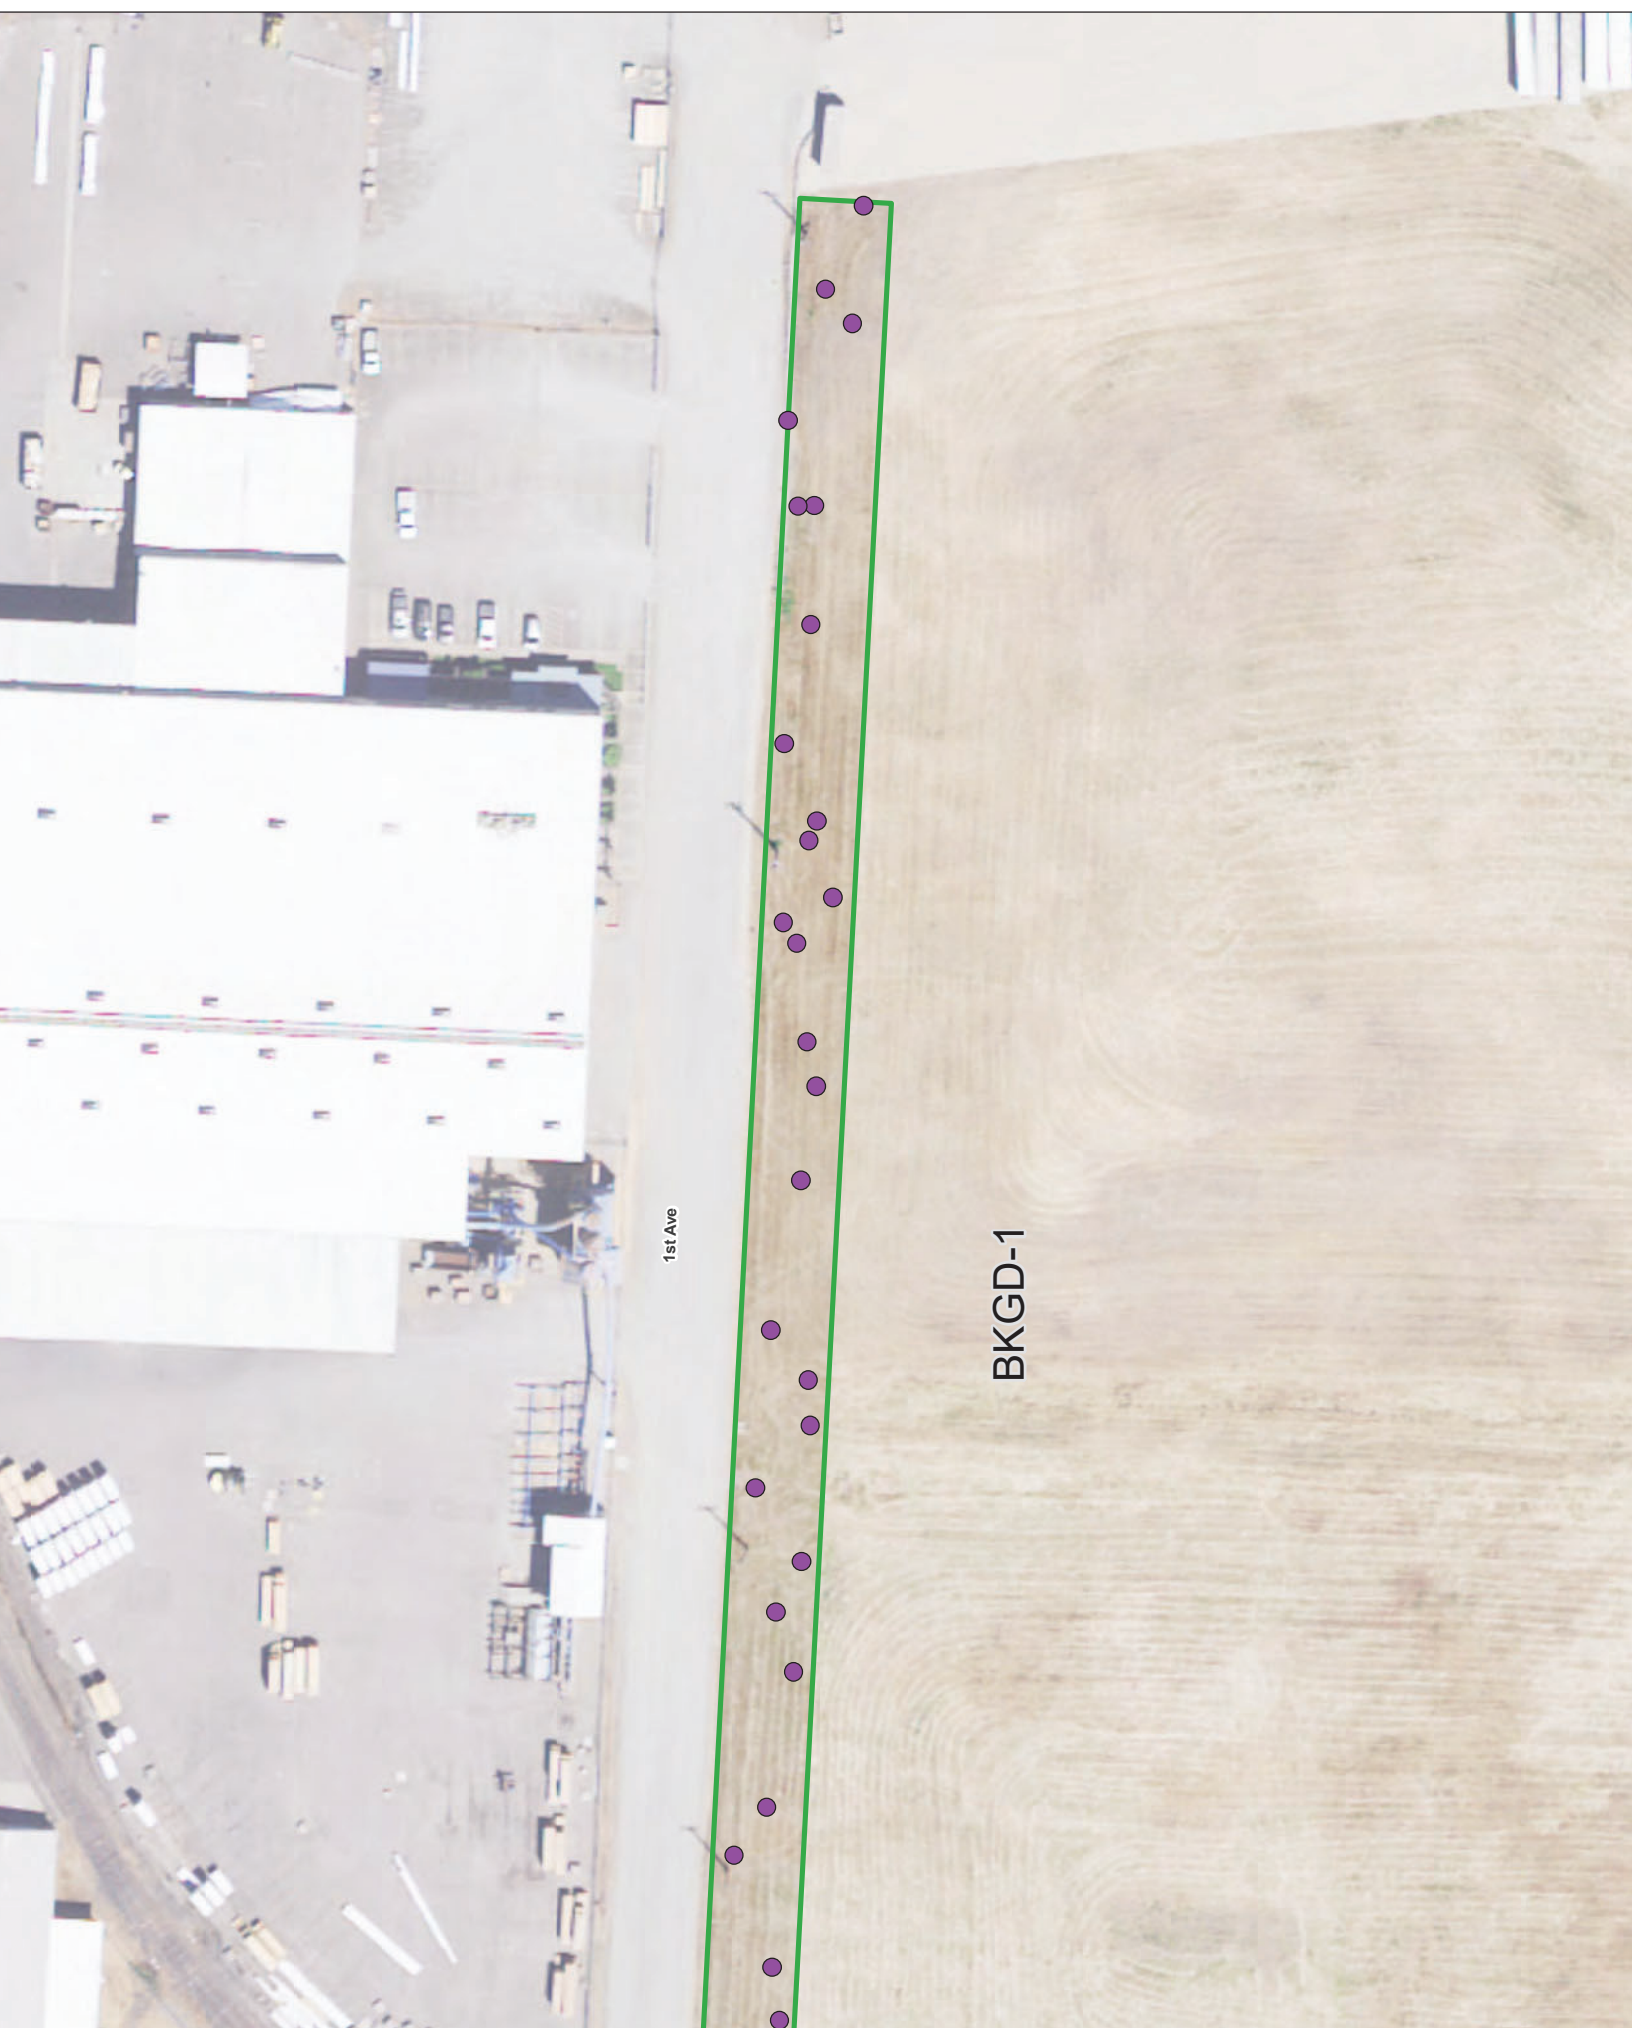
BKGD-1

GSI collected samples from each DU using a stainless-steel push tube, hand trowel and a drill with a small auger bit. All increment sampling locations are shown in Attachment B, some increment locations were adjusted to avoid asphalt, concrete, or areas where access was limited. Each increment was then placed into a single one-gallon sample container provided by the laboratory and were homogenized and processed by Apex Laboratories, LLC (Apex) in Tigard, Oregon, as per the approved SAP (GSI, 2020). The samples were then analyzed by Apex for PCB by EPA Method 8041A, PAHs by EPA Method 8270D LL, TOC by EPA Method 5310B-Mod, Total Solids by EPA Method 2540G, and Metals (Arsenic, Chromium, Copper and Zinc) by EPA Method 6020A. Dioxins/Furans analysis by EPA Method 1613B was subcontracted to Cape Fear Analytical in Wilmington, North Carolina (Cape Fear). DU specific analyses are presented in the approved SAP (Table 1; GSI, 2020).

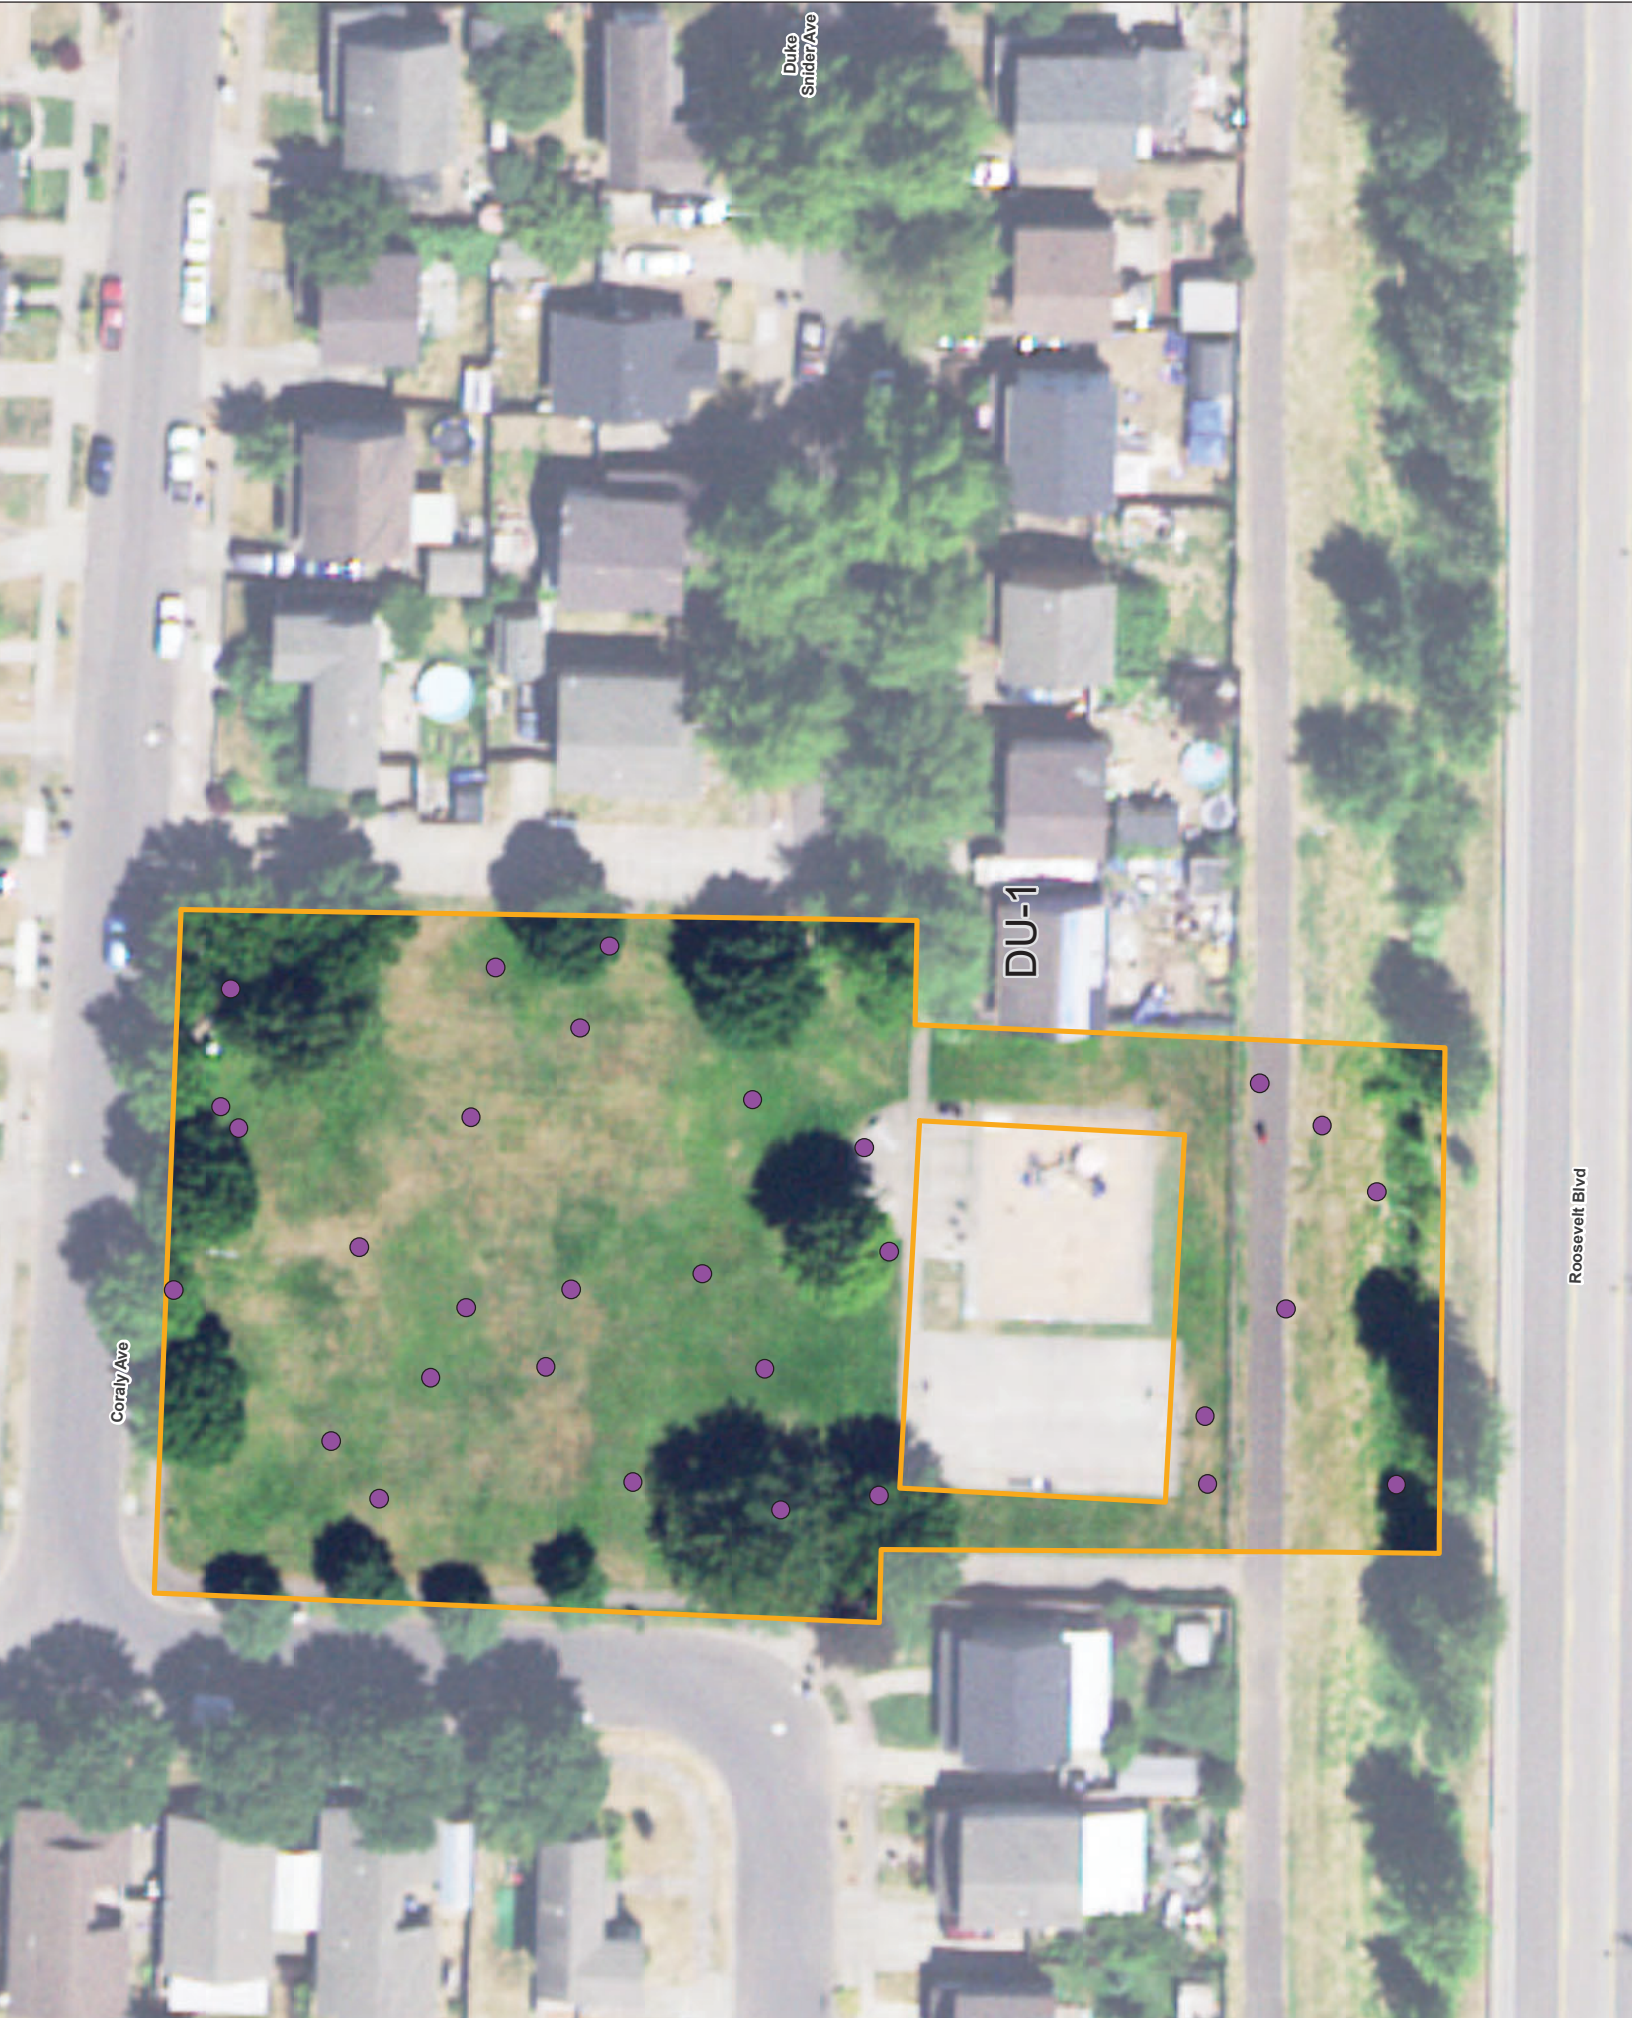
DU-1

- **DU-1:** Silt (ML), brown, moist, medium stiff, few clay, more gravel near south side of park near fence, trace gravelly silt (two increments), ditch increments wet (two increments).
