RE: Temporary Mitigation Measure

N Bradford Street / Union Pacific Railroad Right-of-Way

Peninsula Iron Works Facility Building 2 6618 N. Alta Avenue, Portland, OR

ODEQ ECSI#: 6480

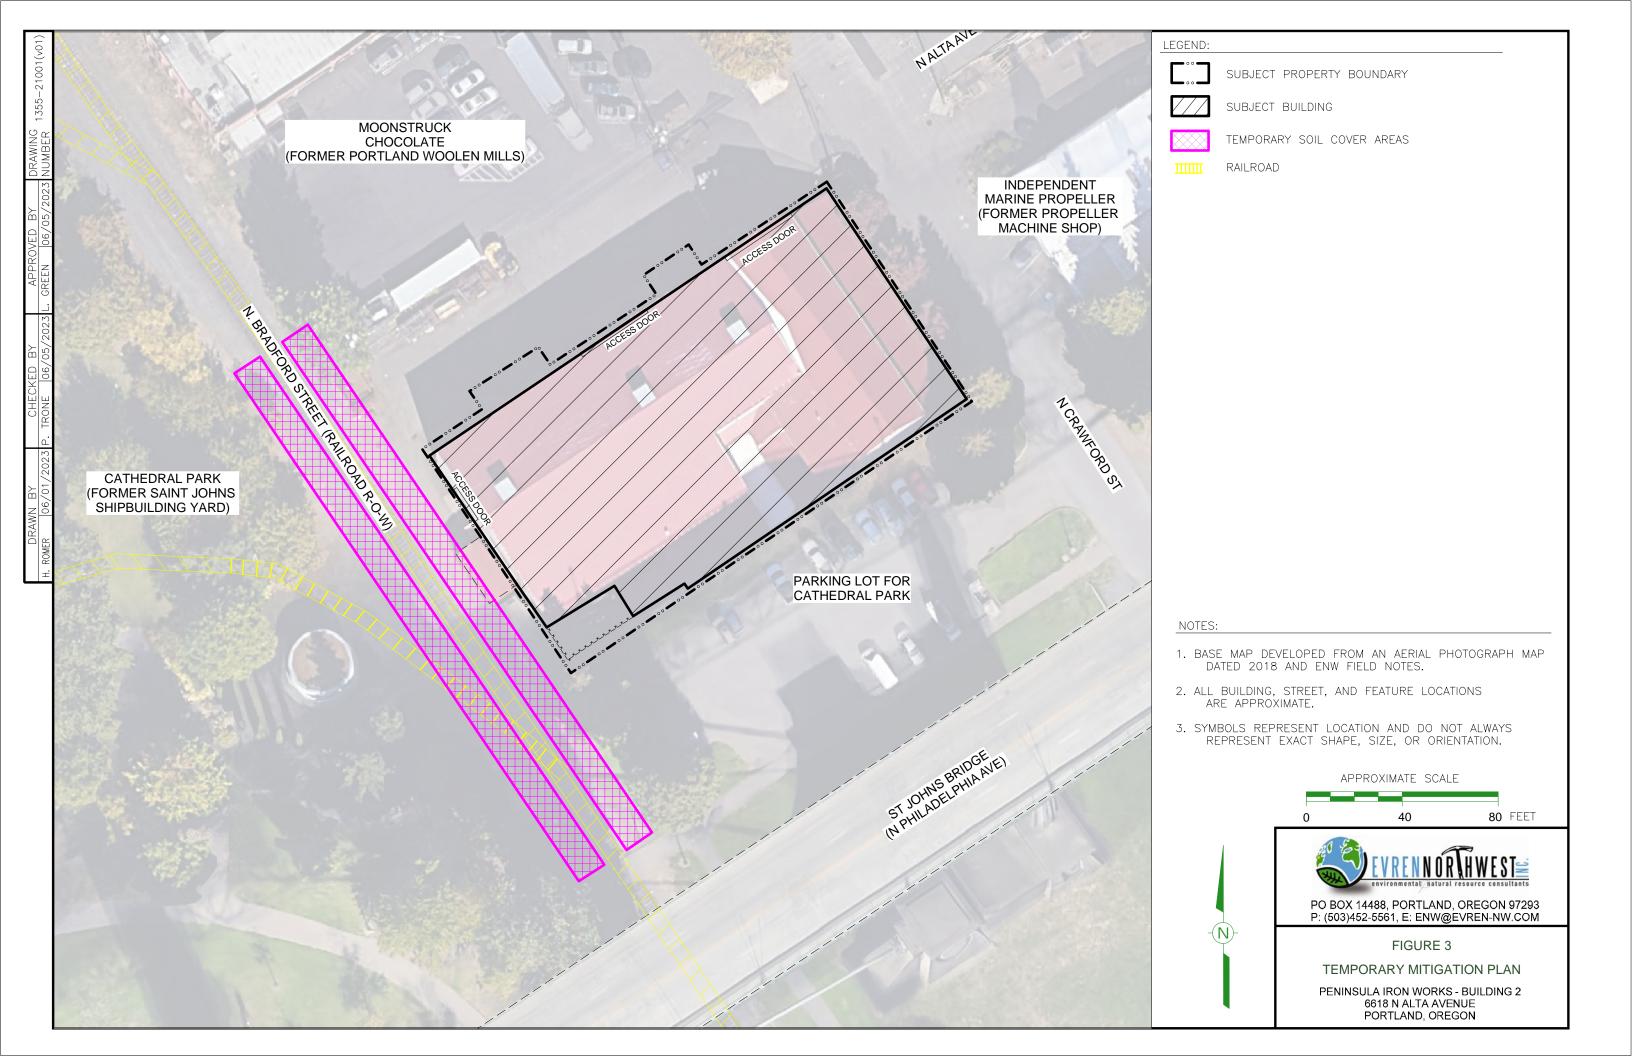
Figure 3 Temporary Mitigation Plan

- Dimensions. Two approximately 255-foot-long by 12-foot-wide sections of geotextile
  were placed along both sides of the railroad tracks to ensure coverage of bare soil and
  gravel in these areas.

- East Section. Covers an approximately 3,000 square foot (sf) area bounded by an asphalt paved pedestrian pathway to the south, asphalt paved apron bordering PIW building to the east, gravel surface approximately 20 feet beyond N Alta Avenue to the north, and rail bed ballast rock for the railroad tracks to the west.

- West Section. Covers an approximately 3,000 sf area bounded by an asphalt paved pedestrian pathway to the south, rail bed ballast rock for the railroad tracks to the east, gravel surface approximately 20 feet beyond N Alta Avenue to the north, and wood chip bedding, grass, and asphalt bordering Cathedral Park to the west.

ODEQ,<sup>2</sup> Union Pacific Railroad (UPRR),<sup>3</sup> and most recently by ENW between November 2022 and January 2023.<sup>4</sup> Based on the findings of these investigations, ODEQ required the placement of a temporary soil cover in the areas outlined on Figure 3.

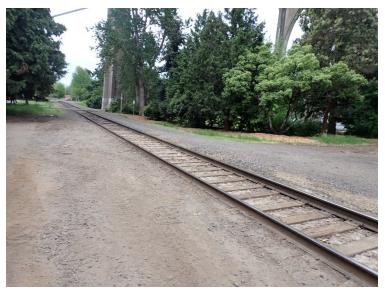
N Bradford Street (railroad ROW) prior to temporary mitigation - view looking southeast. St. Johns Bridge supports visible at the top of photo.

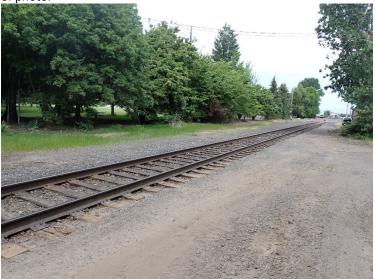
Railroad ROW prior to temporary mitigation – view looking northwest. Cathedral Park on far side of ROW.

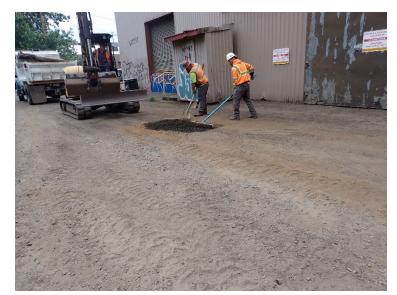
Workers filling a low spot next to PIW building with clean imported crushed rock prior to geotextile installation.

- Surface Preparation. JEI filled in several low spots on the east side of the tracks with clean
  imported crushed rock prior to installing the geotextile to reduce potential safety hazards
  associated with trips and damage to the geotextile.

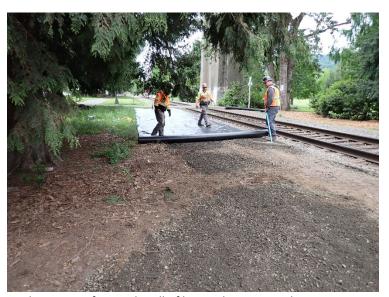
Deploying a 12-foot-wide roll of heavy-duty geotextile starting at the southeast (uphill) side of railroad ROW.

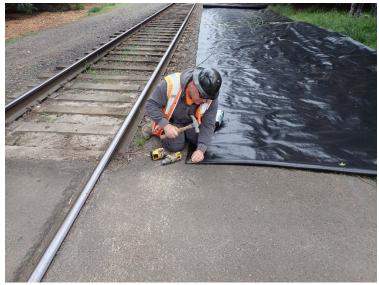
Securing the southeast end of the geotextile to the asphalt-paved pedestrian pathway by installing concrete anchors.

- Fastening the Geotextile. The edges of the geotextile were folded under thereby doubling the thickness at the points of attachment. JEI used a combination of hammered concrete anchors, pneumatic driven nails, and pneumatic driven staples to secure the edges and middle of the east and west sections of geotextile. Concrete anchors and nails were fitted with round machine washers to help prevent the material from tearing. Fasteners were spaced approximately 6 to 12 inches around the perimeter and every 4 feet in two offset lines down the middle to secure each section of geotextile. Care was taken to ensure that there were no loose edges that could cause a trip hazard to recreational users.

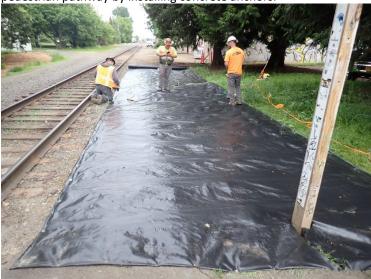
Using a pneumatic nail gun to secure the long edges of the fabric in gravel (left) and grass landscaped areas (right) – view northwest.

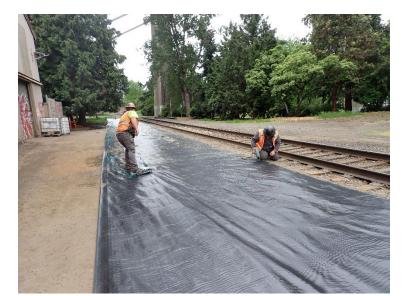
The geotextile was installed against, and secured to, the edge of the asphalt pavement west of the PIW building – view southeast.

- Deviations from Plan. The east section width was less than 12 feet in places to account for the asphalt apron associated with the PIW building. ENW did not cover any asphalt surface more than a few inches necessary install fasteners. The geotextile cover was extended in two additional bare earth areas on the east side of the ROW to prevent potential occupational worker and recreational user exposure to PCB impacted soils in those areas.

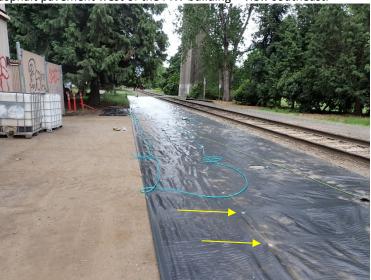
Nails fitted with washers were used to secure the middle of the geotextile.

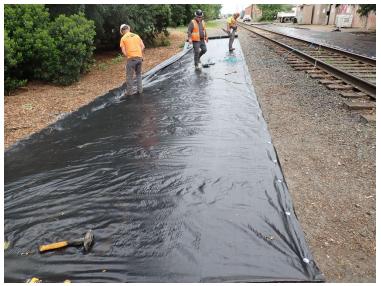
Using a pneumatic nail/staple gun to secure the long edges of the geotextile in chip bedding (left) and gravel ballast (right) – view northwest.

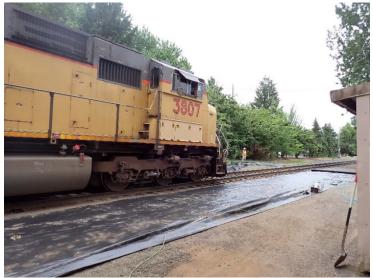
Rail Pros removed derailment measures and asked workers to stand back 8 feet while a north-bound train passed through the work area.

- Permits and UPRR Oversight. Since the temporary mitigation was at least 12 inches from the railroad tracks, and the ROW is not owned by UPRR, ENW was informed that a permit or access agreement with the railroad was not necessary. However, third-party rail safety coordinator (Rail Pros) was contracted to provide on-site oversight, safety instructions, set up derailment measures, and remove those measures when a train came through. JEI and ENW were instructed to remain 8 feet back from the tracks when unprotected. A Health and Safety tailgate meeting was conducted in the presence of ENW, JEI and Rail Pros.

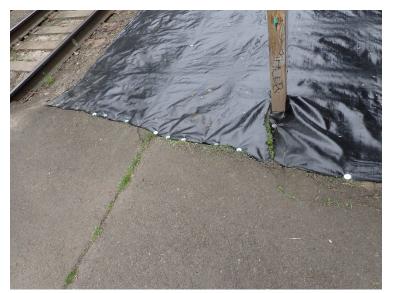
Close-up showing the short edge of geotextile secured to asphalt pedestrian pathway.

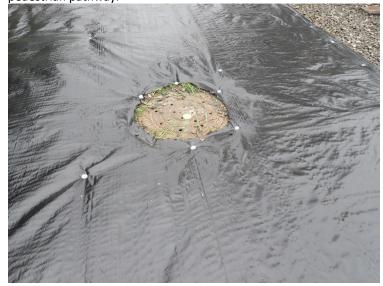
Geotextile was fitted around a manhole cover to ensure it could be accessed, if needed..

- Access to Manholes. The geotextile was trimmed around sewer manholes and water covers to facilitate access to those features during the timeframe the temporary covers are in place.

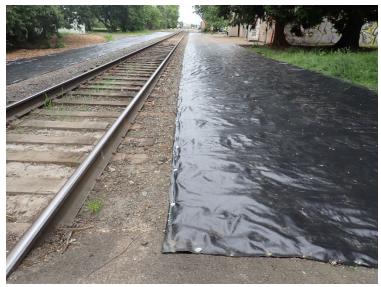
Completed temporary mitigation on the upgradient east side of the railroad ROW – view northwest.

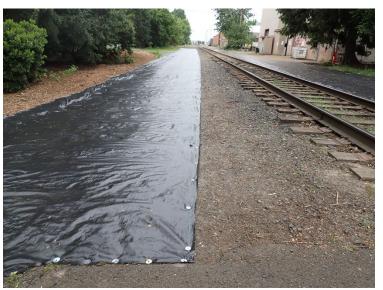
Completed temporary mitigation on the downgradient west (Willamette River) side of the railroad ROW – view northwest.

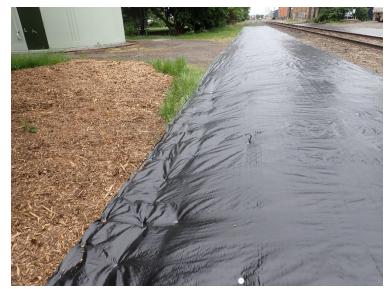
Multiple rows of staples were used to secure the west long edge of the geotextile in wood chip bedding.

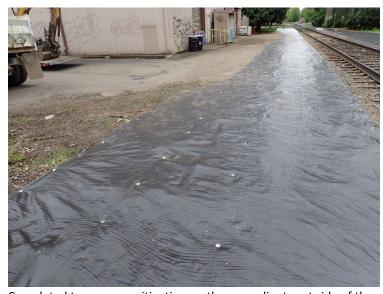
Completed temporary mitigation on the upgradient east side of the railroad ROW – view southeast.
