Water Sampling Results & Oversight: UST Decommissioning, Penske Truck Site

2108 Joseph Street, MEDFORD, OR 97501

Date: September 25, 2013

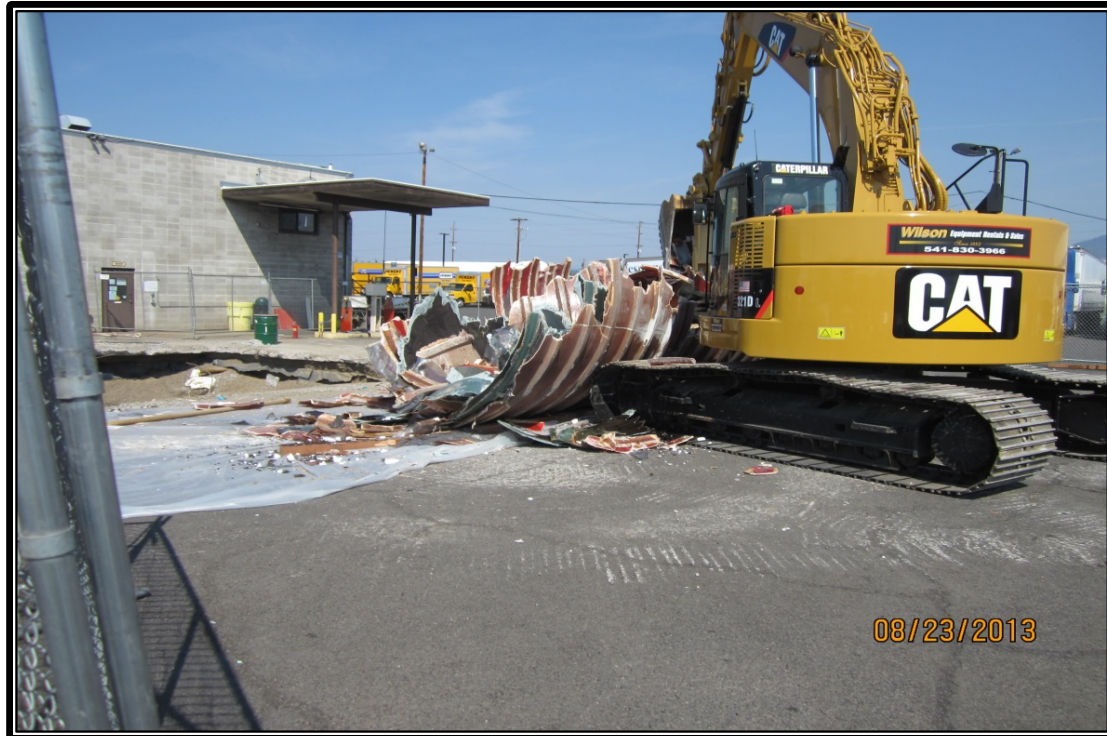
Cover Photograph: Demolition of the northernmost UST after removal and cleanup. 8-23-2013.

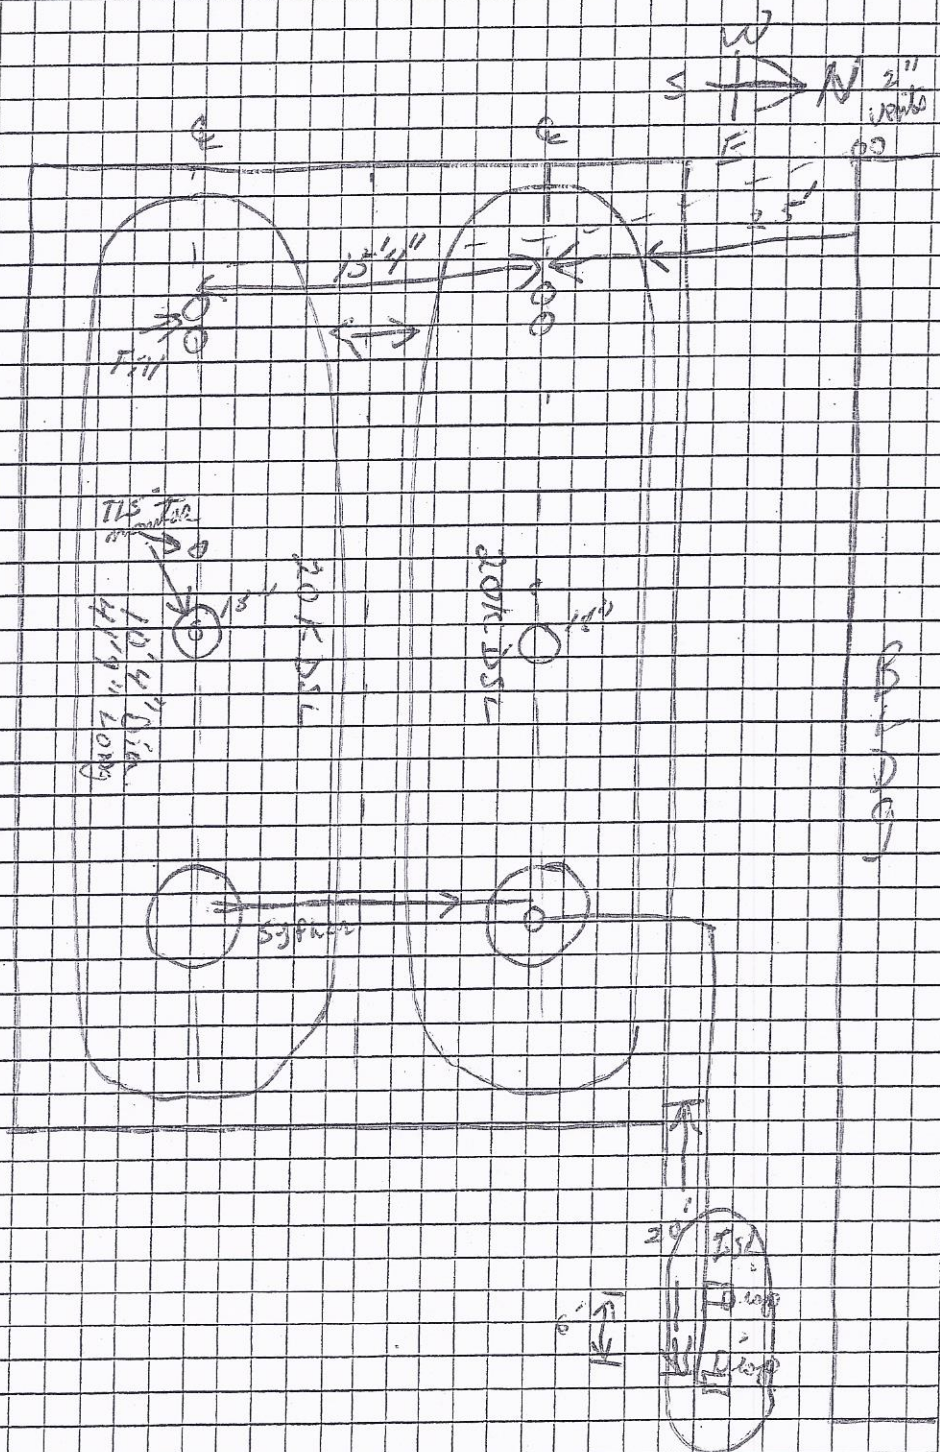
The locations of the UST pad, fuel island, and other relevant structures are shown on the 4 diagrams provided by WSES. On the morning of August 23, during preliminary excavation work for UST removal by WSES, the north side 20,000 gallon diesel fuel storage tank, abetted by the hydrostatic pressure of the groundwater and reduced (through excavation) lithostatic pressure of the overlying material, "floated" as a result of substandard coupling bolts and lines attaching the retaining straps to the cement ballast structure (Ralph Jenkins, WSES, per. Comm.). The upward acceleration ruptured the associated plumbing, and sent the tank into the bucket assembly of the track-hoe being used in the excavation. One end of the tank was fractured as a result (Photograph 3), with some product spilling into the tank pit. WSES immediately applied absorbent pads to collect spilled product (spots of hydrocarbon "sheen" and occasional tarry "dead oil" spots on the surface of the water). Although working carefully through the afternoon hours to excavate the south 20,000 gallon diesel UST, it also gave way, rupturing associated piping. However, on this occasion, the "floating" did not impact construction equipment and the tank itself remained intact.

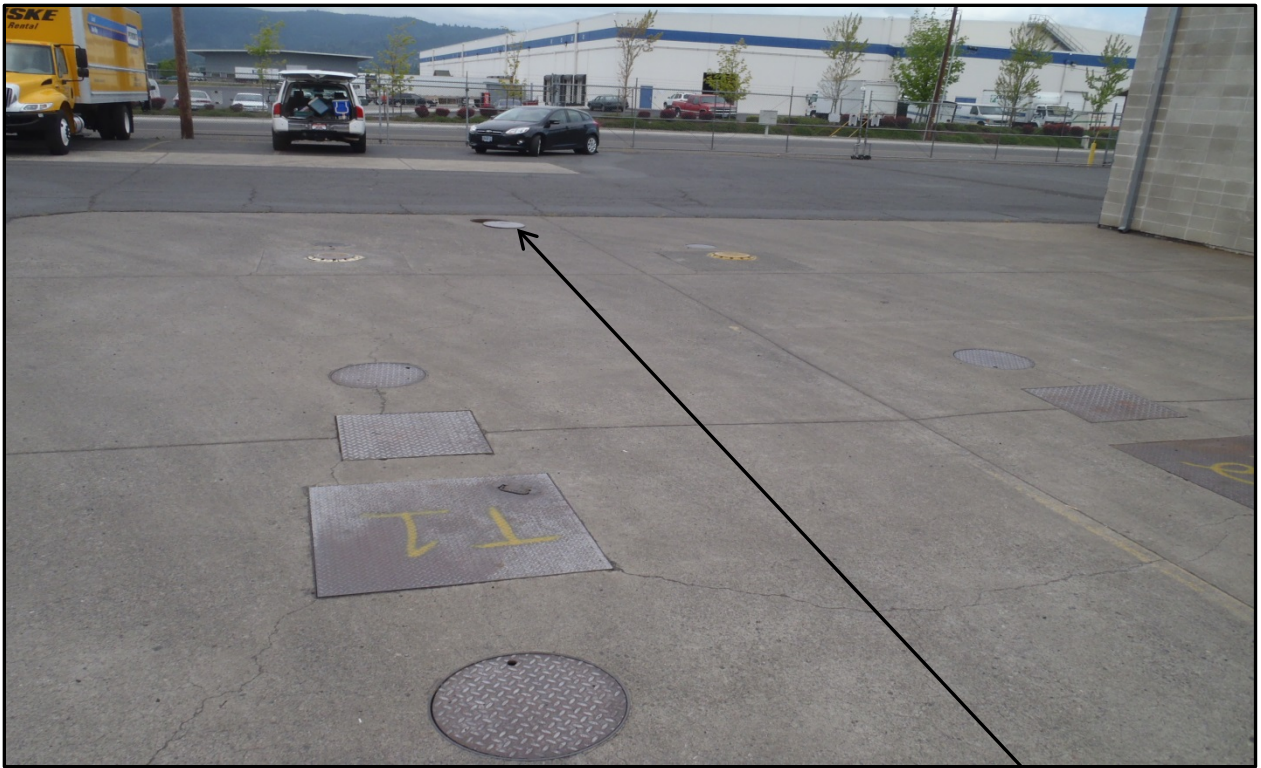
Photograph 1. Looking west at the location of the covers of the two USTs and the Observation Port Cover (background center) between them. 5-6-2013.

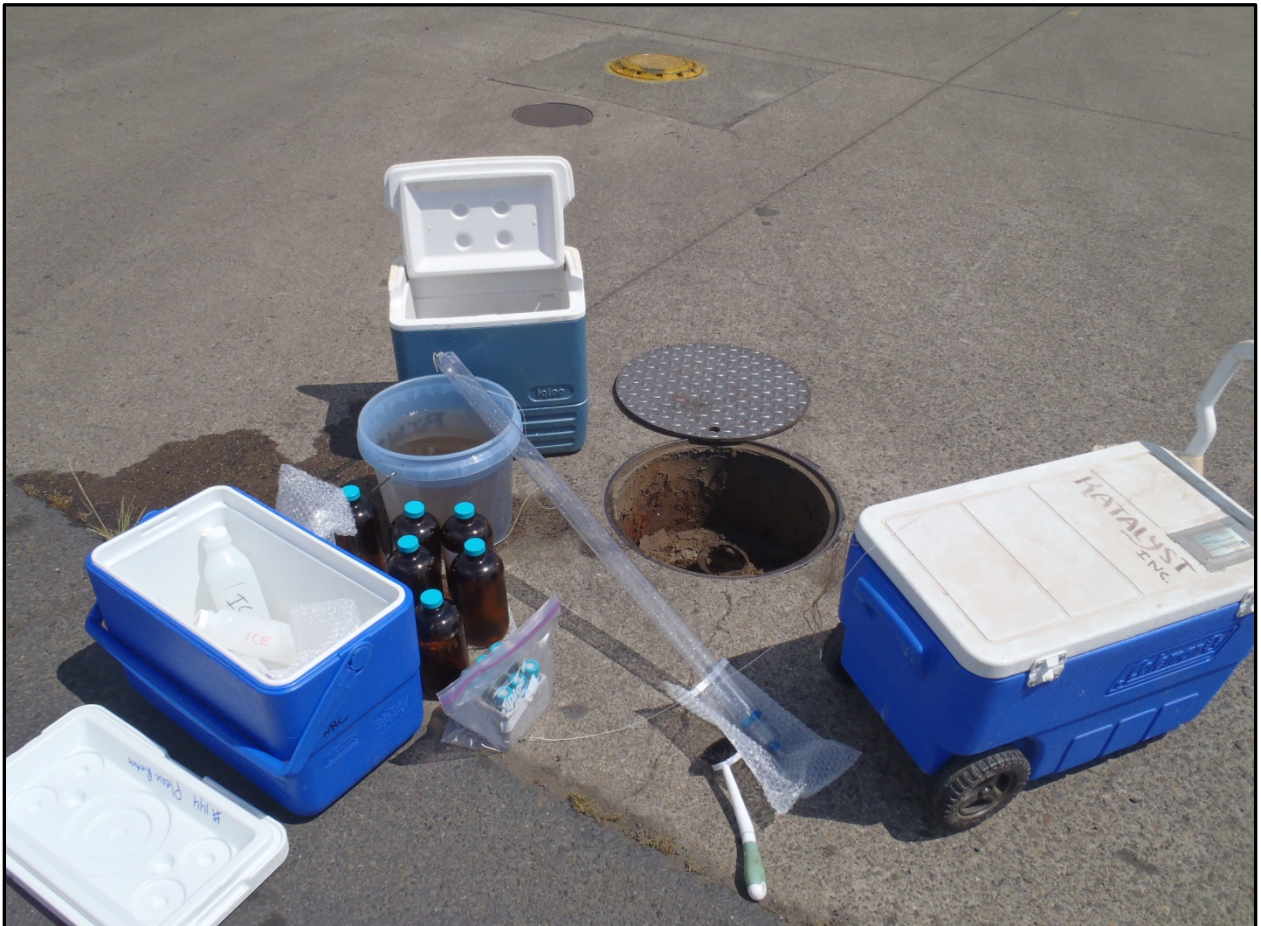
14 feet below ground surface (bgs). As-built depth of the UST's was described as 13.5 feet bgs. Initial static water level (swl) in the observation port was observed as 3.21 feet bgs. One well volume was purged, and the re-equilibrated swl was measured at 3.25 feet bgs. The water sample was then collected with a bailer (Photograph 2). As with all the subsequent water samples, collection was in clean containers provided by the laboratory, placed into an iced cooler, and delivered to Nielsen Laboratories using standard Chain of Custody procedures.

Photograph 2. Collection of the initial groundwater sample from the Observation Port. 5-6-2013.

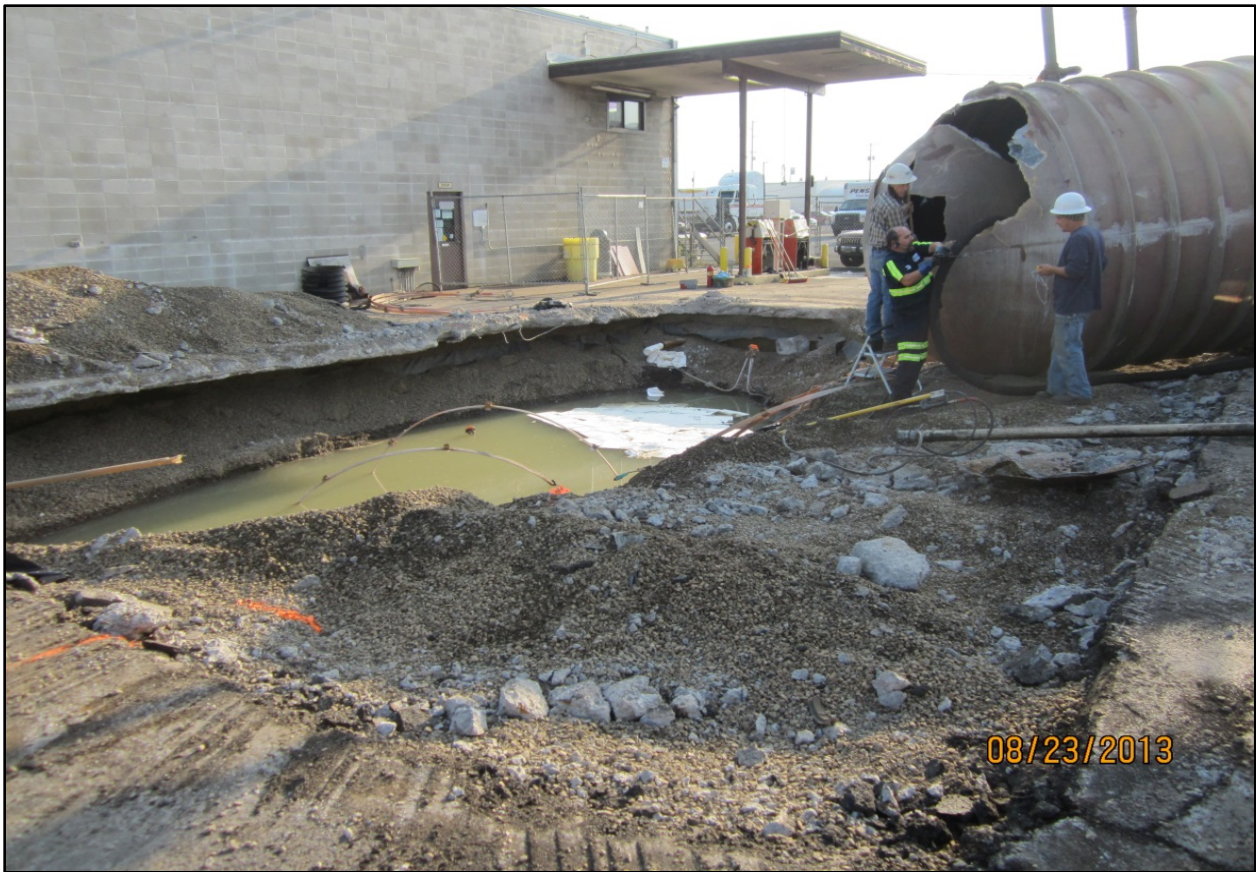
Given the breach of one of the empty USTs, a pit water sample (PTW-1 in Table 1) was collected from the excavation on August 23, 2013 prior to performing any dewatering activities. Low concentrations of petroleum hydrocarbons were detected in PTW-1. Comparison to the most stringent standards appropriate for dewatering showed that the petroleum concentrations from the product release did not exceed the level of the most stringent risk-based assessment standards, and WSES was allowed to dispose of the pit water to the storm water drain system on the west side of the Site (Photograph 4) on August 28, 2013.

Photograph 3. Tank Pit after removal of first tank, note deployment of absorbent pads, fractured tank. 8-23-2013.

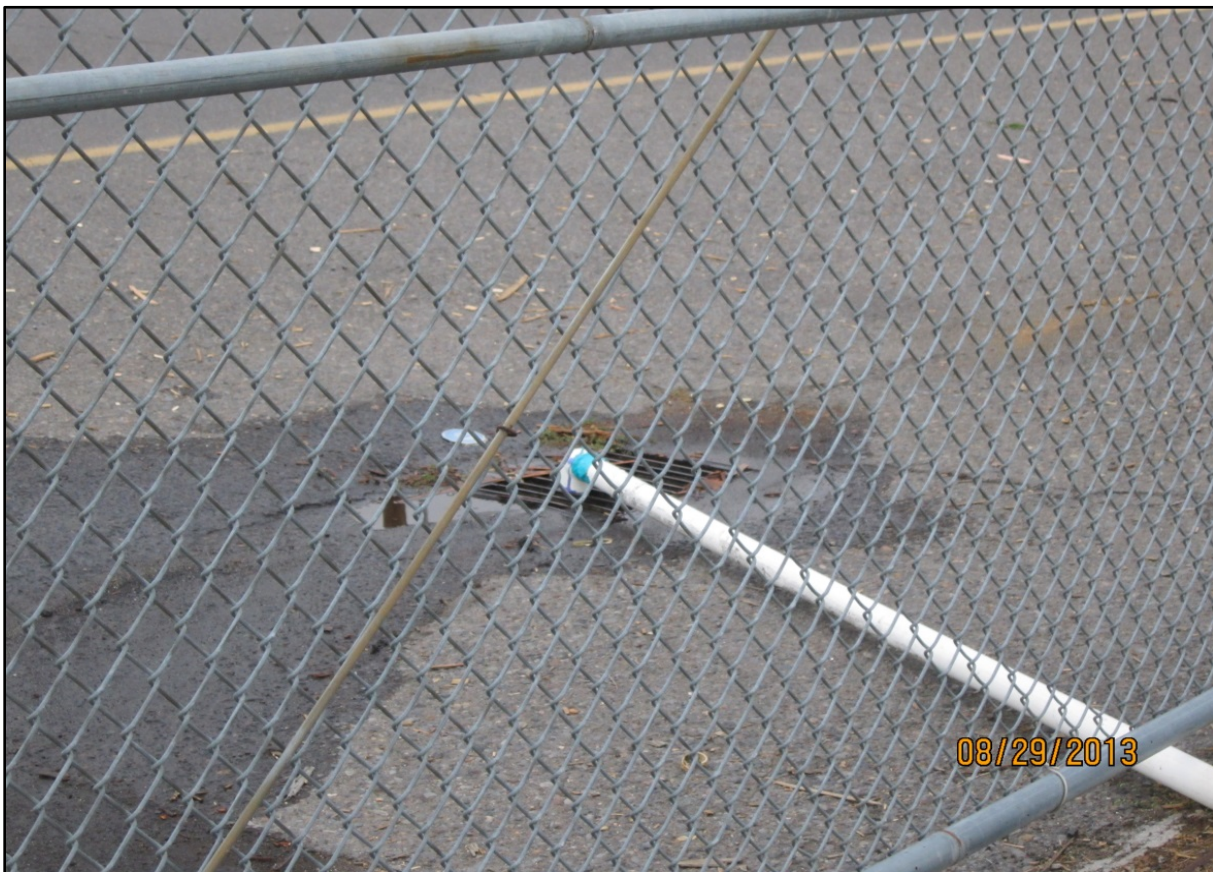
Photograph 4. Dewatering to the nearby storm drain along Joseph St. 8-29-2013.

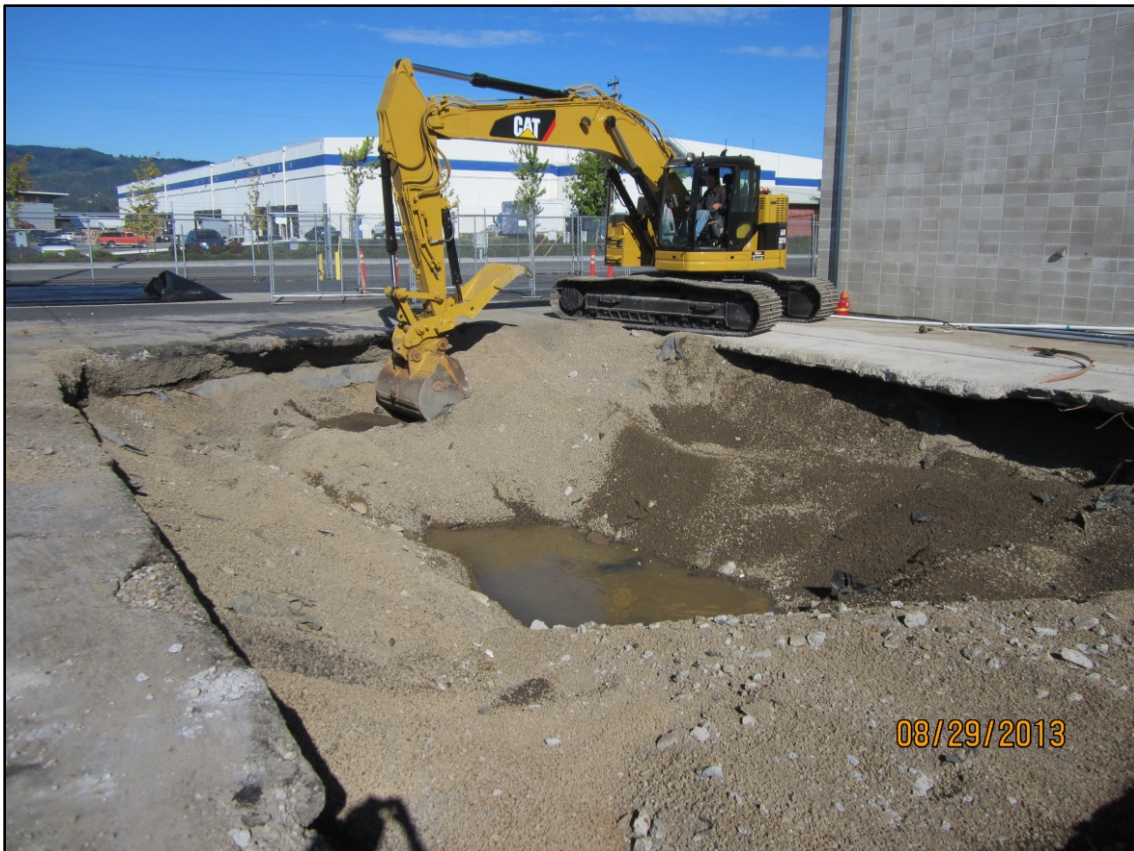
After dewatering, the pit was allowed to stand overnight and another confirmation pit water sample was collected (PTW-2 in Table 1) was collected on the morning of August 29, after groundwater was allowed to recharge the pit (Photograph 5). The excavation was subsequently lined with a textile (Photograph 6) and subsequently backfilled with 3/4 pea gravel and 4" rock the same day (Photograph 7). On the morning of September 9, the site was covered with new concrete (Photograph 8).

Photograph 5. Looking west as groundwater recharges the recently dewatered excavation following UST removal. 8-29-2013.

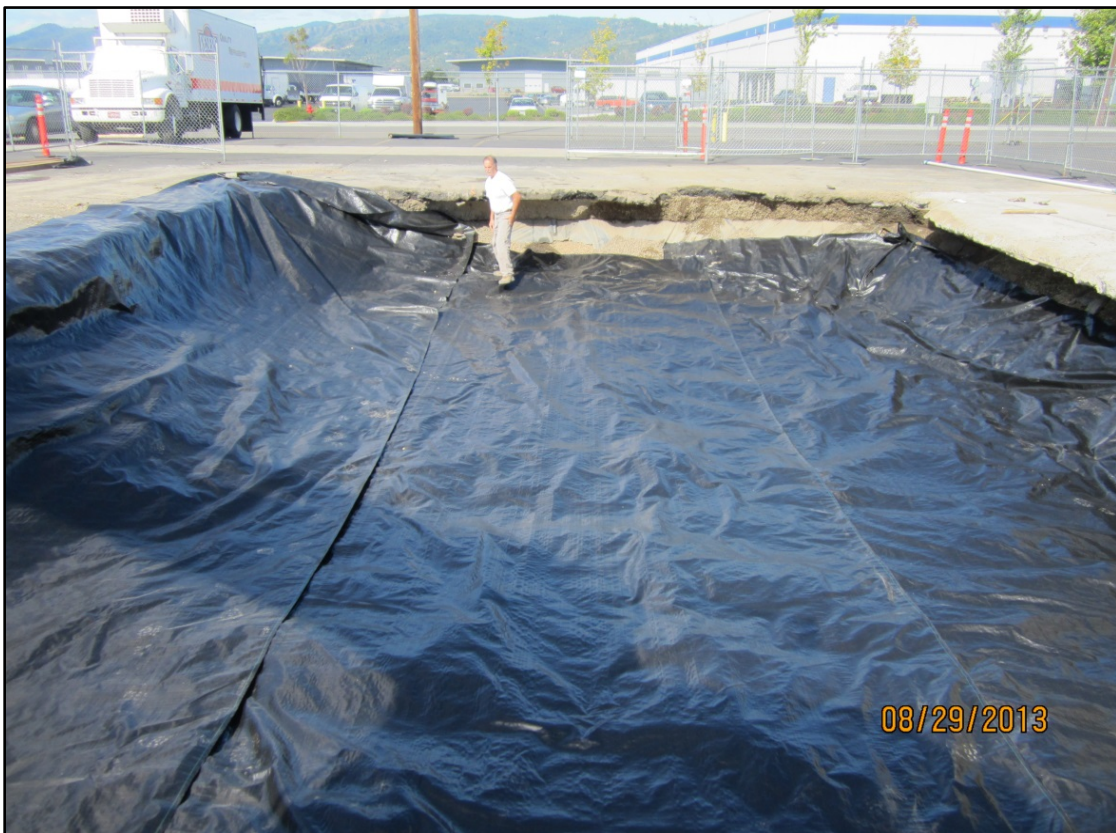
Photograph 6. Looking west at laying the liner prior to backfilling. 8-29-2013.

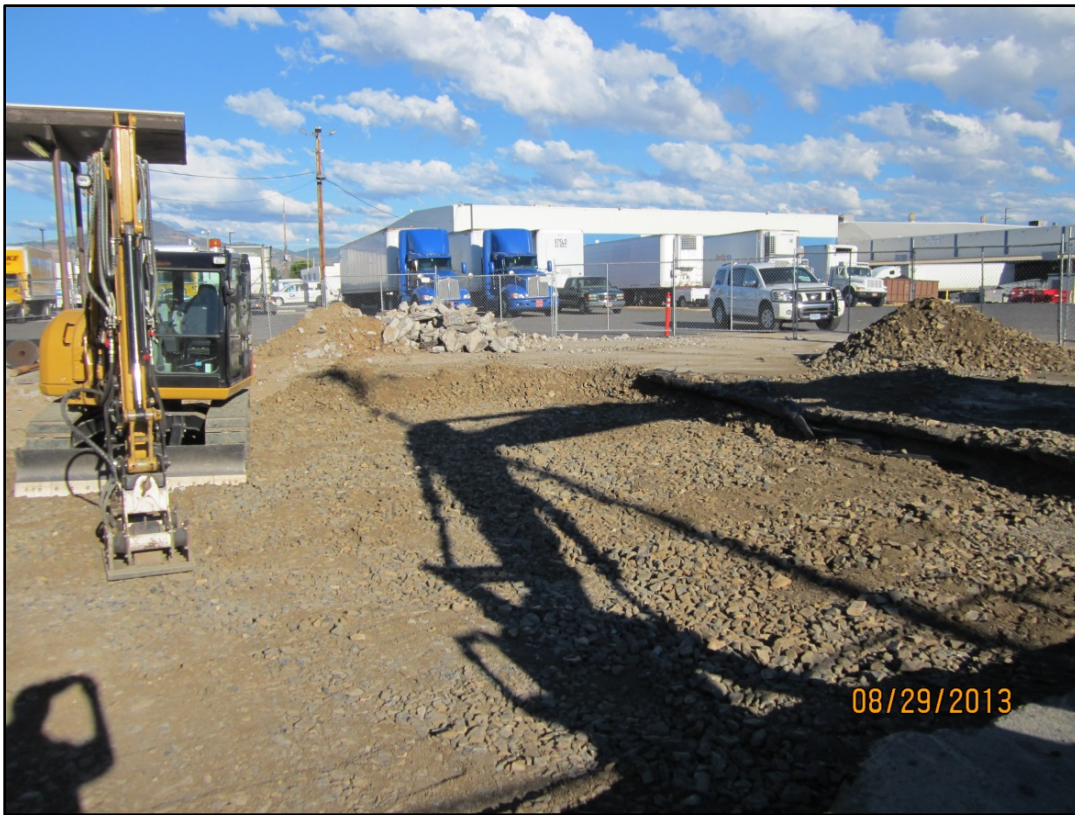
Photograph 7. Looking east as backfill is compacted. 8-29-2013.

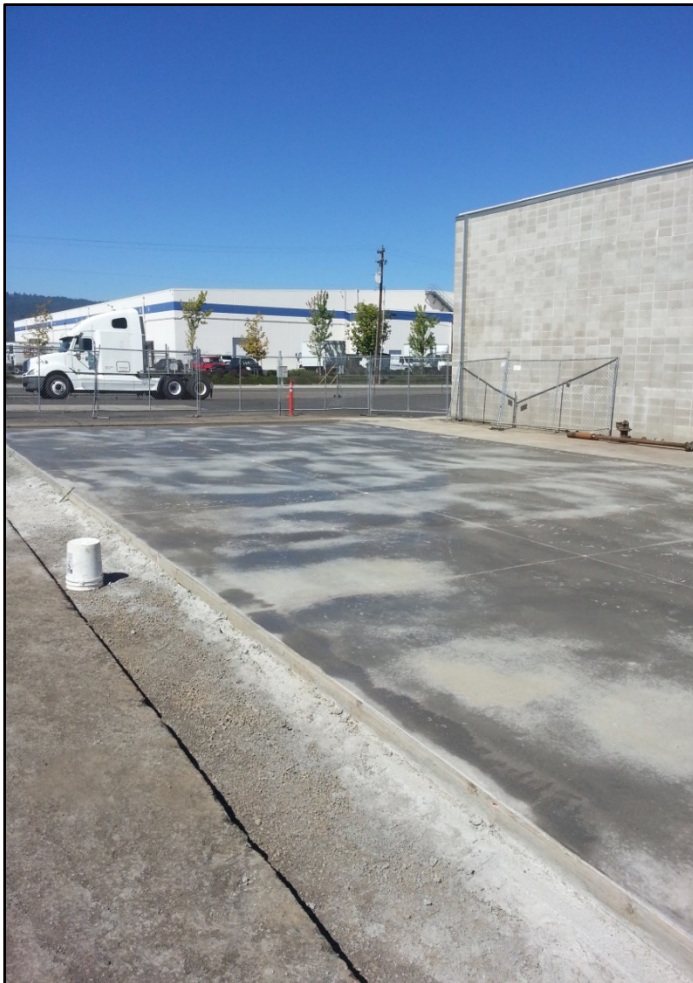
Photograph 8. Looking west just after the new concrete pad has been poured. 9-9-2013
