# TERMINAL 4 STORMWATER UPDATE

Geosyntec Consultants  
24 August 2023

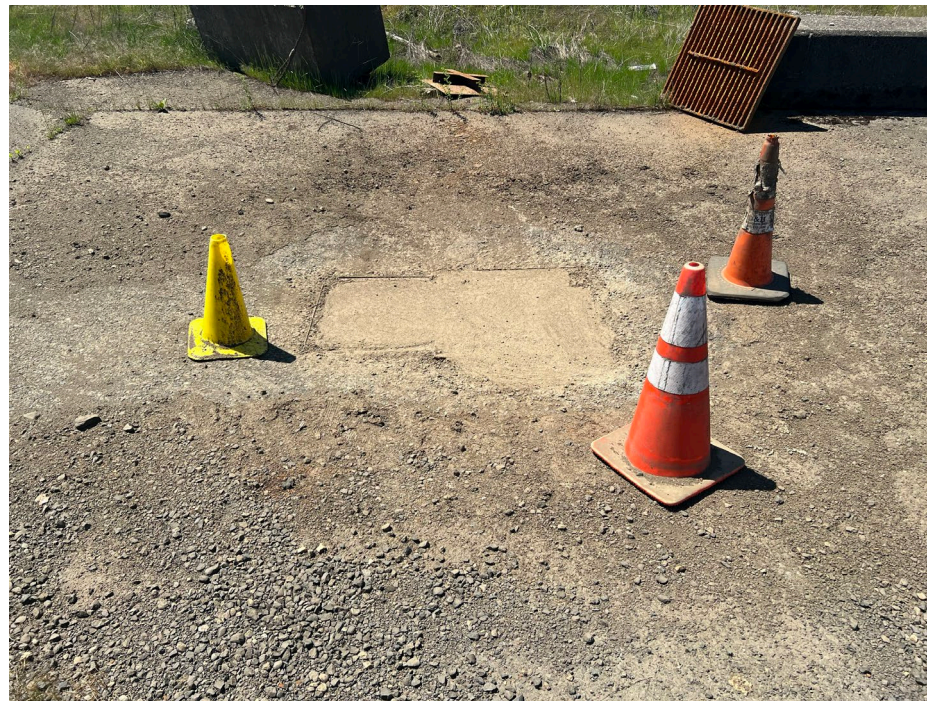
- Basin J
  - All but one catch basin verified as not existing in the field
  - The one catch basin still present (STSCB2654) was filled in May 2023
  - No discharge to outfall observed before or after CB filled

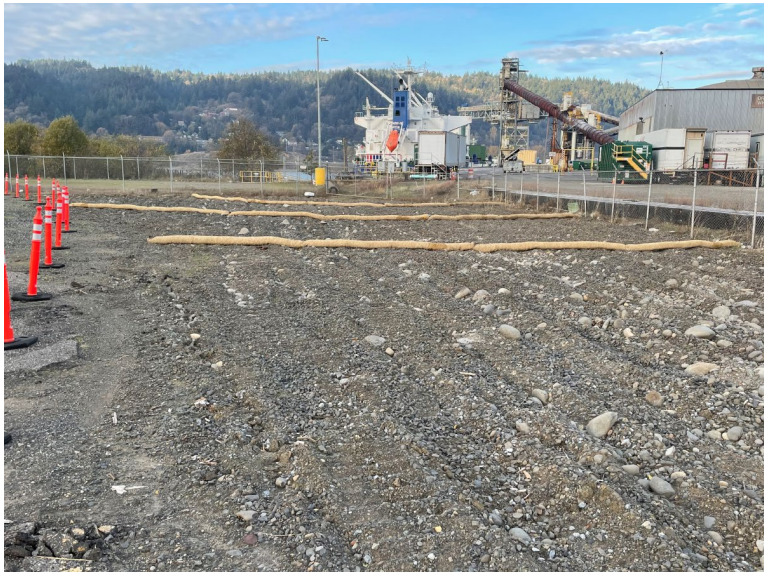
Newly completed BMPs

- CB found to be connected to Basin K1 was capped
- Enhanced disperse infiltration – scarification, wattles
- No discharge to K2 outfall observed before or after CB capping; no discharge from Basin K2 to K1 outfall observed after BMPs installed

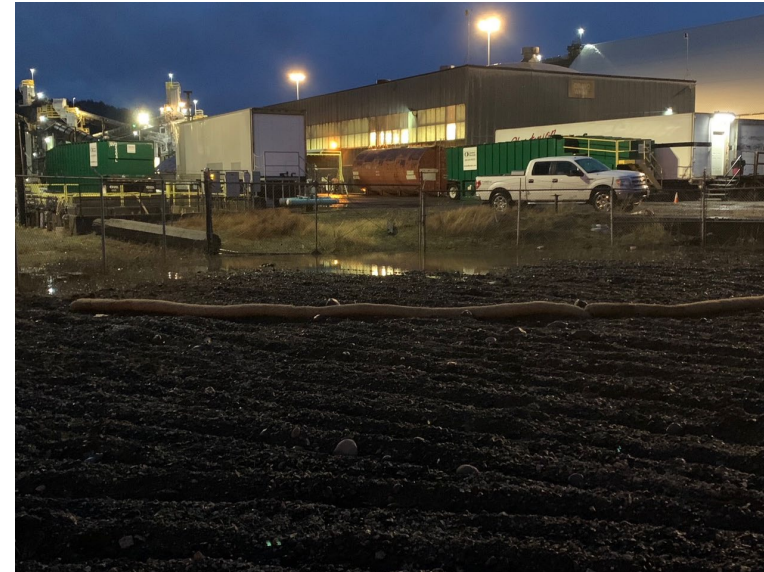
BMPs after a >1" storm in November 2022
