CONTAMINATED MEDIA MANAGEMENT PLAN

Custom Stamping Site – North and Southwest Blocks
Tax Lots 6500, 6800, 6900, 7000, and 7100
1340 SE 9th Avenue
Portland, Oregon

GeoDesign Project: Capstone-12-04

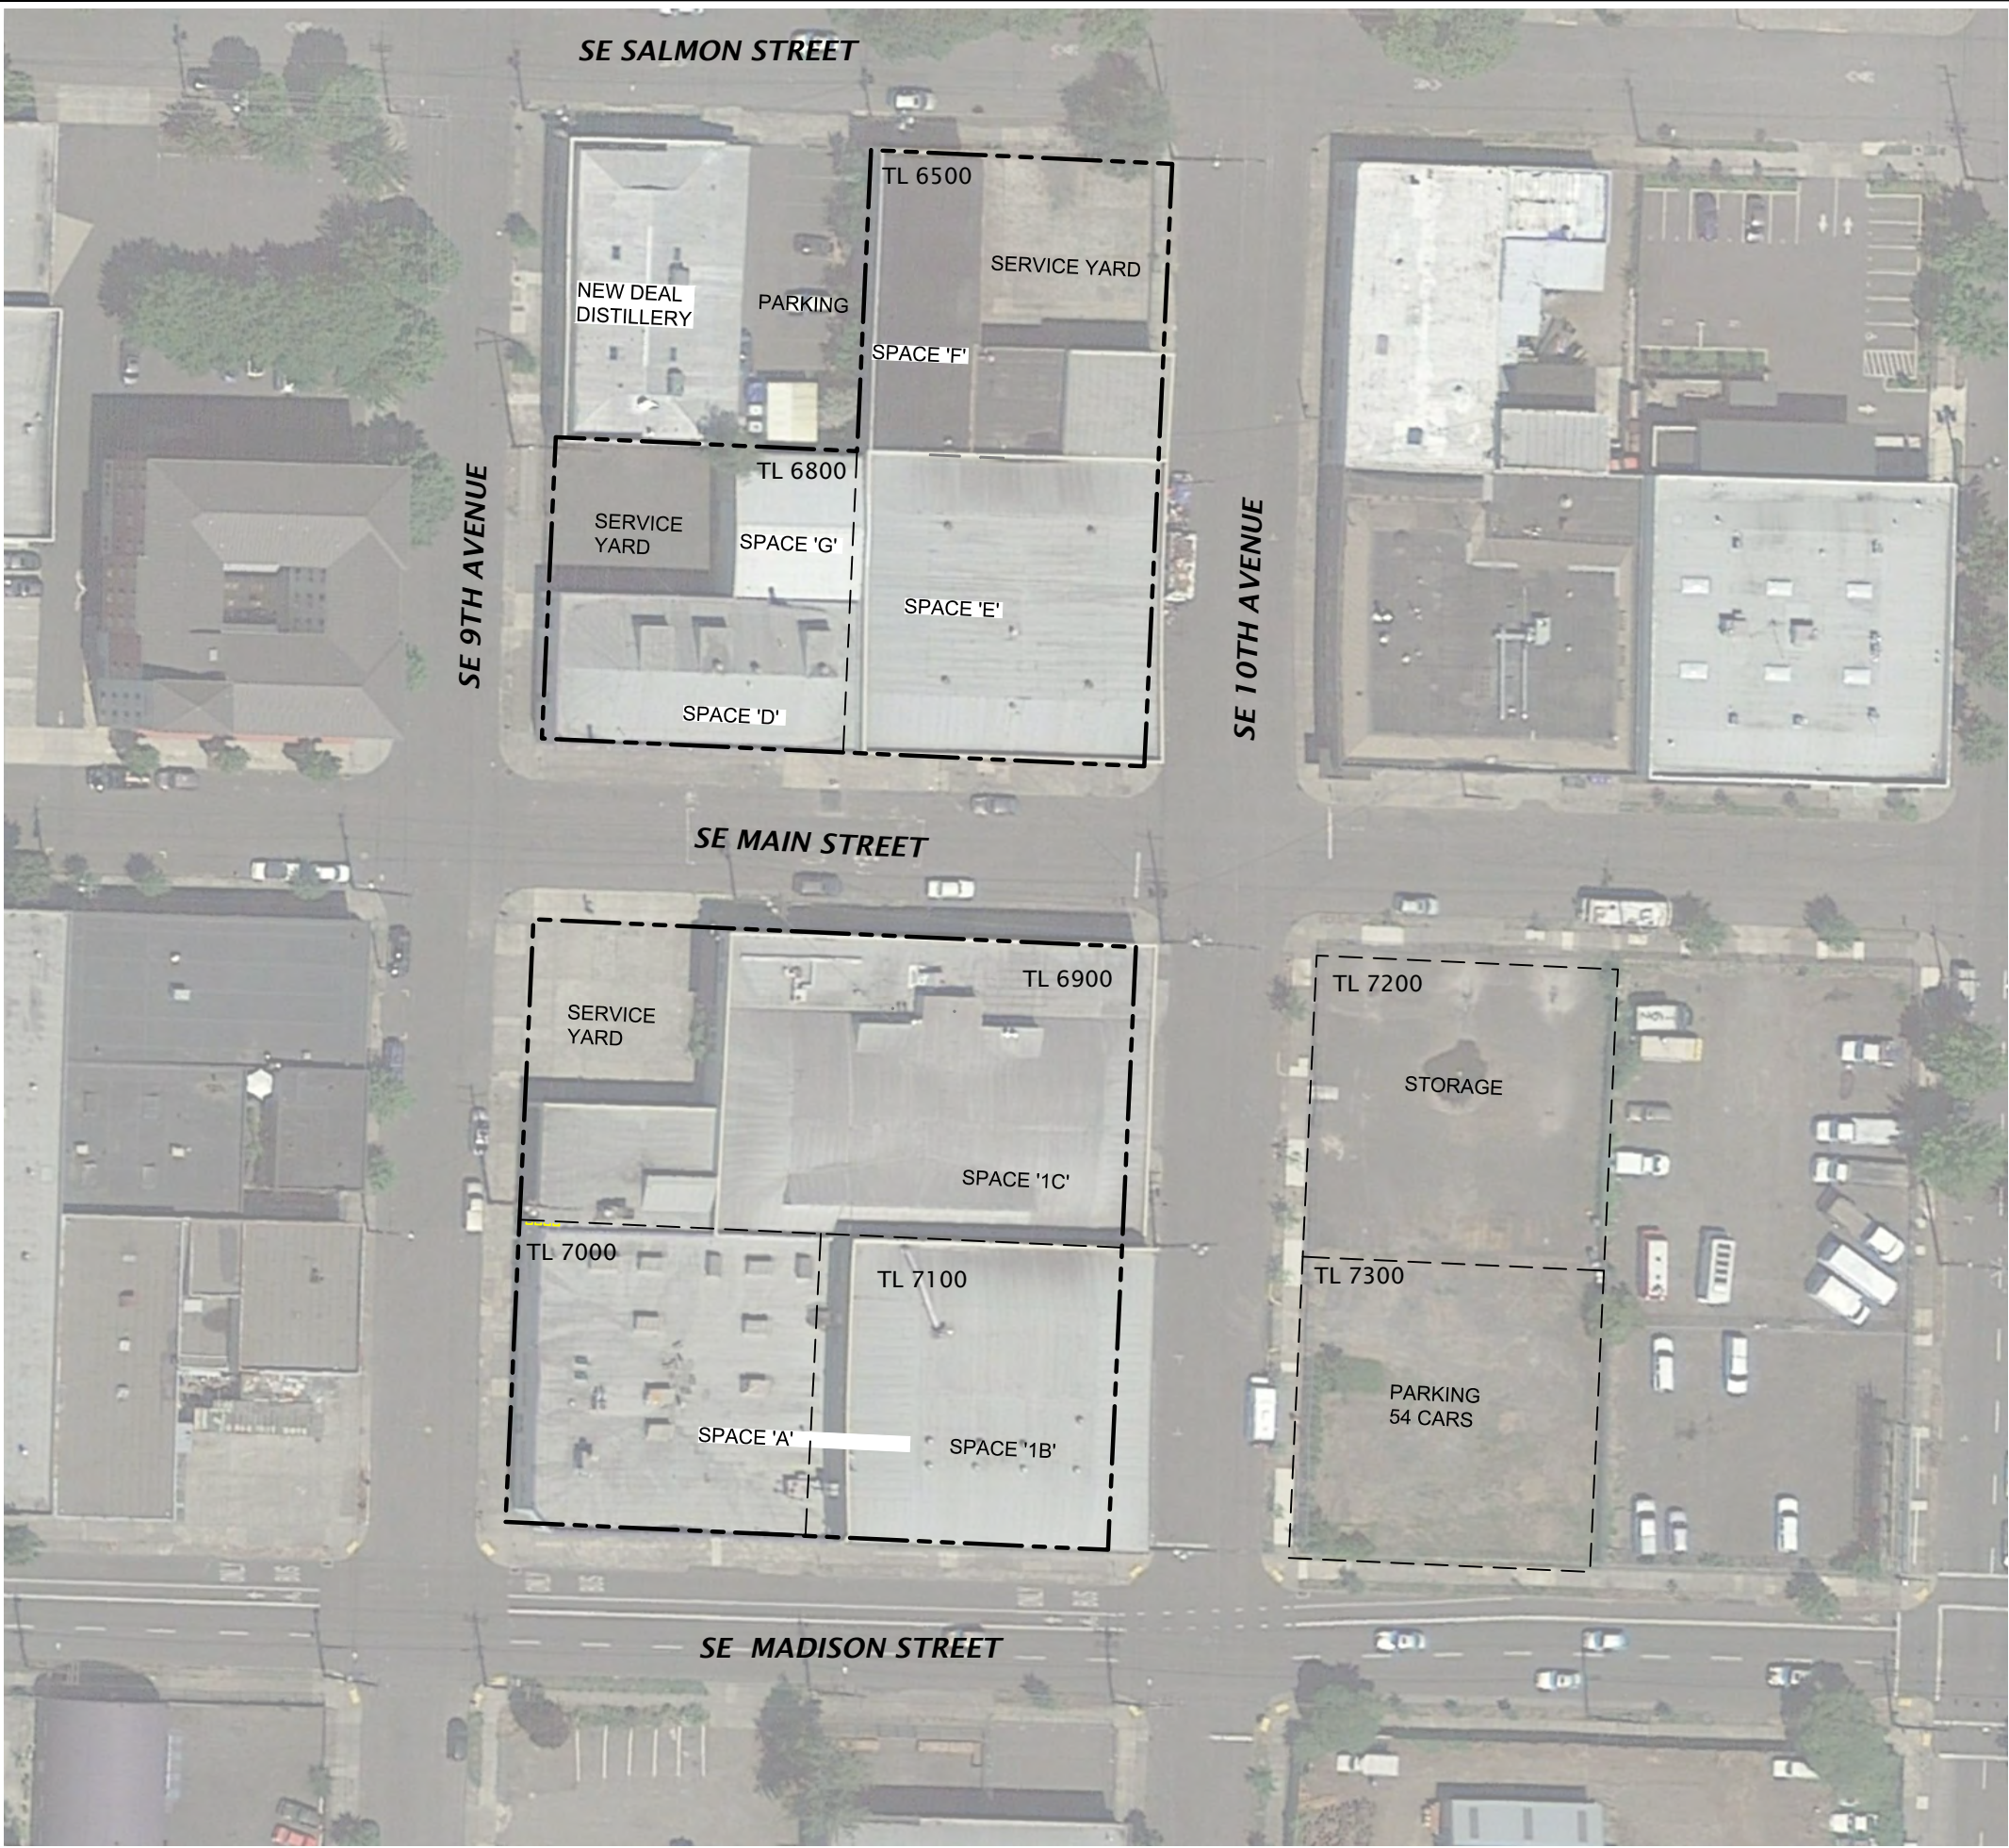
9450 SW Commerce Circle - Suite 300 Wilsonville OR 97070 503.968.8787 www.geodesigninc.com	SITE PLAN	
	CAPSTONE-12-04 FEBRUARY 2017	CUSTOM STAMPING SITE PORTLAND, OR FIGURE 2

LEGEND:
- - - - - PROJECT SITE BOUNDARY
- - - - - TAX LOT BOUNDARY

NOTE:
TAX LOTS 7200 AND 7300 SUBJECT TO
SEPARATE AND FUTURE CONSTRUCTION.

SITE PLAN BASED ON AERIAL PHOTOGRAPH
OBTAINED FROM GOOGLE EARTH PRO®,
JANUARY 9, 2016
