RE: No Further Action Determination

for Former Lum's Auto Center in Astoria

LUST #04-19-0187

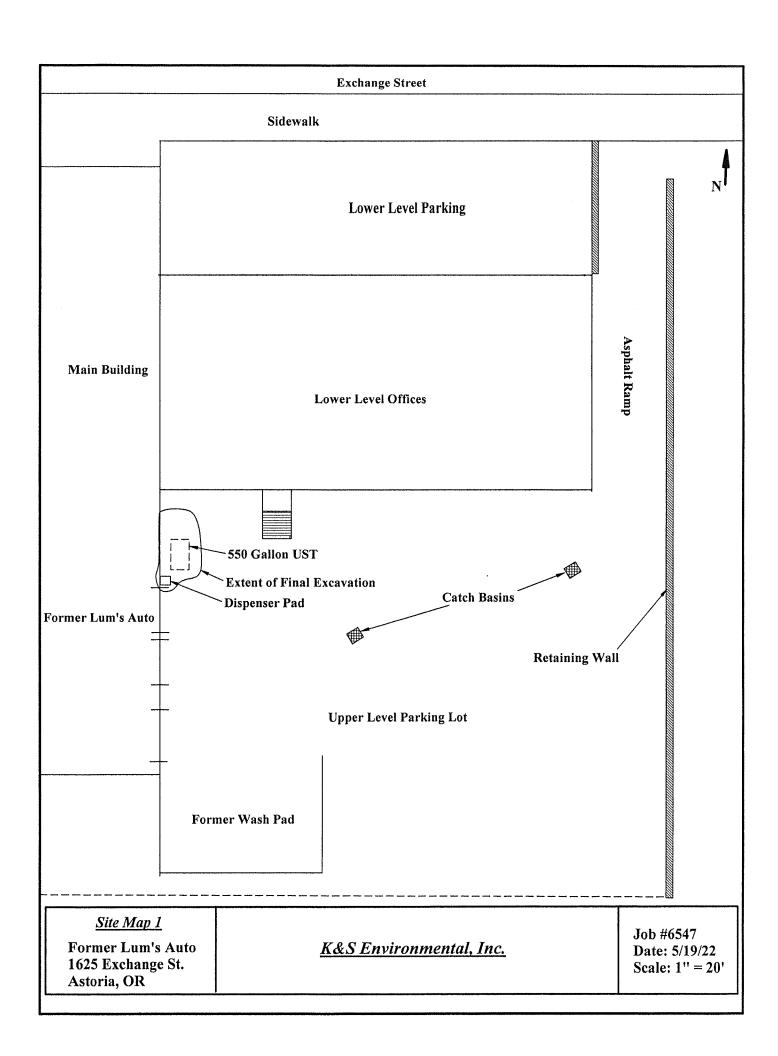
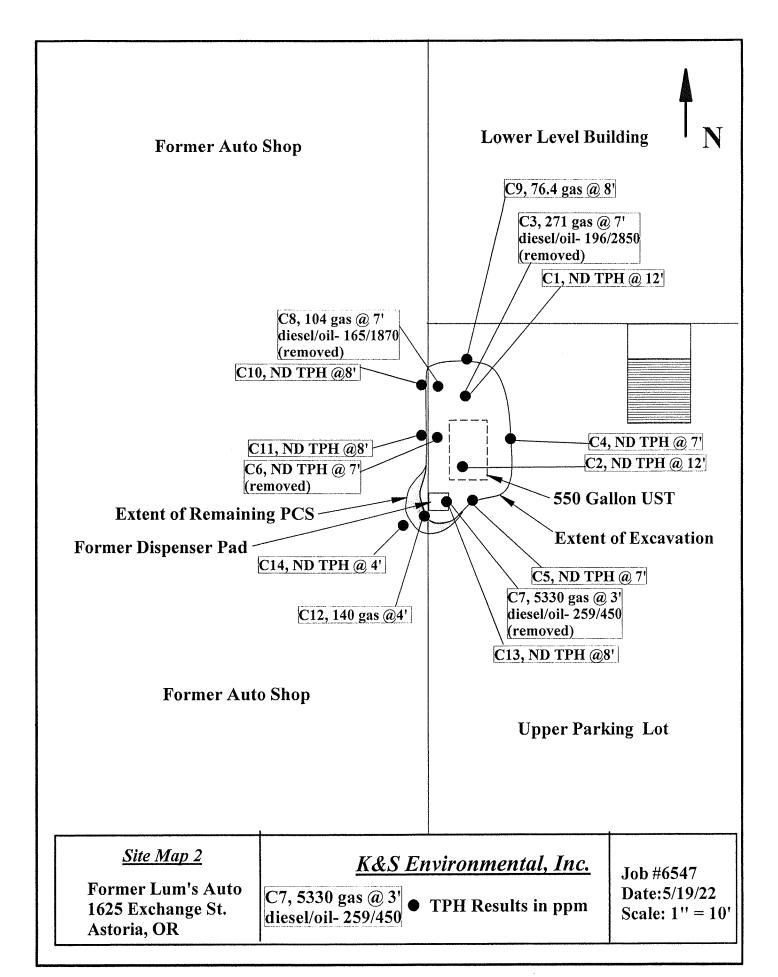
Attachment: Site Maps 1 and 2

The Oregon Department of Environmental Quality (DEQ) has completed a review of the available information for the Former Lum's Auto Center property, including the closure report entitled, *Report for UST Decommissioning and Risk-Based Cleanup*, dated May 25, 2022, which was submitted to DEQ by K&S Environmental, Inc.'s on your behalf. The Former Lum's Auto Center address is 1625 Exchange St in Astoria, Tax Lots 16800, 16600, 16700, 17000, 16900 on Clatsop County map number 80908DC. The attached site maps 1 and 2 show site features.

- Up to 140 parts per million of gasoline remain in-place at sample C12 collected at a depth of four feet bgs, just south of the former tank location. A horizontal boring was installed under the former auto shop also at 4 feet bgs. No petroleum was detected. Approximately three cubic yards of gasoline-contaminated soil was estimated to remain in-place at levels above 80 parts per million.
