**Underground Storage Tank
3063 SE Harrison Street
Milwaukie, Oregon 97222
DEQ File #03-20-0393
UST Site ID: #9355**

**Underground Storage Tank
3063 SE Harrison Street
Milwaukie, Oregon 97222**

This report summarizes the activities conducted by Soil Solutions Environmental Services, Inc. (SSES) at 3063 SE Harrison Street in Milwaukie, Oregon (Site).

Site activities included decommissioning by removal of three underground storage tanks (USTs), soil, and groundwater sampling and analysis. This report describes our activities, summarizes the results of the work and recommends closure of the site based on findings.

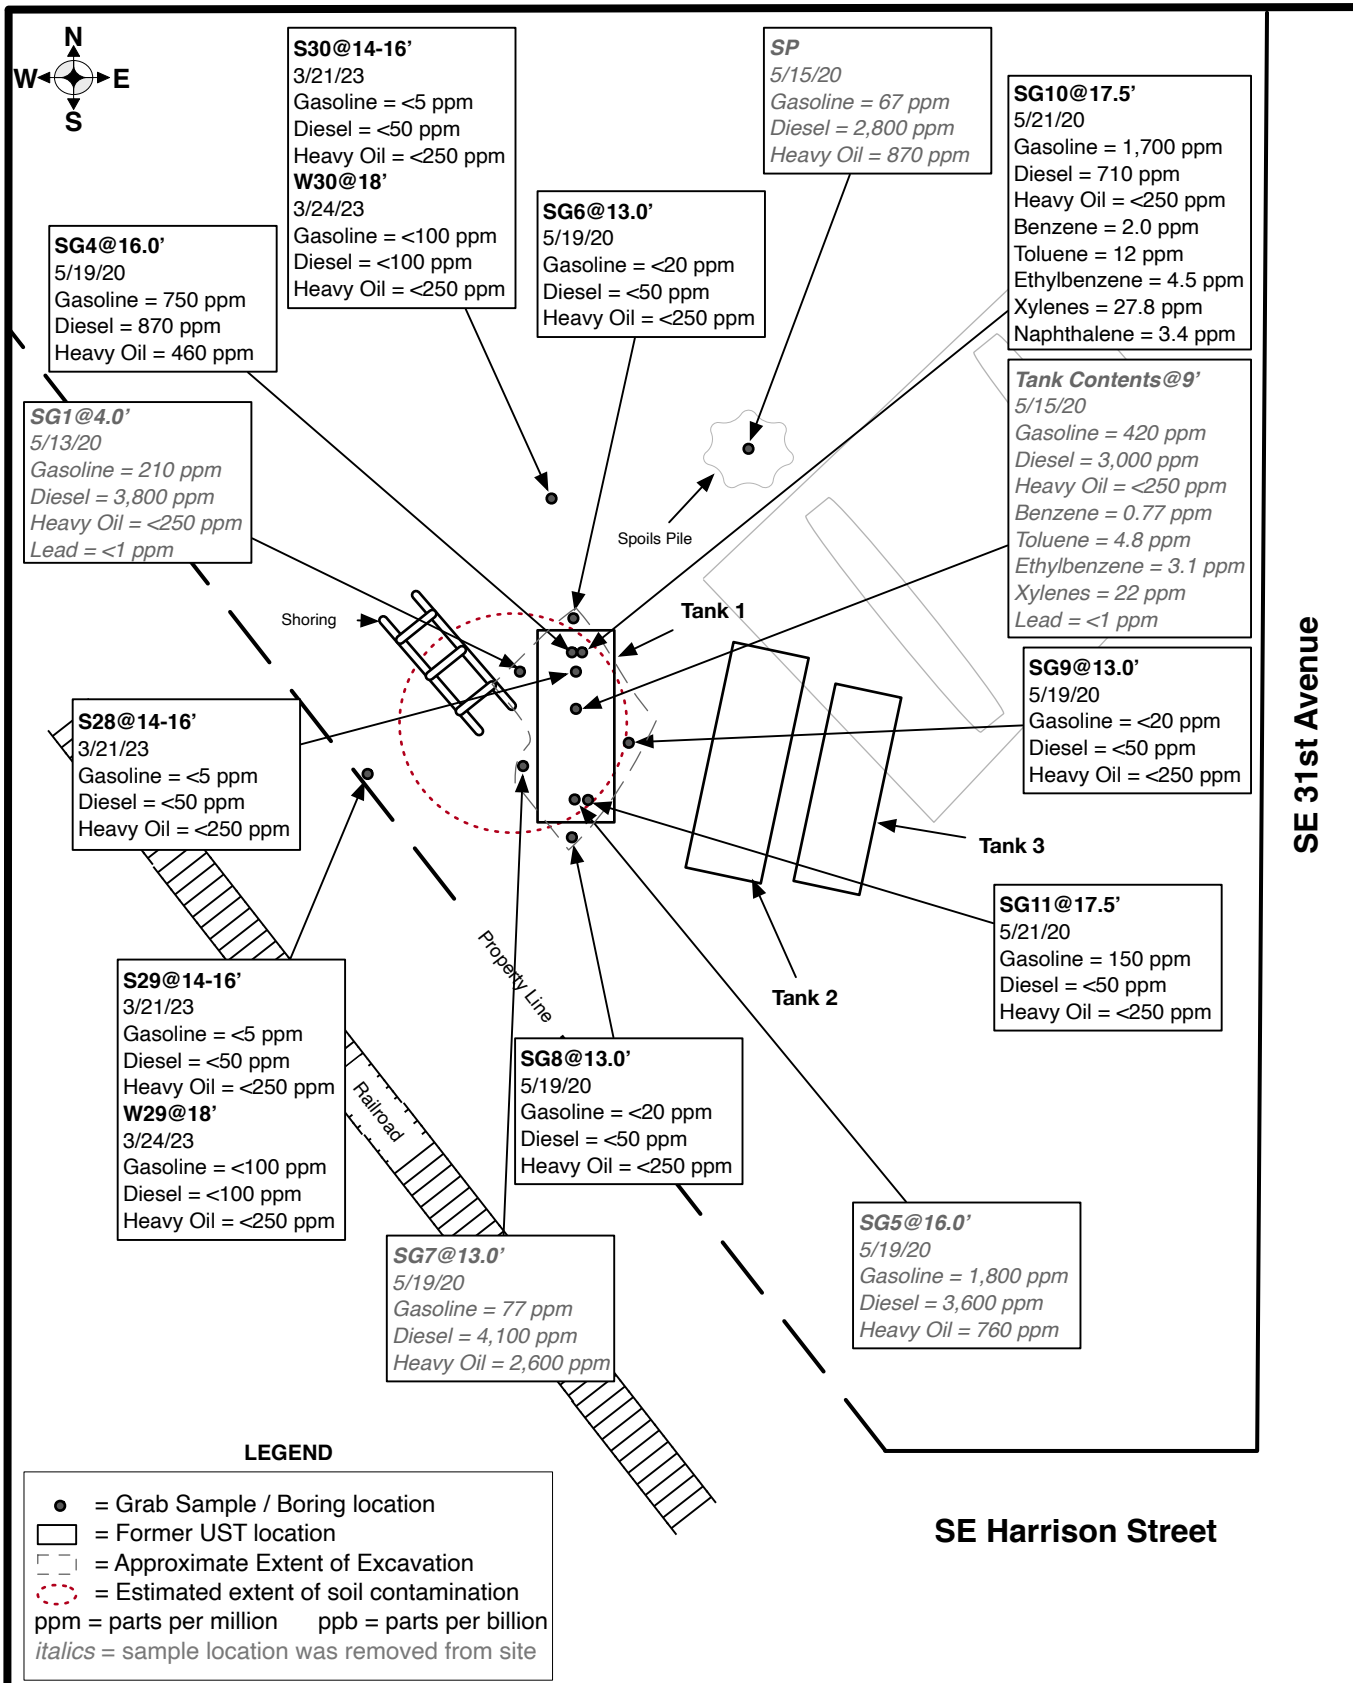
<p>Figure 2: Site Map - Tank 1 3063 SE Harrison Street Milwaukie, OR 97222 DEQ #03-20-0393 UST Site ID #9355</p>	<p>PROJECT: UST</p>
		<p>DATE: 4/13/23</p>
		<p>SCALE: 1" = 20'</p>

The lateral extent of the soil contamination around tank 1 was bounded by samples SG6@13, SG9@13, SG8@13, and borings 29 and 30. borings 4, 5, and 6. Gasoline, diesel and heavy oil were not detected above the laboratory reporting limit in soil samples from these borings. The vertical extent of the soil contamination was identified in boring 28. Gasoline, diesel, and heavy oil were not detected above laboratory reporting limits in a soil sample collected at 22 to 24-foot bgs. Assuming diesel and heavy oil contamination migrated downward and out in an inverted cone shape, the total volume of contaminated soil at the site was calculated at approximately 87 cubic yards. Approximately 100 tons or 75-cubic yards of contaminated soil was removed from the area of tank 1, indicating 12 cubic yards of contaminated soil remains present. The estimated area of contaminated soil is shown on Figure 2.

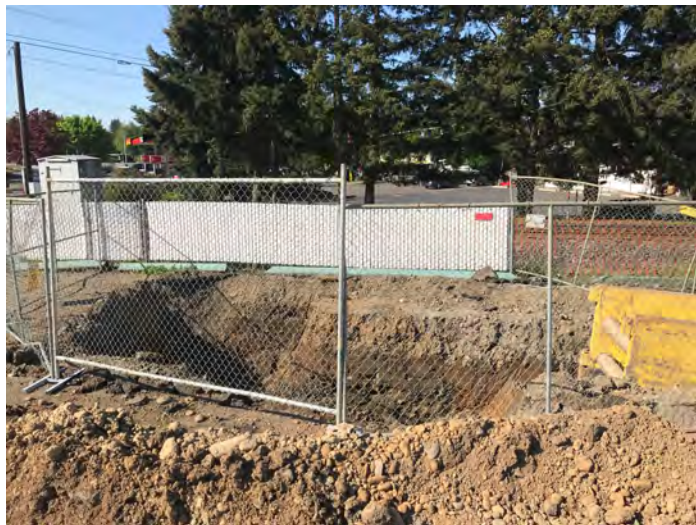
Tank 1 was located towards the west portion of the site.

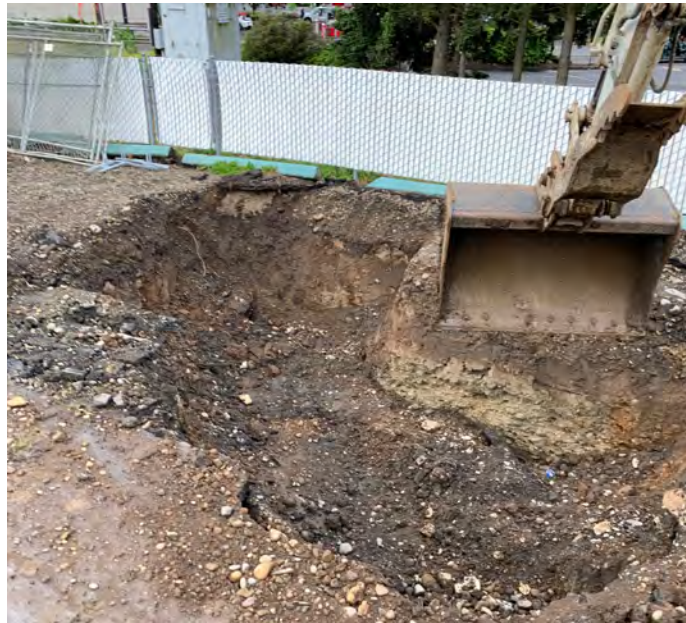
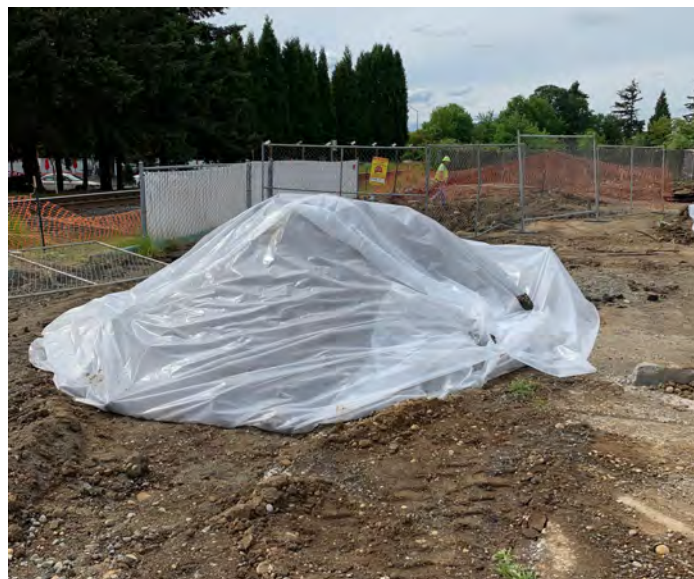
PCS was excavated from above the tank top and stockpiled on site.

On May 15, 2020 tank 1 was further exposed and a portion of the top was cut open. The tank was found partially filled with lightly contaminated concrete slurry. The PCS excavated from above and around the tank was stockpiled on plastic for temporary storage on site. One grab sample, identified as SP, was collected from stockpiled spoils pile of PCS. The tank contents were probed, a sample of the tank contents (tankcontents@9) was collected at a depth of 9-feet.

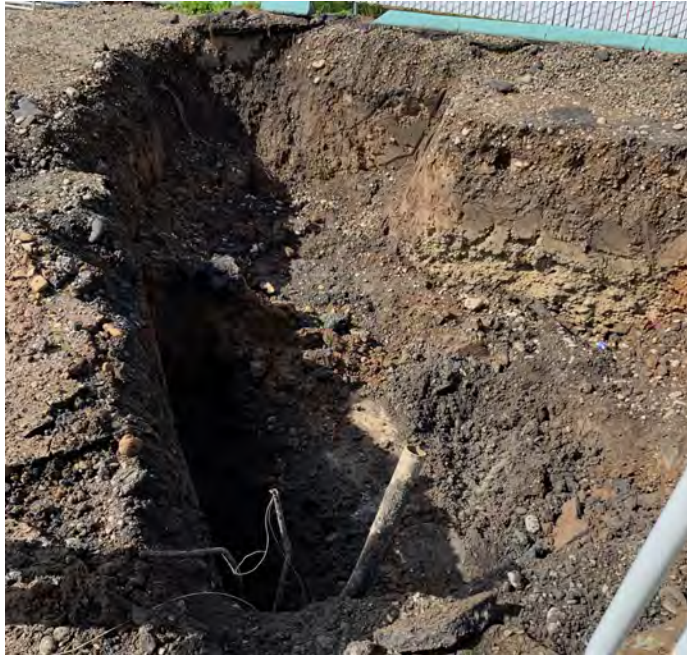
A portion of the top of the tank was exposed and cut open.

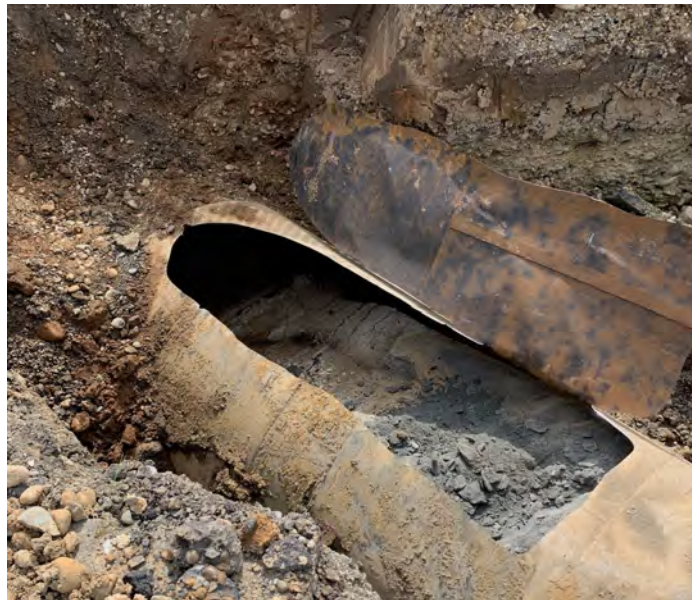
The tank was found filled with concrete slurry.

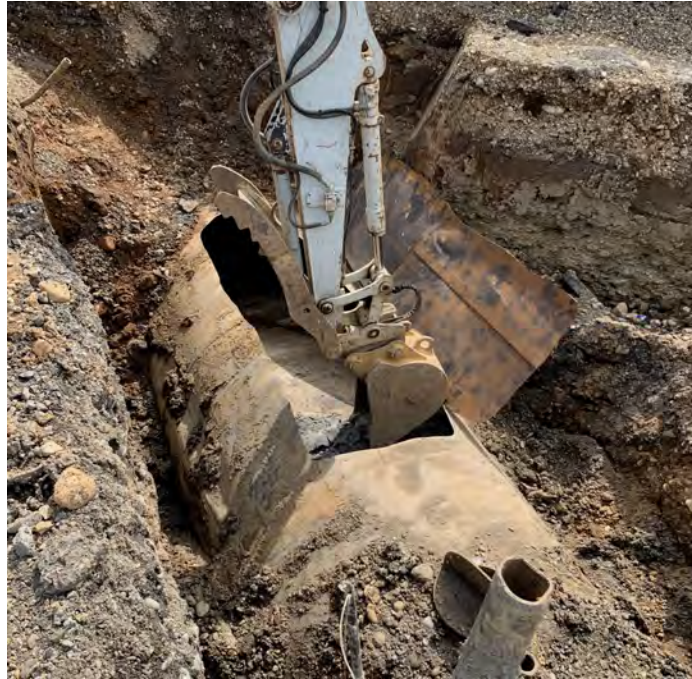
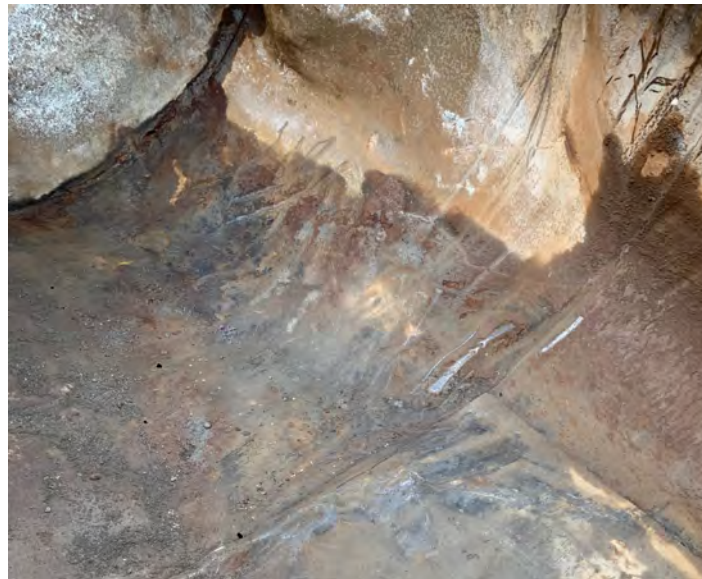
All of the tank contents were removed and the tank interior was thoroughly cleaned.

On May 18, 2020 the contents of tank 1 were removed, and the interior was thoroughly cleaned. The tank contents were temporarily stockpiled on site and later transported to Hillsboro Landfill. On May 19, 2020 the entire tank 1 and associated piping were removed under SSES oversight. The tank and piping were disposed by Murphy Company. Contaminated soil beneath tank 1 was then removed to a depth of approximately 16-feet below ground surface at the north and south excavation ends. Six soil samples (SG4 through SG9) were collected from the excavation.

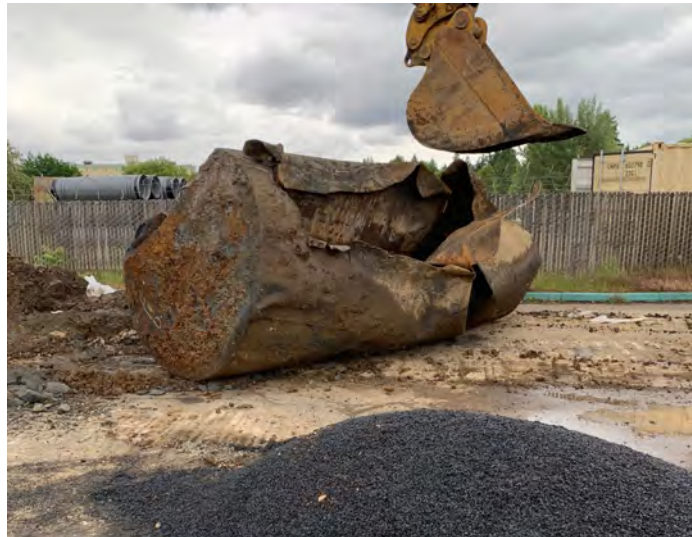
Tank 1 and associated piping were removed from the ground.

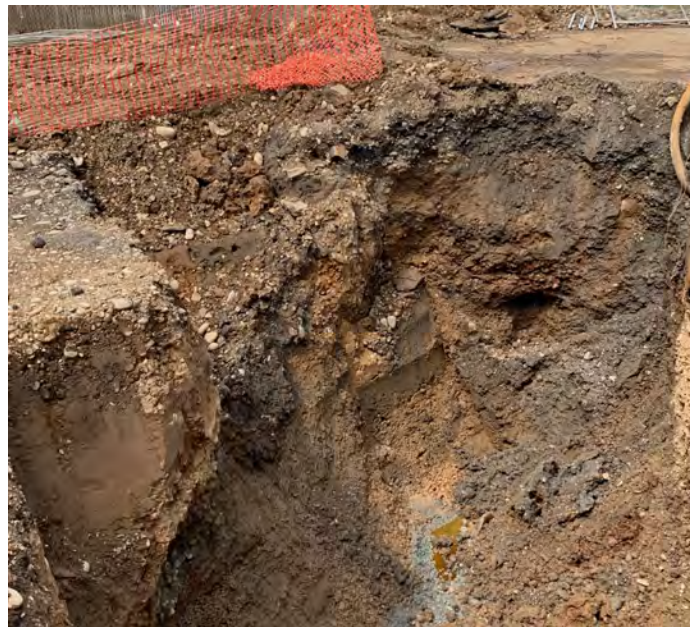
An estimated 100 tons of PCS was removed from the former area of tank 1.

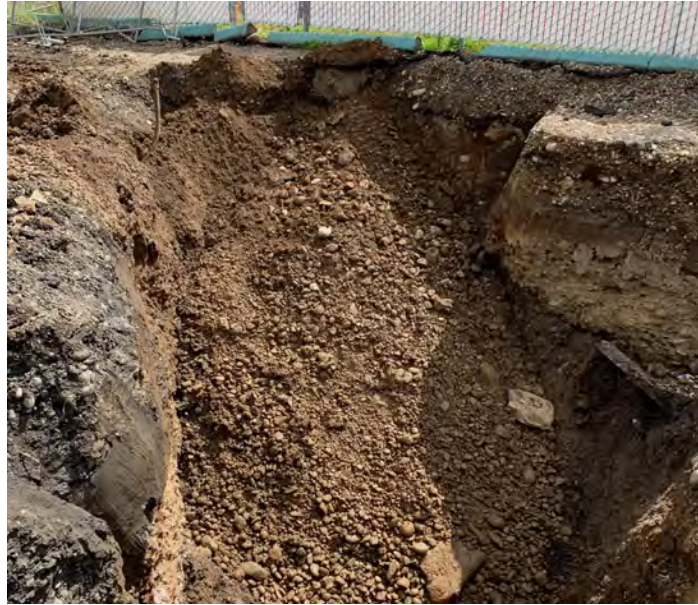
The west pit wall sloughed into the excavation. The excavation was later backfilled with gravel by Murphy Company.

On May 21, 2020 while excavation around former tank 1 was being conducted, visual and olfactory indications of contamination with possible free product was observed in the excavation at a depth of approximately 17 to 18-feet. SSES notified DEQ via email. Recovery of the possible free product could not be conducted by excavation due to safety concerns. A portion of the excavation had begun to cave in, and it was determined that additional removal of soil could not be completed safely. No further indications of free product or groundwater was observed during the remainder of field activities. After consultation with the DEQ project manager, Robert Hood, the remaining portion of the excavation beneath tank 1 was backfilled with compacted gravel and SSES proceeded with the risk-based assessment.

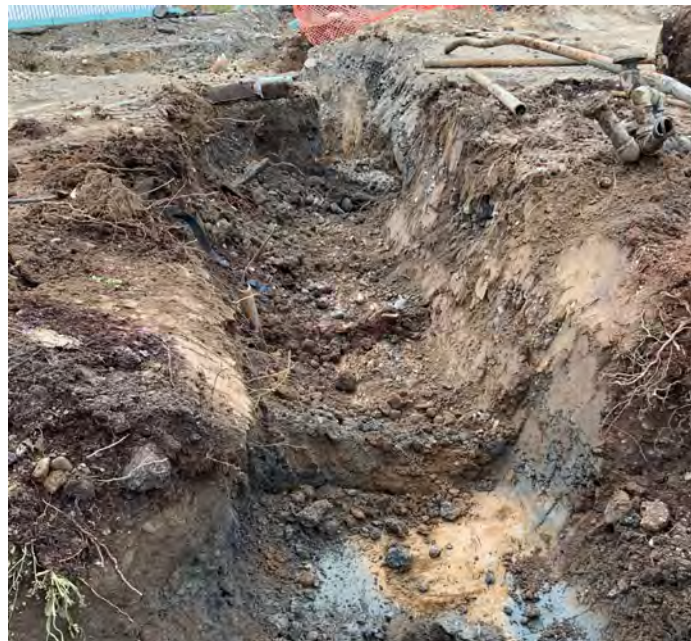
Soil samples were collected below removed product lines.

Underground product lines located between tanks 1 and 2 were removed and disposed of by Murphy Company. On June 8, 2020 SSES collected three soil grab samples (SG12 through SG14) from below the former product lines.

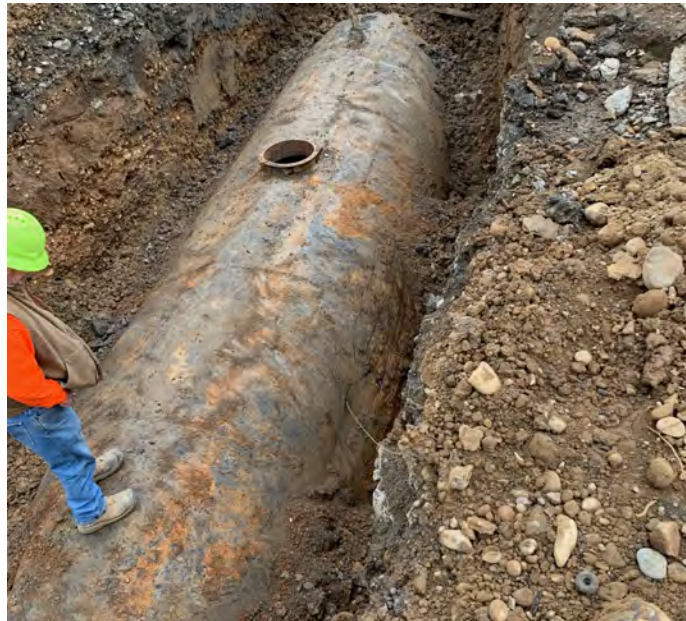
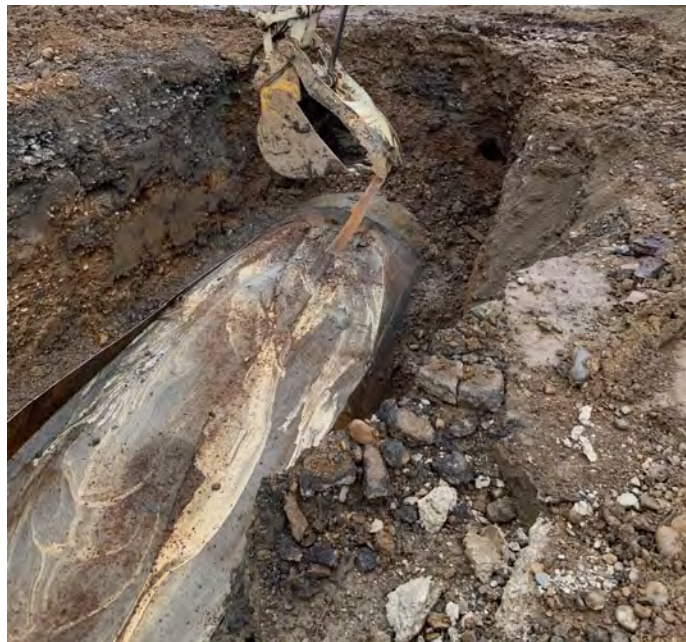
Tank 2 was cut open and found filled with concrete slurry.

On June 11 and 12, 2020 tank 2 was exposed and cut open. The tank was found to be partially filled with concrete slurry. The tank contents were removed, and the interior was thoroughly

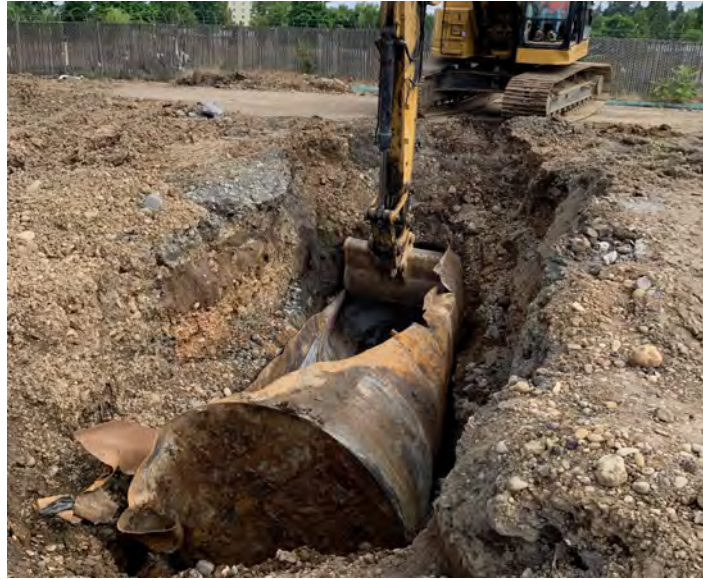
All of the tank contents were removed and the tank interior was thoroughly cleaned.

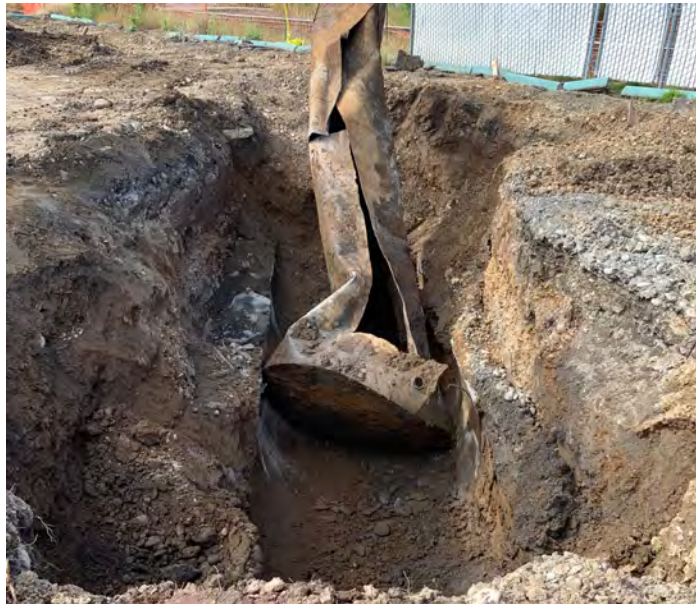
Tank 2 was removed from the ground.

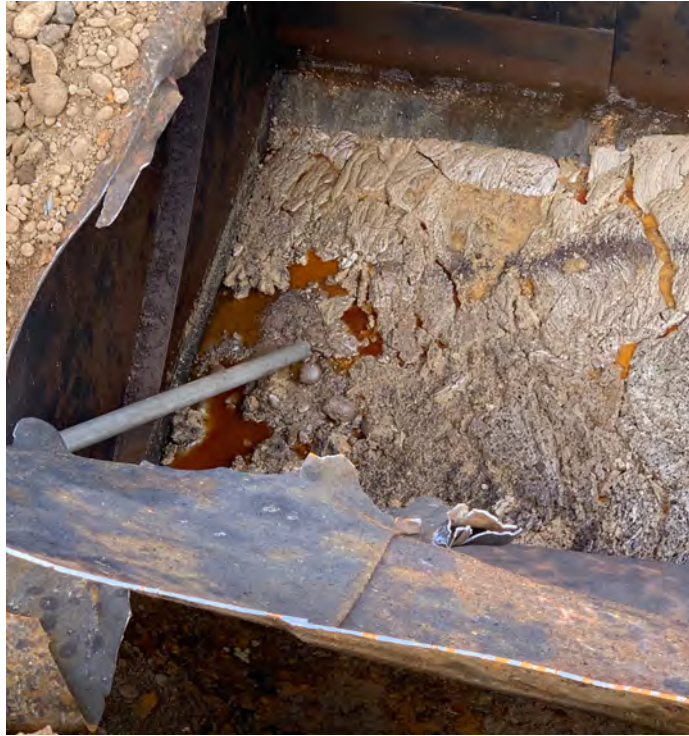
Tank 3 was cut open and found filled with concrete slurry.

On June 20 and 29, 2020 tank 3 was exposed and cut open. The tank was found to be partially filled with contaminated concrete slurry. The tank contents were removed, and the interior was thoroughly cleaned. The solid tank contents were temporarily stockpiled on site and later transported to Hillsboro Landfill. Approximately 242 gallons of emulsified fuel and water was removed and transported by ORRCO for proper disposal. Tank 3 and associated piping were removed under SSES oversight and were disposed by Murphy Company. SSES collected six soil samples (SG222 through SG27) from below tank 3.

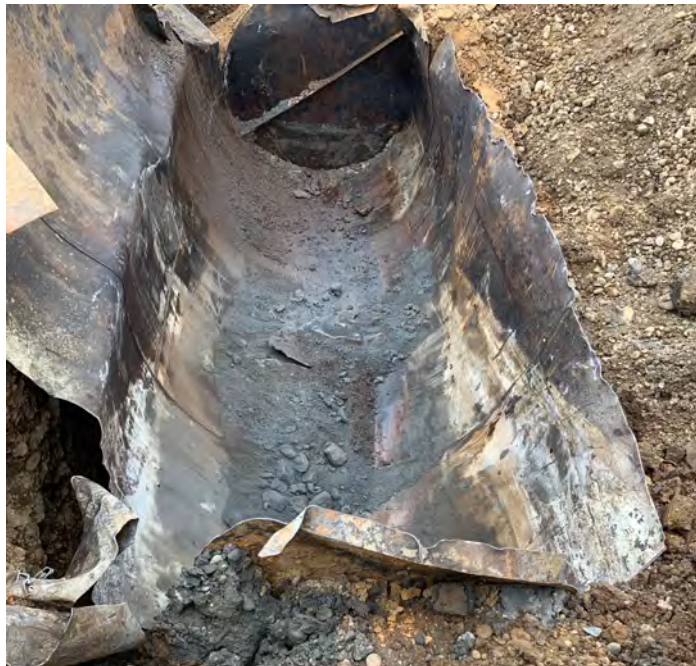
Tank contents were removed and interior thoroughly cleaned.

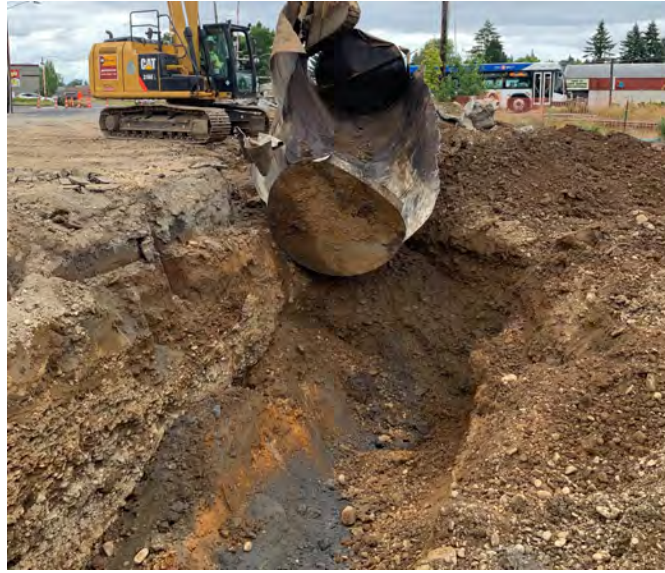
Tank 3 was removed from the ground.

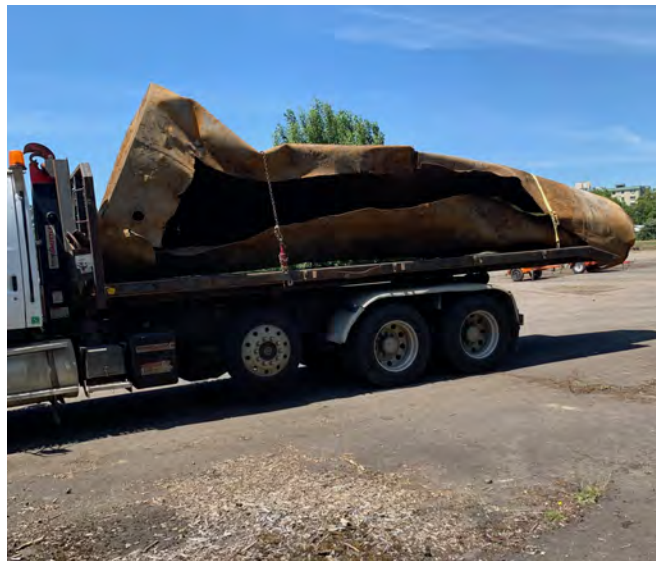
USTs were disposed by Murphy Company.
