**Underground Storage Tank Closure Report  
3608 Airport Drive  
Hood River, Oregon 97031  
DEQ File #14-21-1213**

November 29, 2022

Soil Solutions Environmental Services, Inc.  
3540 Southeast 28<sup>th</sup> Avenue  
Portland, Oregon 97202

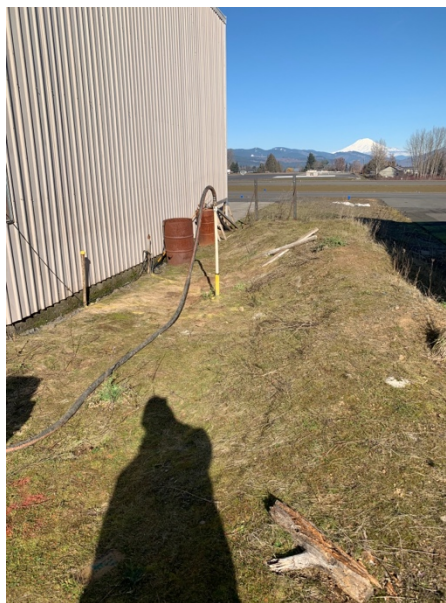
Photo 2. Fill pipe over W end of UST with SSES pump running down pipe. View is to the NNW.

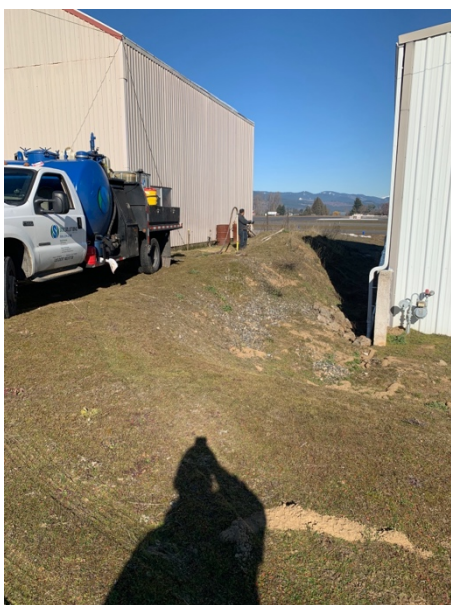
Photo 3. Wider view of UST site. View is to the NNW. Notice slope is towards the hangar on the right.

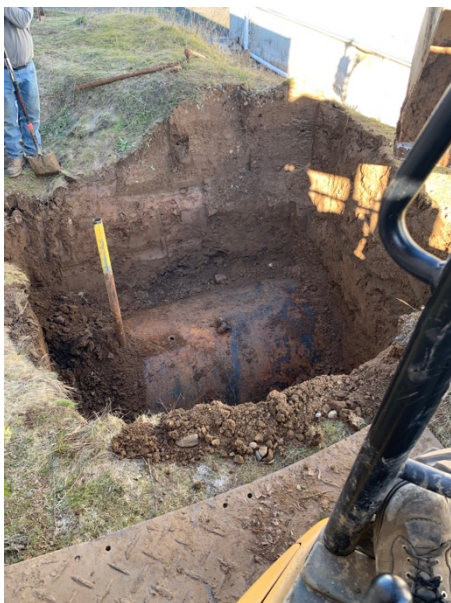
Photo 5. Exposed 1,400-gallon diesel UST.

On February 10, 2022, SSES uncovered the tank and cut it open. The tank was found to contain approximately 909.6 gallons of fuel. The contents were removed, and the interior of the tank was thoroughly pressure-washed using approximately 10 gallons of rinsate. The tank contents were transported to the SSES equipment yard for temporary storage and then transported for recycling, in bulk, by Oil Re-Refining Company (ORRCO). On February 11, 2022, SSES cut the tank in half and removed it from the ground. The tank was transported to the SSES equipment yard for recycling, in bulk, by Metro Metals Northwest, Inc. The tank measured 6-feet in length and 6.3-feet in diameter for a capacity of 1,400 gallons. The UST appeared corroded with many holes in the exterior, and dark brown and gray petroleum-impacted soil was observed when the tank was removed. One worst-case soil sample, SG5@10', was collected from the worst area of stained soil, under the east half of the former tank. This sample was analyzed using Northwest Total Petroleum Hydrocarbons Diesel Analysis (NWTPH-Dx). Laboratory analysis revealed a diesel concentration of 14,000 ppm and a heavy oil concentration of <2,500 ppm.

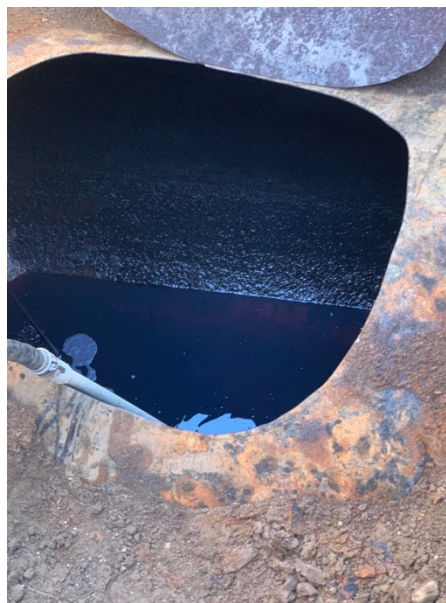
Photo 6. Interior of UST. Approximately 909.6 gallons of fuel was removed.

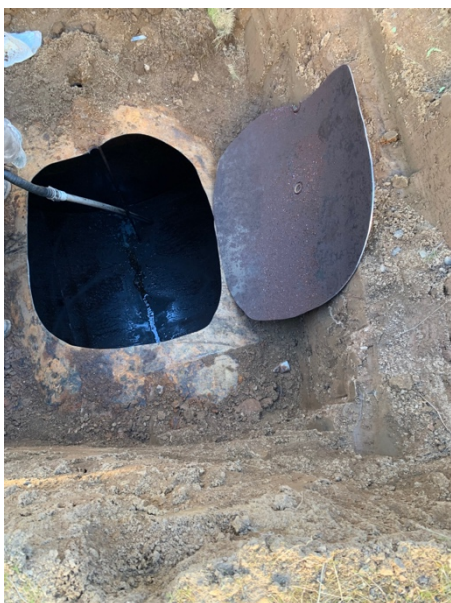
Photo 7. Triple-rinsing the interior of the UST after pumping the fuel found inside.

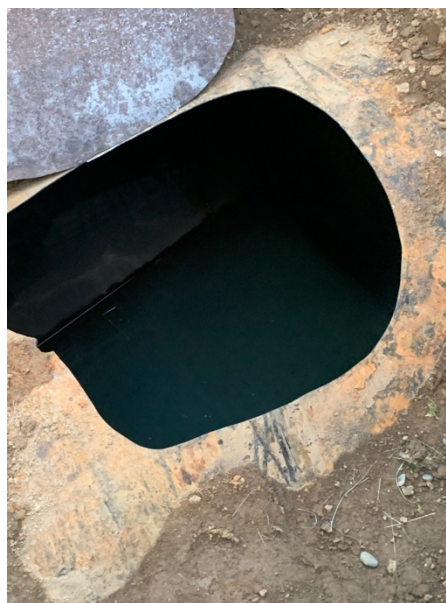
Photo 8. Water recharging the tank through holes after pumping the fuel and triple-rinsing the interior.

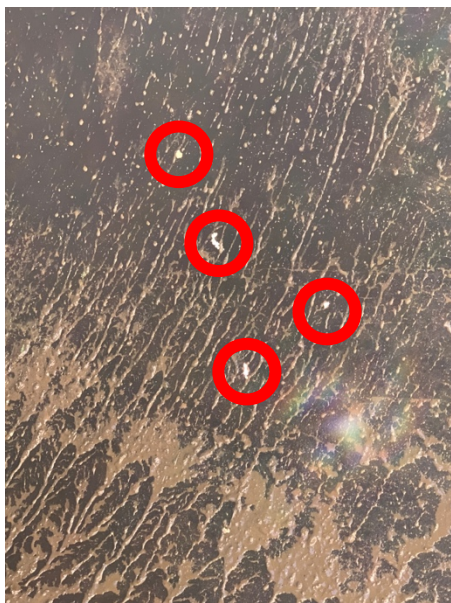
Photo 9. Holes in the UST exterior circled in red.

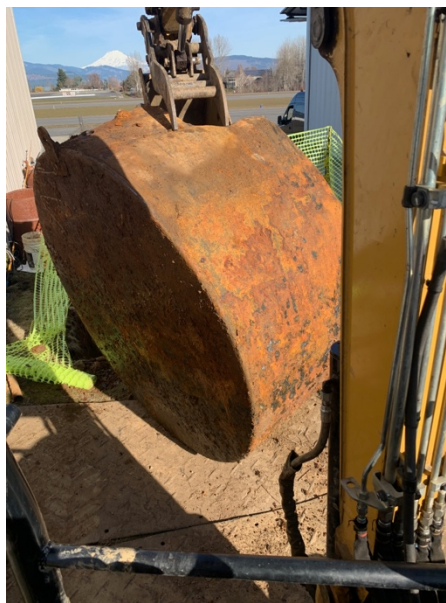
Photo 10. UST being removed from the tank pit. Tank was cut in half for removal.

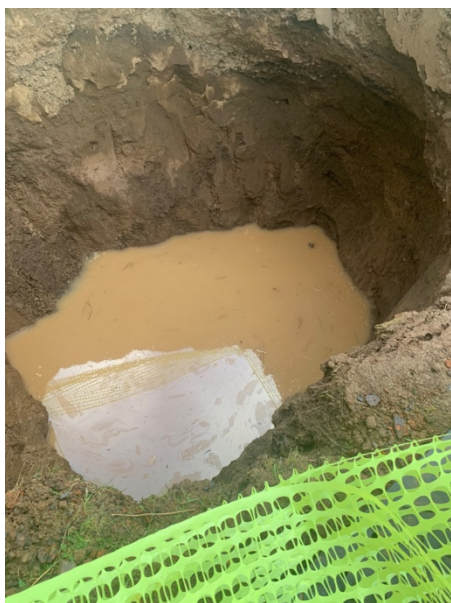
Photo 11. Groundwater in the tank pit.

Groundwater was encountered in the excavation at approximately 11-feet bgs. On March 8, 2022, ORRCO pumped approximately 1,374 gallons of water from the excavation to facilitate removal of PCS.

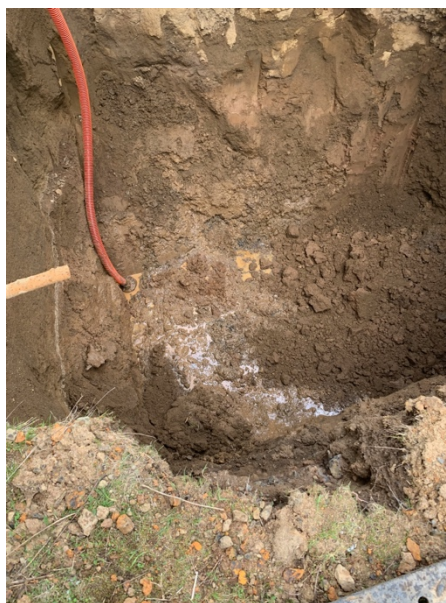
Photo 12. ORRCO pump hose removing groundwater in the tank pit.

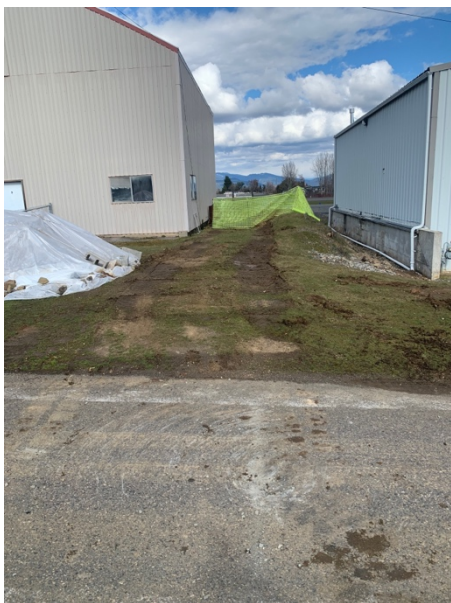
Photo 13. Overview of site. UST excavation fenced off in center of photo. Contaminated soil on left side of photo under white tarp.

On March 8 and 9, 2022, SSES removed PCS to a depth of approximately 12.5-ft bgs around the former tank area. A total of 36.23 tons of PCS was removed and placed in a metal dropbox for transport and disposal at Wasco County Landfill.

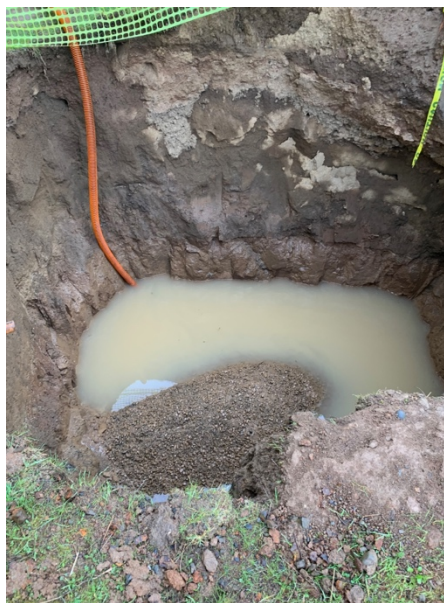
Photo 14. Groundwater in tank pit with ORRCO pumping hose.

On March 18, 2022, ORRCO pumped approximately 1,856 gallons of water from the excavation before it was backfilled with compacted gravel and restored to grade.

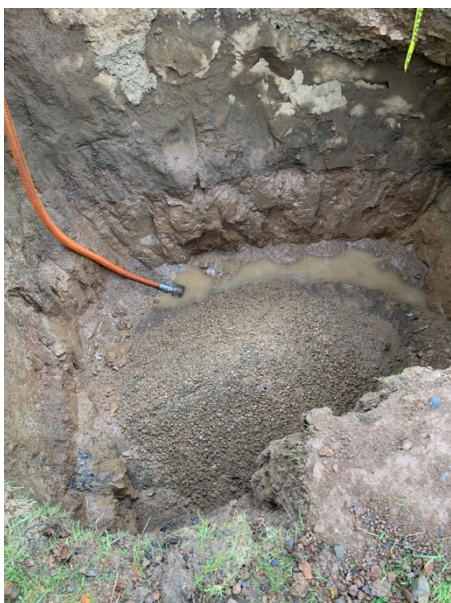
Photo 15. Drained tank pit from Photo 14.

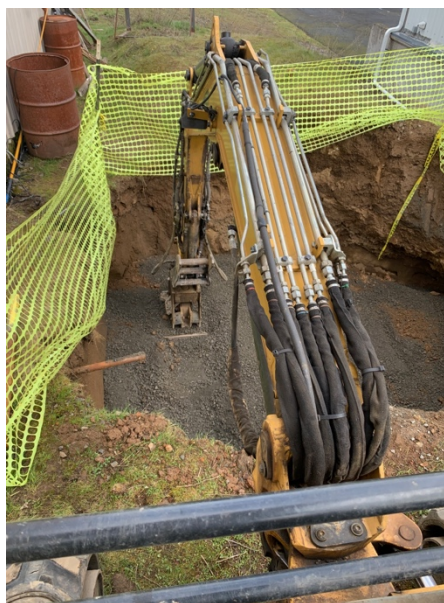
Photo 16. Compacting gravel during backfilling process of the tank pit.

Following receipt of all laboratory soil sampling reports, the removed tank excavation was backfilled with gravel and restored to grade with clean overburden.

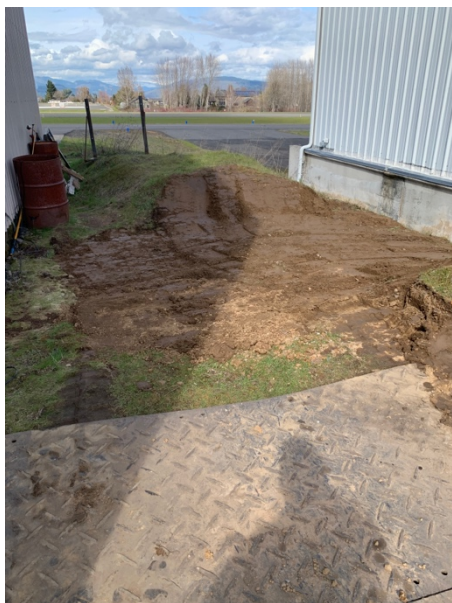
Photo 17. Tank excavation pit restored to grade with clean soil. View is to the NNE.

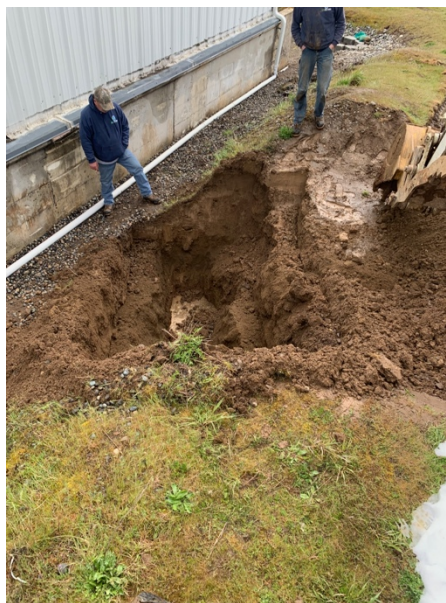
Photo 18. Groundwater recovery trench to the NE of the former tank excavation pit. View is to the SE.

On April 13, 2022, SSES completed a groundwater recovery trench located approximately 10-ft northeast of the tank excavation. The trench was dug to a depth of 11-ft bgs and measured approximately 10-ft long and approximately 6-ft wide at ground surface. Groundwater was encountered approximately 7-ft bgs but was slow to flow into the trench. Groundwater did not show visual or olfactory signs of contamination.

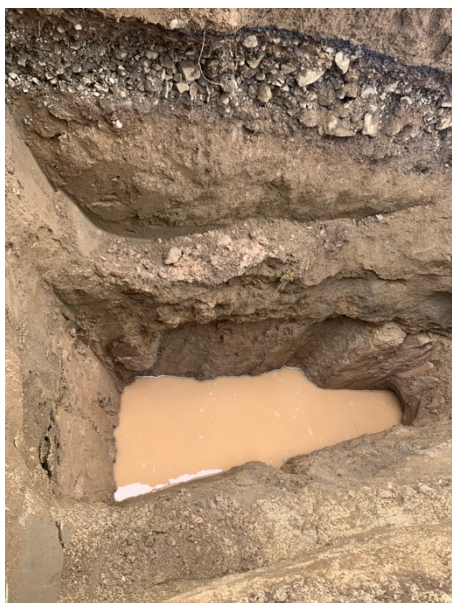
Photo 19. Groundwater recovery trench being recharged by groundwater.

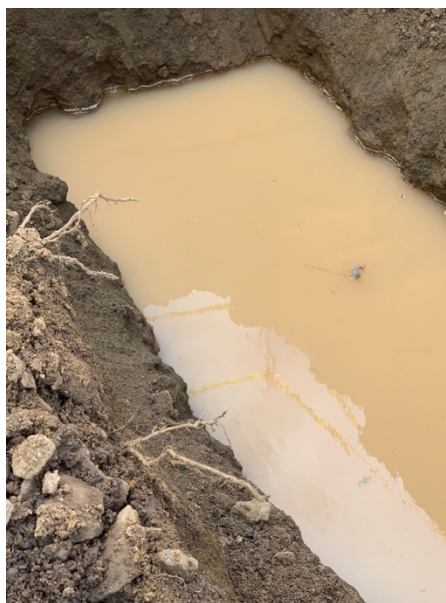
Photo 20. Groundwater recharge trench full of groundwater. No oily sheen or smell was observed.

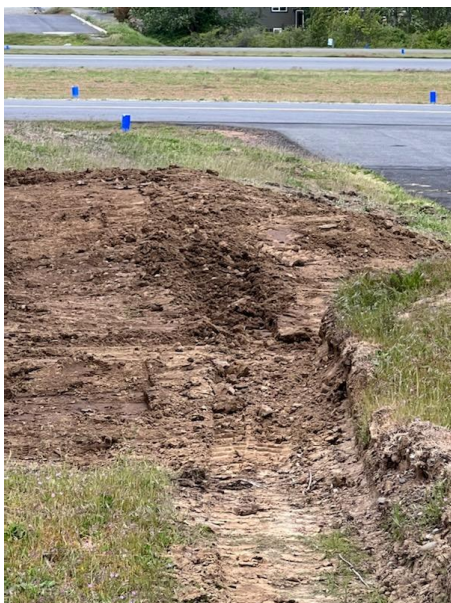
Photo 21. Groundwater recovery trench backfilled and restored to grade with clean overburden.

On May 9, 2022, approximately 879-gallons of water was pumped from the groundwater recovery trench before it was backfilled and restored to grade.

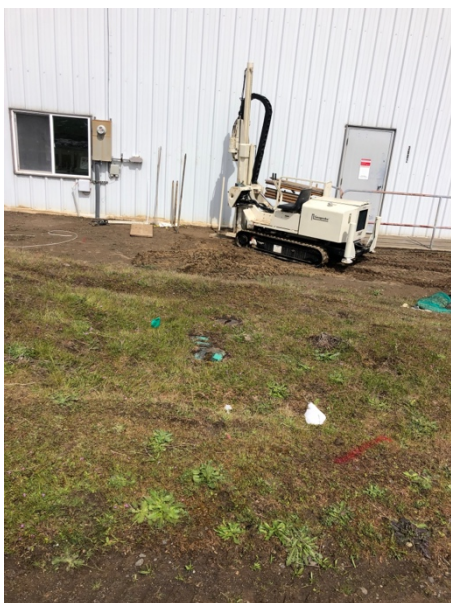
Photo 23. Geoprobe completing boring 15 on the S side of 3602 Airport Drive, to the SE of the removed tank area.

On April 7, 2022, SSES completed borings 13 to 15, located south, north, and southeast of the tank area, respectively. Soil samples were collected at depths of 12-ft and 13-ft bgs in borings 13 and 15, respectively. Groundwater was encountered in boring 14 at 12.5-ft bgs, where one soil sample was collected. One groundwater sample was collected in boring 13 at a depth of 15-ft bgs.

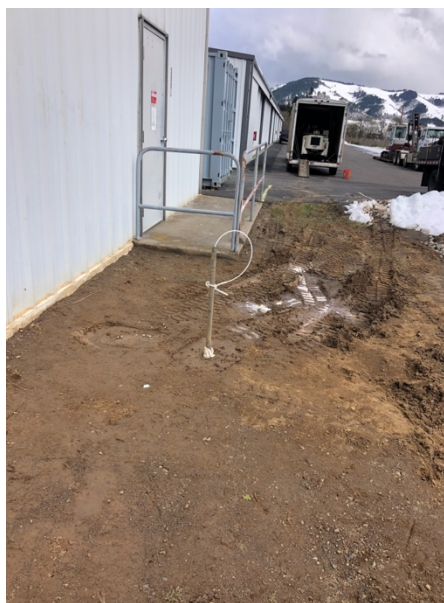
Photo 24. Collecting groundwater in boring 15.

On April 27, 2022, SSES collected one groundwater sample from boring 15 at a depth of 15-ft bgs. One confirmation groundwater grab sample was also collected from trench, identified as WG17@12.
