**UST Decommission Report
6605 SW Canyon Lane
Portland, Oregon 97225**

February 4, 2019
Updated September 13, 2023

Underground Storage Tank Closure Report
6605 SW Canyon Lane
Portland, Oregon 97225
DEQ File #34-18-1201

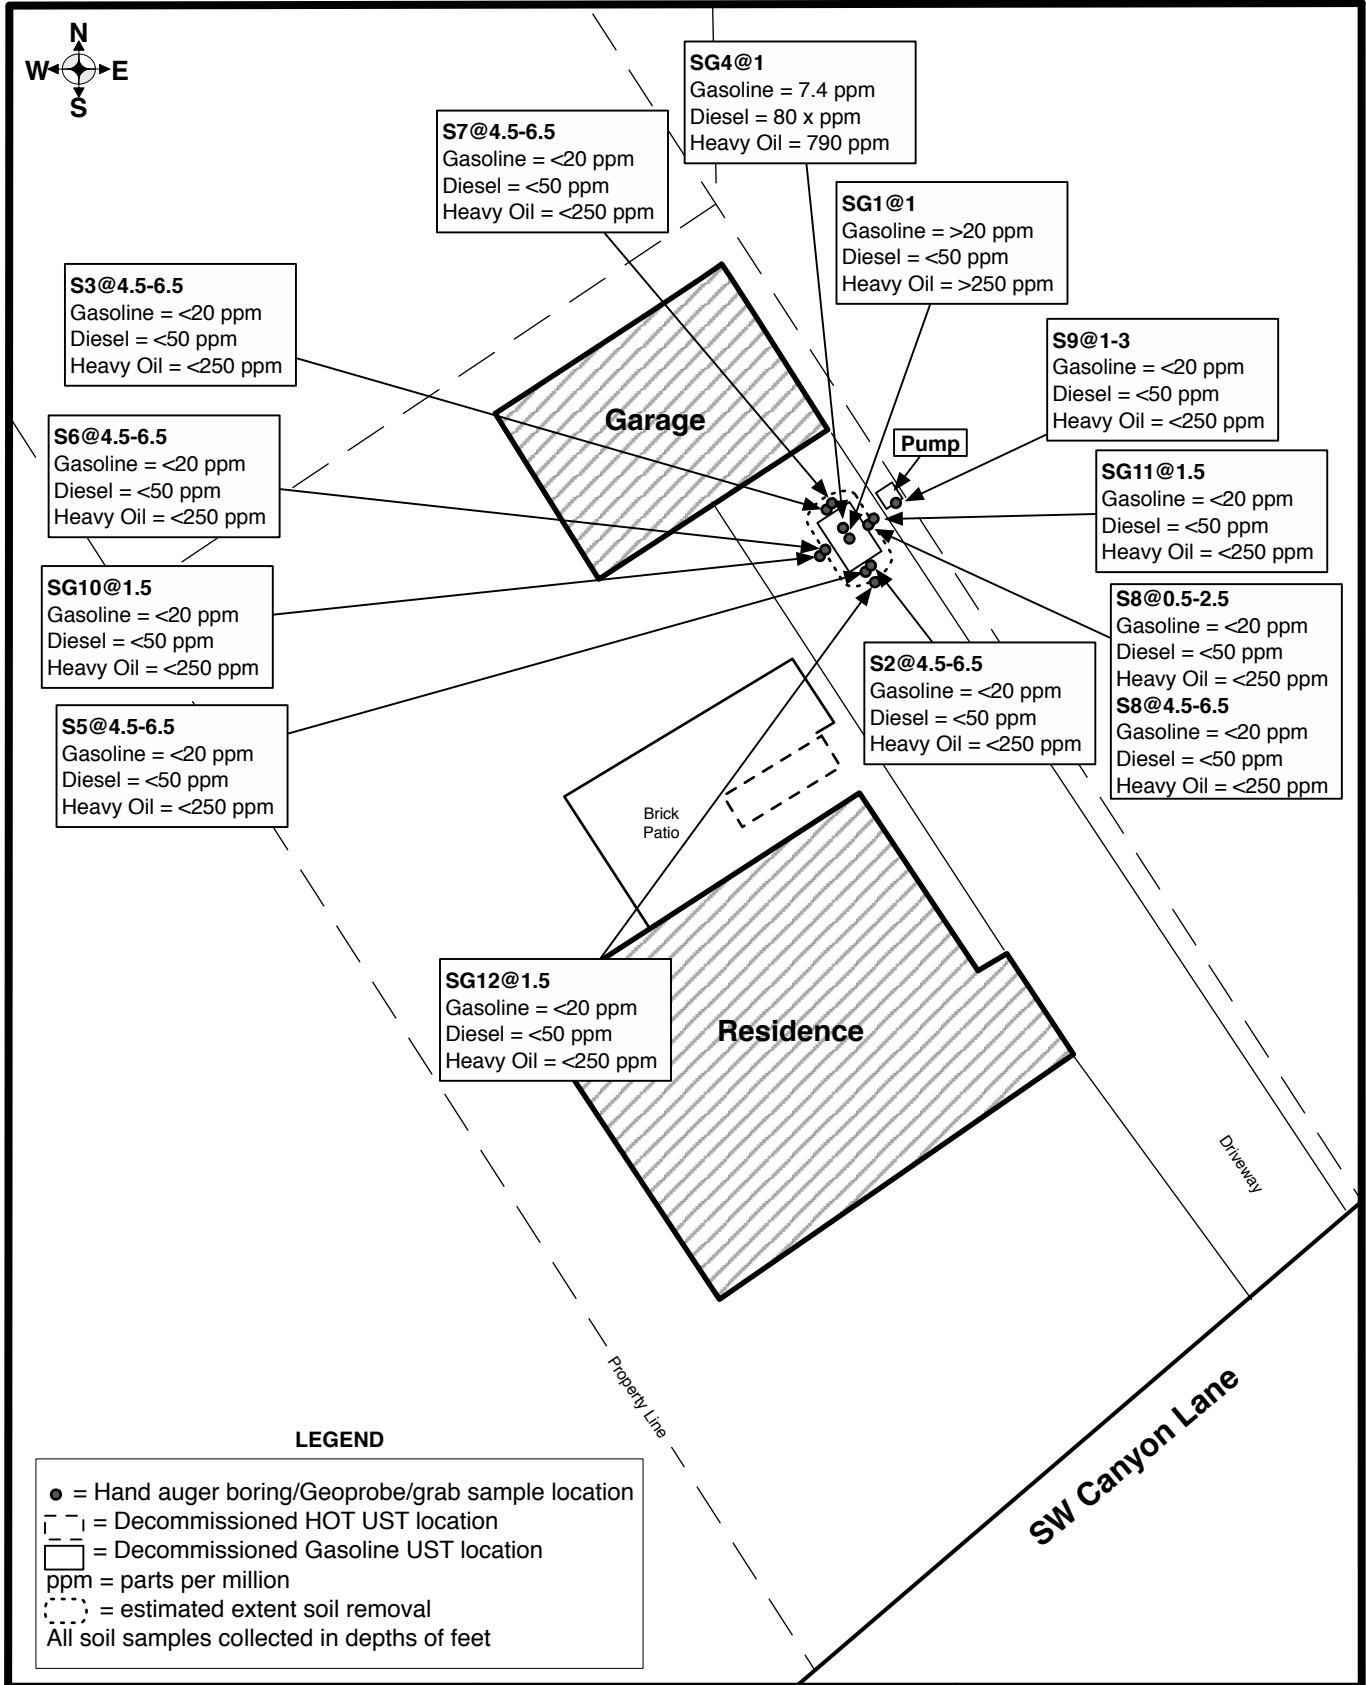
Figure 2: Site Map
6605 SW Canyon Lane
Portland, Oregon 97225
DEQ File #34-18-1201

Field activities were completed between October 17, 2018 and January 4, 2019. Photographs of field activities are included in Appendix A. Boring locations are shown on Figure 2. Depths are measured from ground surface at the UST. All equipment was decontaminated between boring locations. New nitrile gloves were donned by the sampler prior to each sample collected. Groundwater samples were collected using disposable Teflon tubing and a peristaltic pump and/or

On December 27, 2018 SSES completed five borings, designated 5 through 9. Borings 5 through 8, located south, west, north, and east of the UST area. Soil samples were collected at 4.5 to 6.5-feet, and at 0.5 to 2.5-feet in boring 8, located between the UST and the pump. Boring 9 was placed under the pump and a soil sample was collected at 1 to 3-feet.

On January 4, 2019 SSES removed remaining stained soil located on top of the UST and some soil located around the sides of the UST by hand. The excavation was irregular in shape but measured approximately 3-feet by 4-feet and was completed to a depth of 1.5-feet. The total volume of soil removed was approximately 0.81-tons. Removed soil, along with the previously removed overburden soil was transported to Hillsboro Landfill for disposal. Three soil grab samples, SG10, SG11, and SG12 were collected following soil removal from the edges of the removal area.

Samples were transported under chain of custody documentation to Friedman & Bruya, Inc. laboratory in Seattle, Washington. Laboratory analysis included Northwest Total Petroleum Hydrocarbons identification method (NWTPH-HCID), gasoline by NWTPH-Gx, diesel and residual range oil by NWTPH-Dx, benzene, toluene, ethylbenzene, and xylenes (BTEX) by United States Environmental Protection Agency (EPA) Method 8021B. Laboratory results are presented in Table 1 and chains-of-custody are included in Appendix B. Select analytical results are shown on Figure 2.

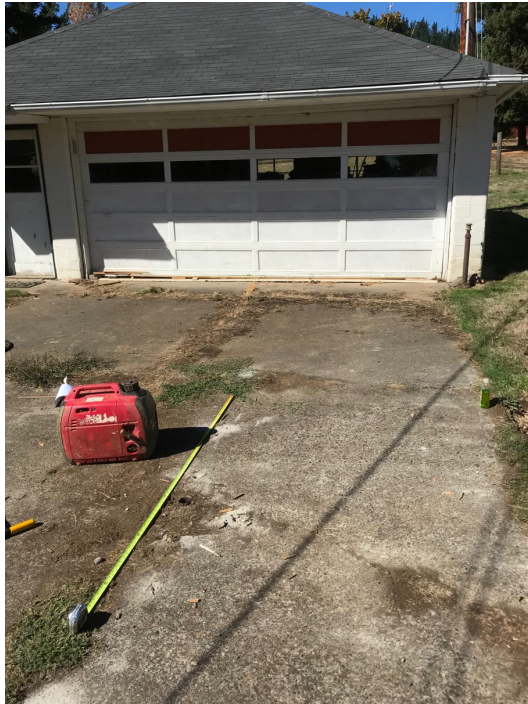
The site had an underground storage tank located south of the garage within the driveway.

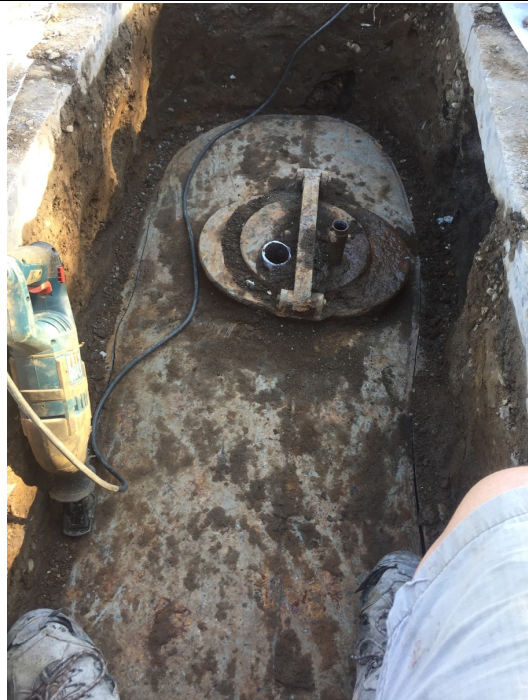
SSES removed the concrete located above the UST and dug to the top of the UST. The overburden soil was placed on plastic sheeting for disposal. SSES personnel inerted the UST and cut it open.

SSES removed the concrete located above the UST and dug to the top of the UST. The overburden soil was placed on plastic sheeting for disposal. SSES personnel inerted the UST and cut it open. The UST was found to contain about 250 gallons of fuel and water. The UST contents were removed and the UST was thoroughly pressure washed with approximately 20 gallons of rinsate. No holes were observed on the UST bottom. The UST contents and rinsate were transported for recycling, in bulk, by Oil Re-Refining Company (ORRCO).

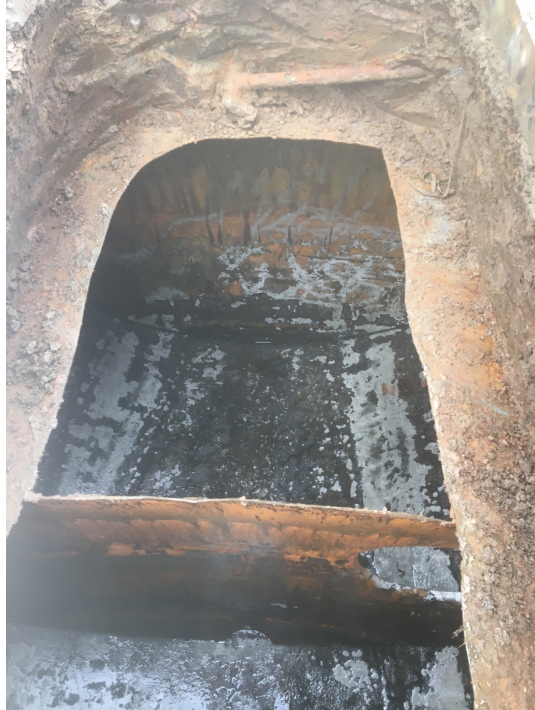
The UST contents were removed and the UST was thoroughly pressure washed with approximately 20 gallons of rinsate. No holes were observed on the UST bottom.

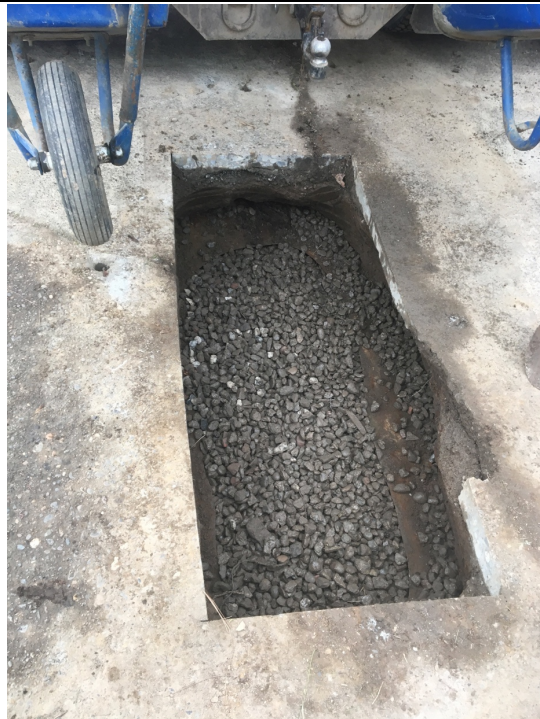
The UST area was backfilled with gravel.

The UST area was filled in place with gravel and the driveway was restored to grade with a concrete patch on January 15, 2019.

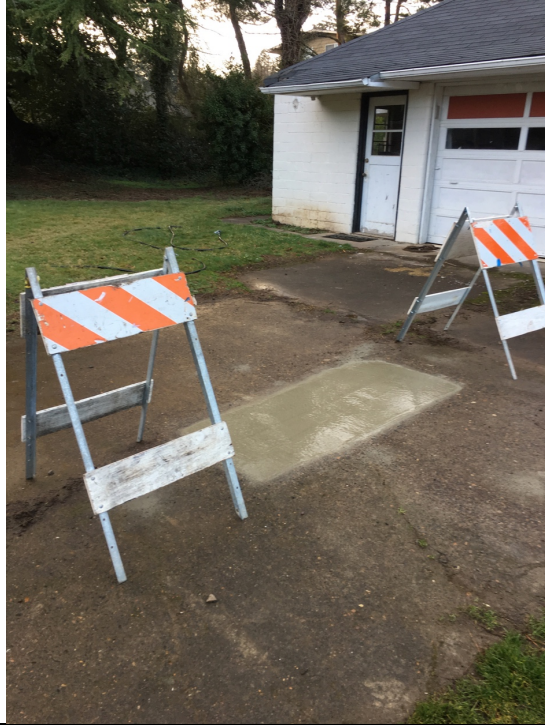
The UST area was restored to grade with a concrete patch.
