## **PHASE II SUBSURFACE INVESTIGATION**

8510 SW Terwilliger Boulevard  
Portland, Oregon 97219

8510 SW Terwilliger Boulevard  
Portland, Oregon 97219  
SEC Project: BH-1-01

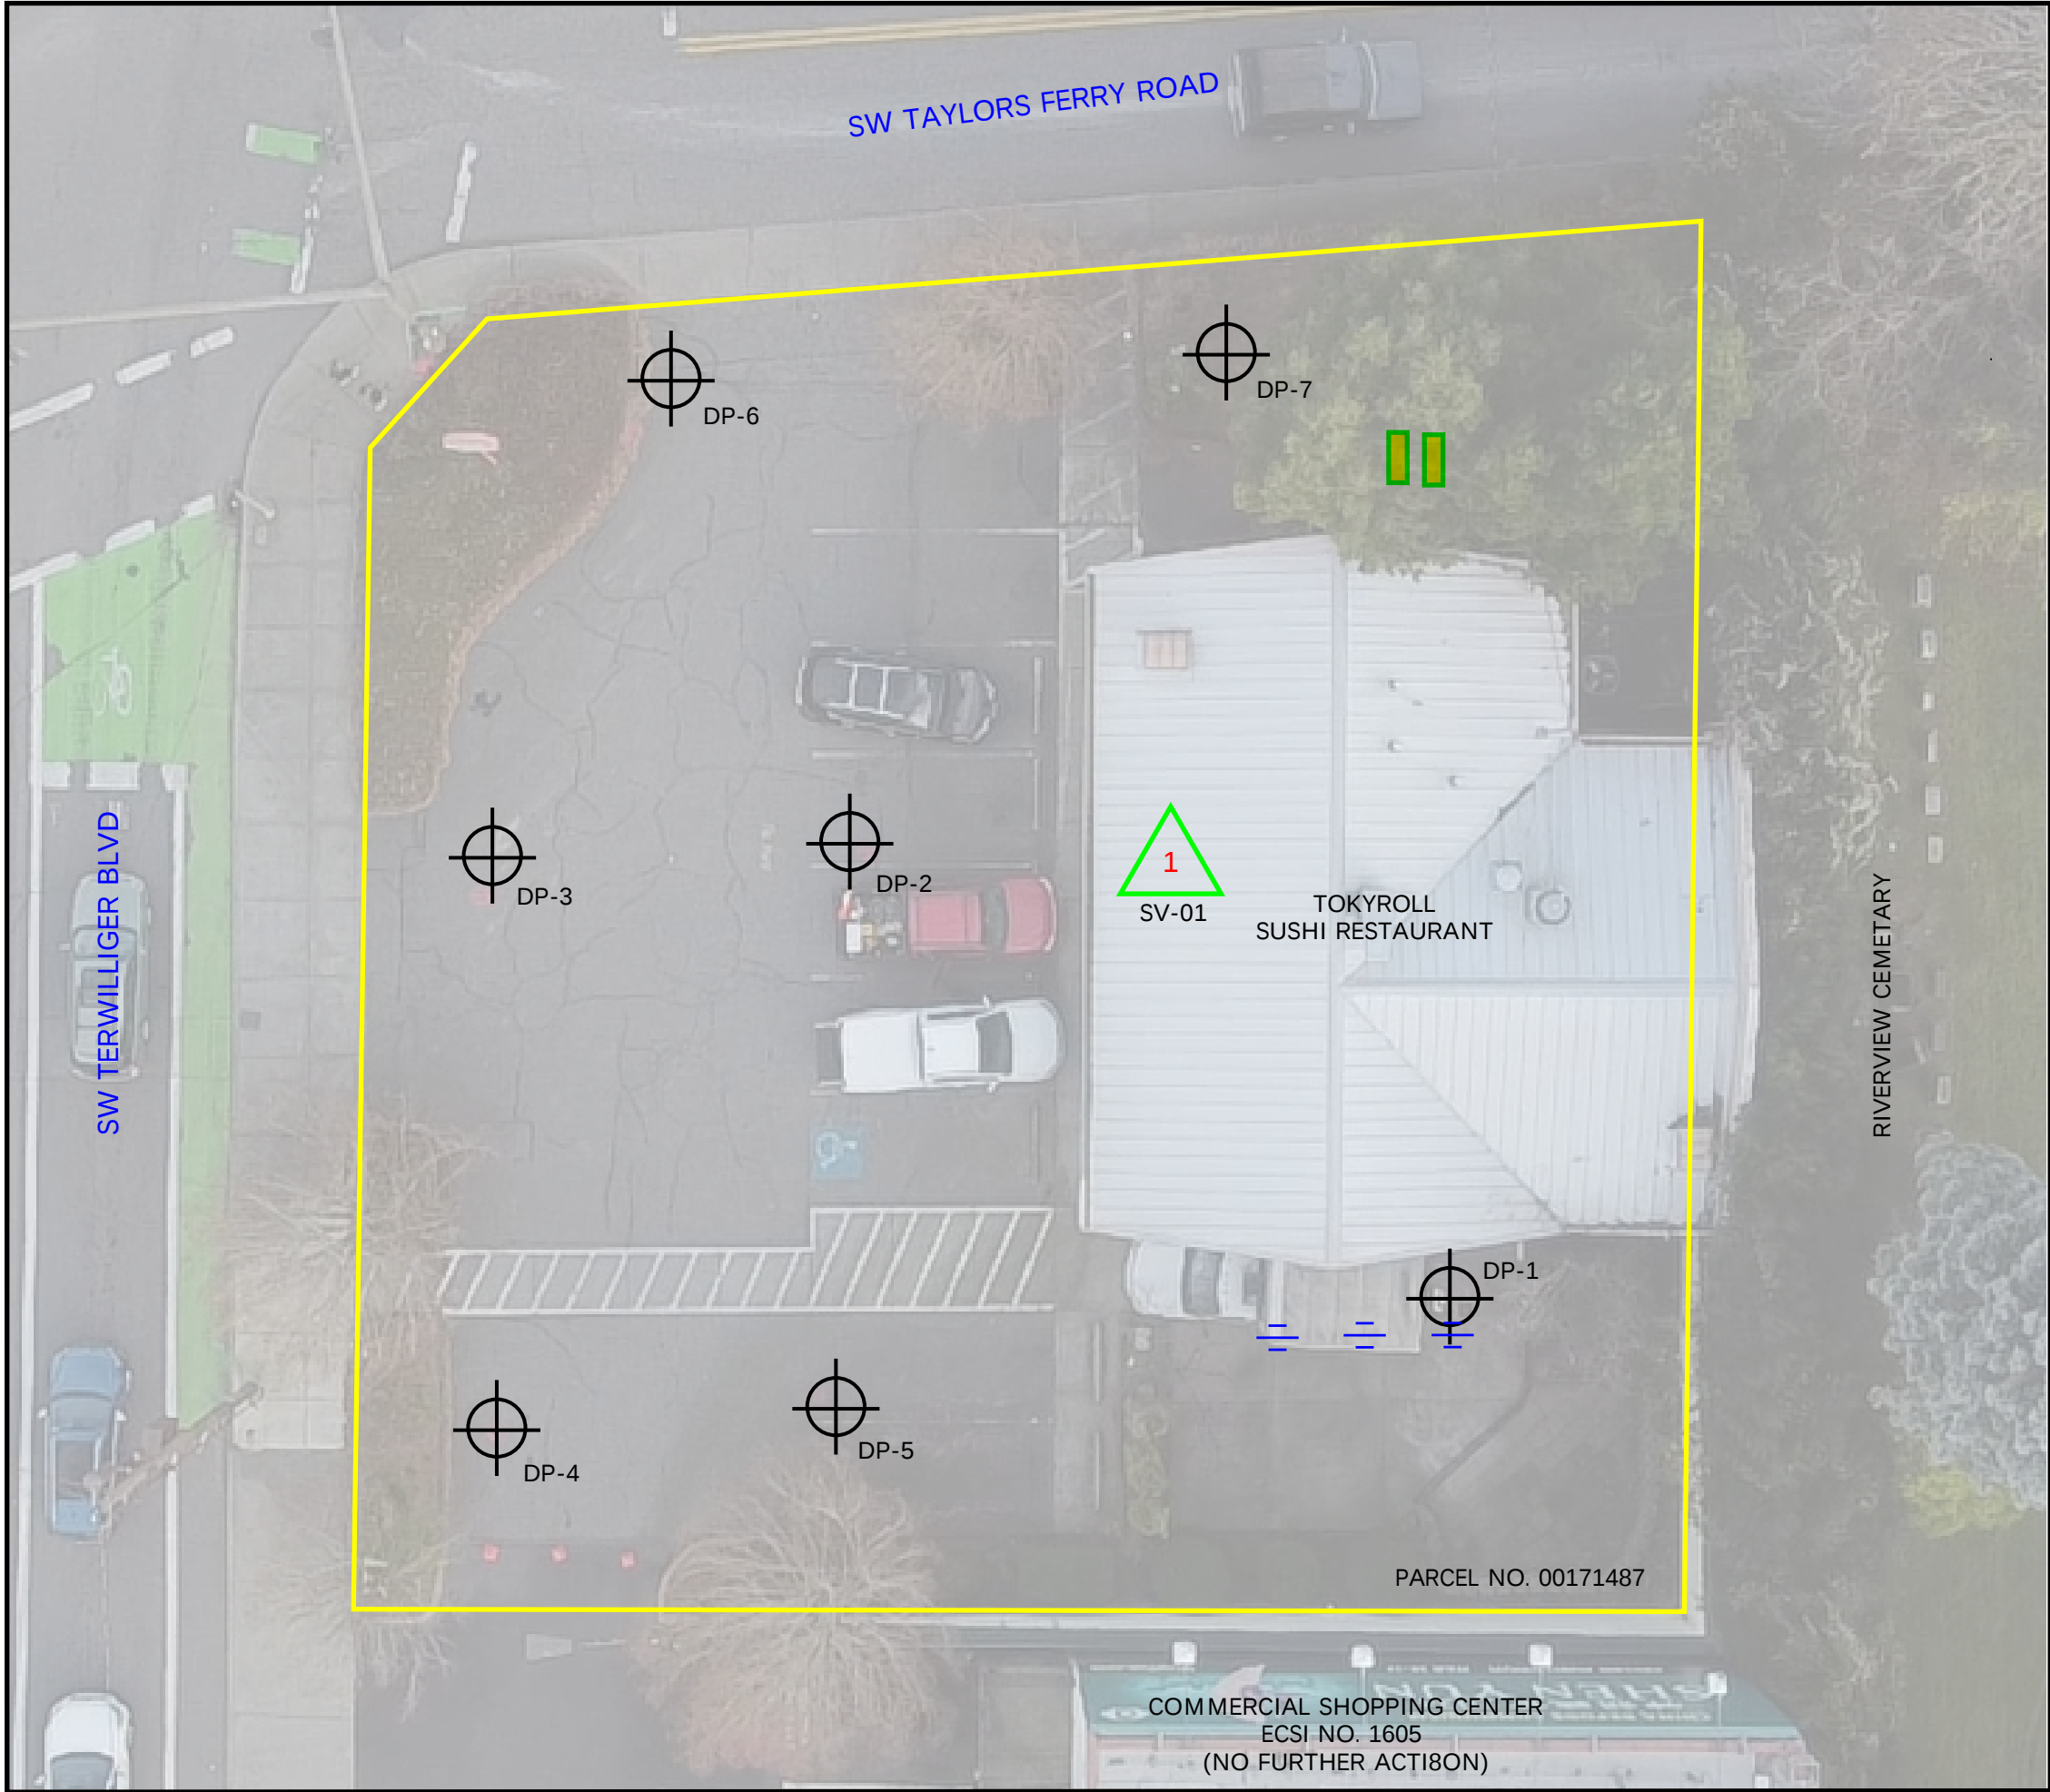
| | FIGURE 2 | | |

Field activities conducted by SEC on December 18, 2023, consisted of the collection of one soil vapor sample (SV-01), and the advancement of seven direct-push borings (DP-1 through DP-7), as discussed in the following sections. The approximate exploration locations are presented on Figure 2.

On December 18, 2023, SEC collected one soil vapor sample (SV-01) from the project site at the approximate location shown on Figure 2. The sample was collected as described below:

| <br>SUCCEED<br>ENVIRONMENTAL<br>CONSULTING, LLC | BH-1-01 | SITE PLAN | |
