Remedial Action Completion Report

205 Auto Salvage Site, 5605 NE 105th
Avenue, Portland, Oregon

Project No. M0106.30.001

Maul Foster & Alongi, Inc.

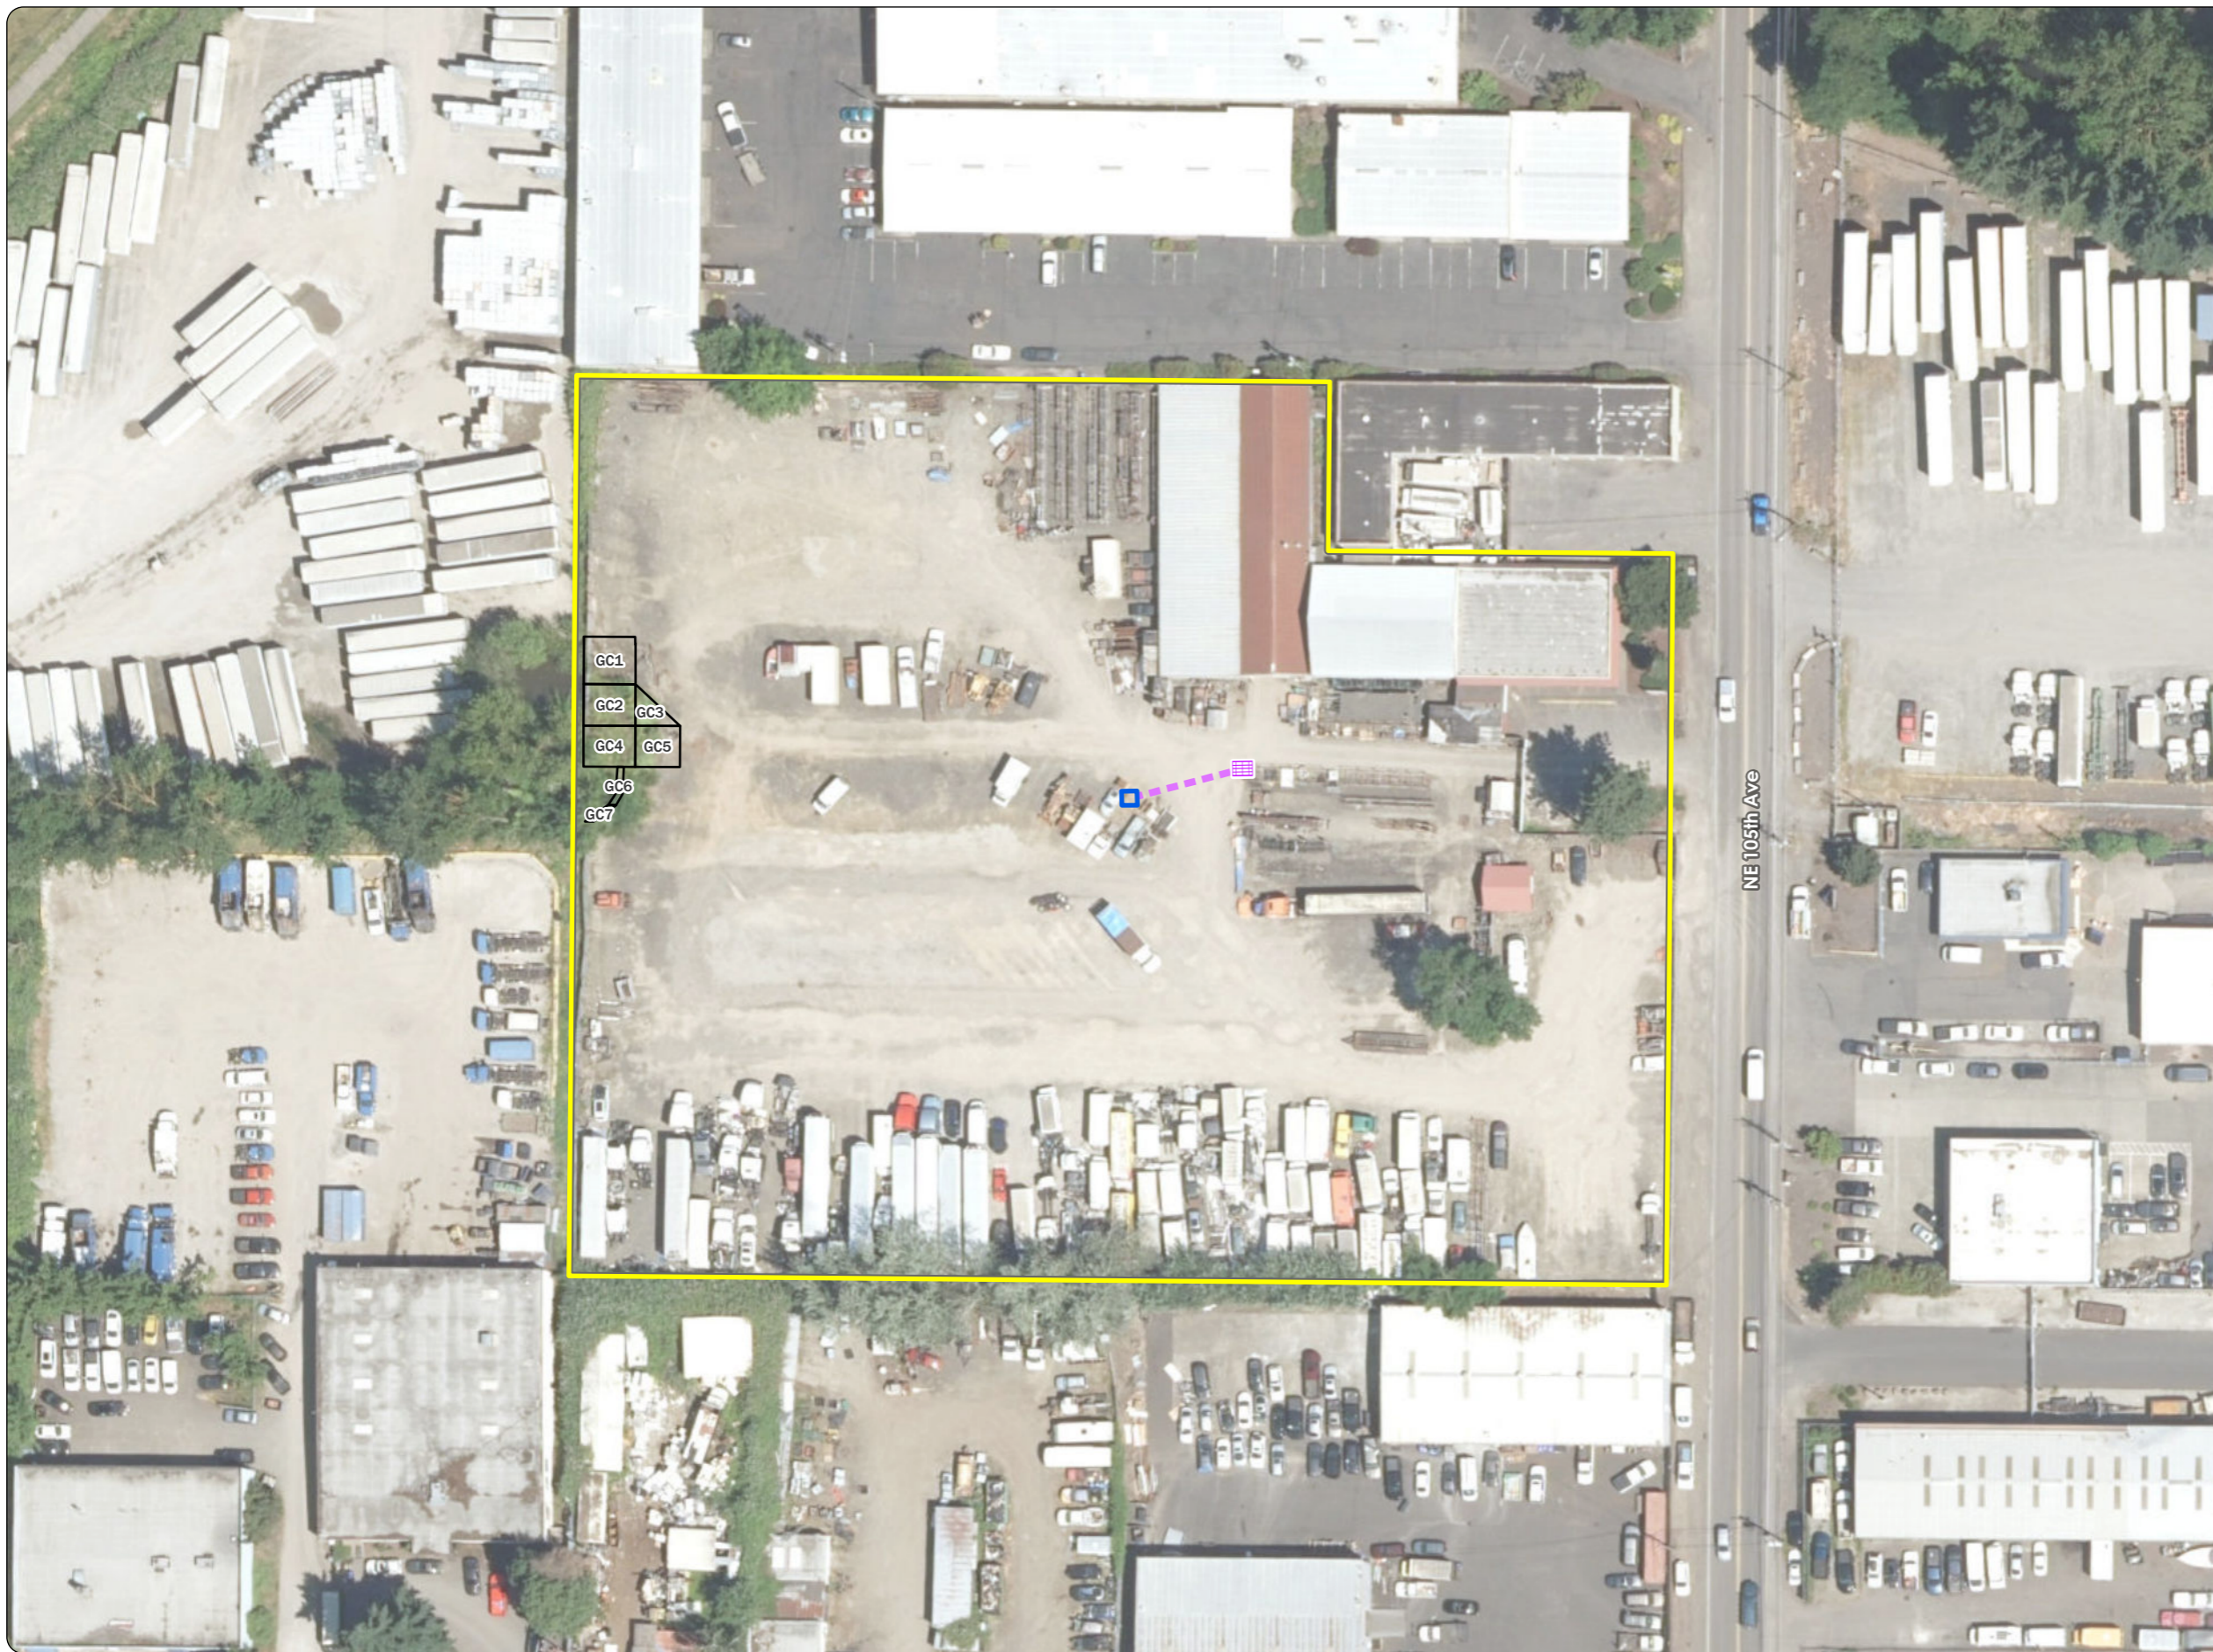
Notes
The arsenic impacted area was adjusted to the location of where the 8-inch stormwater pipe terminates at the surface, which differs from that shown on prior Evren Northwest Inc. figures.

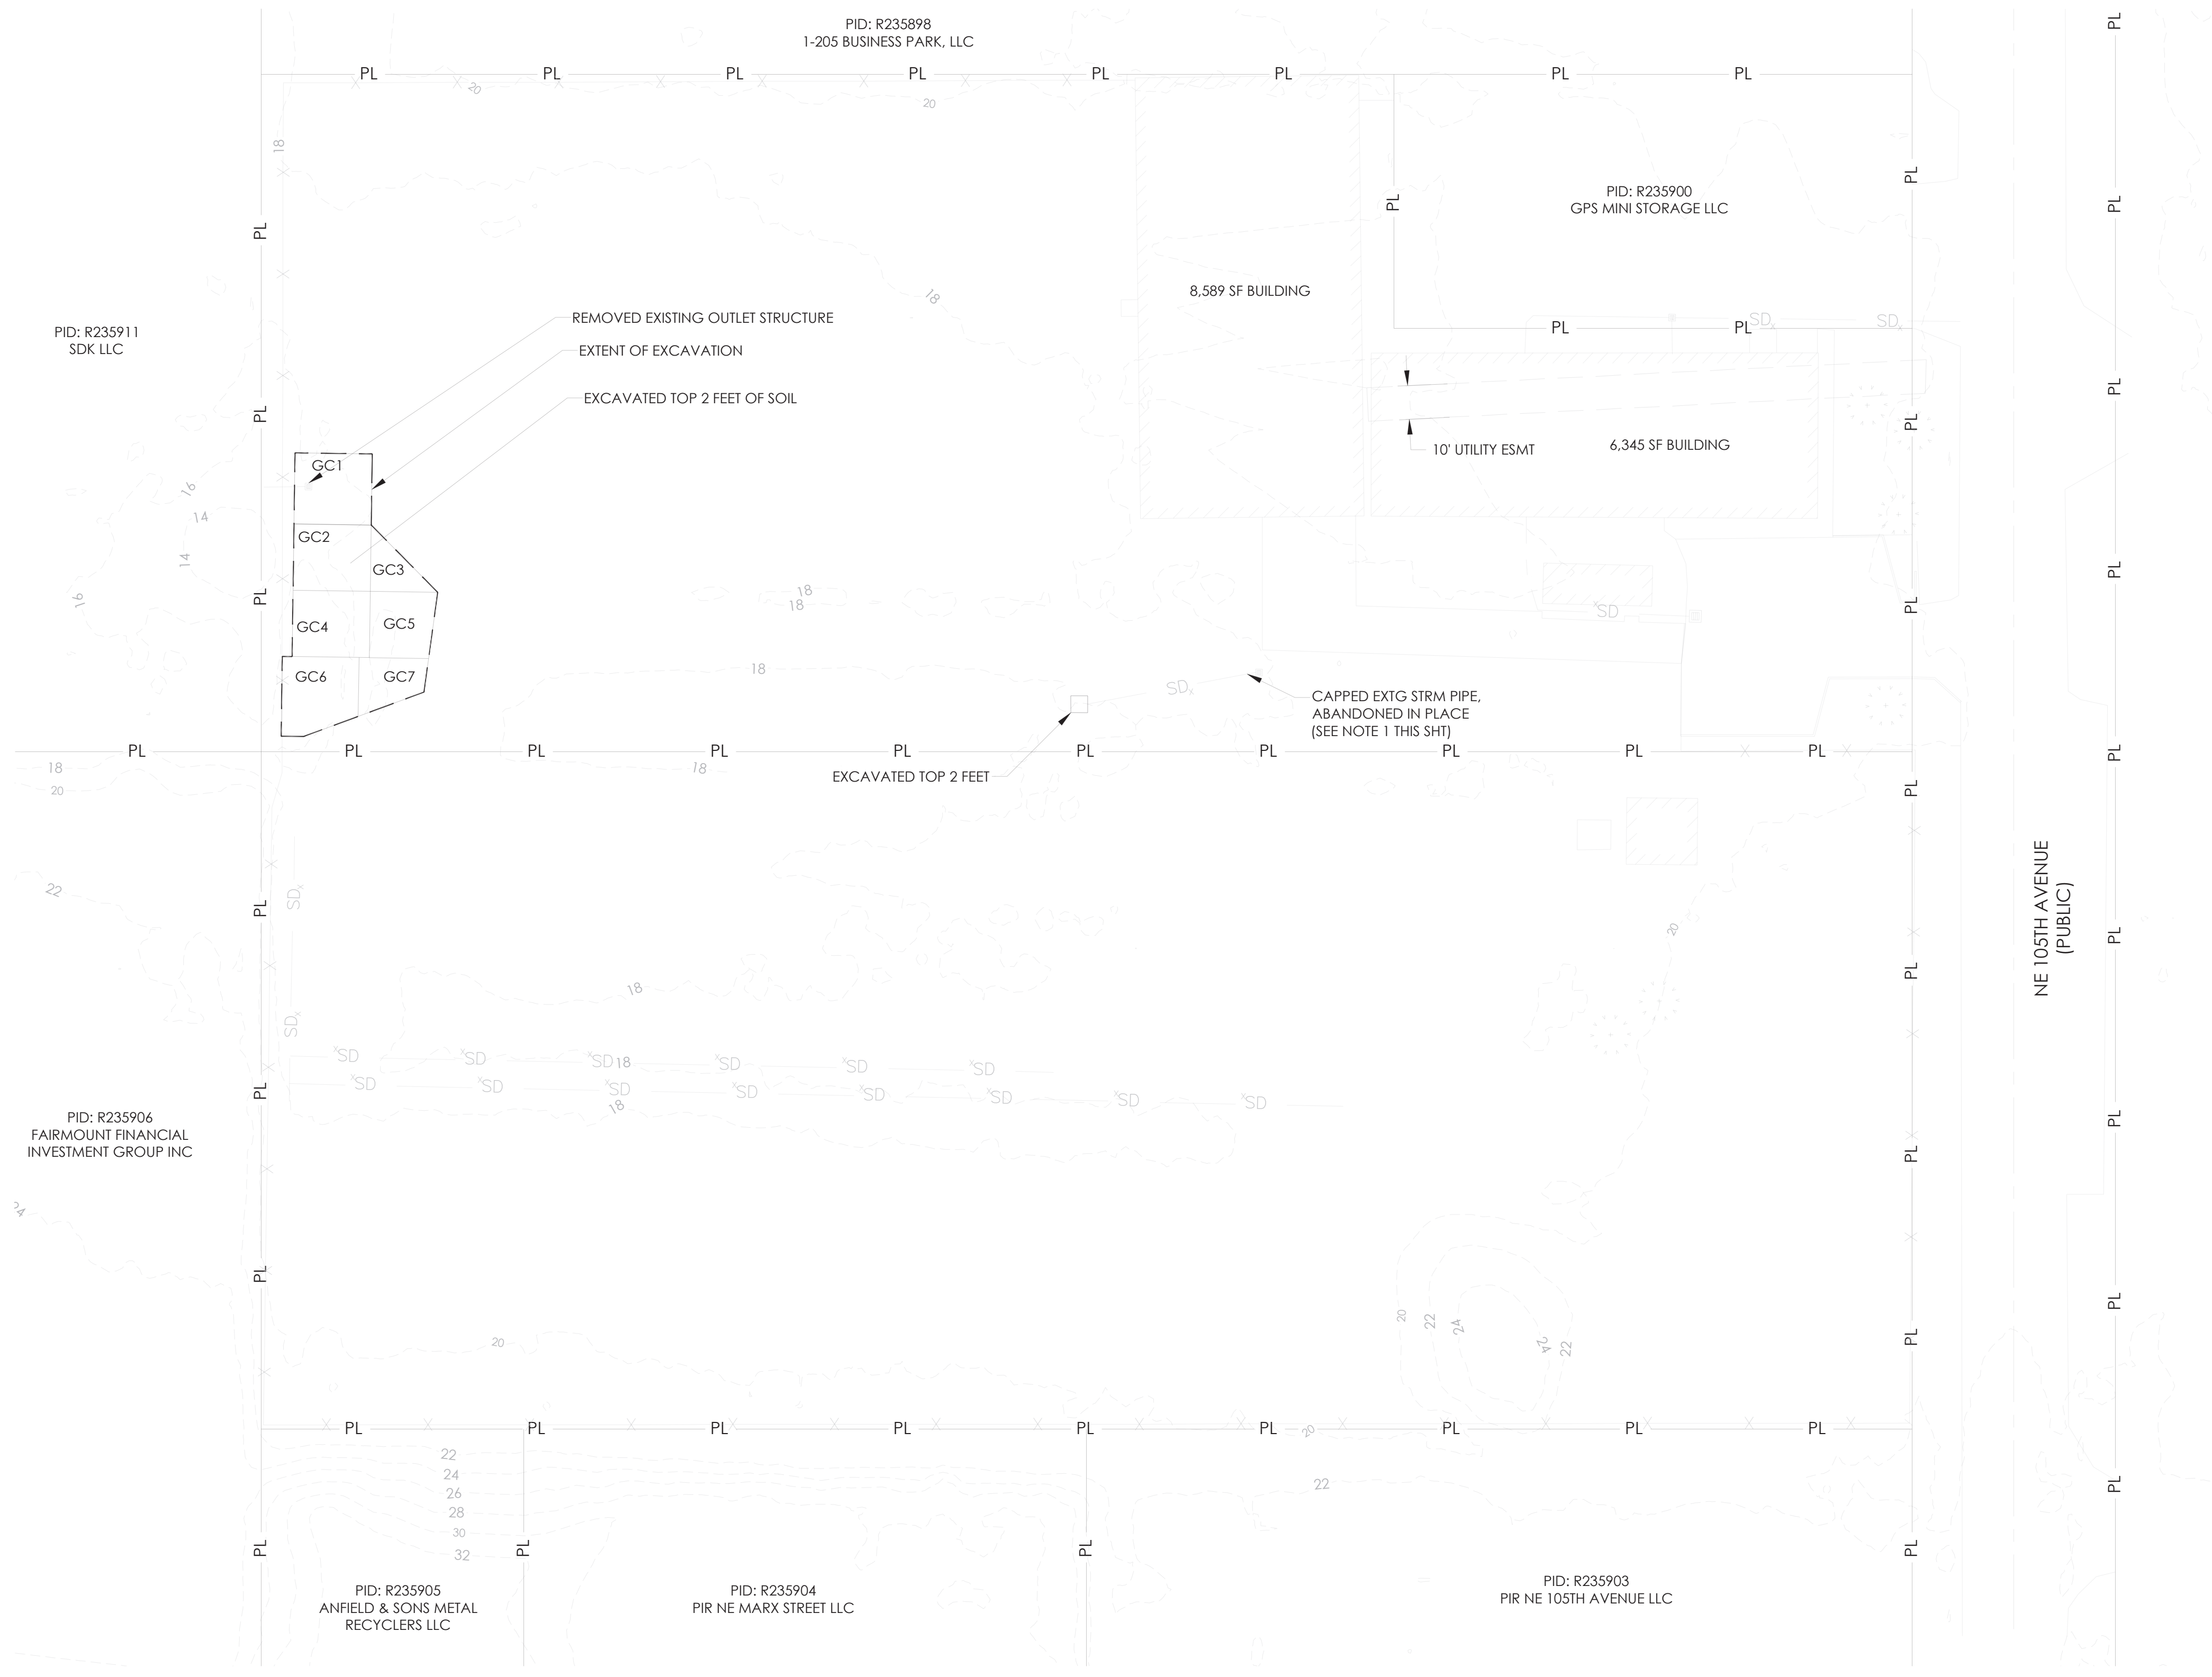
NOTES:
 1. STORMWATER PIPE WAS ABANDONED WITH A FAST-SETTING CONCRETE PLUG THAT WAS POURED AROUND AND IN THE END OF THE PIPE FOR A DISTANCE OF TWO PIPE DIAMETERS.

From conversations with the property owner and site observations, MFA identified that 1) the damaged stormwater line was the only connection to the catch basin, and 2) the stormwater line terminates at the property line. Additionally, as noted above, when the stormwater line was damaged, water flowed onto the Site and not off site to the East Pond. Based on these factors, MFA concluded that the system was substantially/fully non-functional as a conveyance system from the Site to the East Pond and, therefore, was of no value. The catch basin was removed, and the plugged stormwater line was abandoned in place.

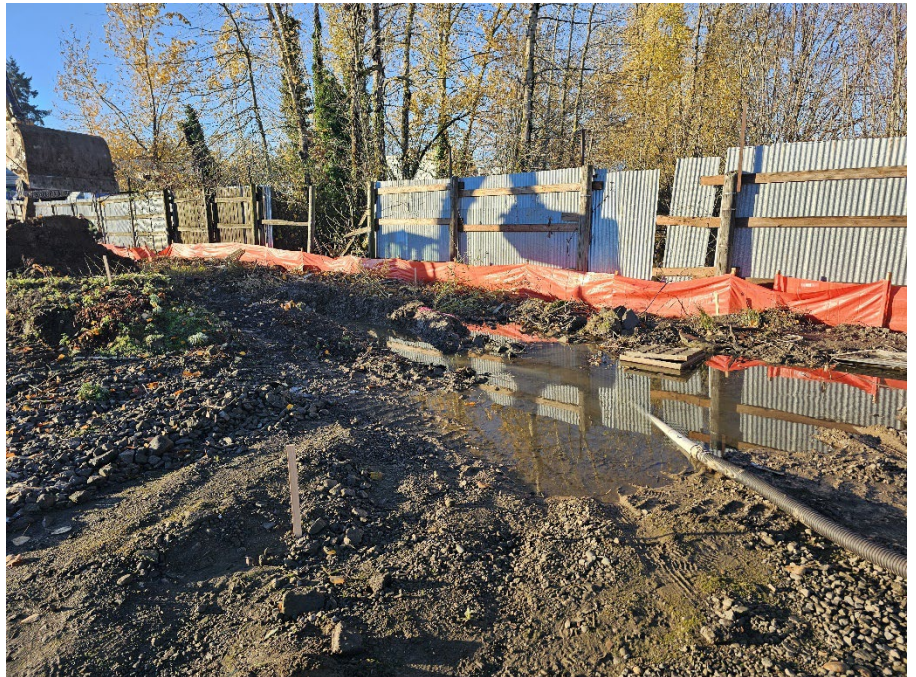
Pumping out the accumulated water from the northern portion of the stormwater retention system excavation prior to removal activities. 12/12/23.

Recent wet weather conditions resulted in water accumulating in the stormwater retention pond prior to the excavation activities beginning. The accumulated water in the excavation was pumped off by a vacuum truck operated by Telluric and stored in 275-gallon totes. Additional dewatering was performed throughout the excavation activities. A total of 2,750 gallons of water was pumped from the excavations and is stored on the Site pending future disposal.

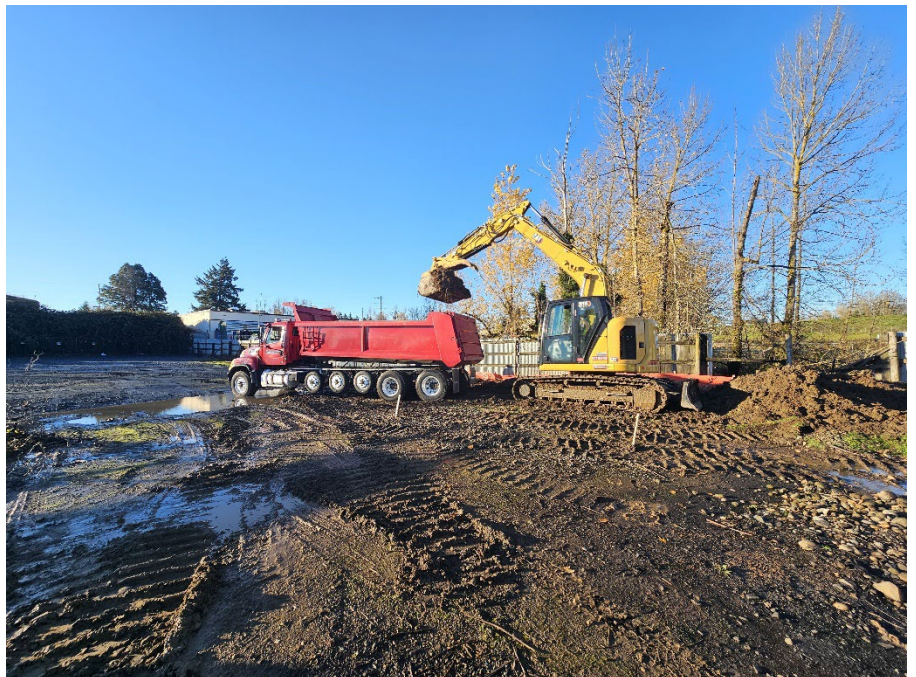
Photo No. 2.

Loading excavated soil directly into trucks for disposal to Hillsboro Landfill. 12/12/23.

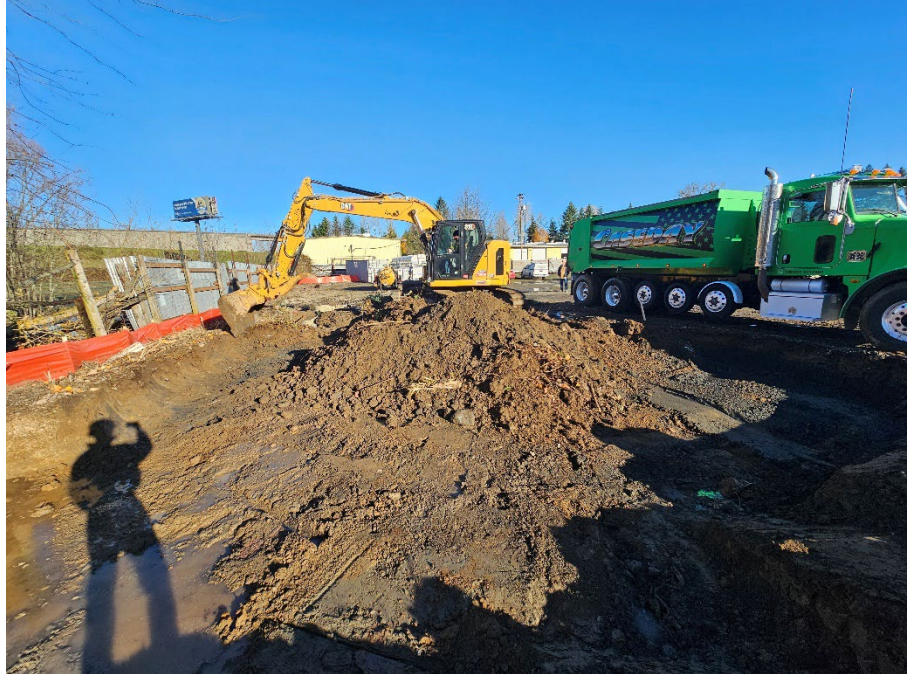
View of removal activities in the central portion of the stormwater retention system excavation. Soil was excavated to two feet below existing grade. The soil buffer remaining onsite is visible to the left. 12/12/23.

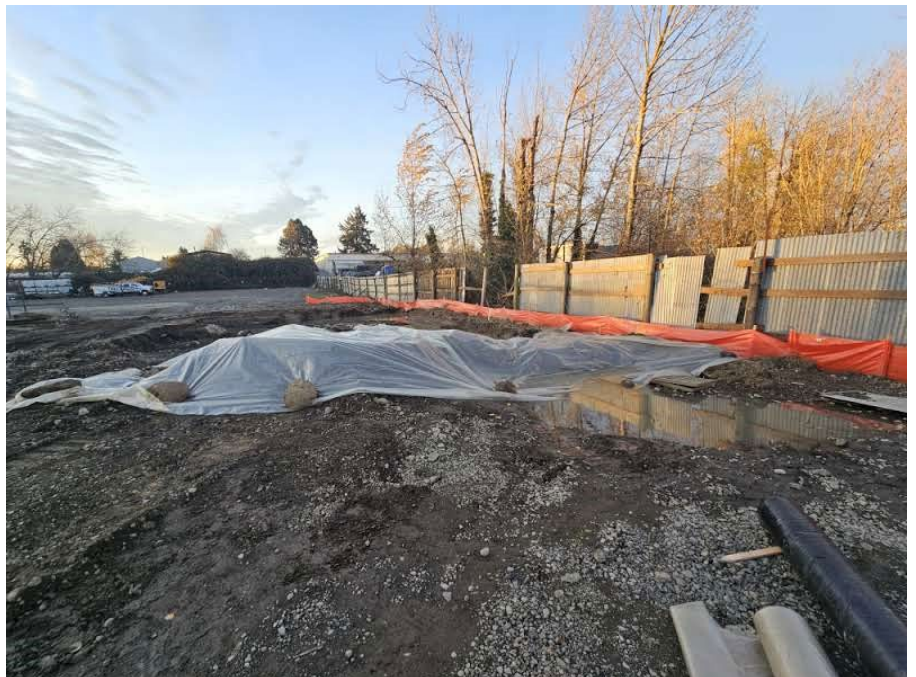
Photo No. 4.

View of the covered temporary stockpiled material located within the excavation area. The material located was temporarily stockpiled pending loading directly into trucks for disposal. 12/13/23.

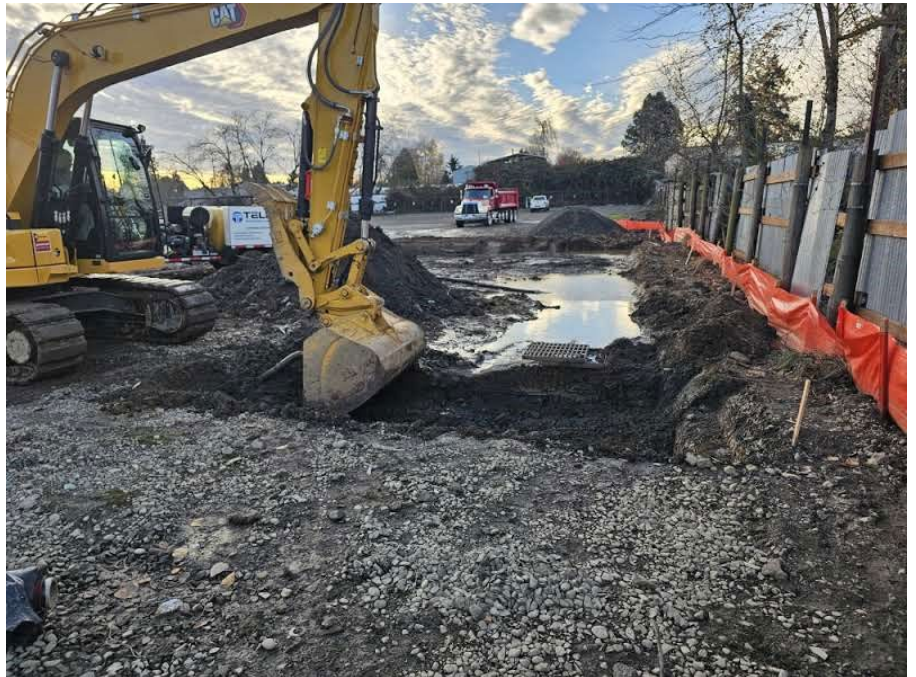
Excavating soil at the northern portion of the stormwater retention system excavation near the catch basin. The soil buffer remaining onsite is visible to the right. 12/13/23.

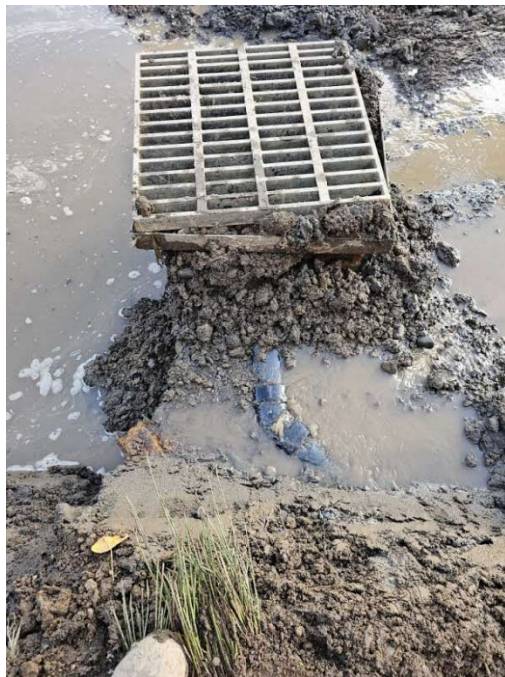
Photo No. 6.

During excavation activities conducted in the stormwater retention pond on December 12, 2023, a stormwater pipe located on the west side of the catch basin outlet structure that purportedly conveyed water from the Site stormwater pond to the East Pond sustained minor damage (a 4-inch laceration approximately ¼” inch in diameter). As a result of the damage to the pipe, water from the East Pond began to enter the excavation area. The pipe was promptly cut and plugged to prevent additional off-site water from entering the excavation. The accumulated water was pumped off by a vacuum truck and stored in two 275-gallon totes.

View of the damaged stormwater pipe that was intended to convey stormwater from the catch basin to the adjacent property. The damage caused water from the adjacent property to enter the excavation zone. 12/13/23.

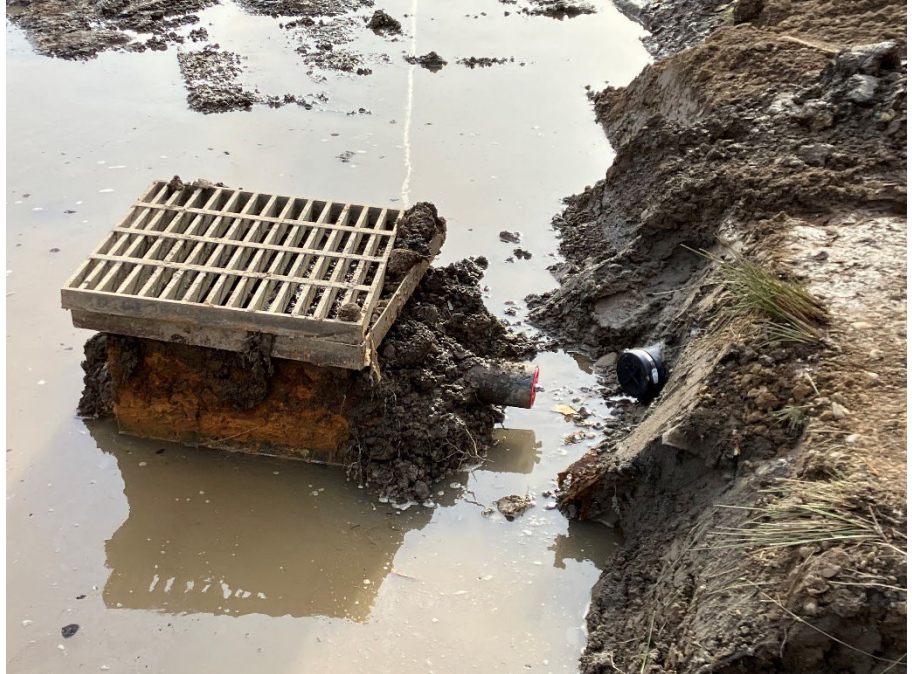
Plugging of the damaged pipe near the catch basin in the excavation. 12/13/23.

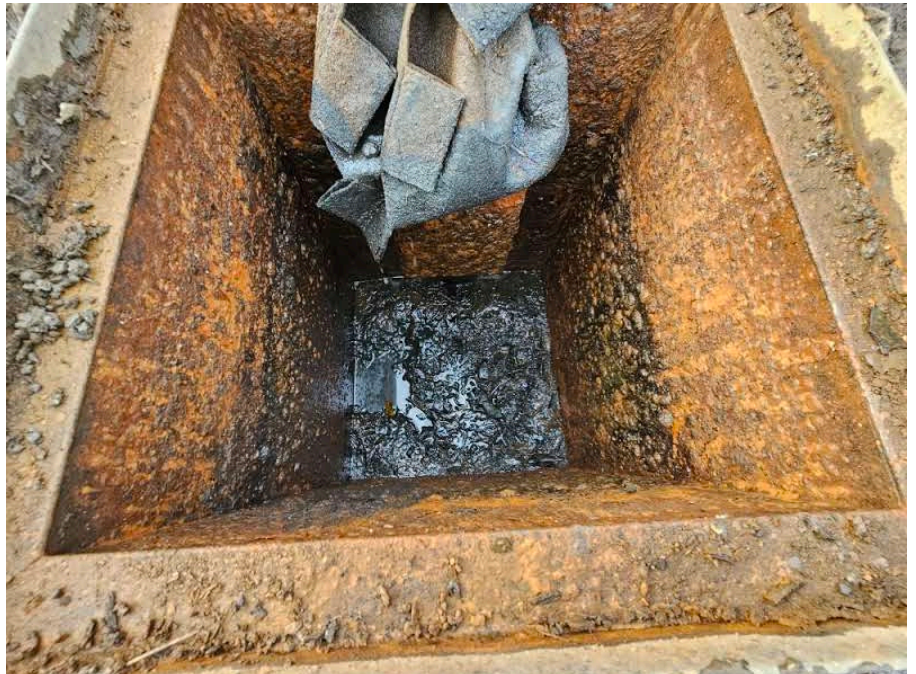
Photo No. 8.

View of interior of the catch basin. Only one outlet pipe is present. 12/13/23.

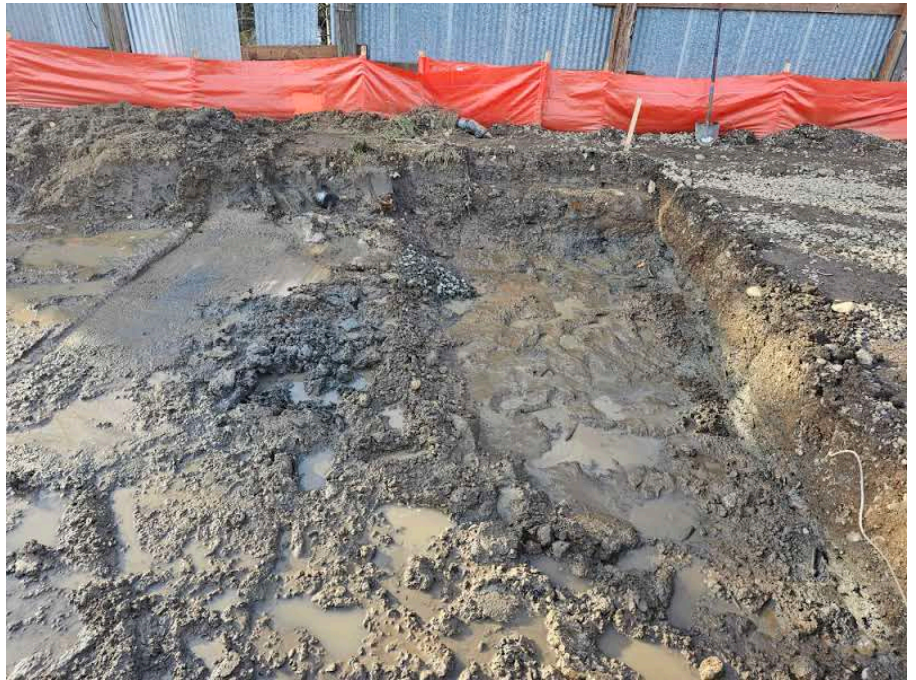
View of the leave surface at the northern end of the stormwater retention system excavation after the catch basin was removed. 12/13/23.

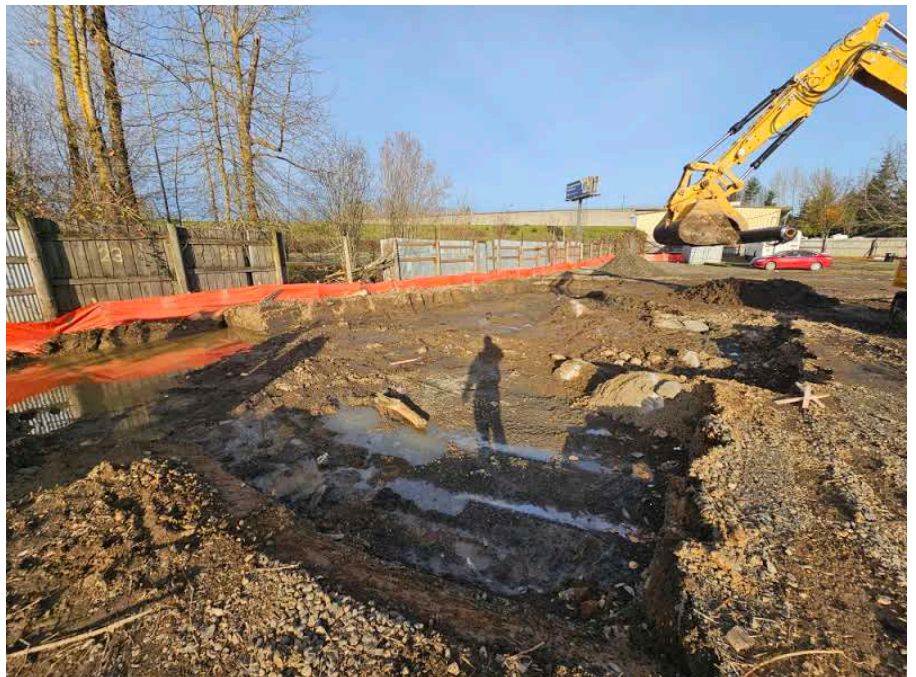
Photo No. 10.

Leave surface at the southern portion of the stormwater retention system excavation. 12/13/23.

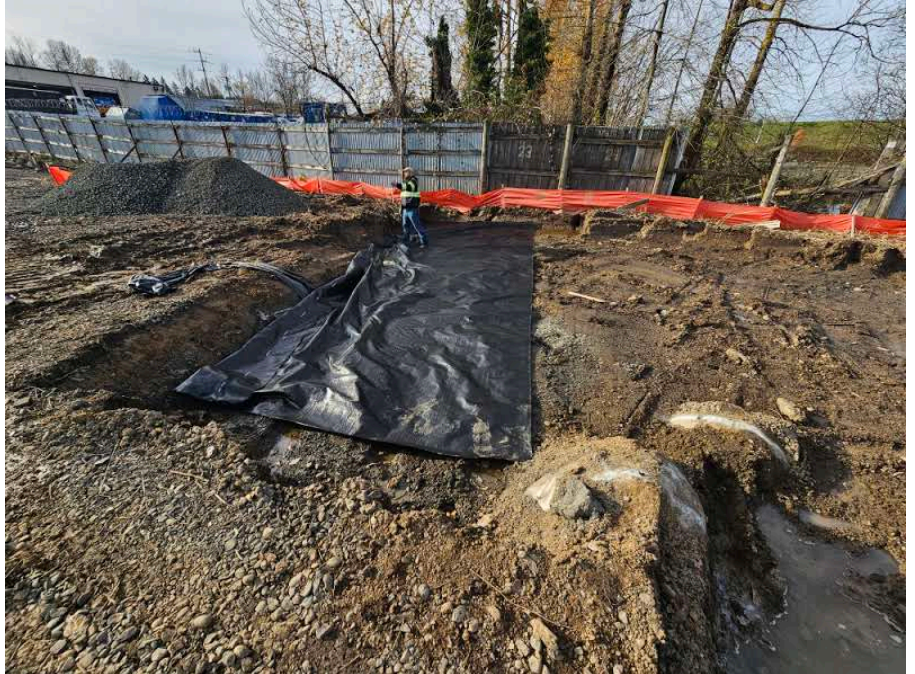
Demarcation layer being installed over the leave surface at the southern portion of the stormwater retention system excavation. 12/13/23.

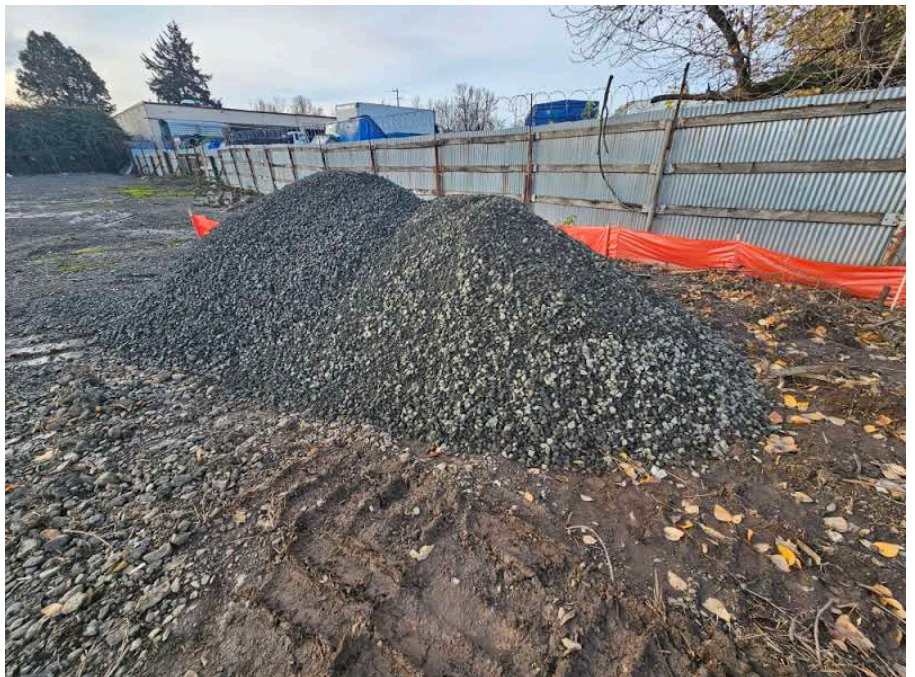
Photo No. 12.

Clean 1 ½"-minus crushed rock used as backfill material. 12/13/23.

Placement of backfill material began on December 13, 2023, and was completed on December 22, 2023. A 1 ½"-minus crushed rock was used to backfill the excavations. The clean backfill was placed in 8-inch lifts and compacted with the excavator tracks and bucket. Approximately 305 tons of clean backfill were imported from Portland Sand and Gravel, CalPortland, or Knife River. The suspect infiltration feature excavation was backfilled to original grade with 1 ½"-minus crushed rock, while the stormwater retention system excavation was backfilled with approximately 16 inches of 1 ½"-minus crushed rock, 6 inches of topsoil, and approximately 2 inches of ¾"- to 1 ½"-minus crushed rock on top of the topsoil for the final surfacing of the stormwater retention system excavation.⁷ Import tickets are included in Appendix G.

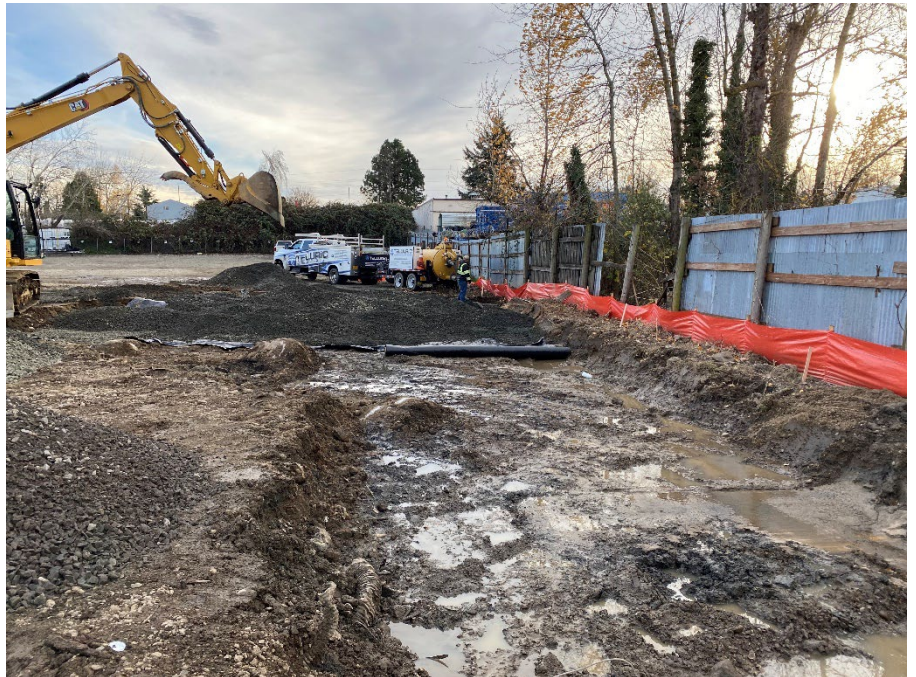
View of backfilling activities in the stormwater retention system excavation. 12/13/23.

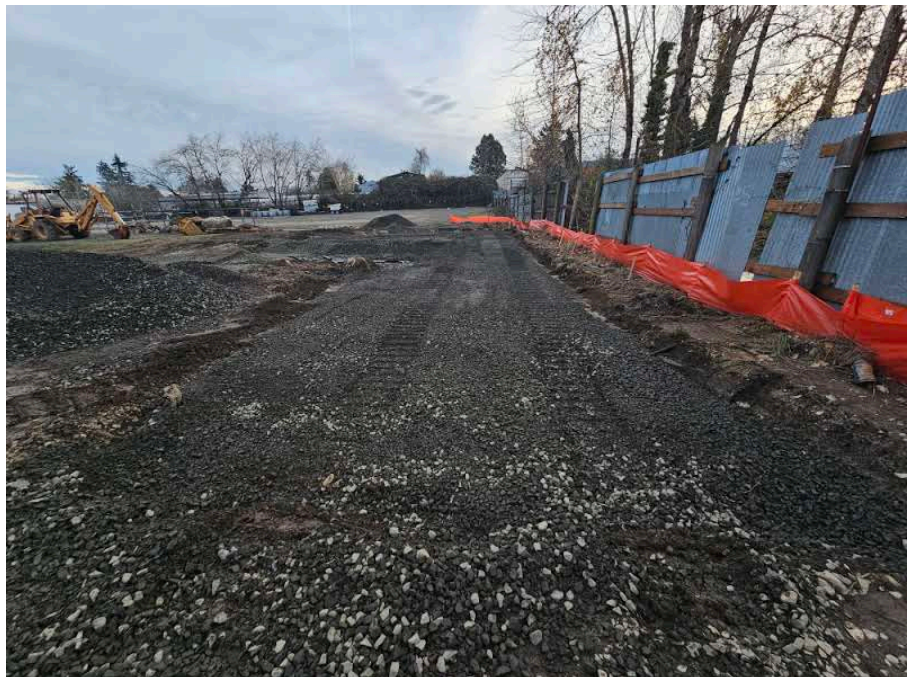
Photo No. 14.

View of the compacted backfill in the stormwater retention system excavation. Approximately 16 inches of gravel was installed. The soil buffer remaining onsite is visible to the right. 12/13/23.

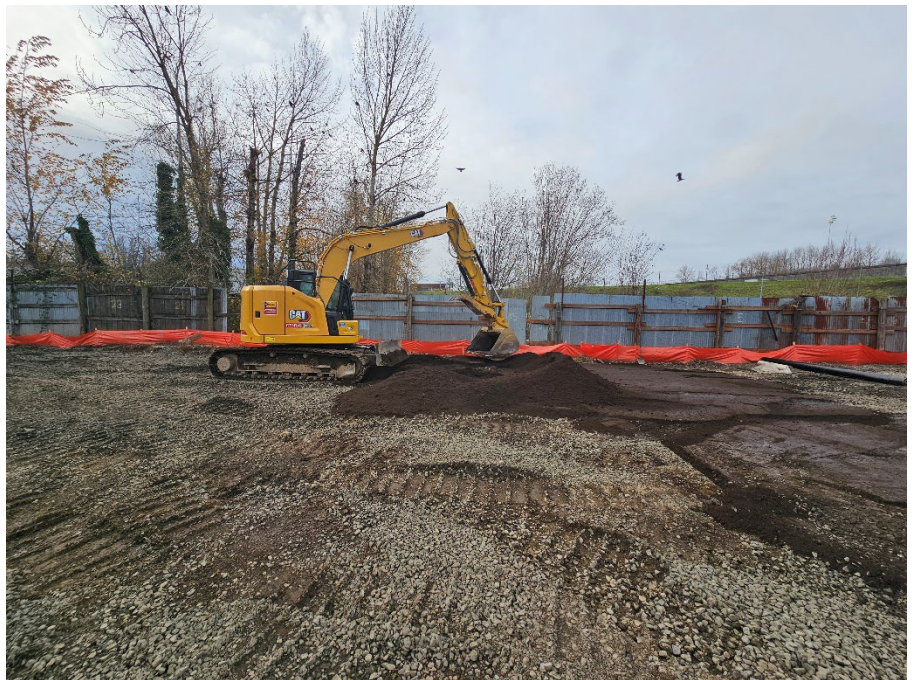
Description

Placement of topsoil
over the stormwater
retention system
excavation. 12/14/23.

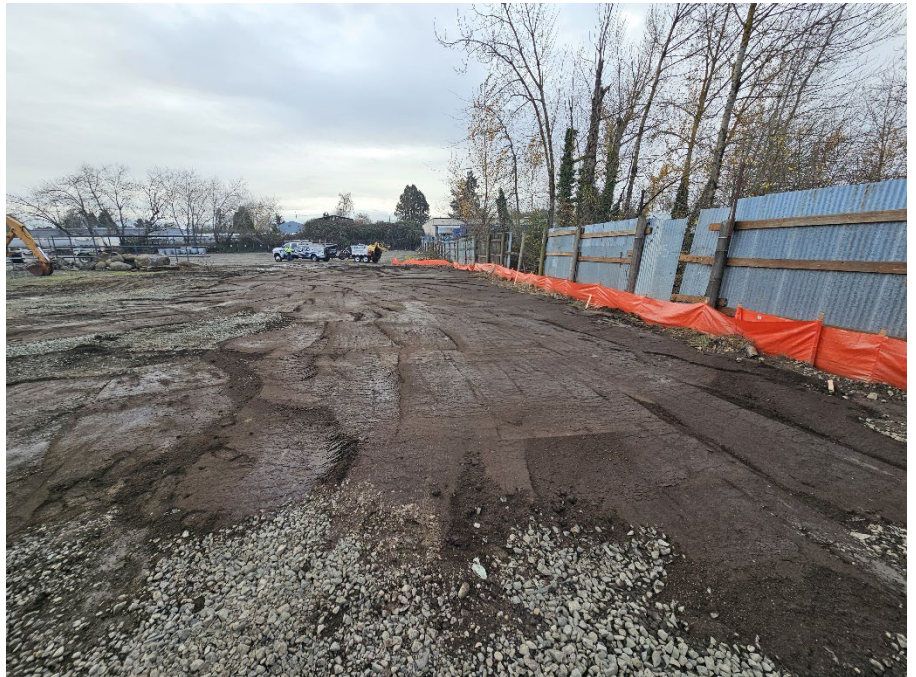
The backfill surface at the stormwater retention system excavation on 12/14/23.

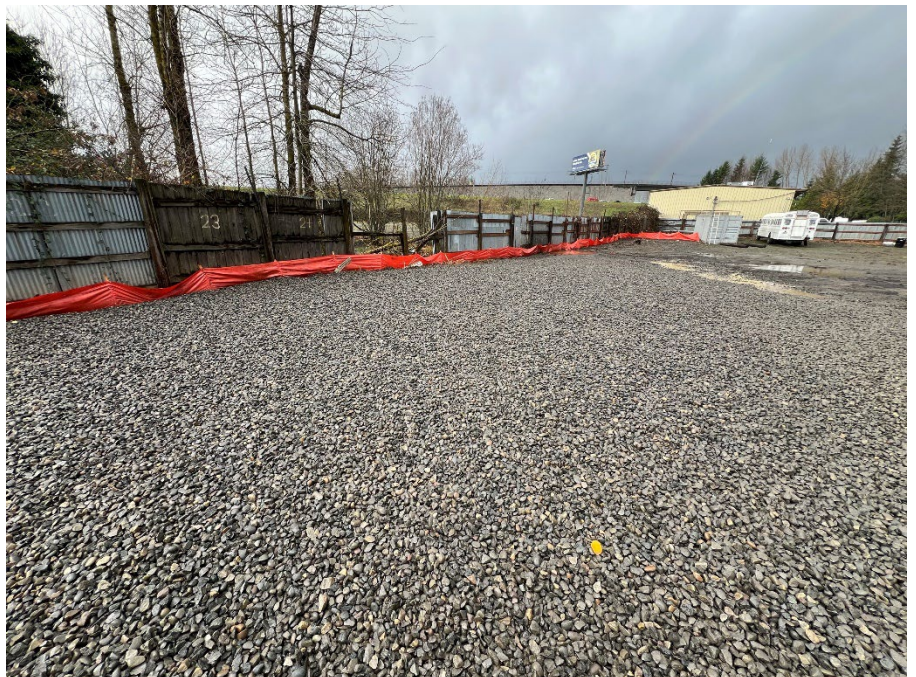
Photo No. 18.

The finalized backfill surface at the stormwater retention system excavation. 12/22/23.

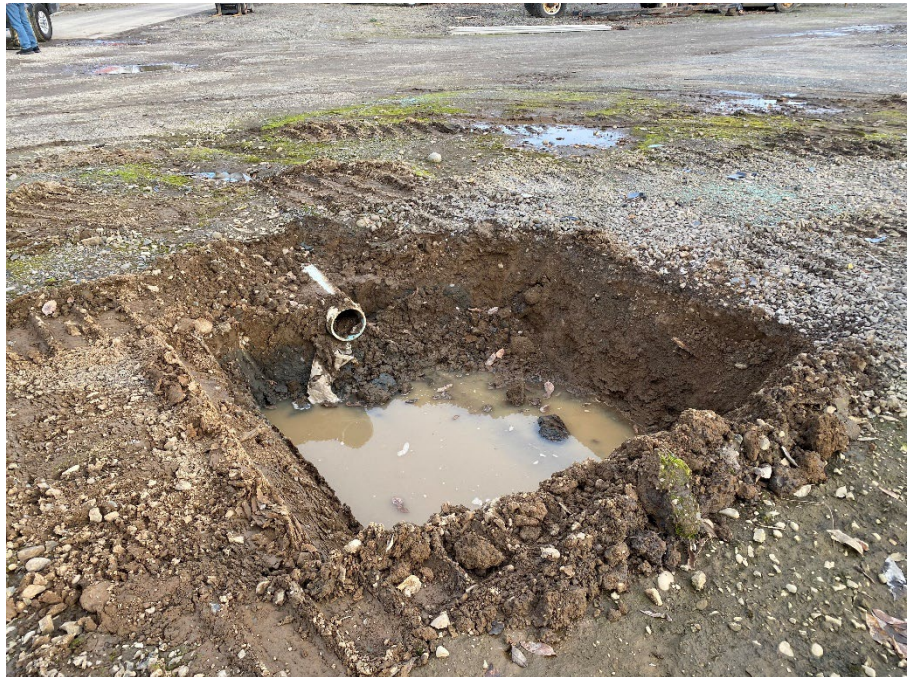
View of the suspect infiltration feature excavation located in the central portion of the site. Excavated soils were removed to two feet below existing grade. The daylighting stormwater pipe to be decommissioned is visible. 12/13/23.

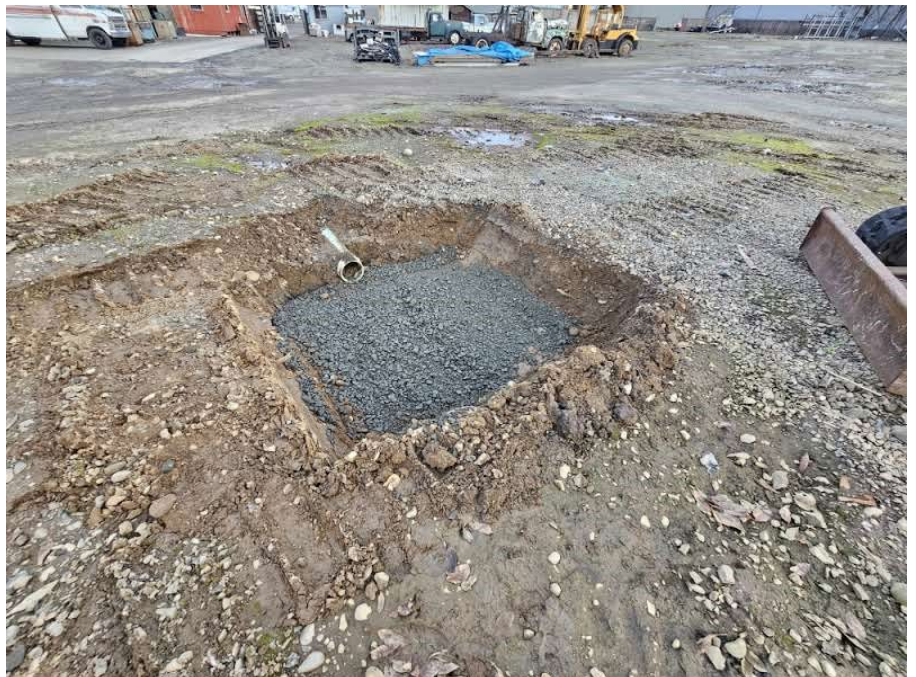
Photo No. 20.

Partial backfill at the suspect infiltration feature excavation. 12/13/23.

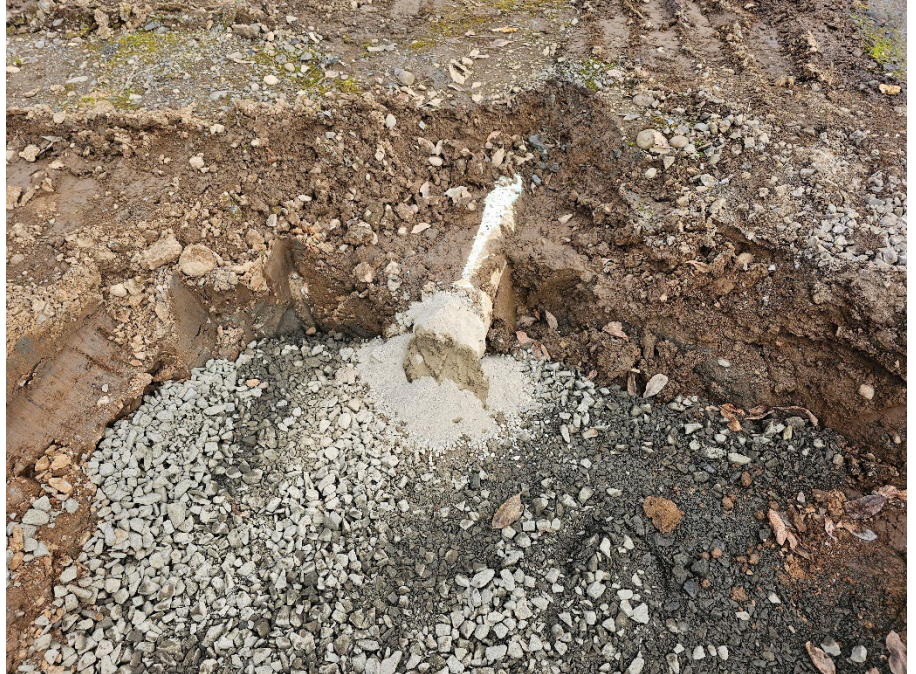
Grouting and plugging the stormwater pipe located in the suspect infiltration feature excavation. 12/14/23.

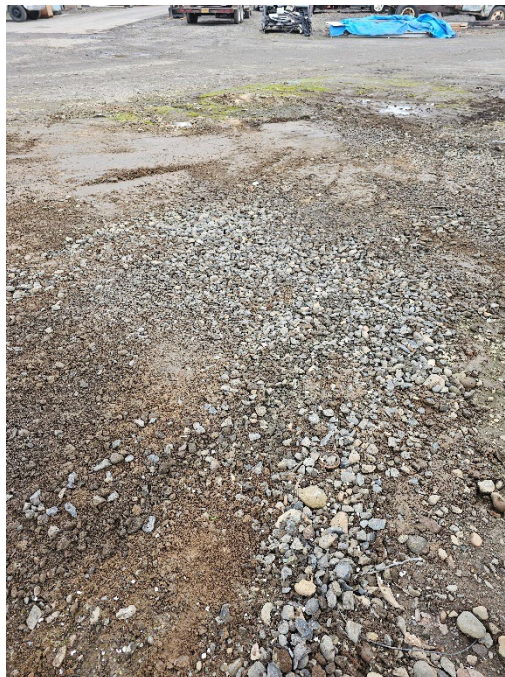
Photo No. 22.

The finalized surface at the suspect infiltration feature excavation after backfilling. 12/14/23.

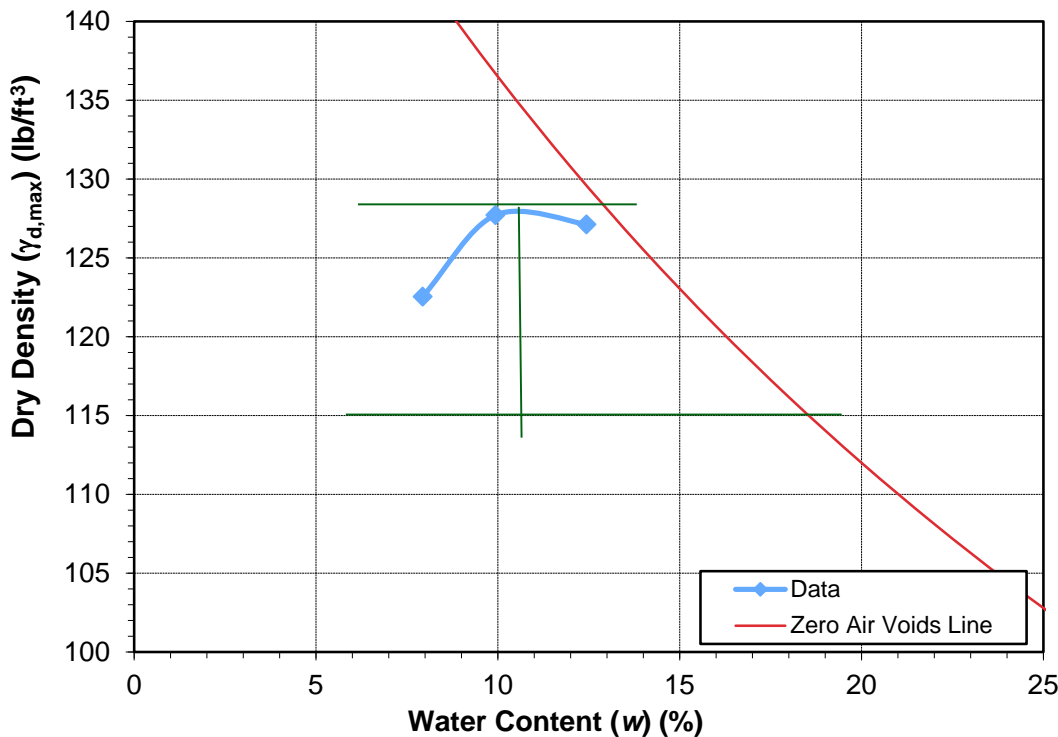
UNCORRECTED
 $\gamma_{d,max}$ (lb/ft³): 128.3
 OMC (%): 11

CORRECTED
 $\gamma_{d,max}$ (lb/ft³): 135.1
 OMC (%): 9.3

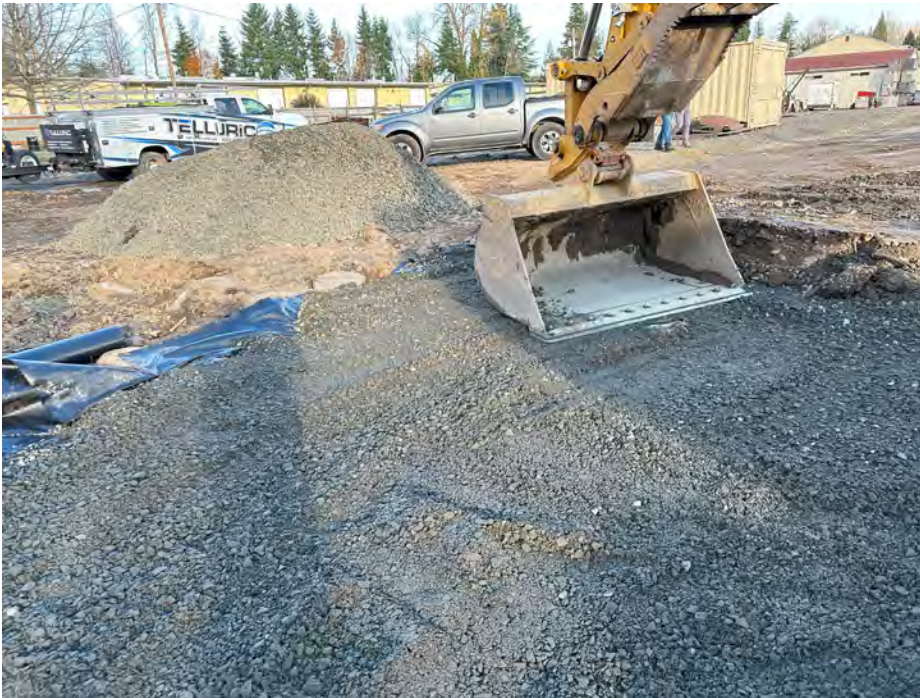
IMAGE 1: Water management completed prior to compaction efforts.
