Remedial Action Completion Report

205 Auto Salvage Site, 5605 NE 105th
Avenue, Portland, Oregon

Project No. M0106.30.001

Maul Foster & Alongi, Inc.

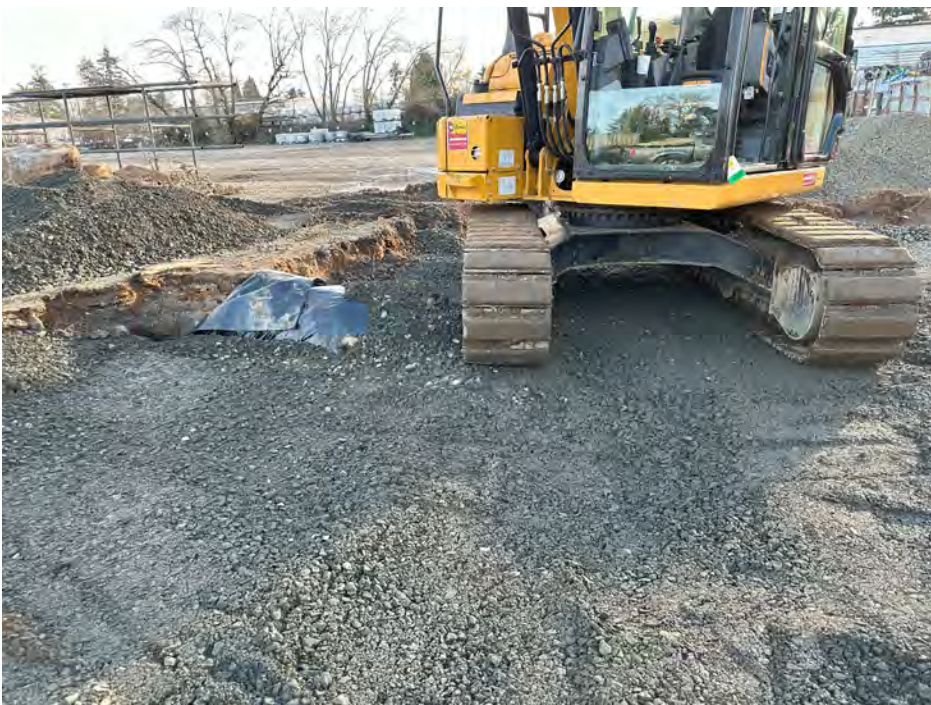
IMAGE 2: Track Walking and bucket compaction of import.

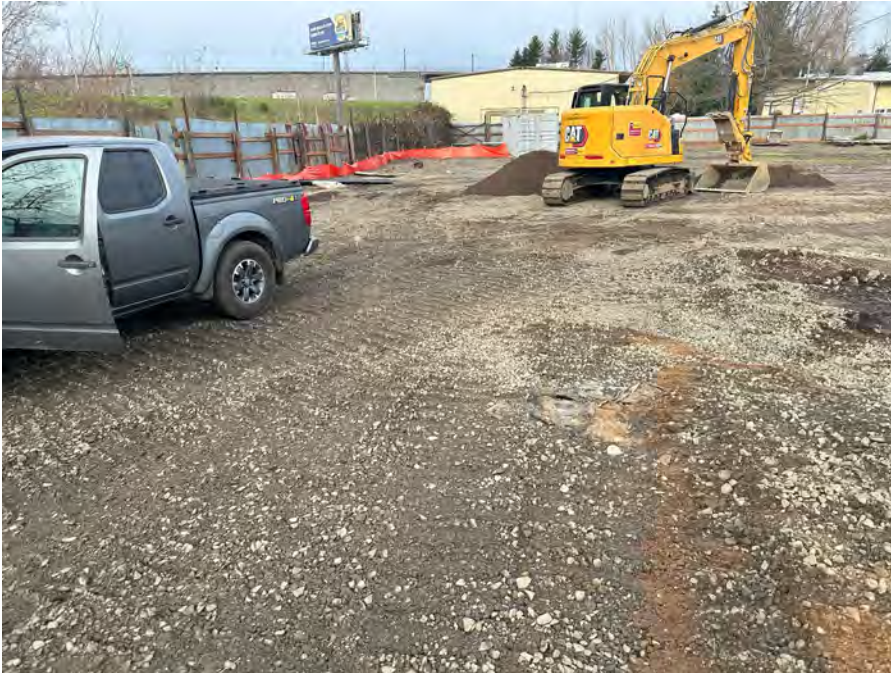
IMAGE 1: Import after bucket compaction and trackwalking, but prior to proofroll.

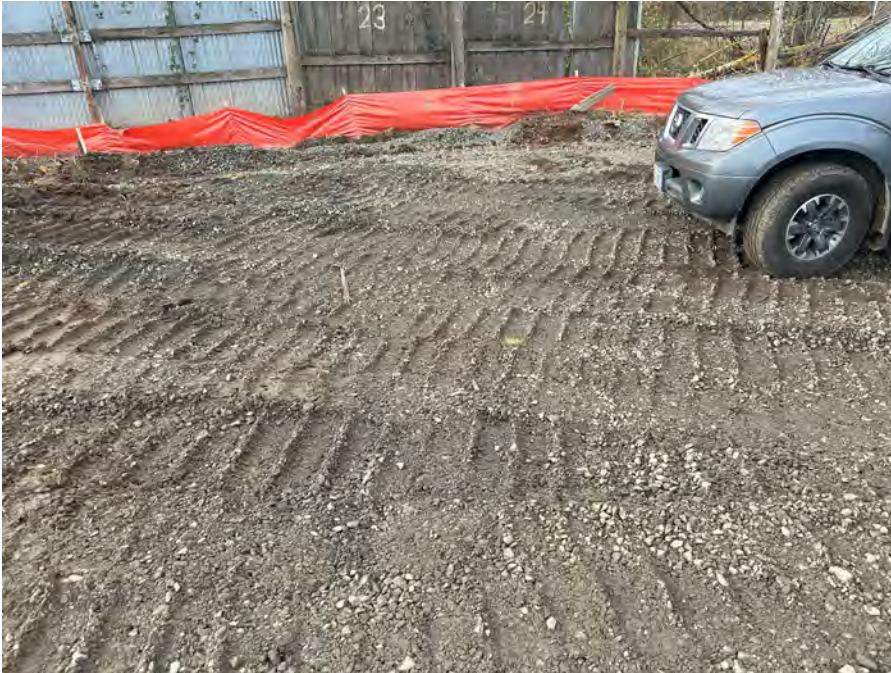
IMAGE 2: Import after bucket compaction and trackwalking, but prior to proofroll.
