# STORM WATER SOURCE CONTROL EVALUATION REPORT

## OREGON HUMANE SOCIETY FACILITY

7865-7885 NE 14<sup>th</sup> Place  
(Previous address: 1409 NE Columbia Blvd)  
Portland, Oregon

Project No. 351-18019-09

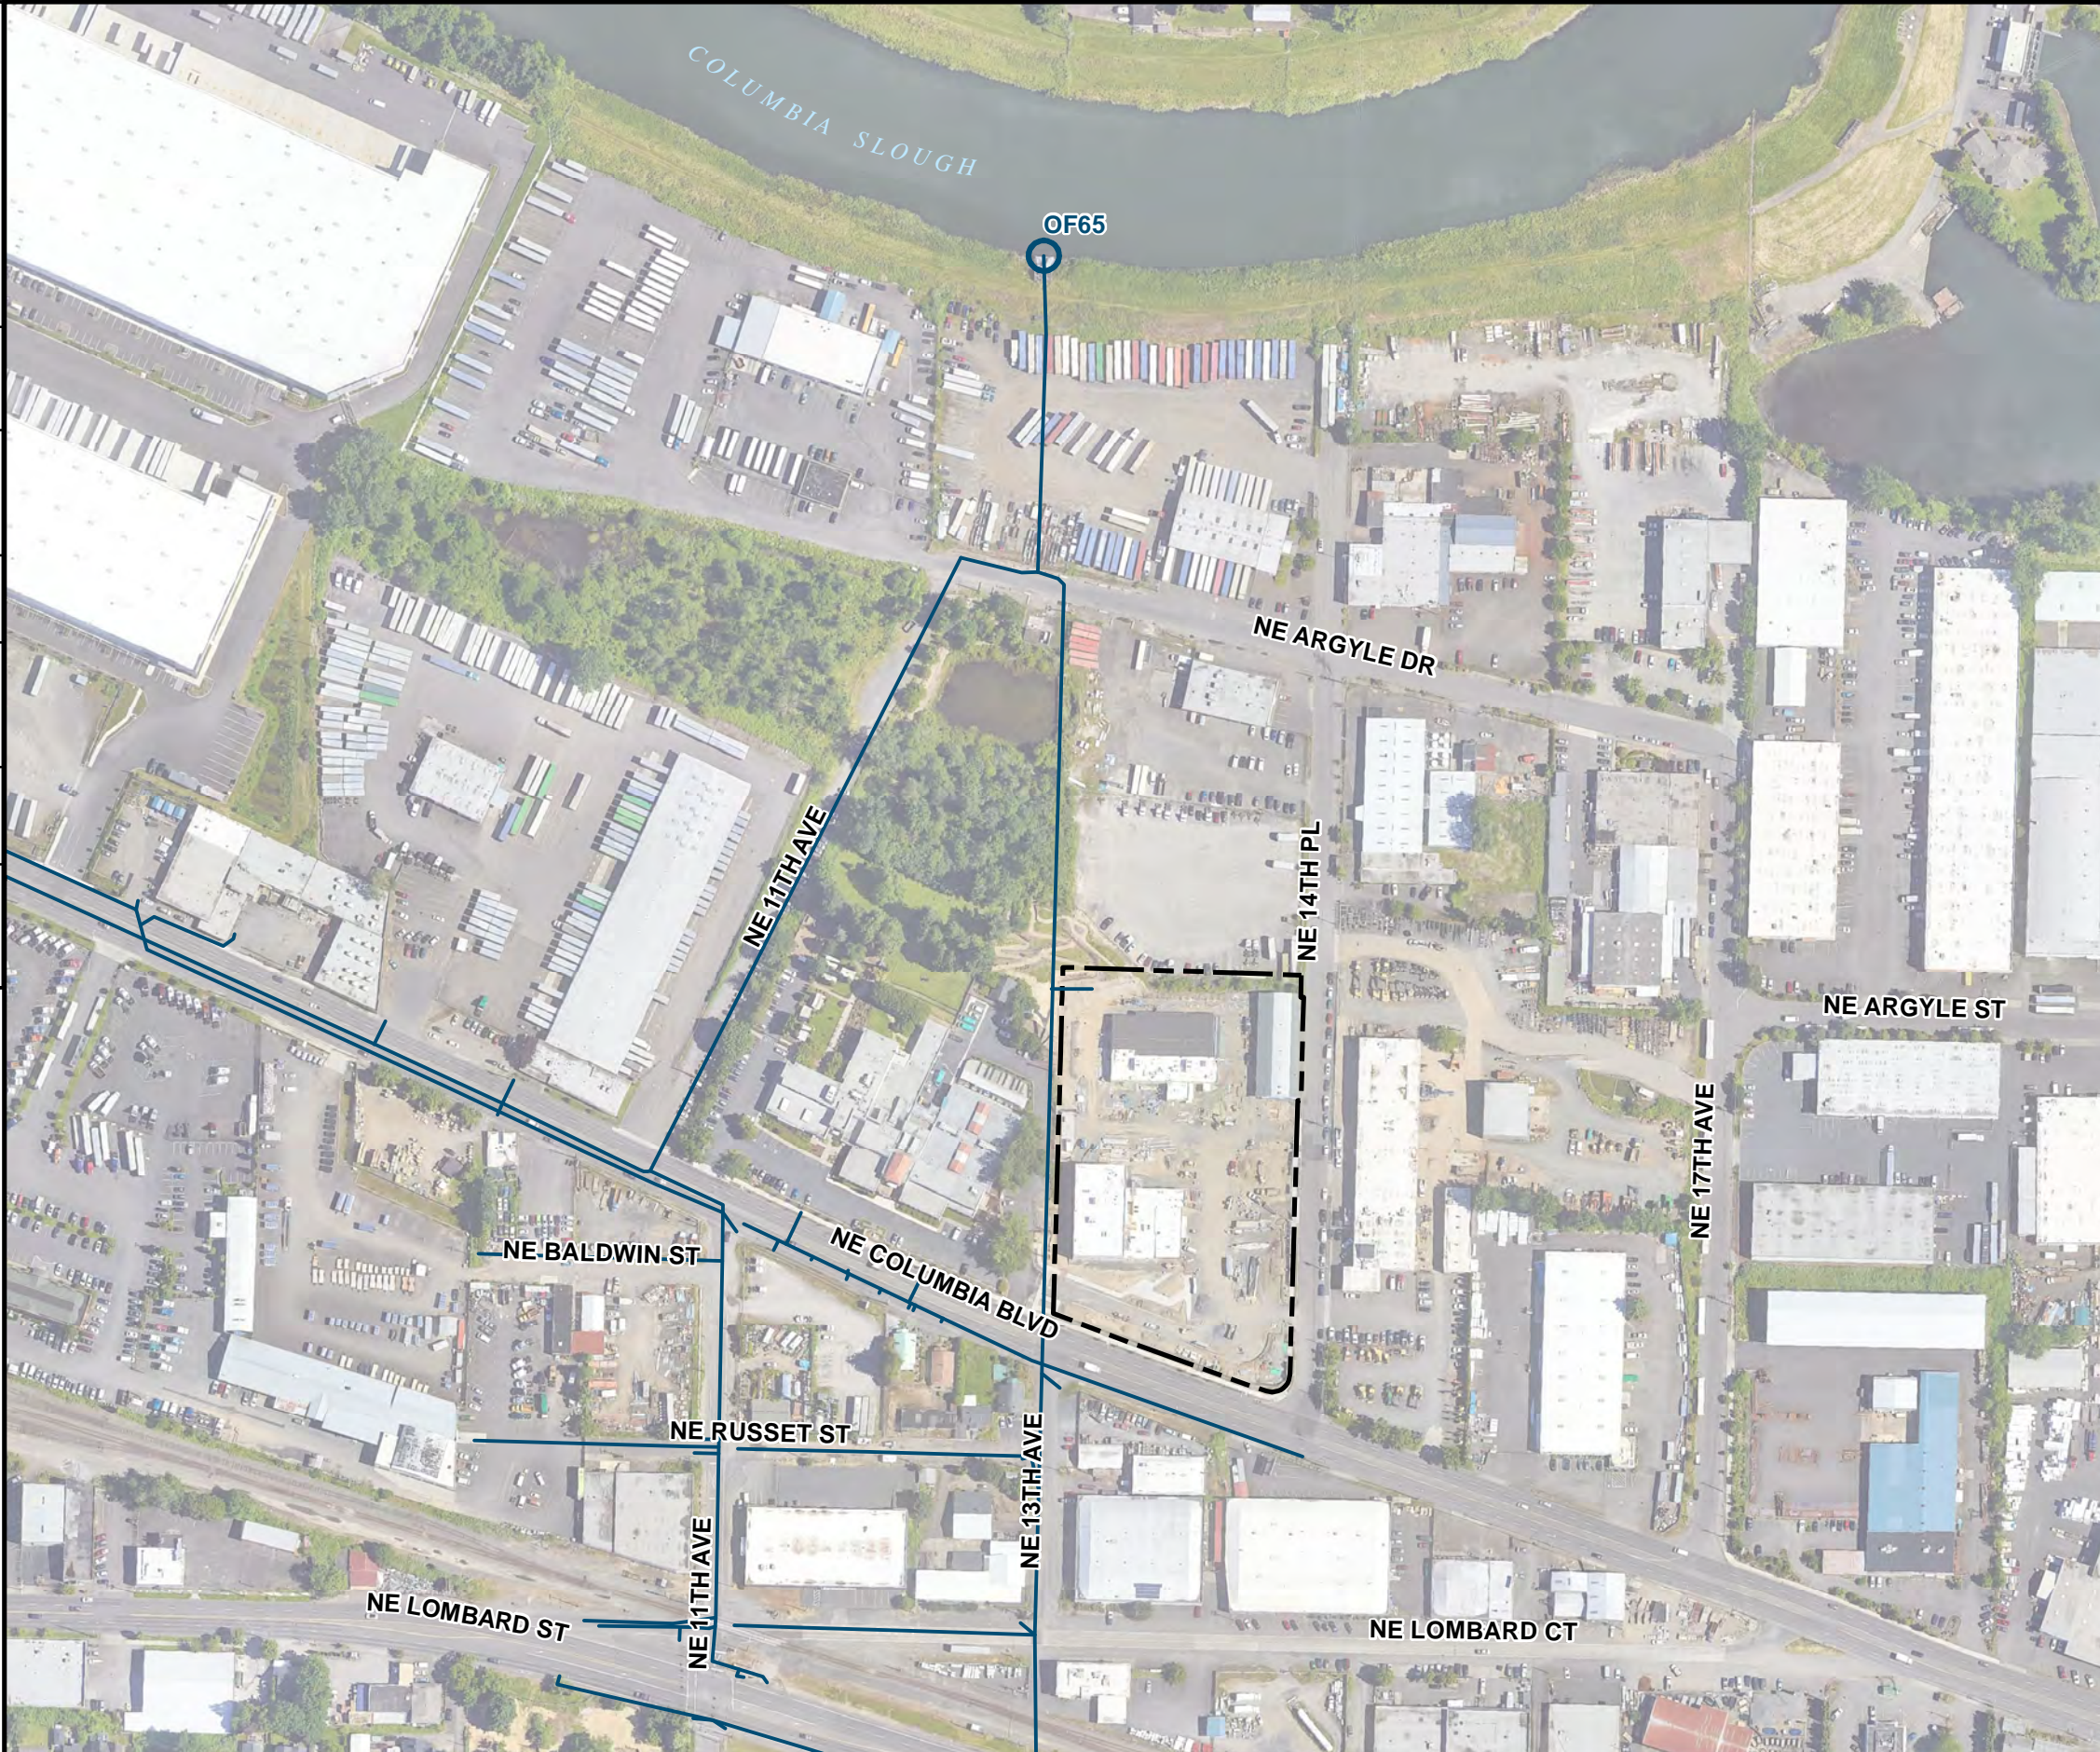
| 4 | Storm Water Conveyance Map (Distal) |

According to utility as-built drawings provided by City of Portland<sup>10</sup> storm water from the subject property enters the City storm-only sewer connection near the northwest corner of the subject property. From there, storm water flows north to City Outfall 65 in the Lower Slough, joining additional inflow from several industrial and commercial properties at NE Argyle Drive.

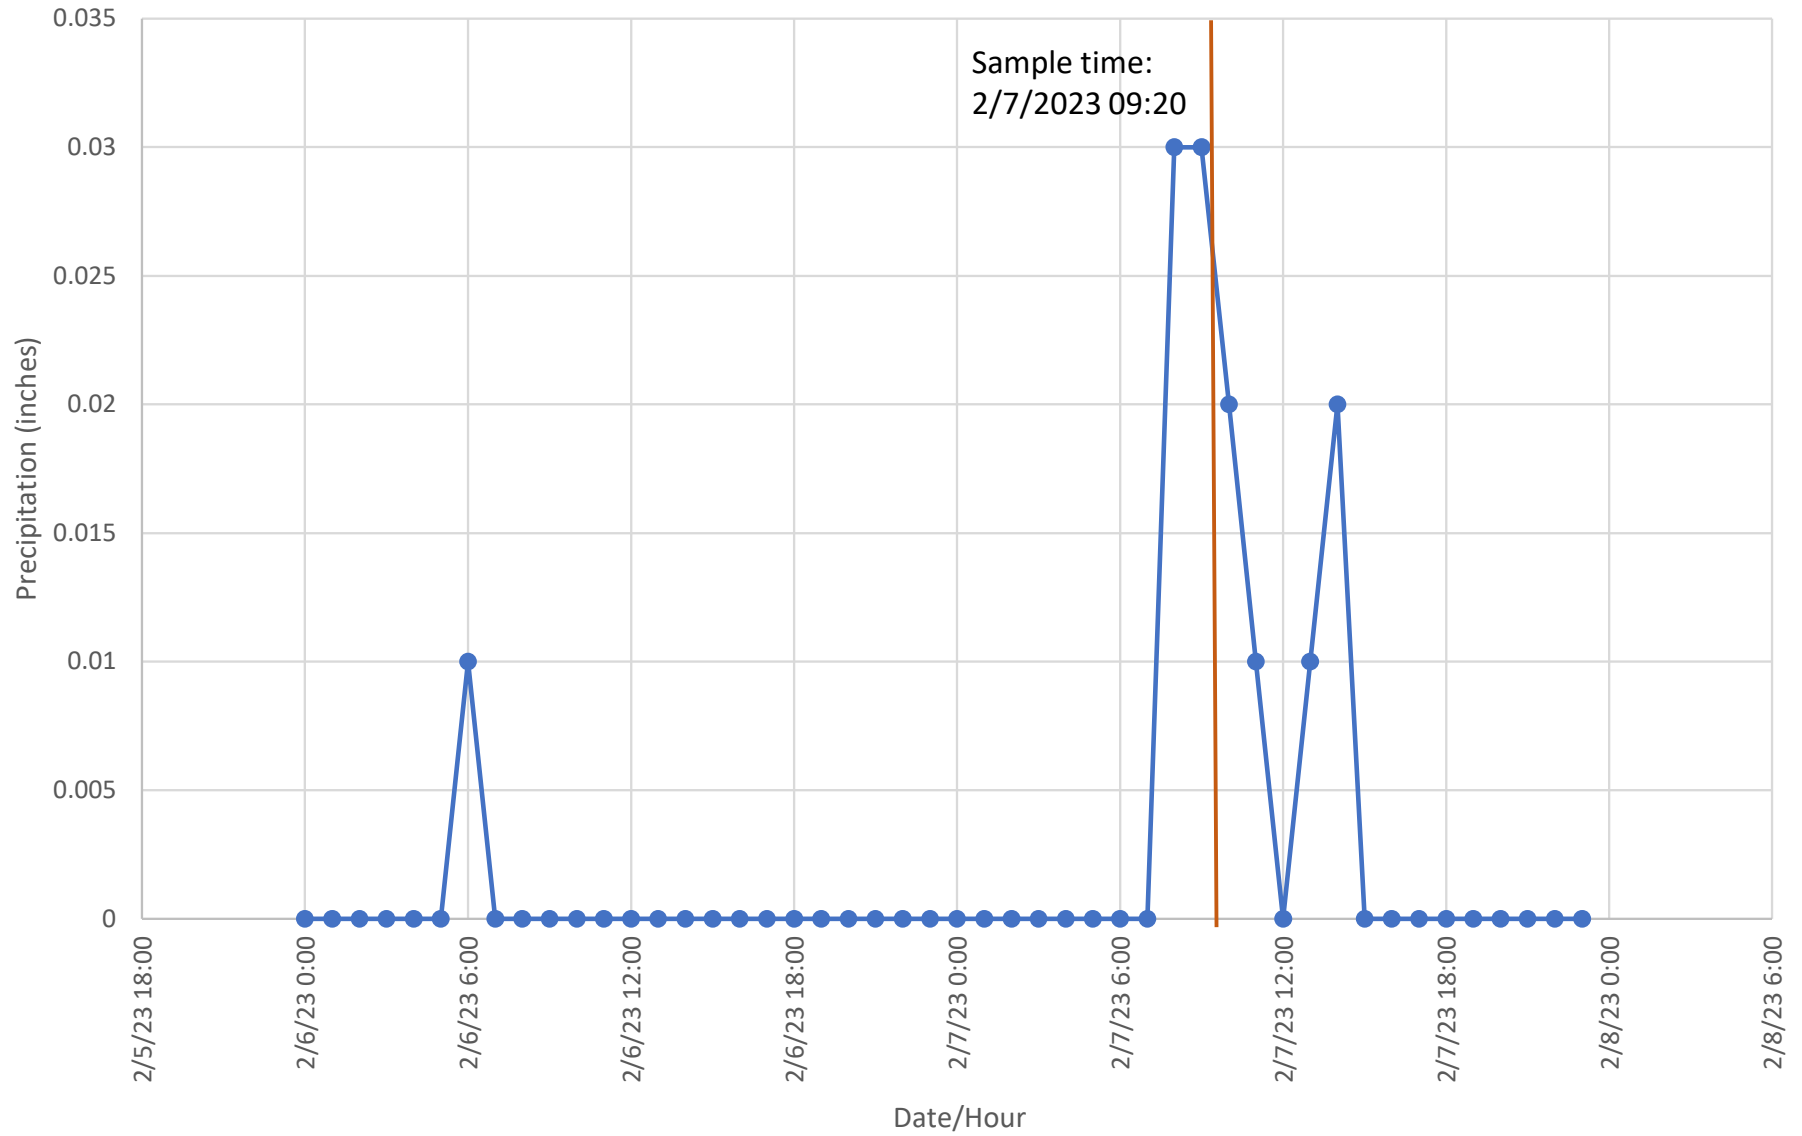
# Hydrograph for February 6-7, 2023

## Mallory Rain Gauge - 8030 NE Mallory Avenue

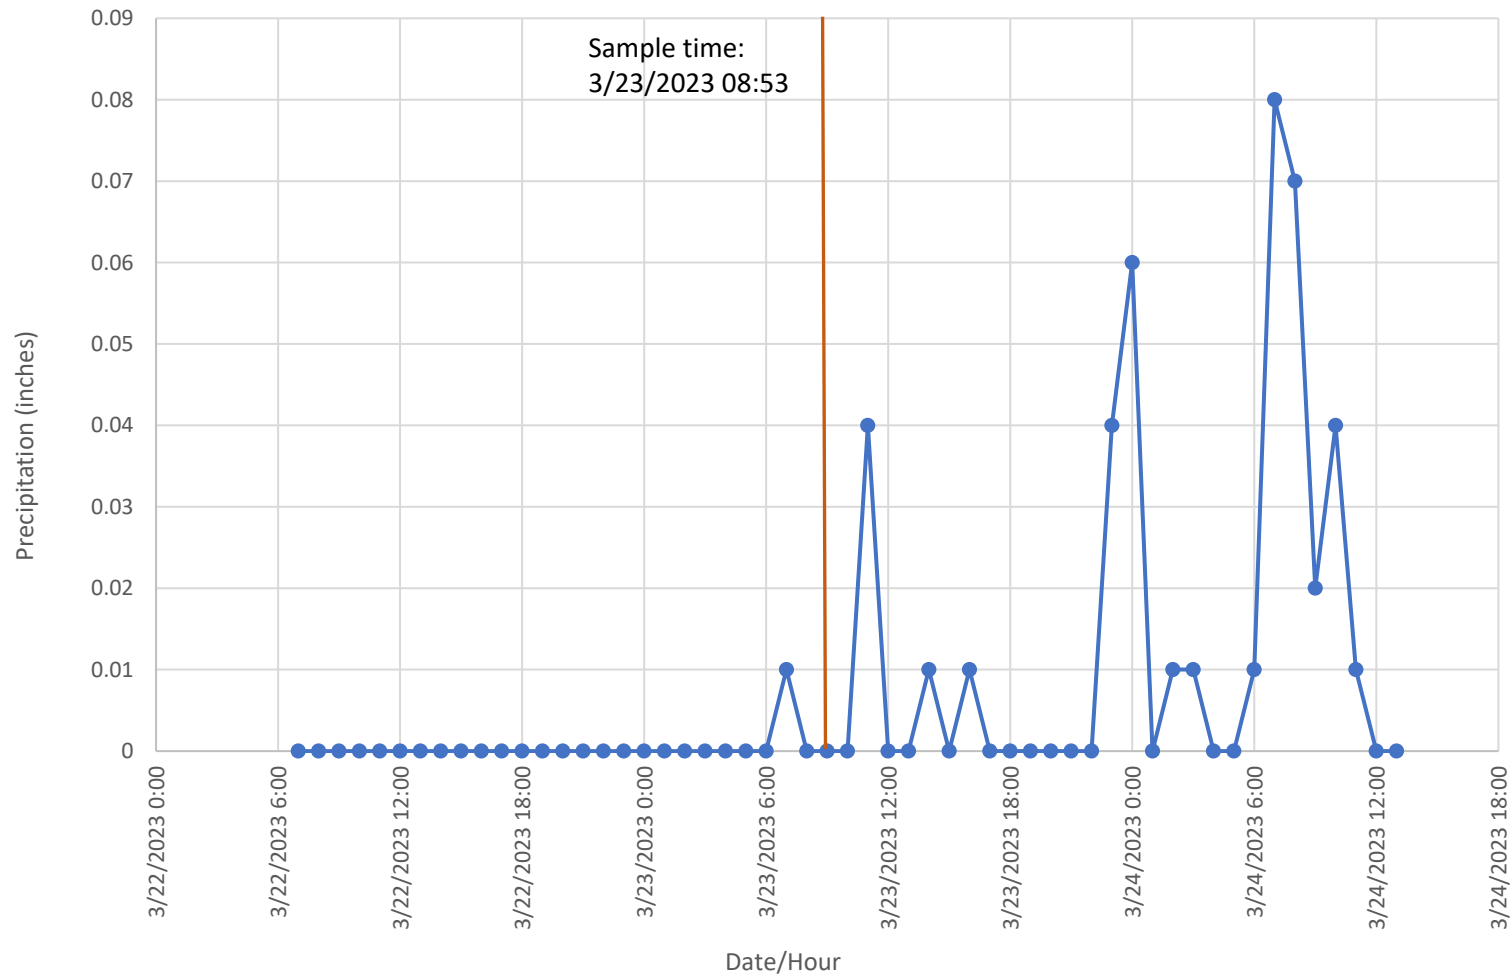
# Hydrograph for March 22-24, 2023

## Mallory Rain Gauge - 8030 NE Mallory Avenue

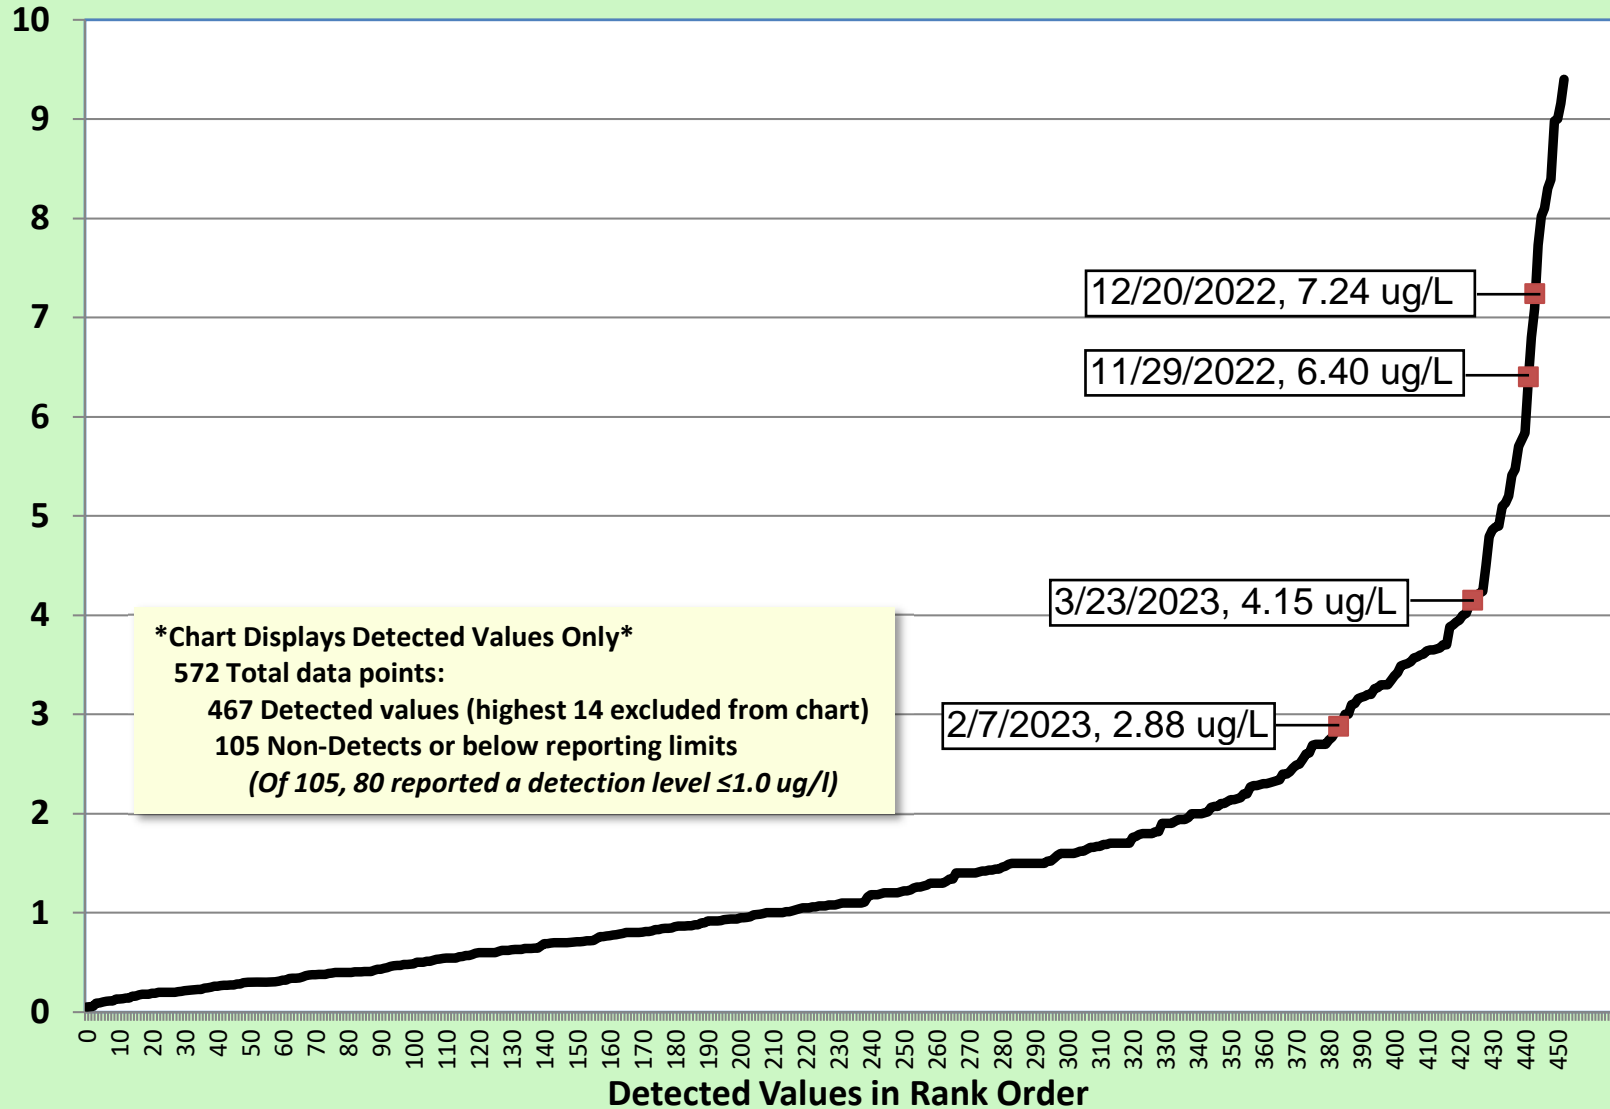
# Arsenic (ug/L) in Stormwater at Portland Harbor Heavy Industrial Sites

ENW Sample Date, Concentration

- b) In storm water, arsenic has been detected exceeding its JCS SLV and also what is considered typical of industrial storm water. The source of elevated levels of arsenic in storm water was further investigated and determined to likely be related to use of rodent traps containing poison on site. During the third storm water sampling event, one of these traps was observed in a landscaped area. Since rodent traps sometimes contain arsenic, to mitigate potential contribution of arsenic from these traps to storm water, the property owner removed all rat traps from areas that may come into contact with precipitation. Based on additional storm water sampling following removal of the rat traps, the concentration of arsenic in storm water is within the knee of the curve for "typical industrial stormwater concentrations" per ODEQ's *Tool for Evaluating Stormwater Data* (see Appendix C).

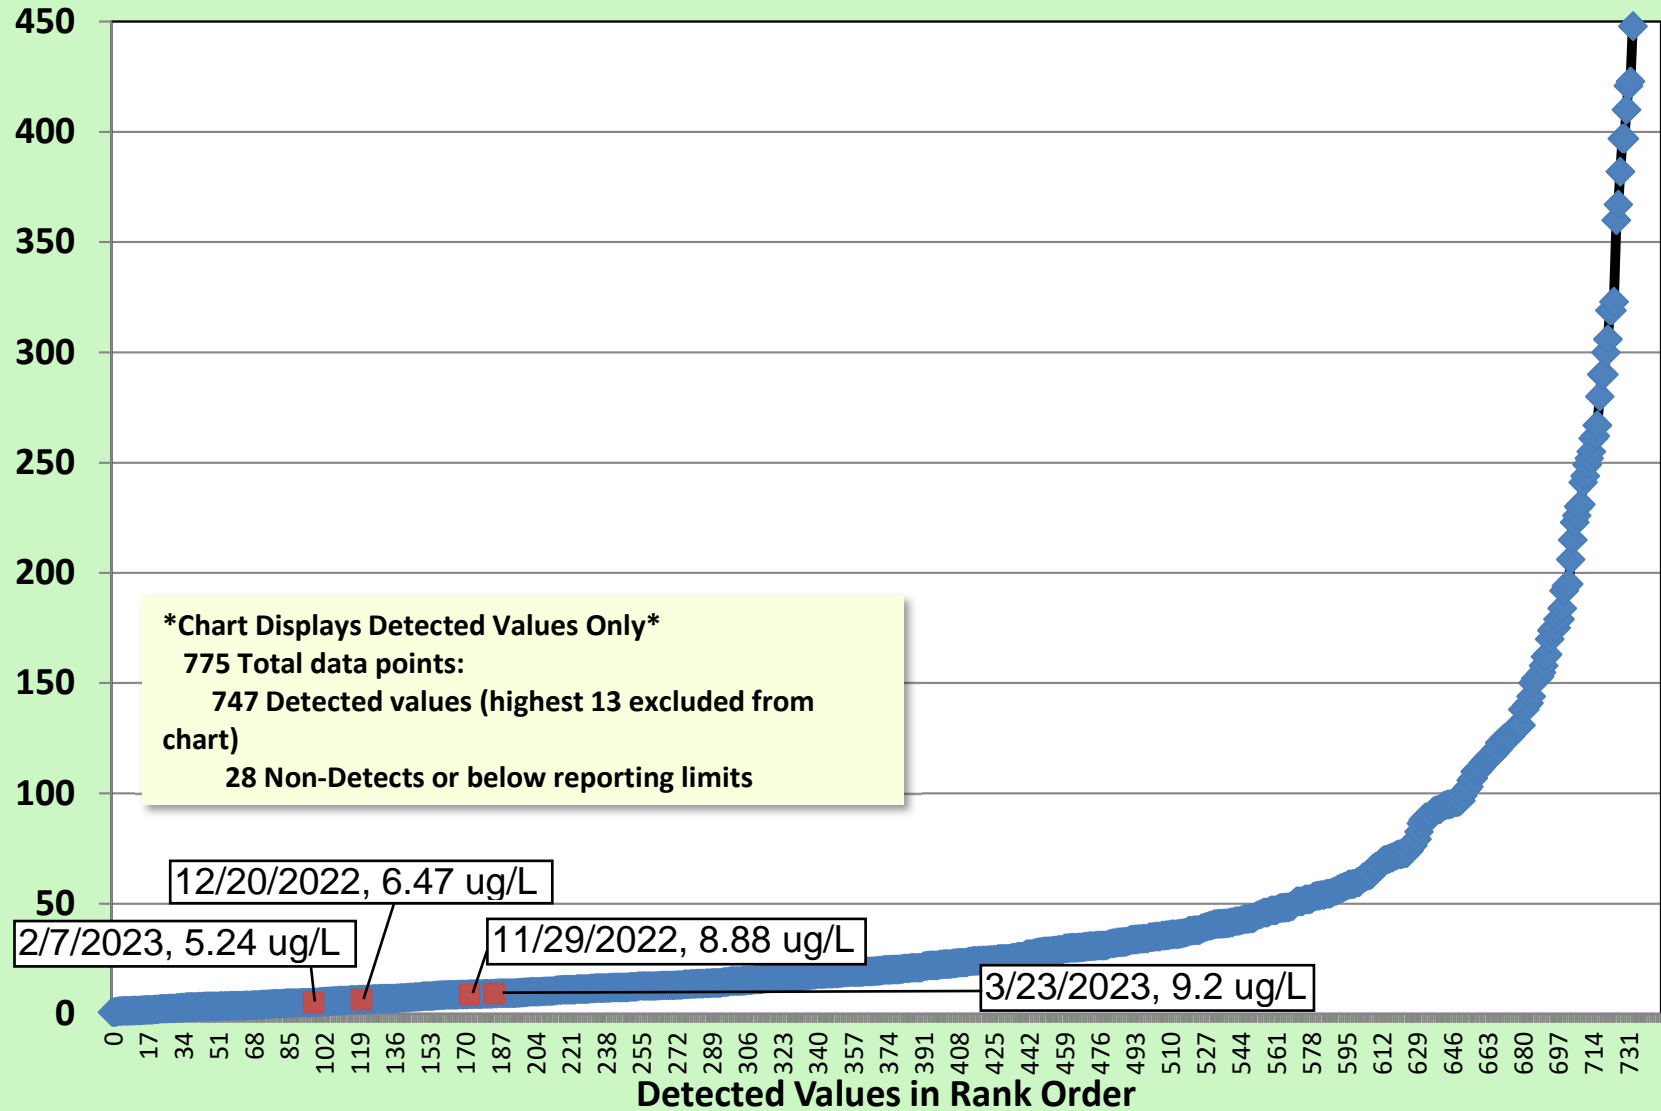
# Copper (ug/L) in Stormwater at Portland Harbor Heavy Industrial Sites

ENW Sample Date, Concentration

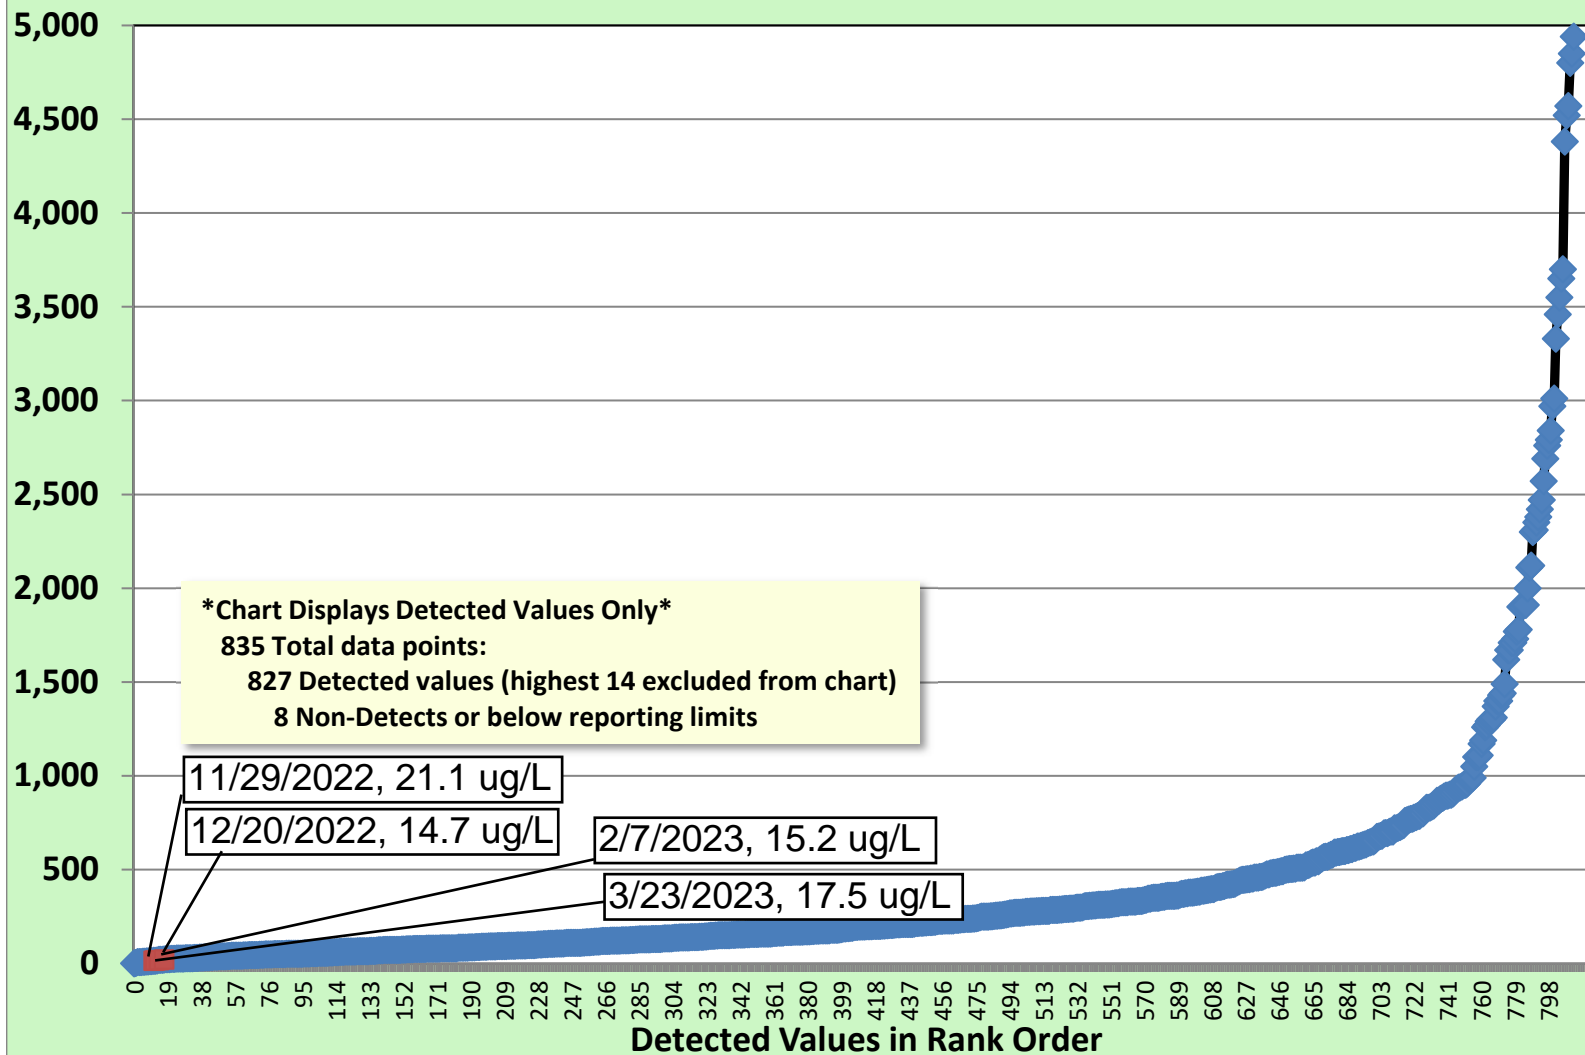
# Zinc (ug/L) in Stormwater at Portland Harbor Heavy Industrial Sites

ENW Sample Date, Concentration
