**Subject:** Western Farm Services - Hopmere, ECSI # 4030; Staff Memorandum in Support of a No Further Action Determination

This document presents the basis for the Oregon Department of Environmental Quality's (DEQ's) recommended No Further Action (NFA) determination for the Western Farm Services site in Salem (Hopmere), Oregon. As discussed in this memorandum, contaminant concentrations in soil and groundwater do not pose a threat to human health and the environment.

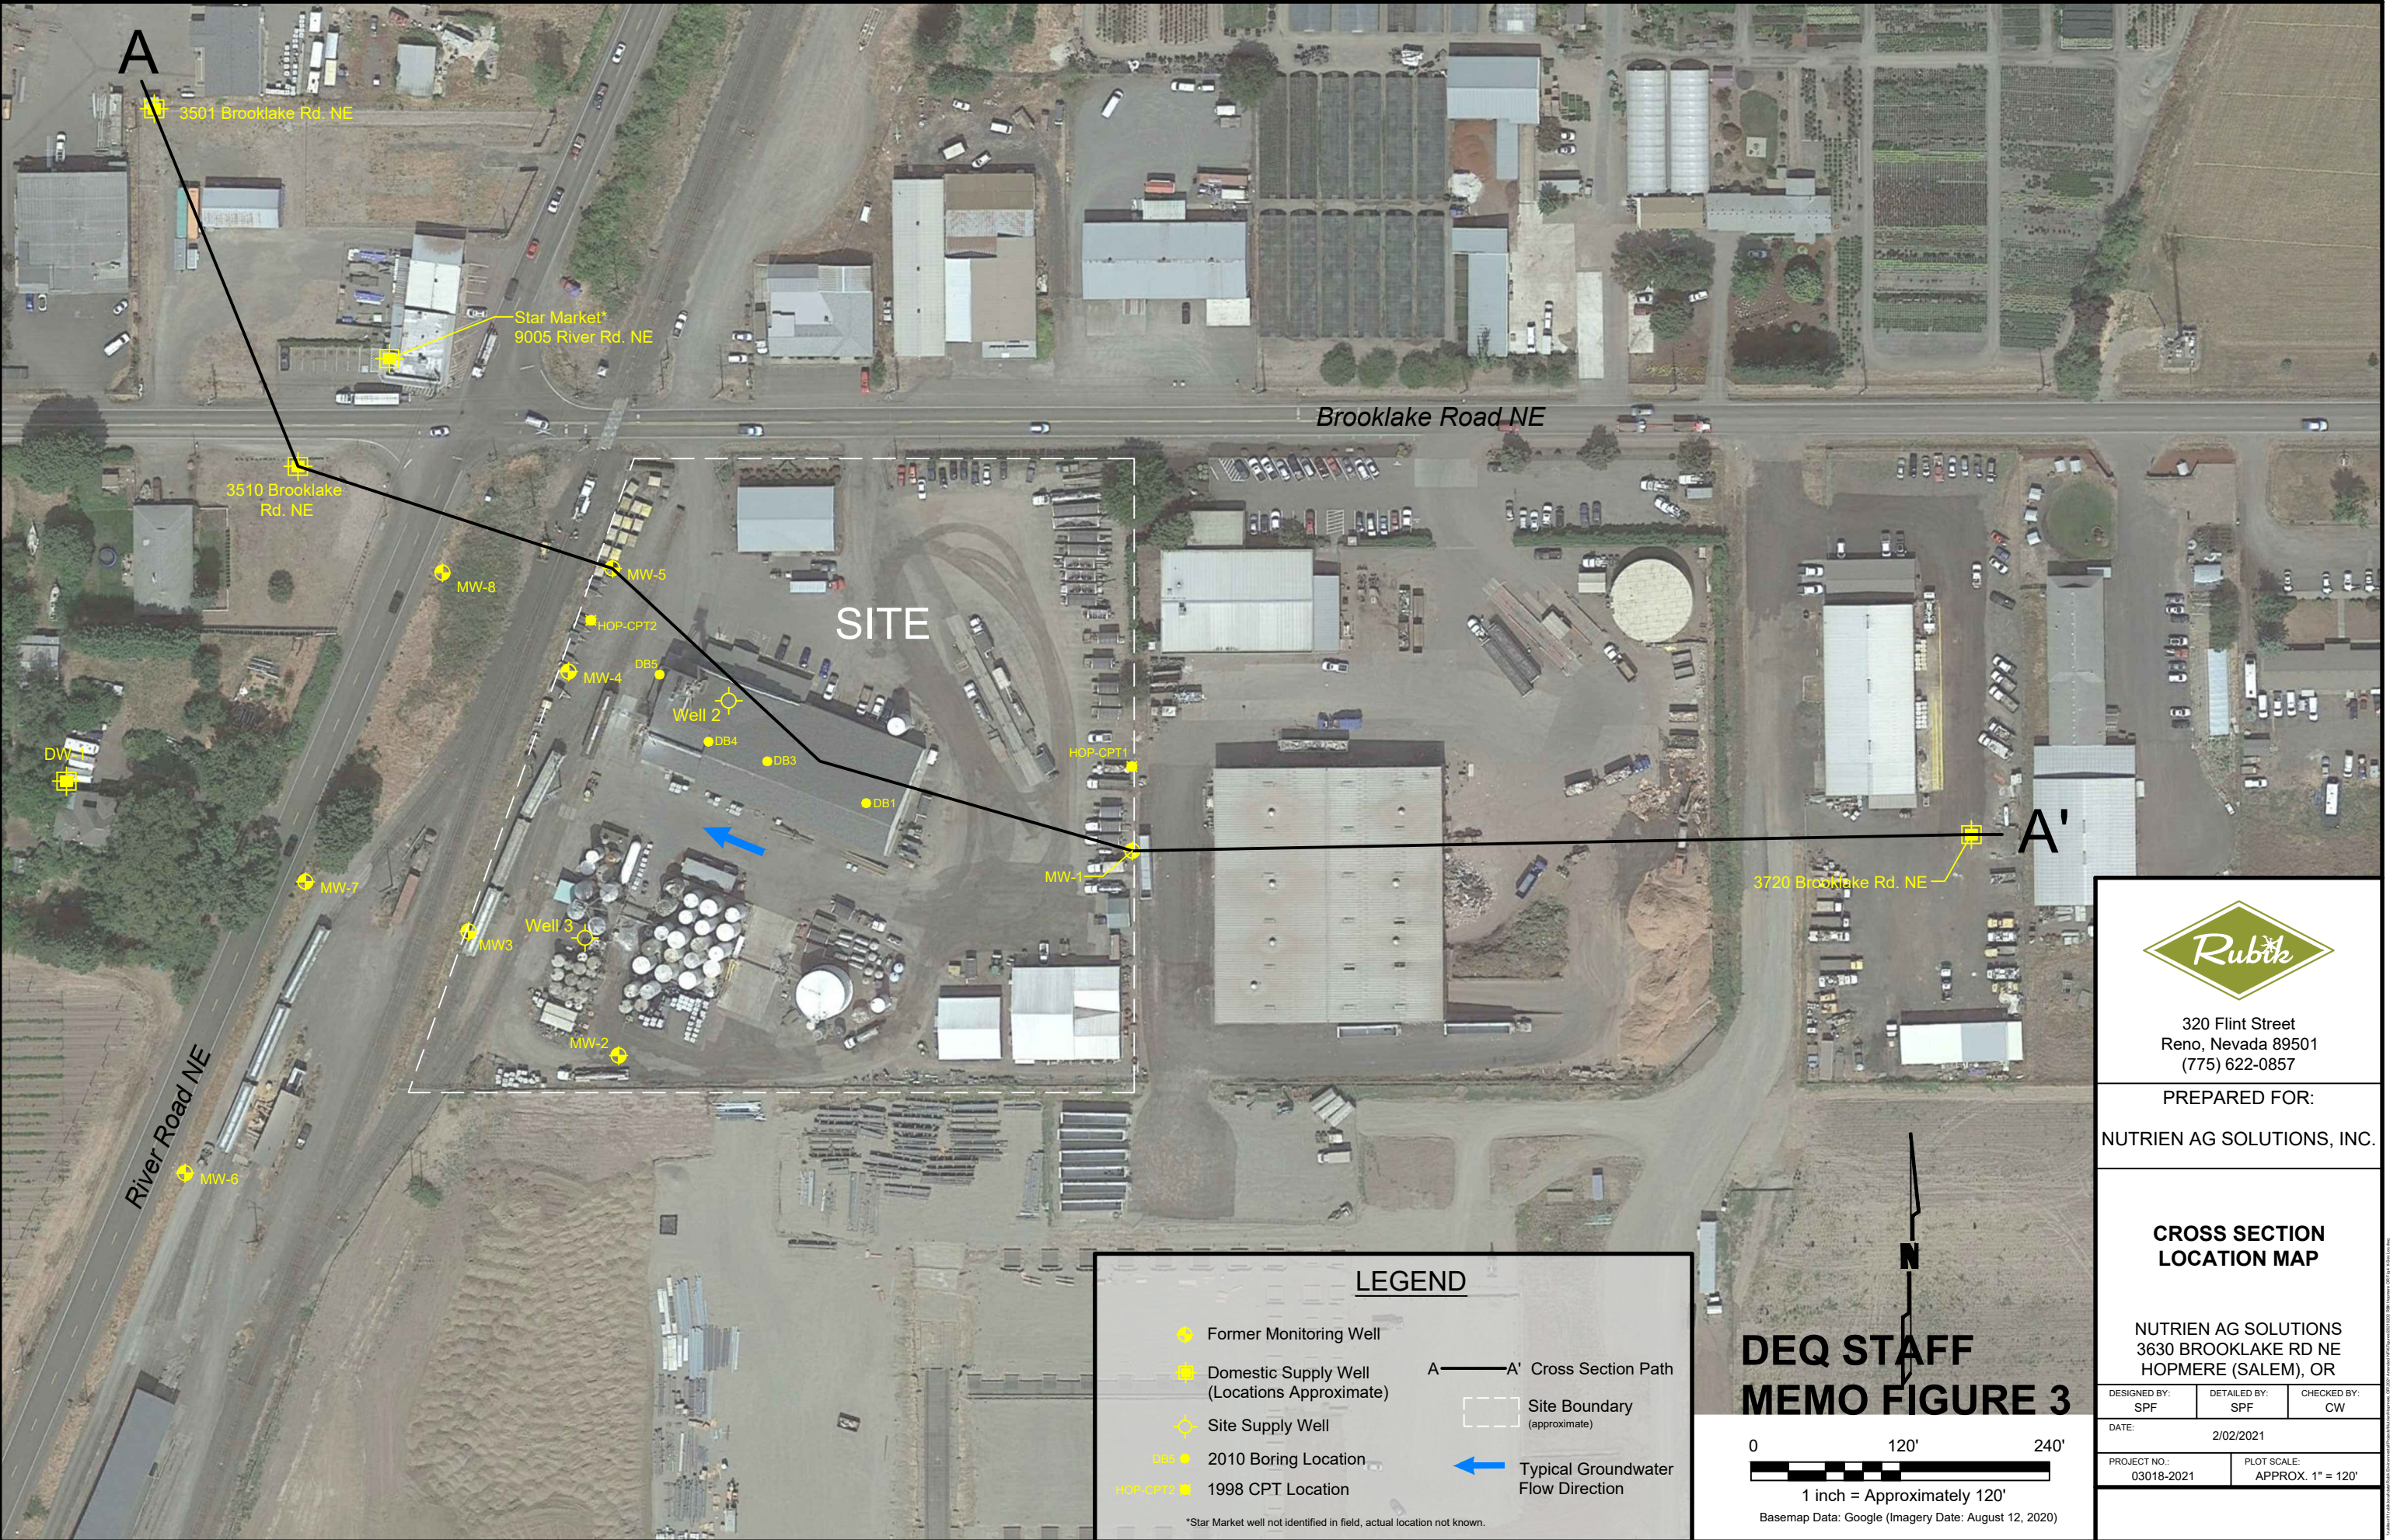
**DEQ STAFF  
MEMO FIGURE 3**

Well logs indicate the deeper aquifer used for potable purposes near the site begins at approximately 80 feet bgs. A geologic cross section and line of section with local supply well locations are presented on Figures 3 and 4.

**CROSS SECTION  
LOCATION MAP**

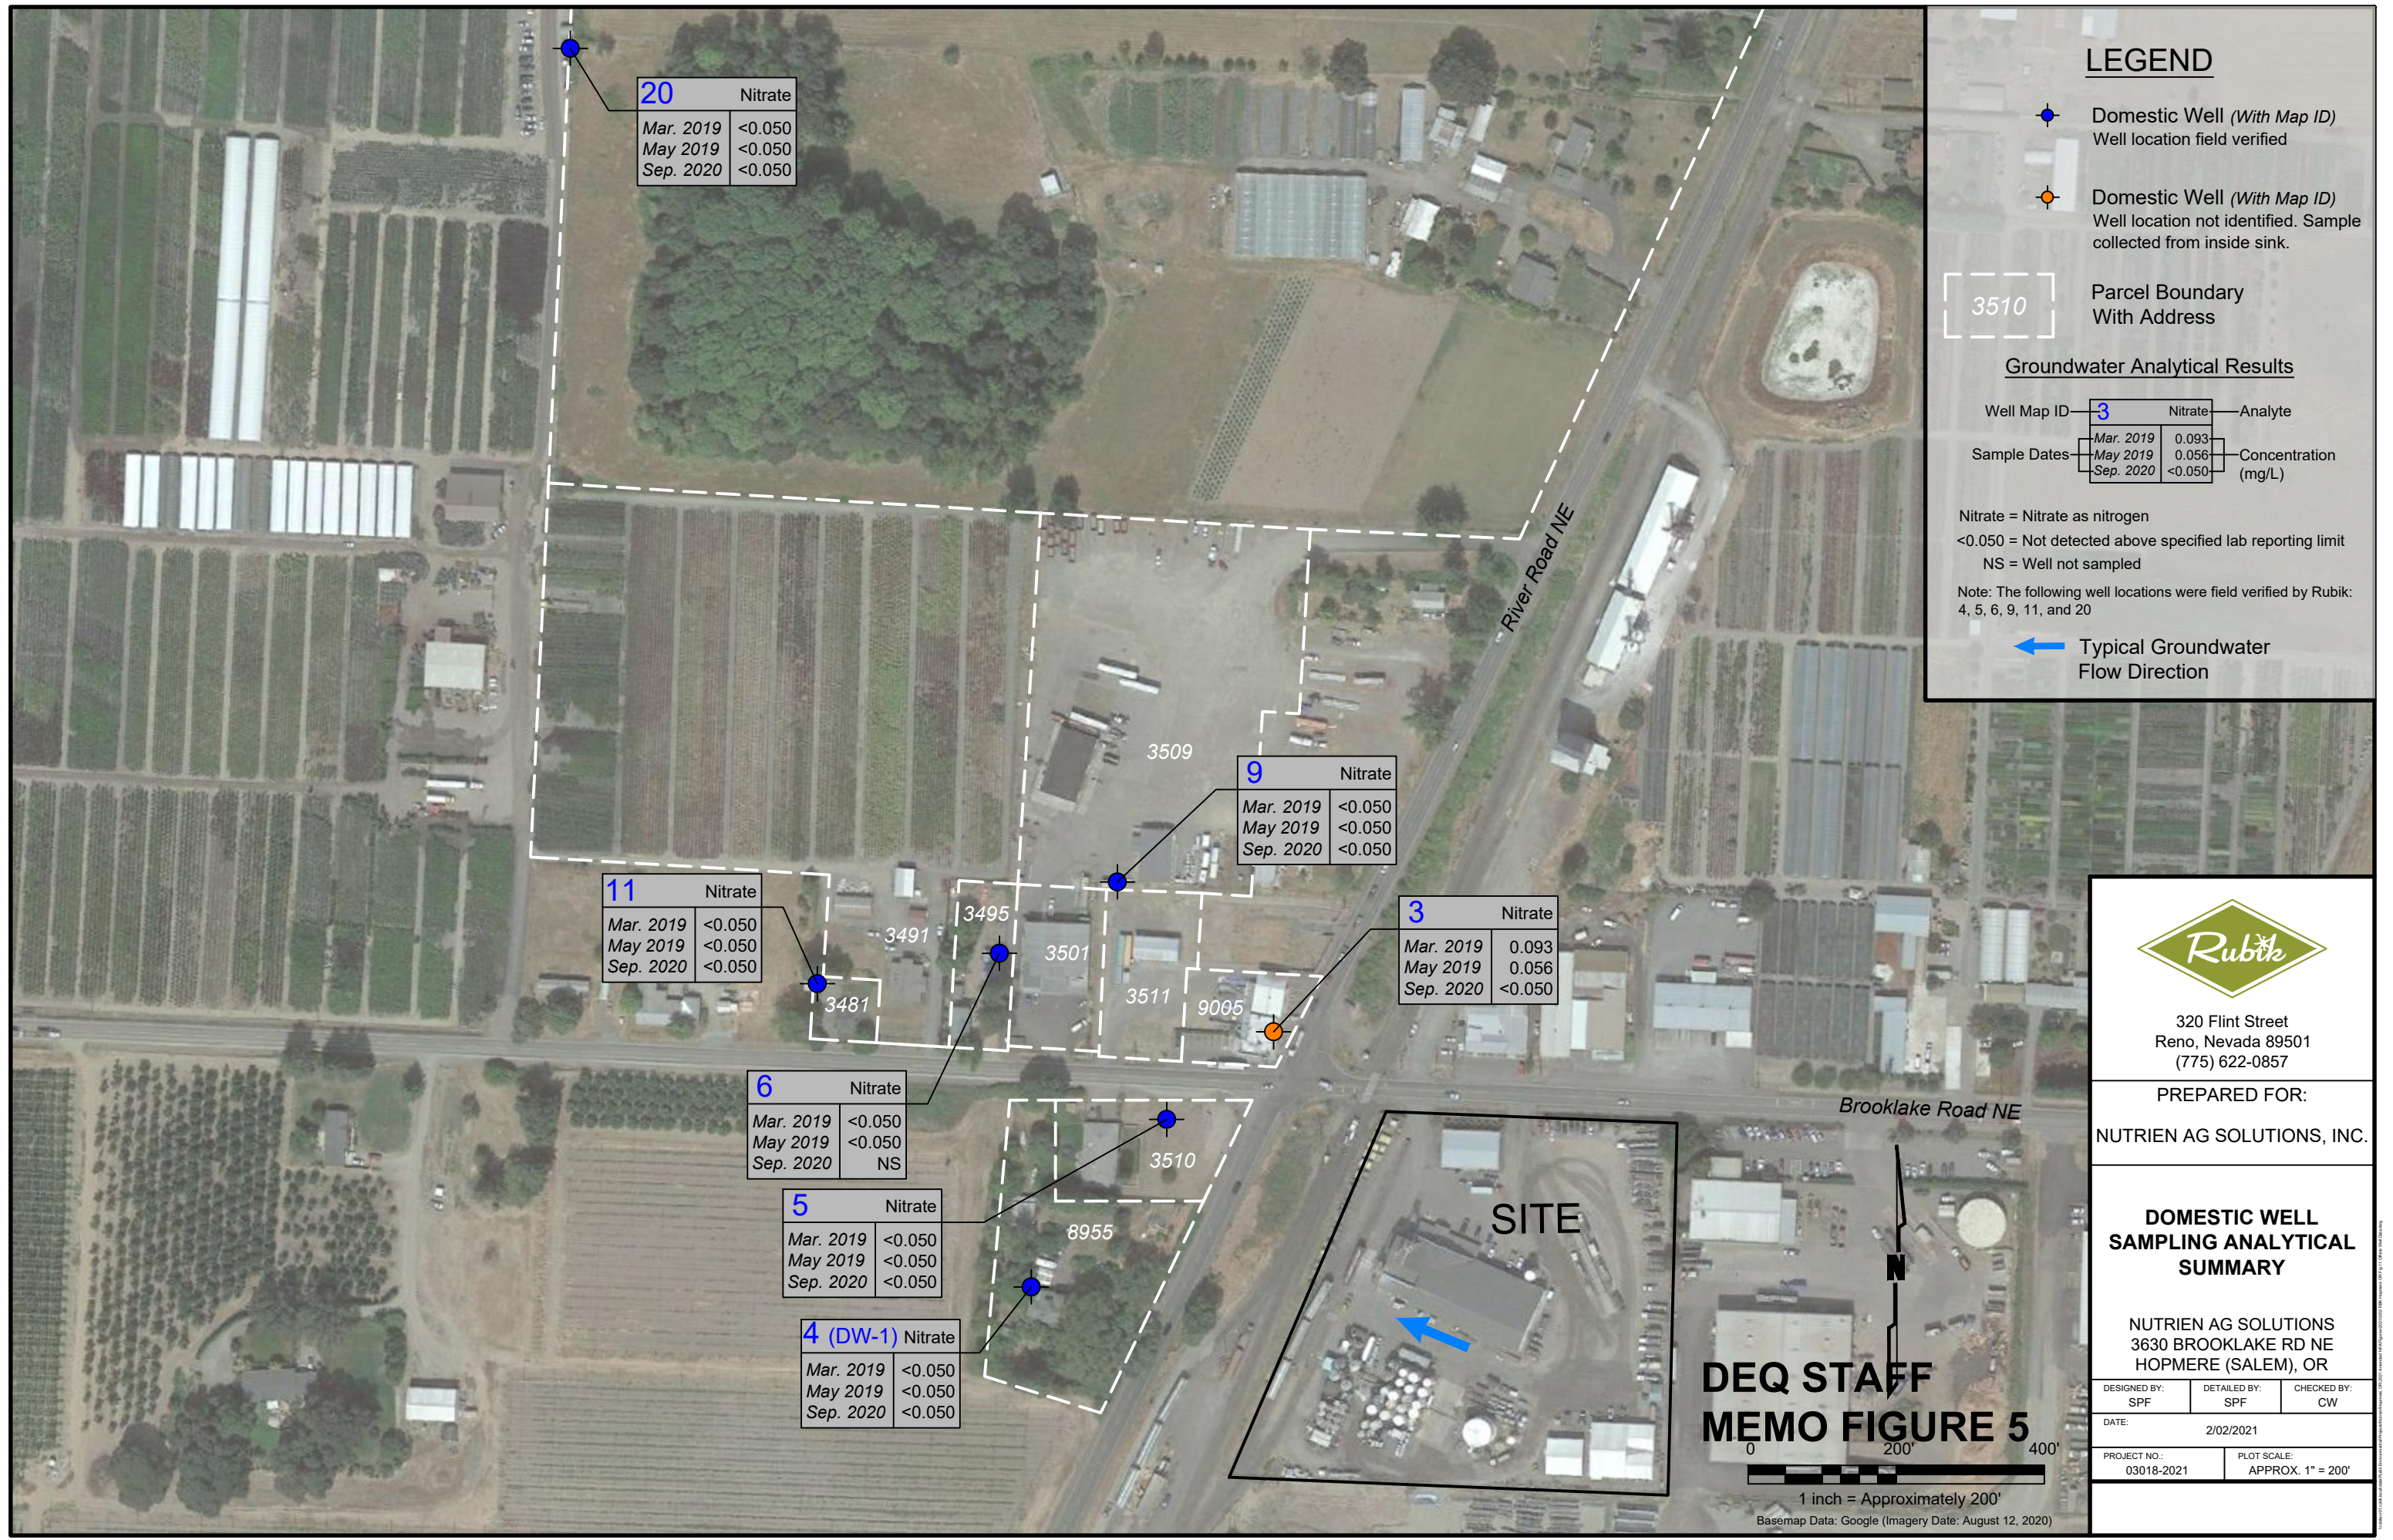
DEQ STAFF  
MEMO FIGURE 5

No other COCs were detected in the offsite supply wells, except for 4-4,DDE (DDE), which was detected at 0.0016 micrograms per liter ( $\mu\text{g/L}$ ) during the September 2020 sampling at the well located at 3491 Brooklake Rd NE. The concentration detected was an order of magnitude less than the EPA RSL for tap water ingestion and DEQ's residential RBC of 0.046  $\mu\text{g/L}$ . DDE was not detected in any previous samples from the well or in any of the samples collected from upgradient supply wells located closer to the site in 2019 and 2020. See Figure 5 for offsite well sample locations and results.

DOMESTIC WELL  
SAMPLING ANALYTICAL  
SUMMARY

Nitrate was detected up to 0.093 mg/L in one of the offsite wells, far below the MCL of 10mg/L. None of the other offsite wells had reportable detections of nitrate. Additionally, seasonal variation was not observed in results between the spring and fall sampling events.

To address potential migration of site contaminants to nearby offsite supply water wells downgradient from the site, during spring of 2019 and fall of 2020, accessible wells were sampled. Nitrate or other COCs were not detected in any of the wells above their respective screening levels.
